Inspection Photos

Operator: Hilcorp Oil and Gas
API: 067-06442
Date: 7/28/2020

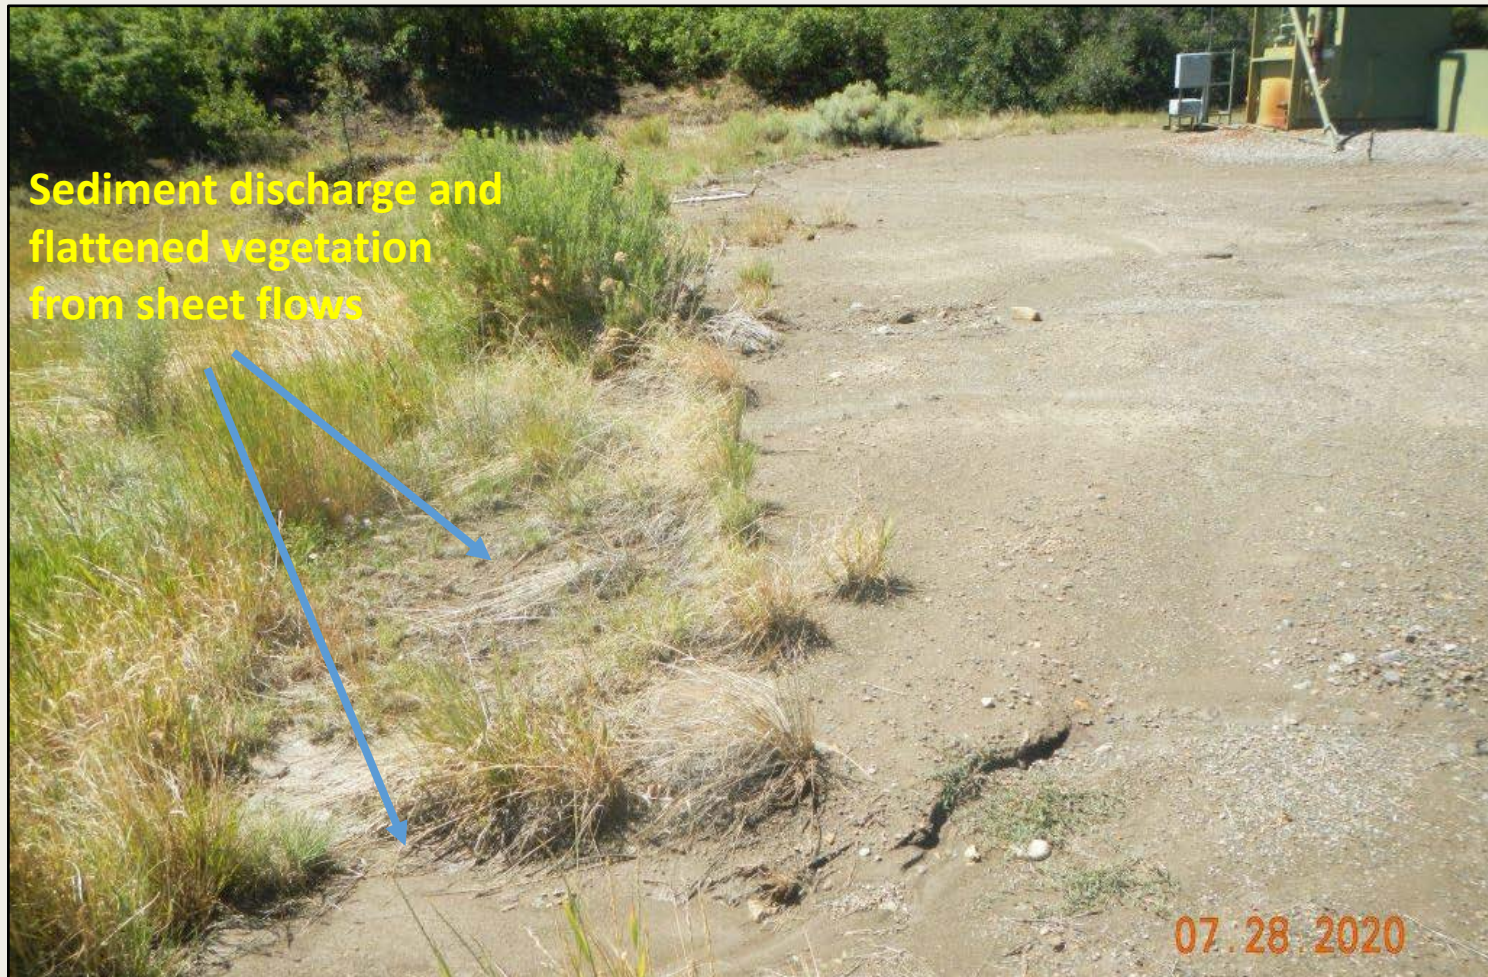
Photo 1. View of the eastern project area from the eastern edge facing southward. Stormwater sheet-flows are carrying sediment off of the eastern edge of the project area.

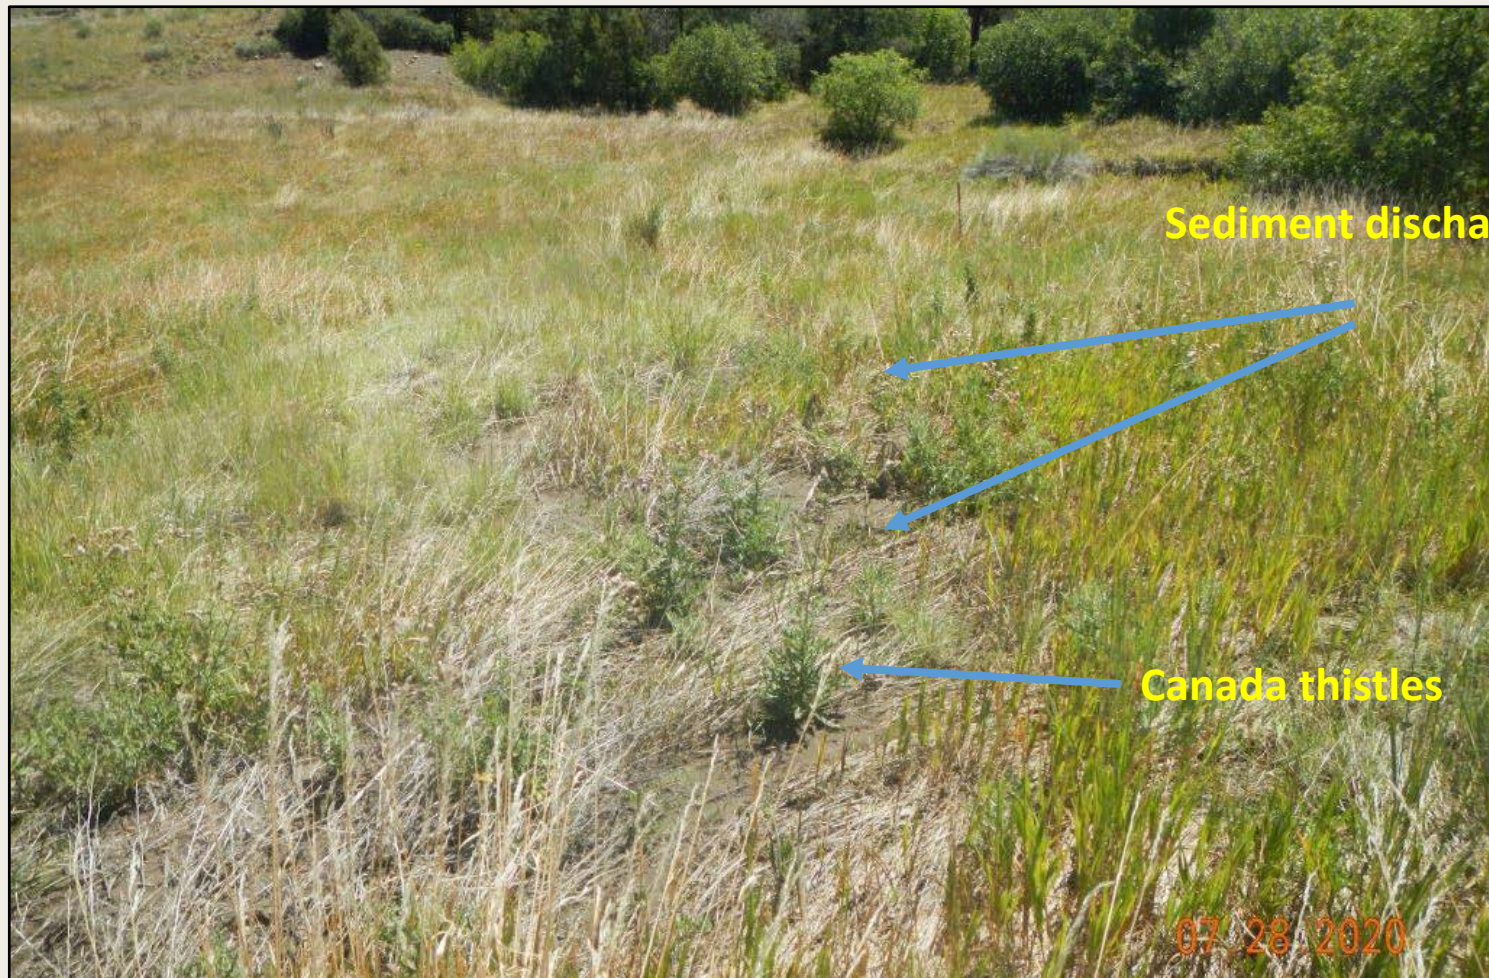
Photo 2. View of the eastern interim reclamation area facing down-slope. Vegetation is established and largely comprised of smooth brome and western wheatgrass. Sediment discharge from the well pad flows down-slope and off of the project area. Canada thistles are also present here.

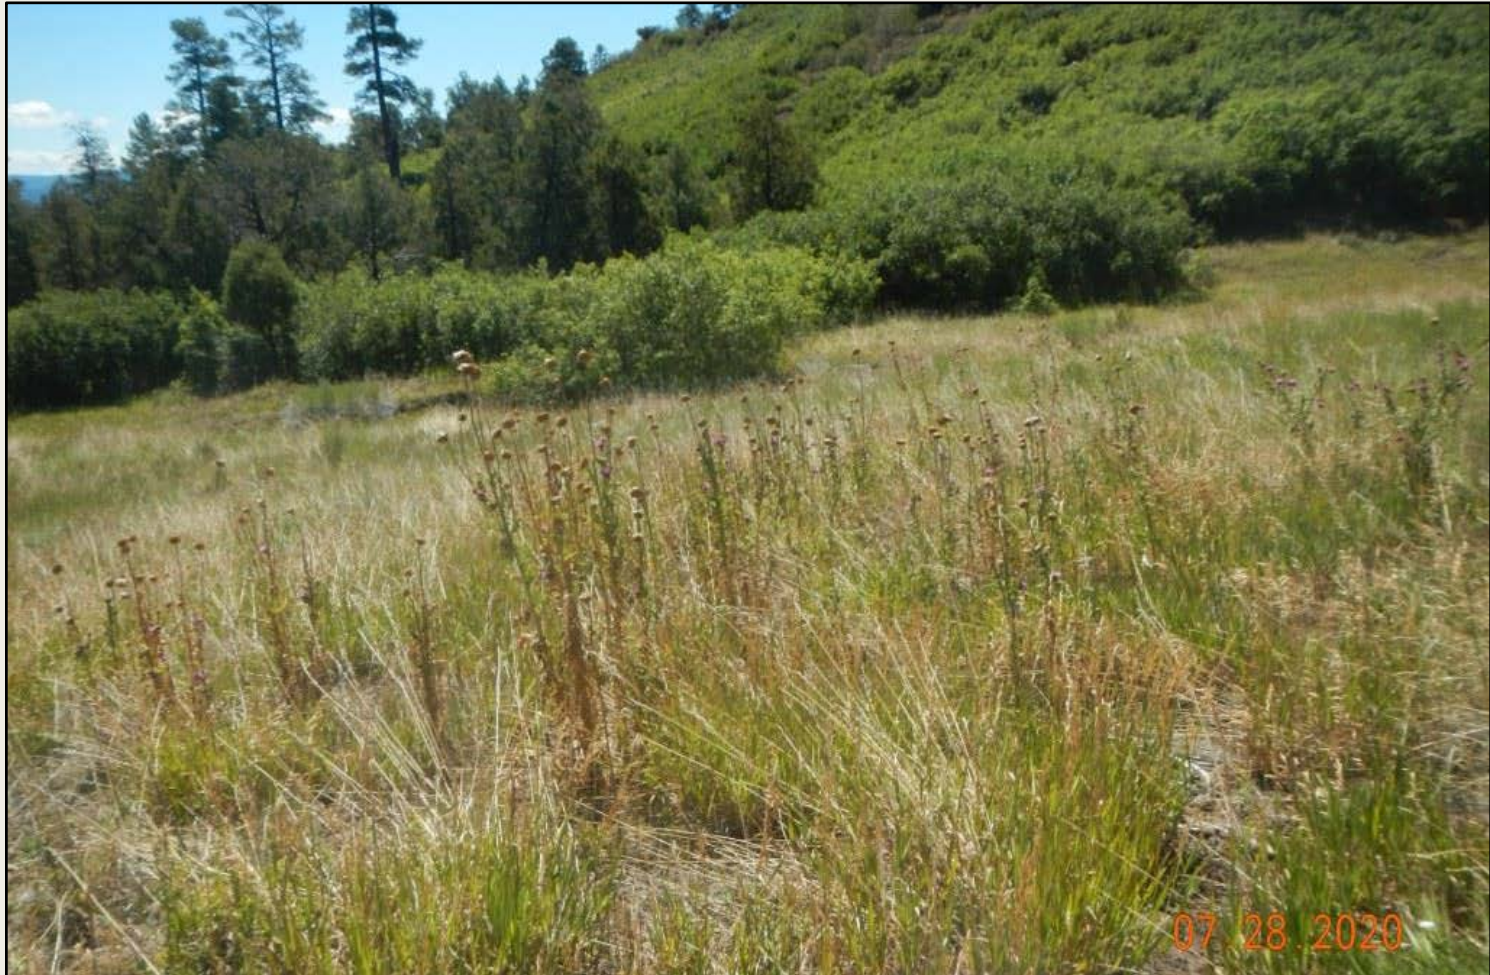
Photo 3. View of musk thistles within the eastern project area. Approximately 200 individuals observed.
