Inspection Photos

Location Name: MARALEX RESOURCES INC USA-610S98W /22SWSW

Location ID: 312576

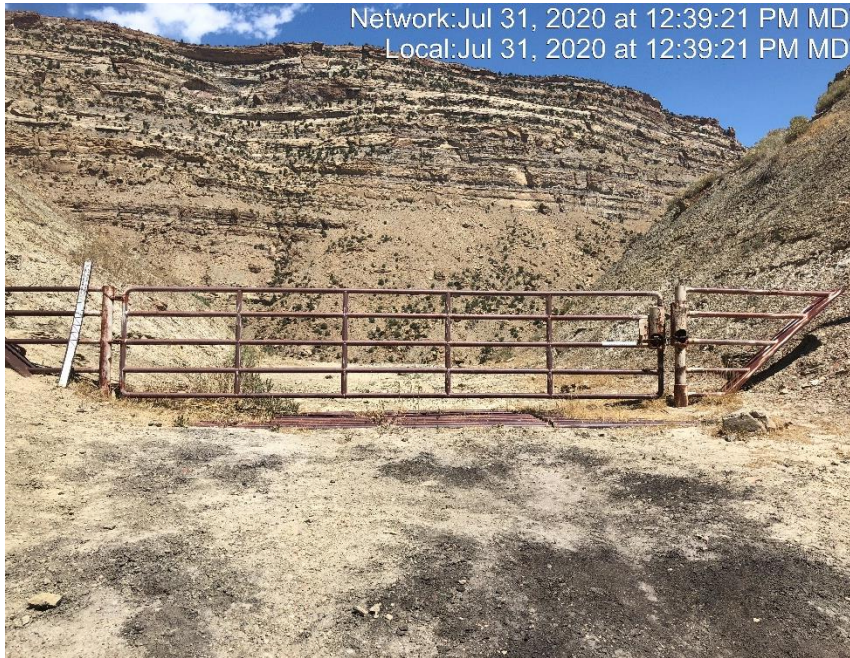
Photo #1657 Locked gate.
