# Inspection Photos

7/31/2020

Operator: CHEVRON USA INC - 16700

Location ID: 383262

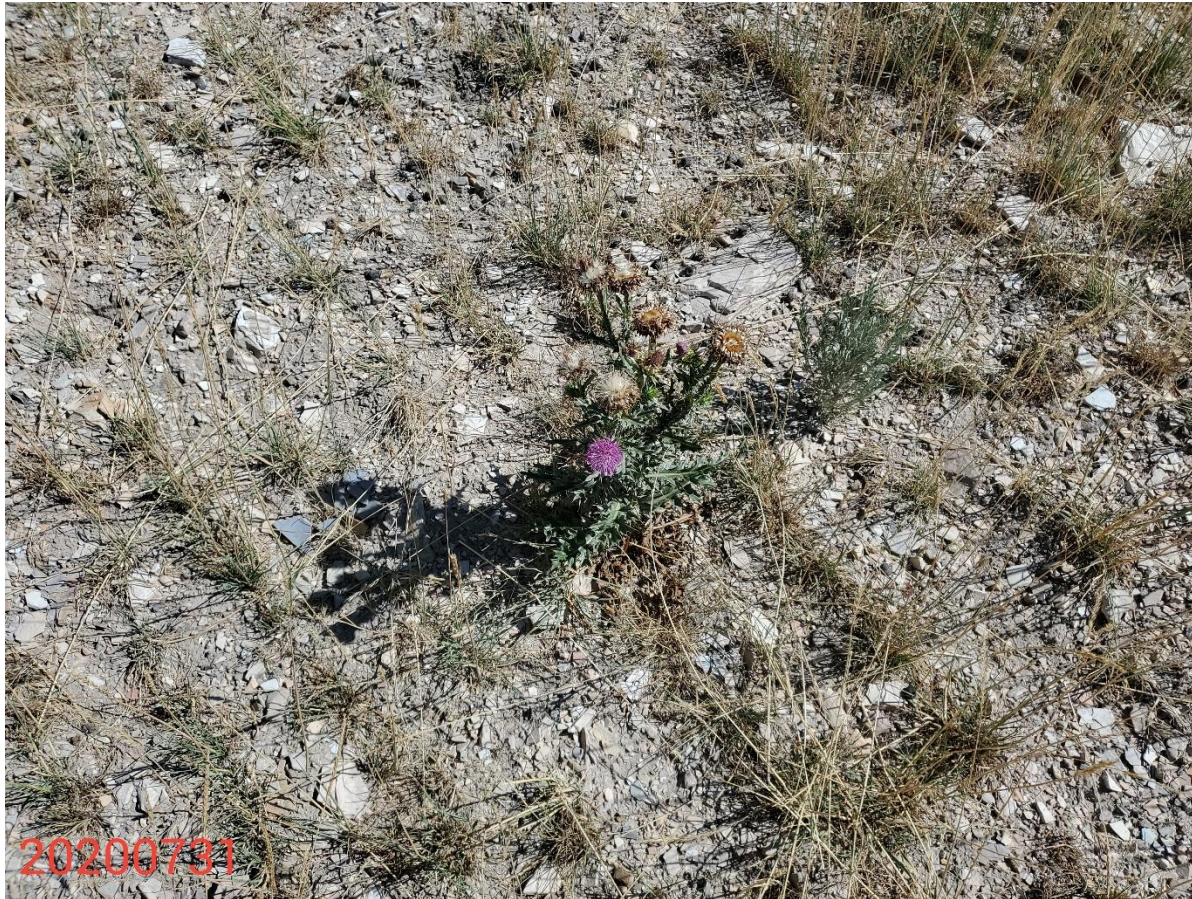
**Photo 1:** Photo taken from the Location. Photo shows Musk thistle establishing on the location.

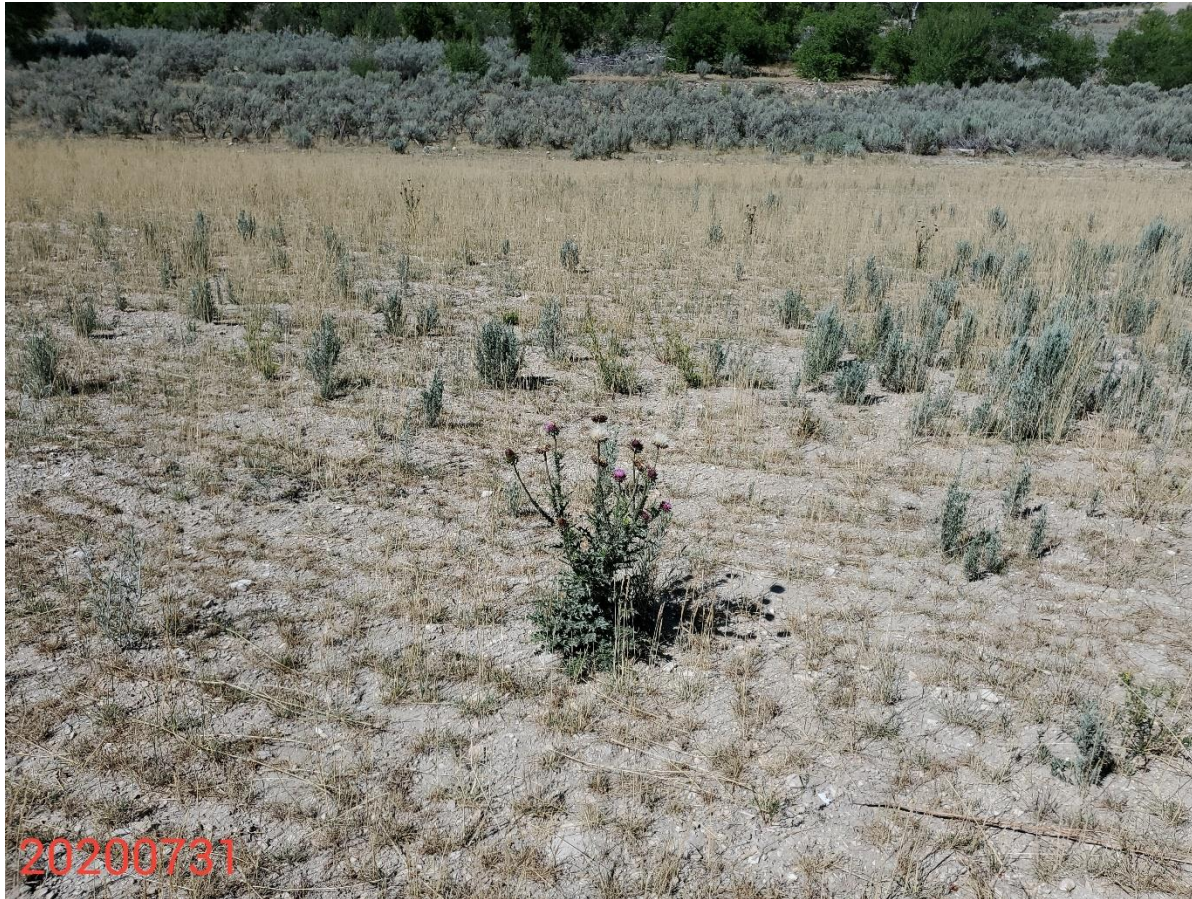
**Photo 2:** Photo taken from the Location. Photo shows Musk thistle establishing on the location.

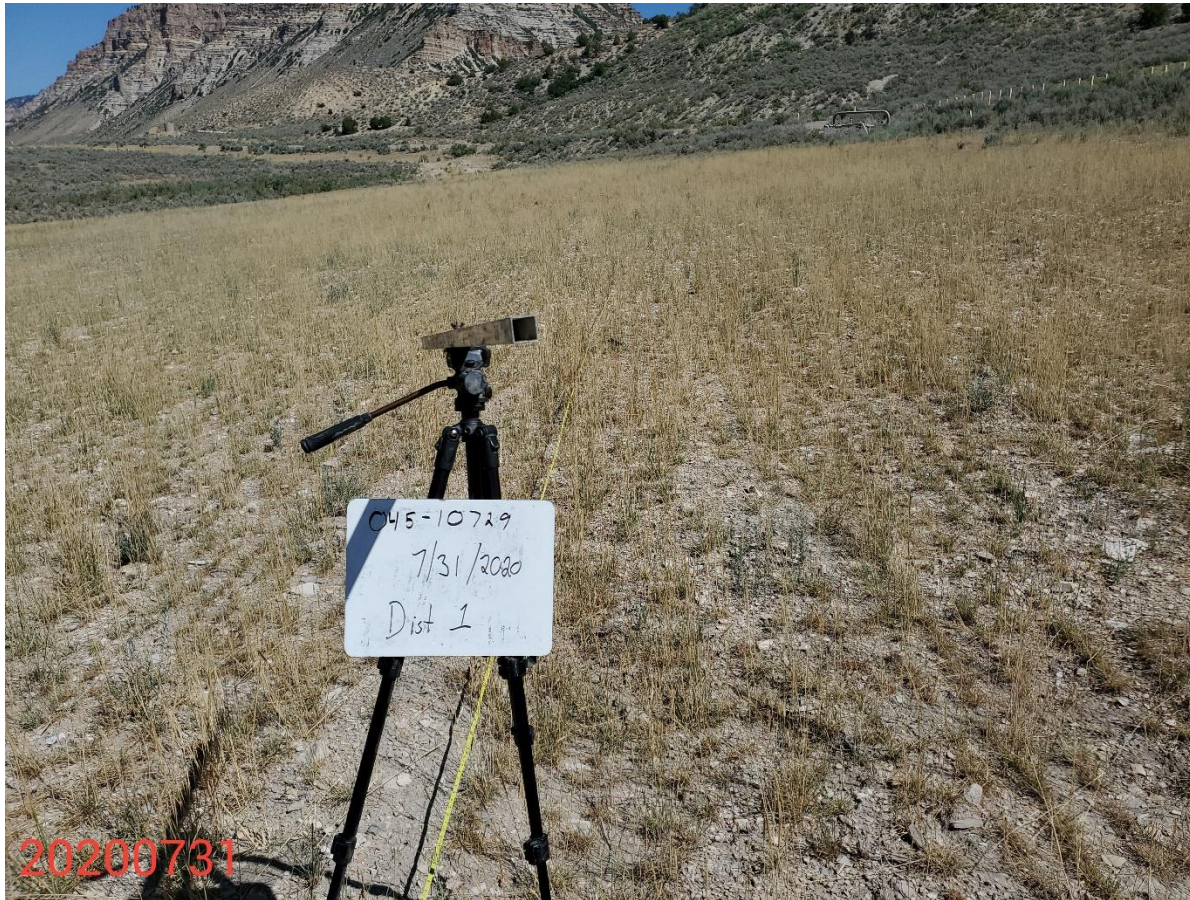
**Photo 3:** Photo of the starting point for **disturbance area transect #1**, facing north.

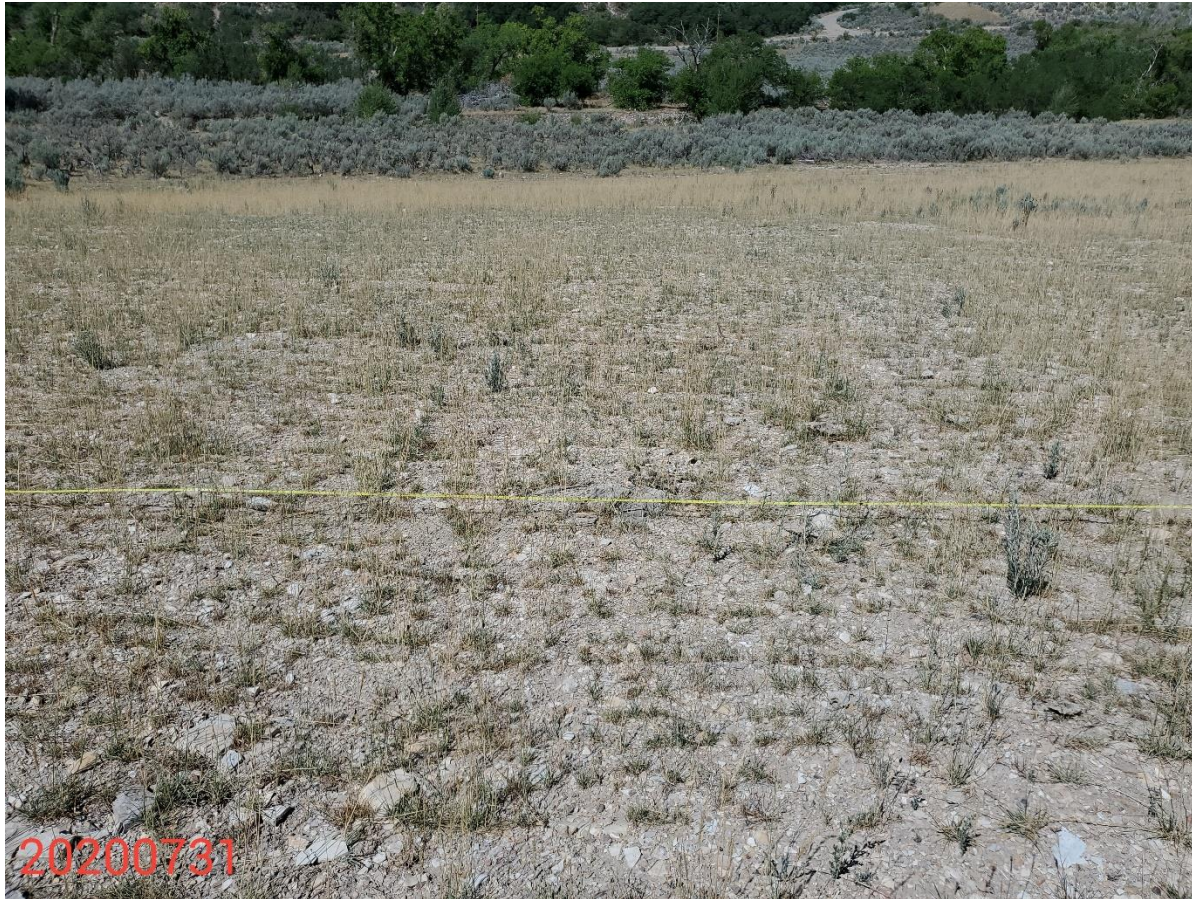
**Photo 4:** Photo of the 50<sup>th</sup> point of the **disturbance area transect #1**, facing west.

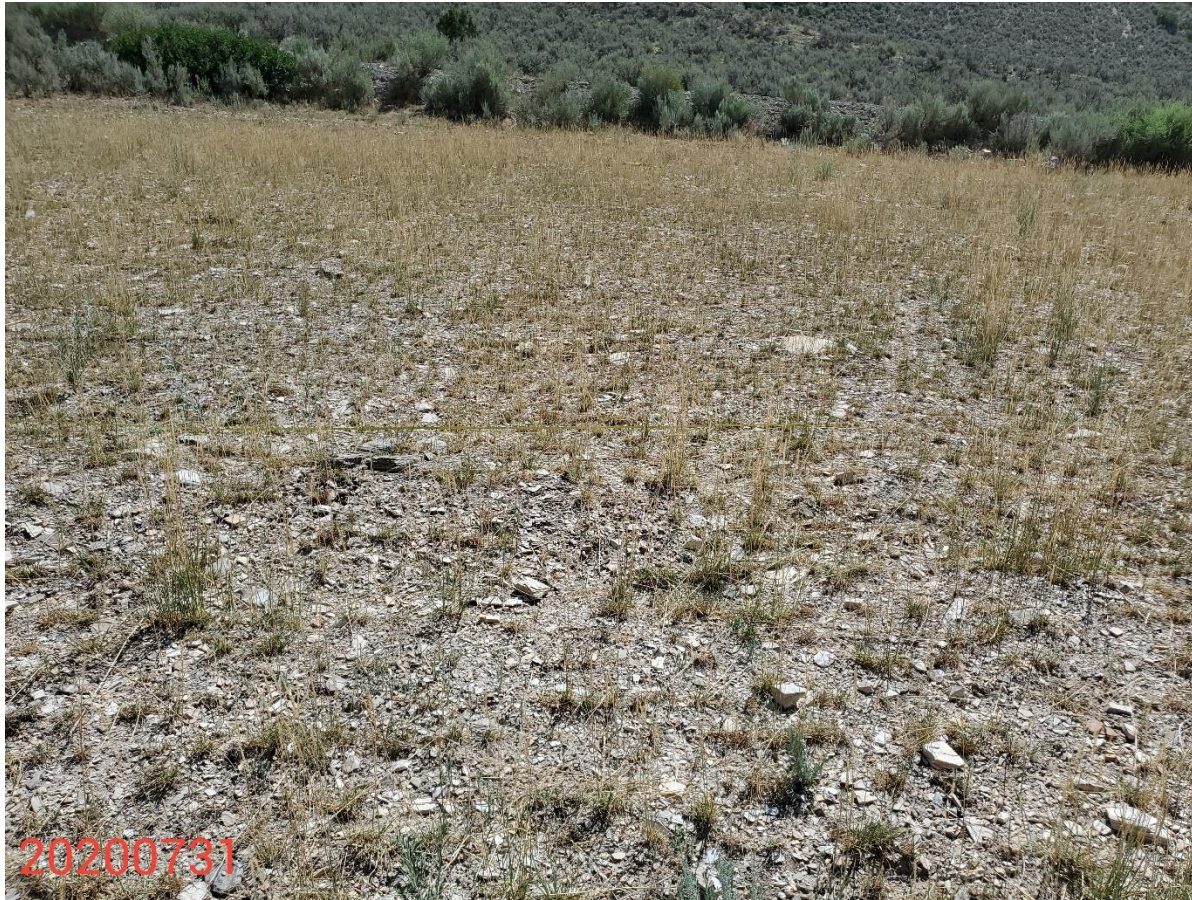
**Photo 5:** Photo of the 50<sup>th</sup> point of the **disturbance area transect #1**, facing east.

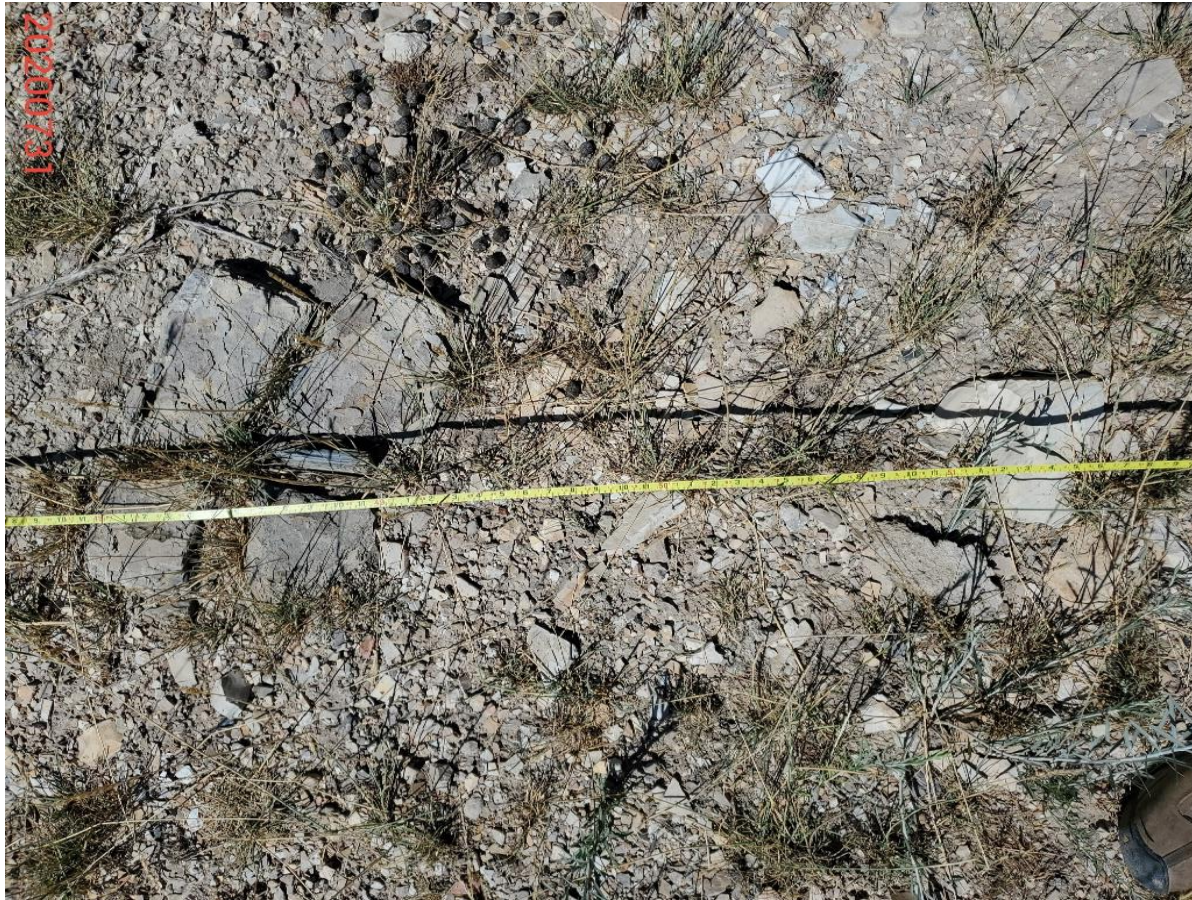
**Photo 6:** Photo of the 50<sup>th</sup> point of the **disturbance area transect #1**.

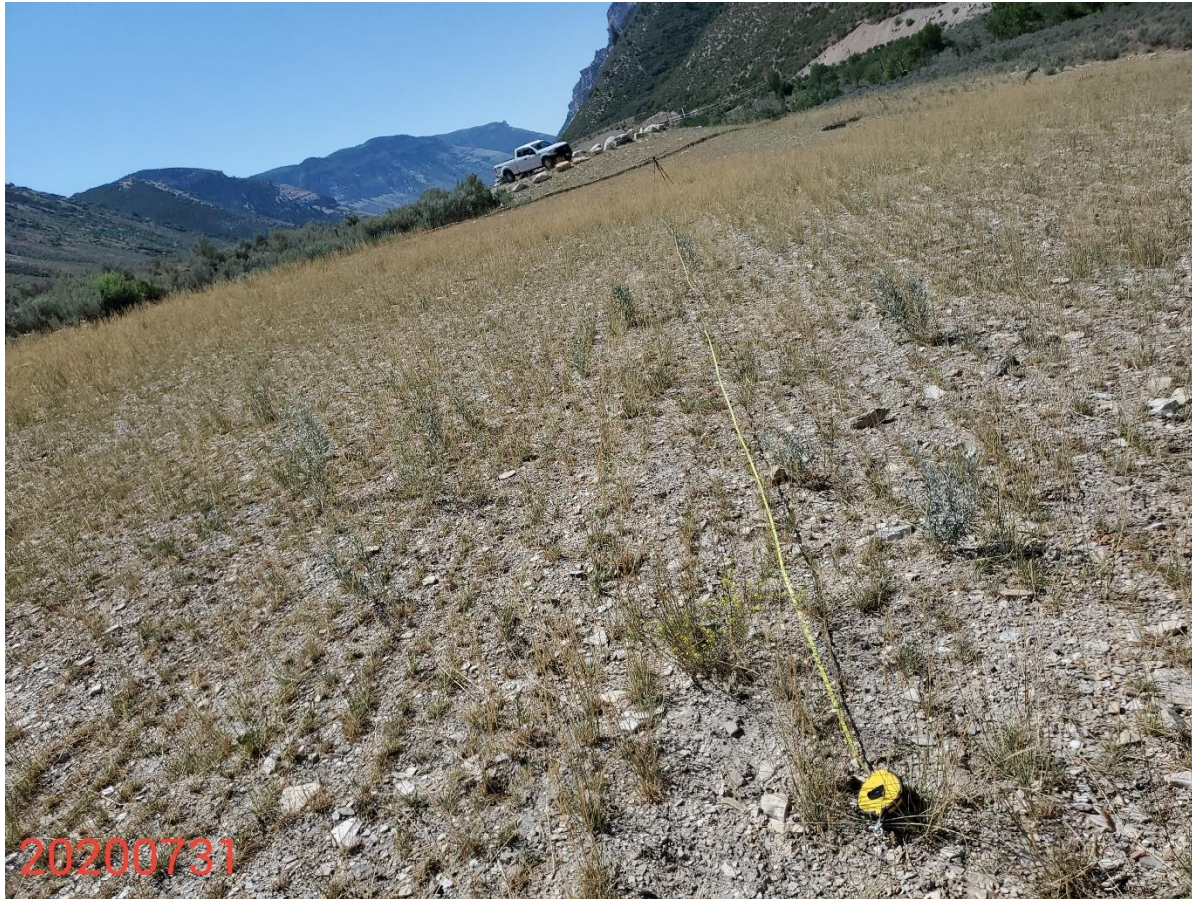
**Photo 7:** Photo of the end point for the **disturbance area transect #1**, facing south.

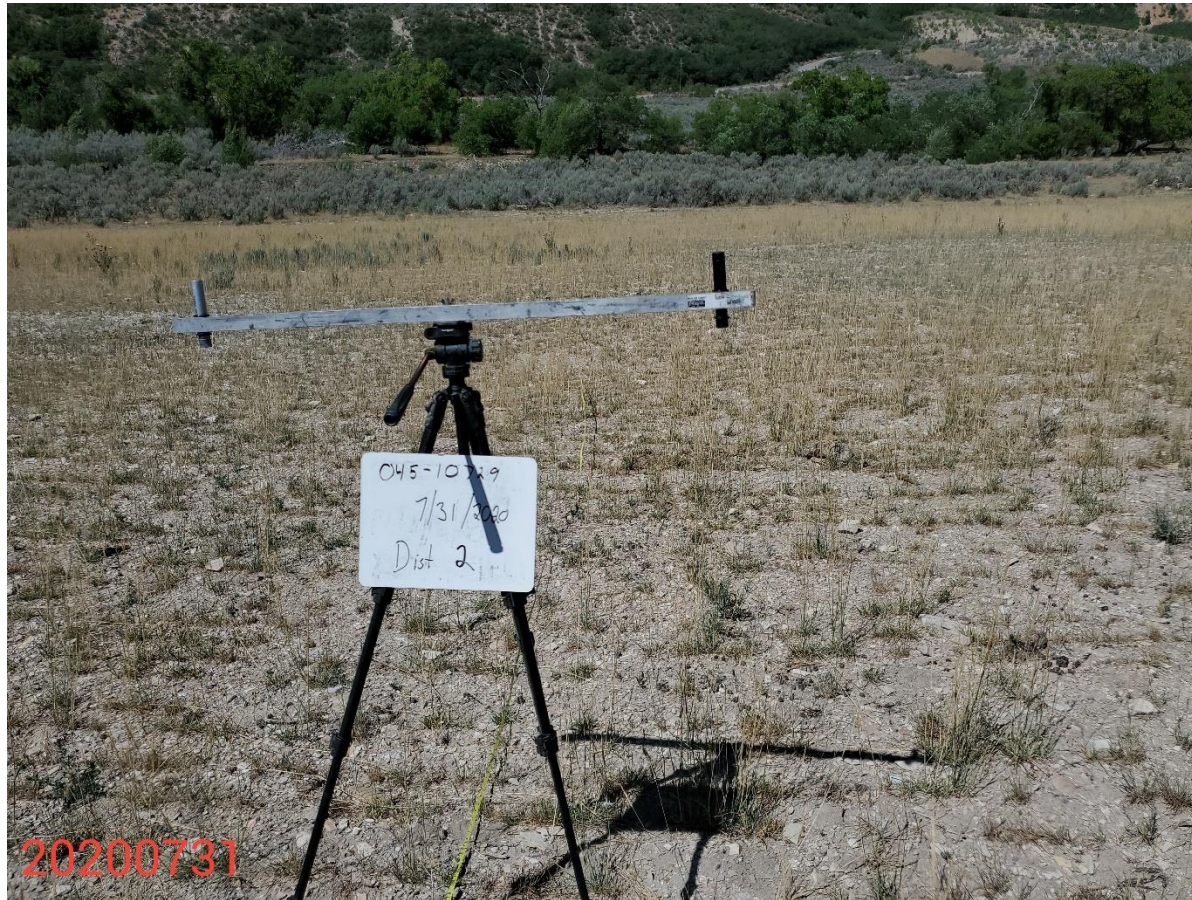
**Photo 8:** Photo of the starting point for **disturbance area transect #2**, facing west.

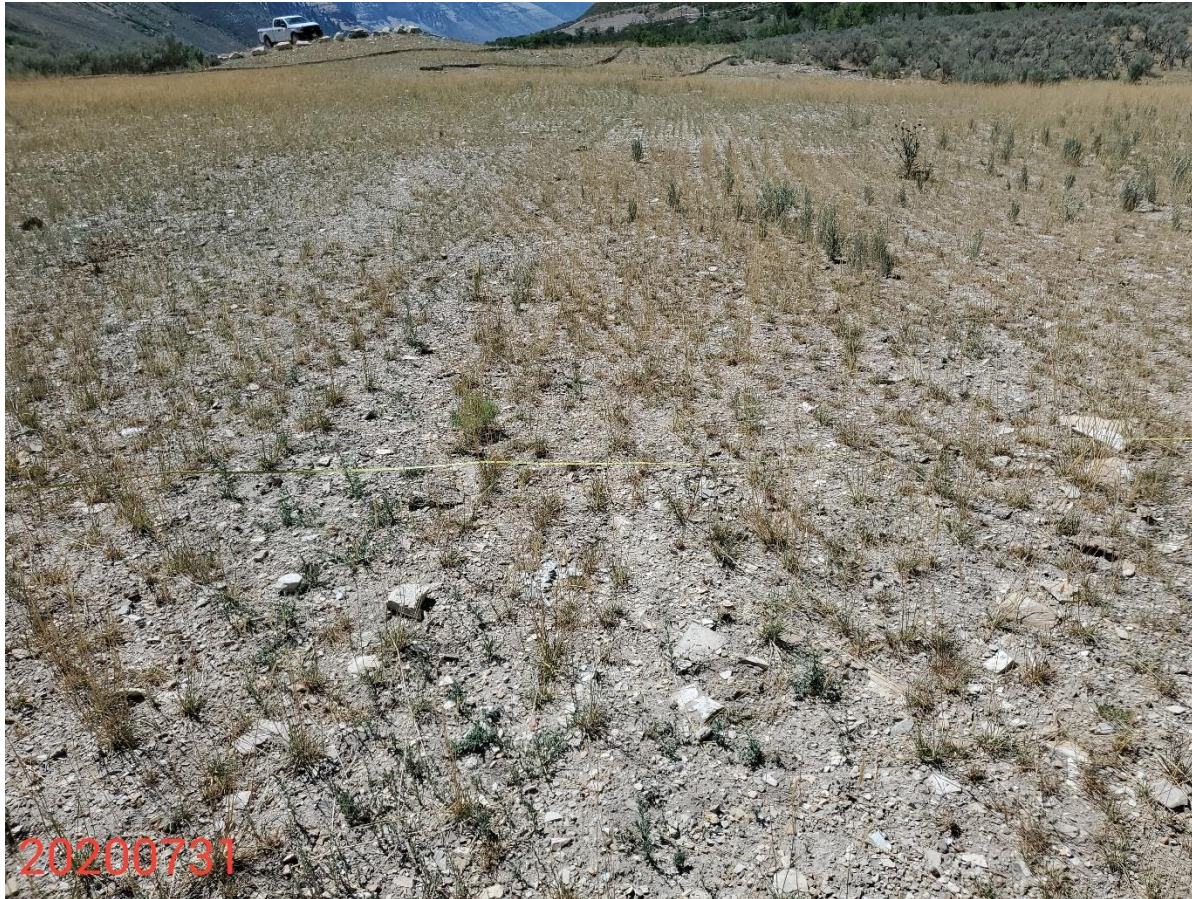
**Photo 9:** Photo of the 50<sup>th</sup> point of the **disturbance area transect #2**, facing north

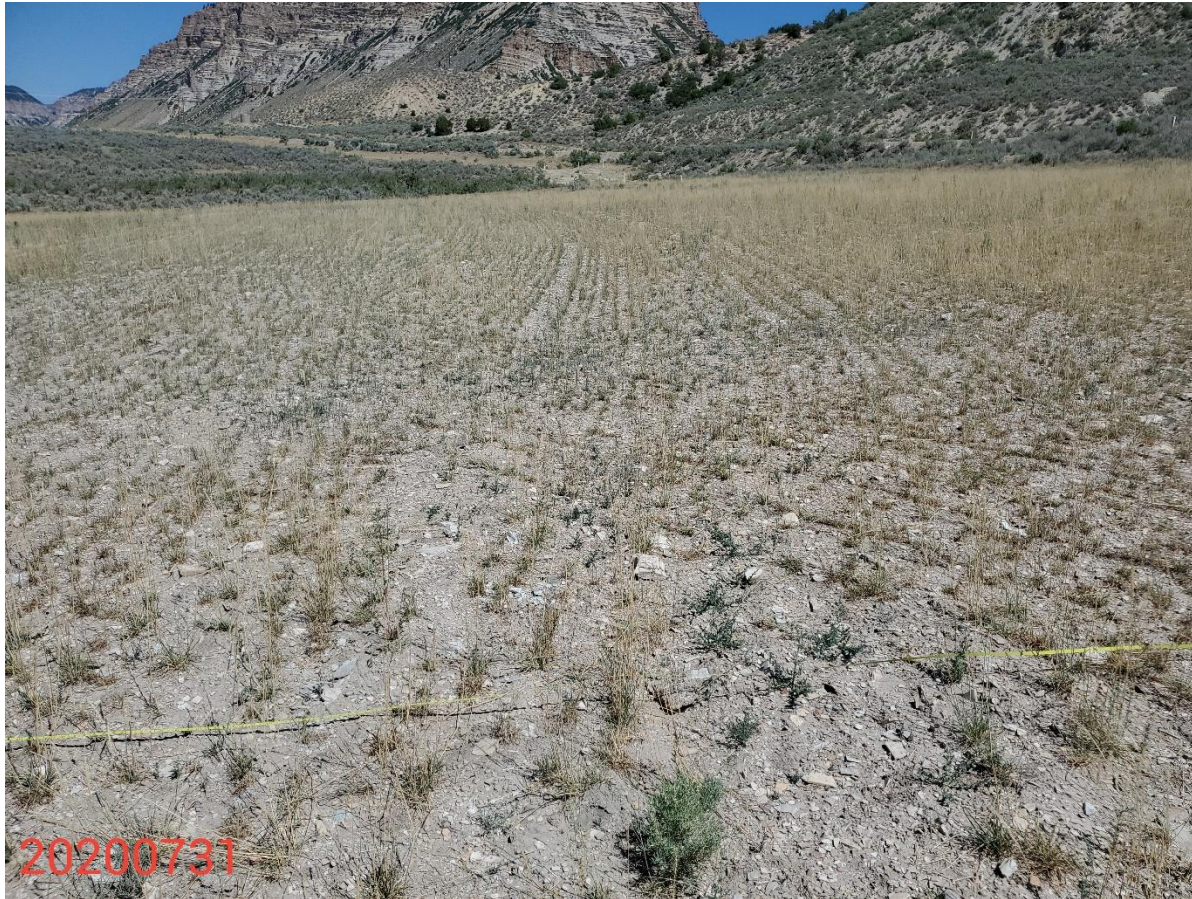
**Photo 10:** Photo of the 50<sup>th</sup> point of the **disturbance area transect #2**, facing south

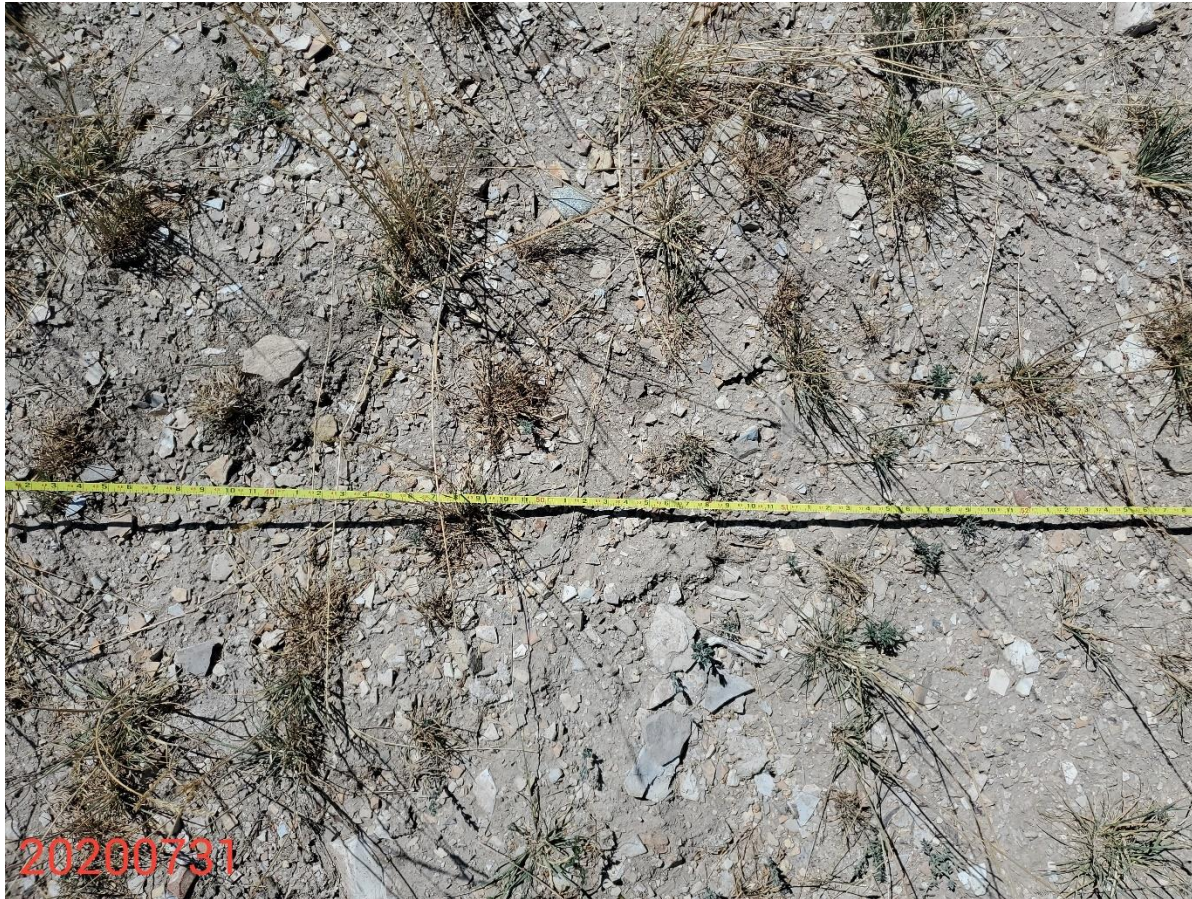
**Photo 11:** Photo of the 50<sup>th</sup> point of the **disturbance area transect #2**.

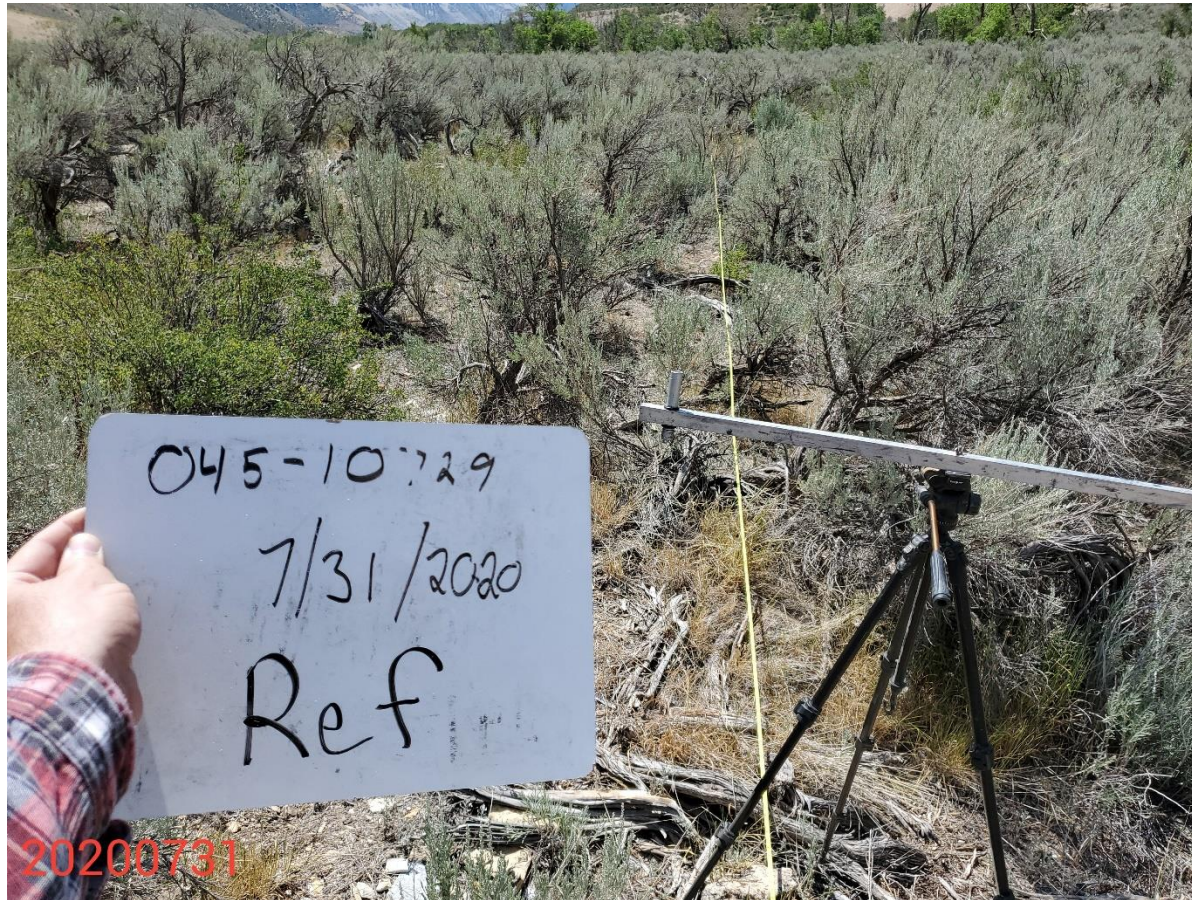
**Photo 13:** Photo of the starting point for **reference area transect**, facing south.

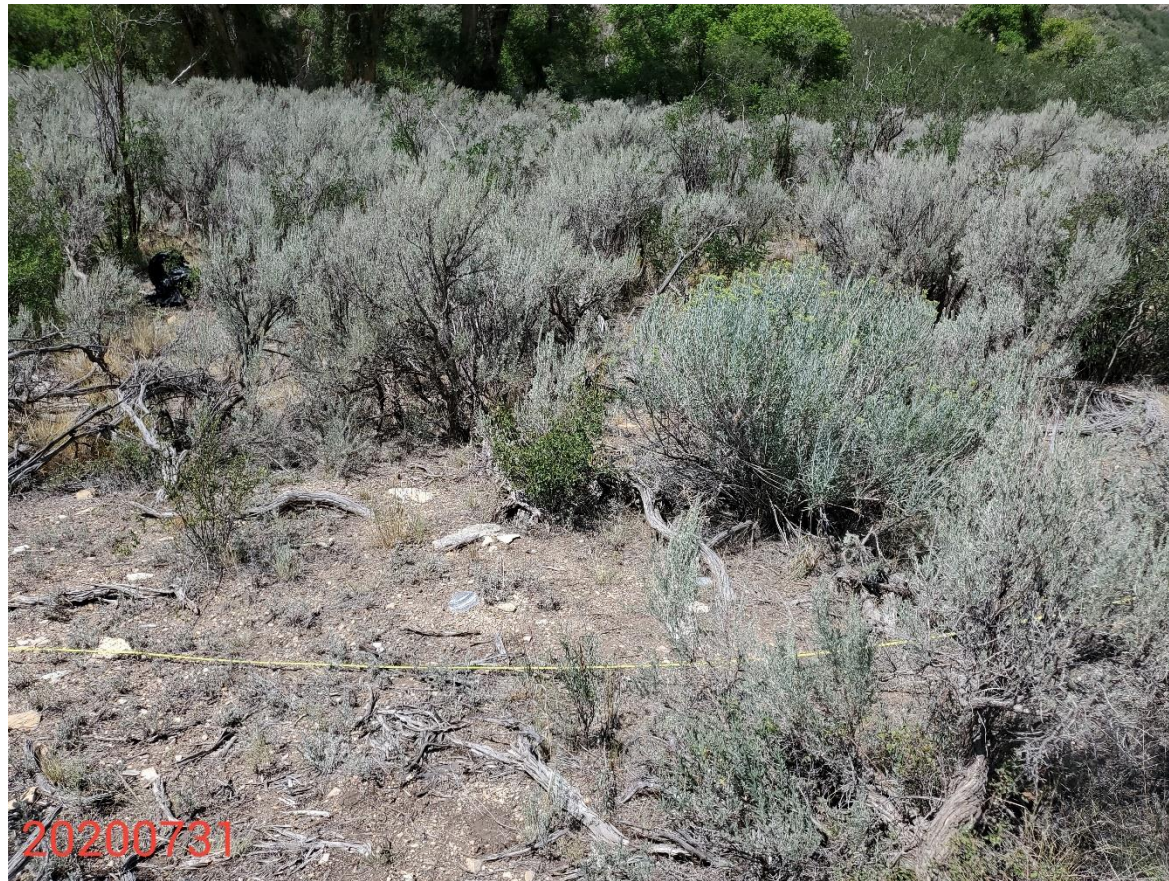
**Photo 14:** Photo of the 50<sup>th</sup> point of the **reference area transect**, facing west

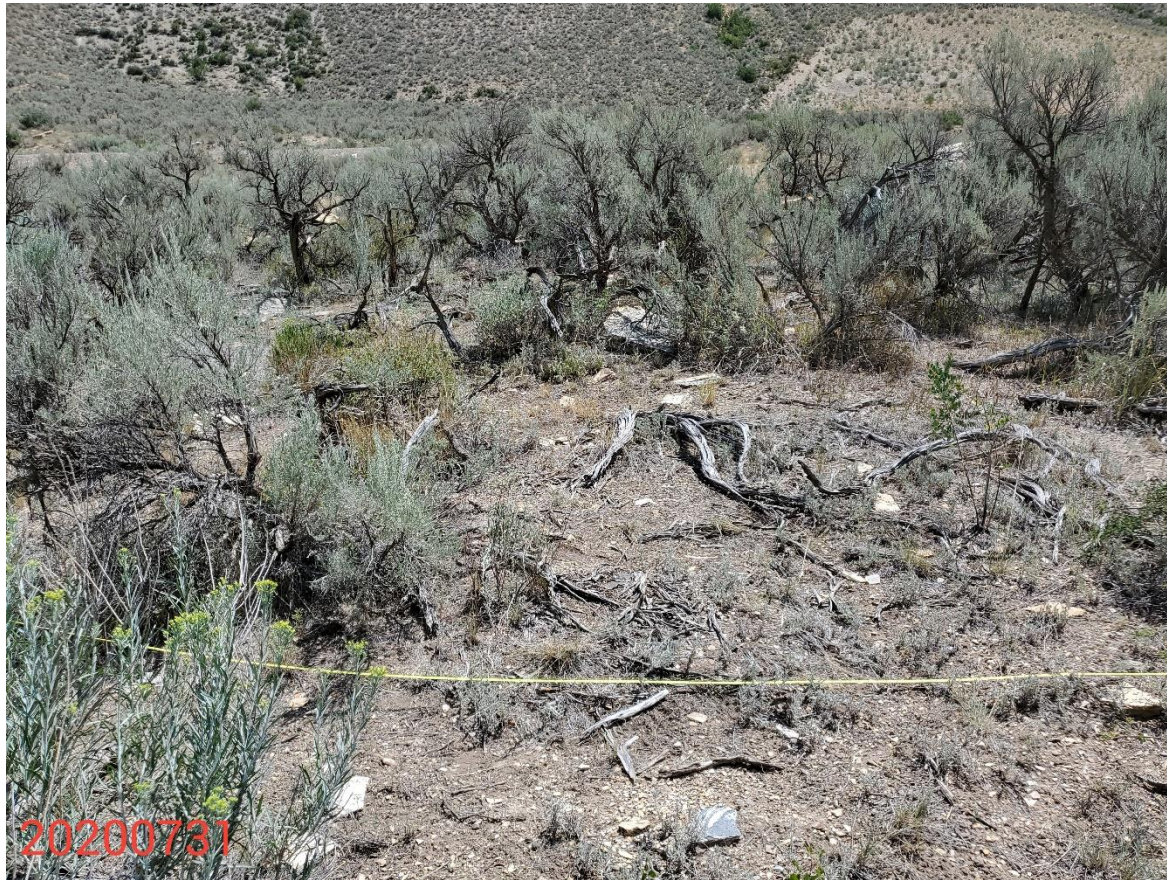
**Photo 15:** Photo of the 50<sup>th</sup> point of the **reference area transect**, facing east

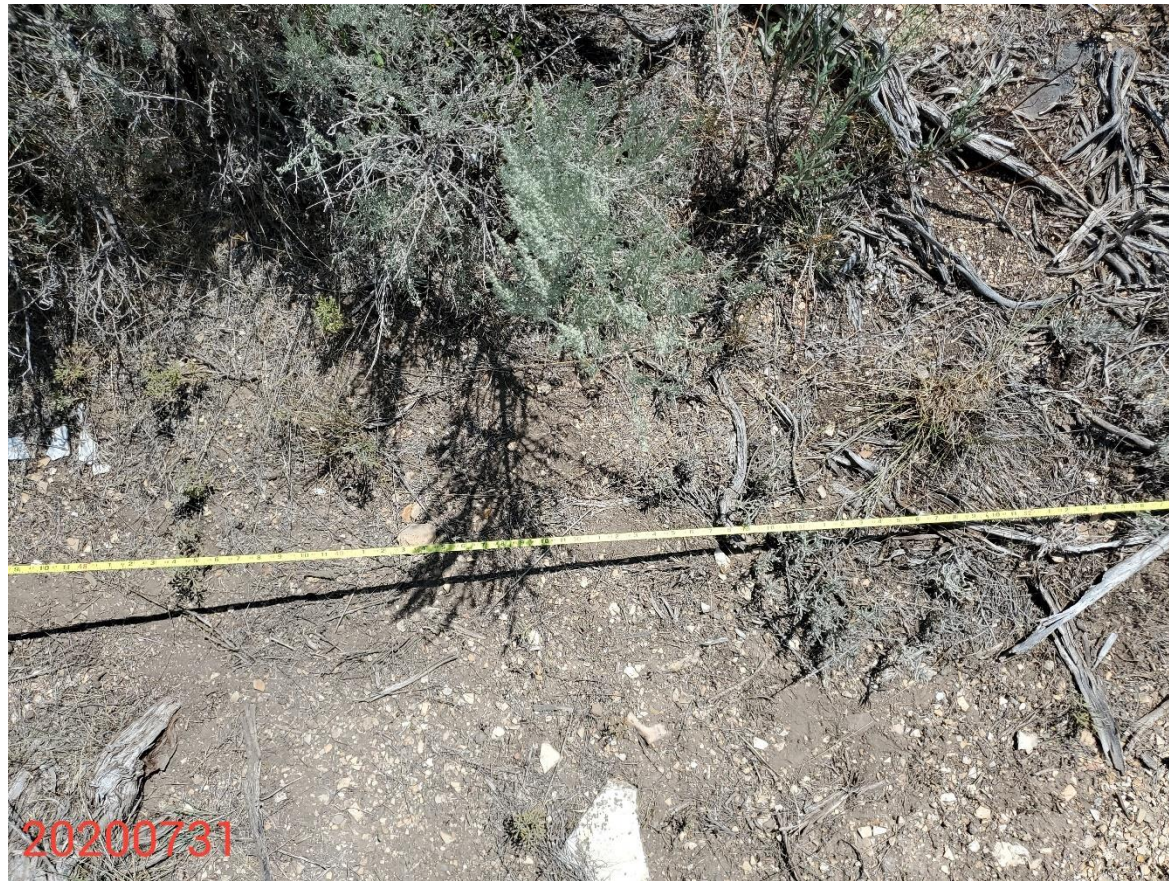
**Photo 16:** Photo of the 50<sup>th</sup> point of the **reference area transect**.

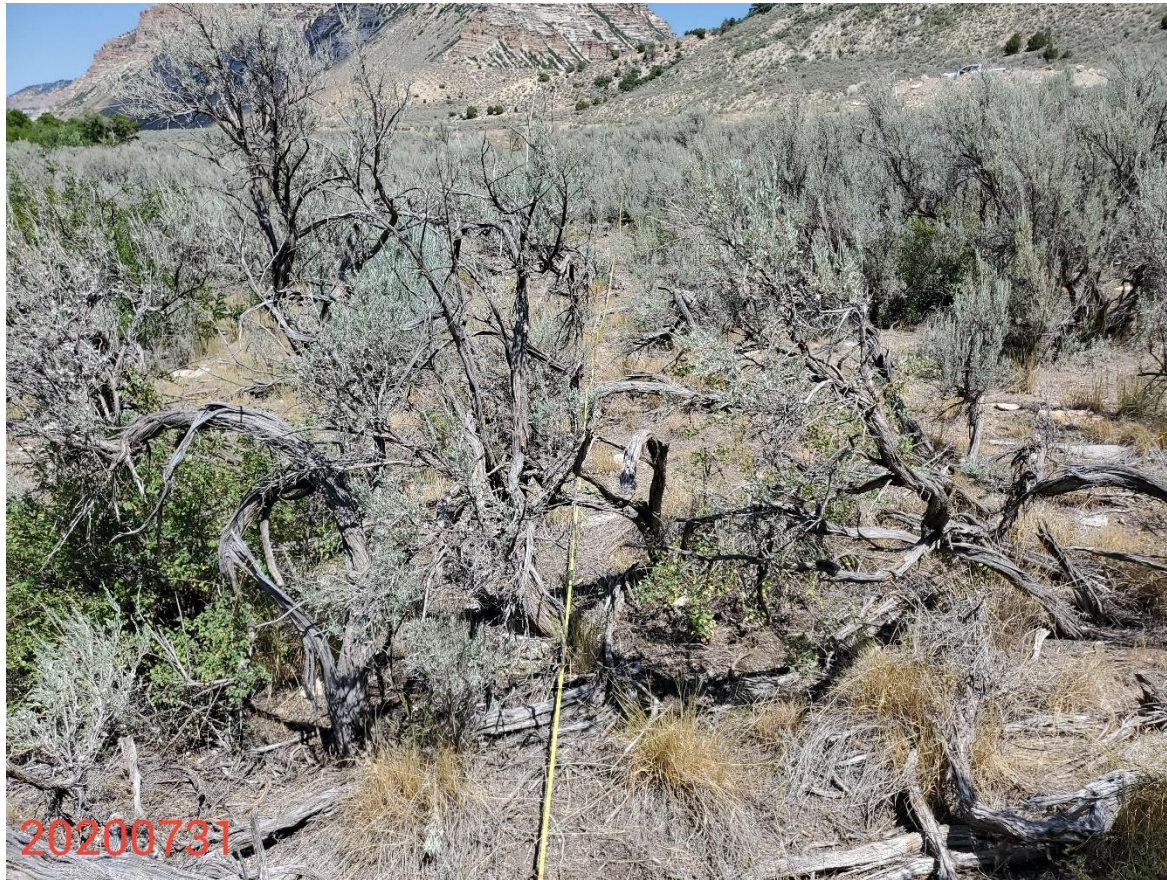
**Photo 17:** Photo of the end point for **reference area transect**, facing north
