Inspection Photos

API: 071-06223

Operator: TIMBER CREEK OPERATING LLC

Inspection Date: 8/3/2020

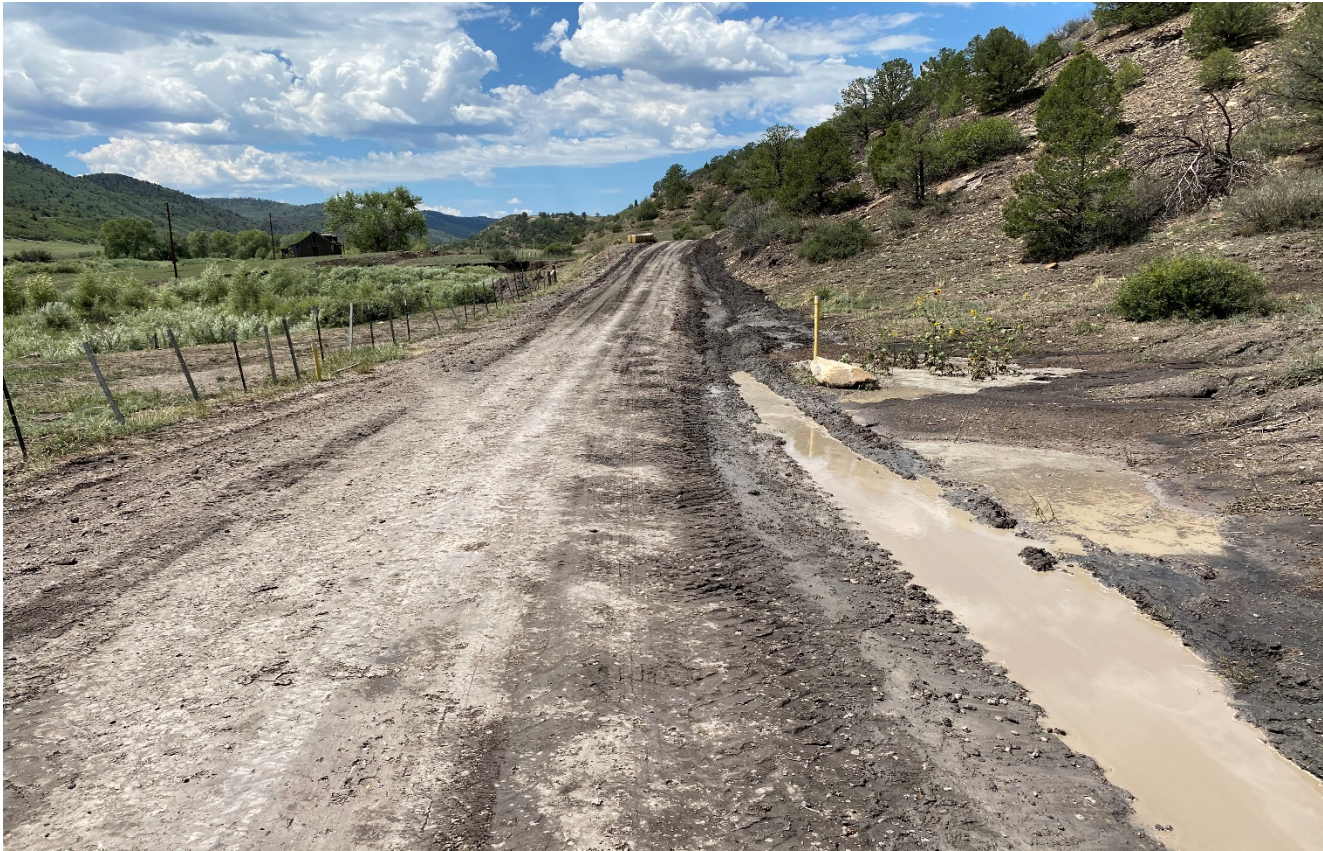
Photo 1. Facing southwest along the main road in the South Fork. Significant storm events have caused erosion along the road. Culverts are filled in with sediment and need to be cleaned out and maintained.

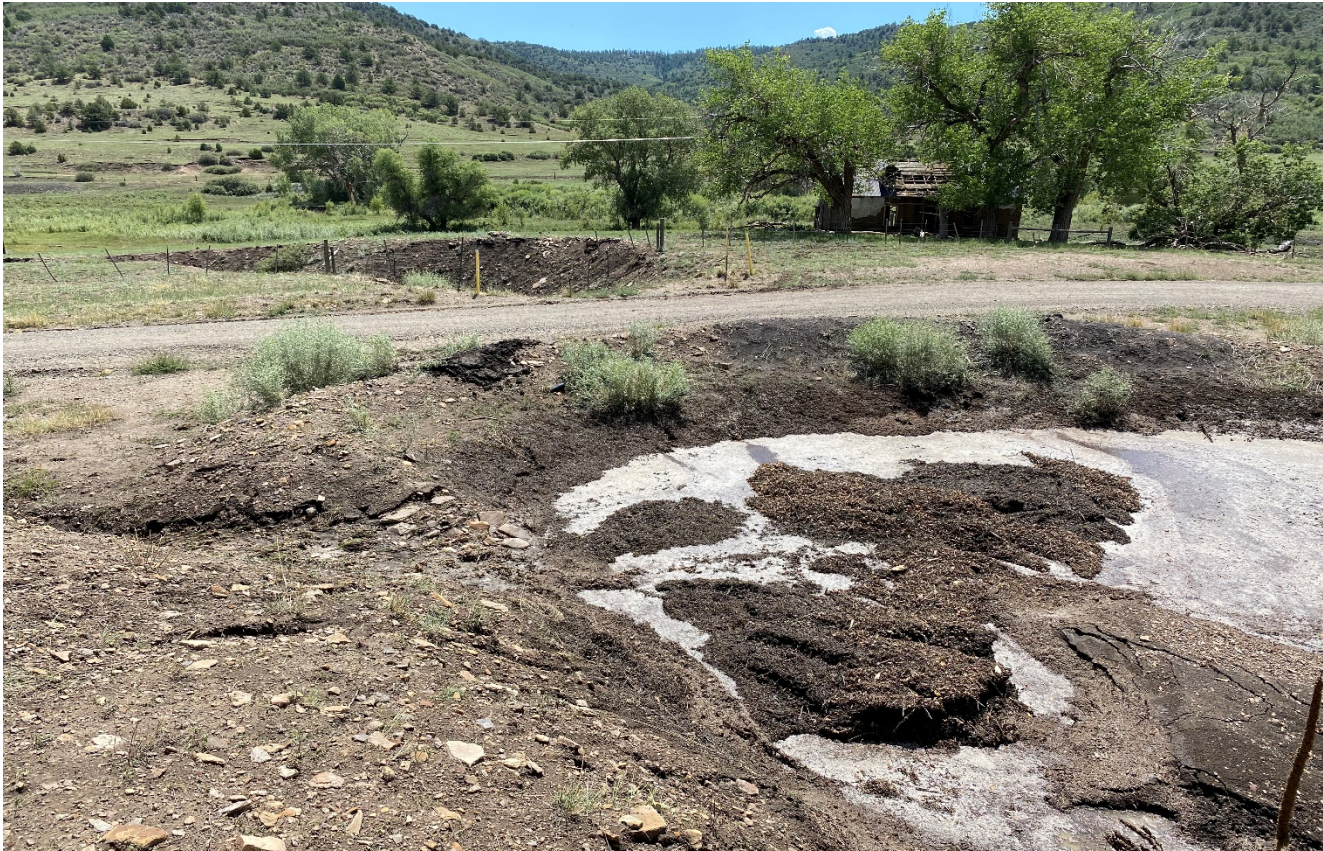
Photo 2. There is a culvert at this point along the road which is filled in with sediment causing water to not properly drain. The next storm event could cause erosion additional erosion and degradation of the road. The culvert needs to be cleaned out.

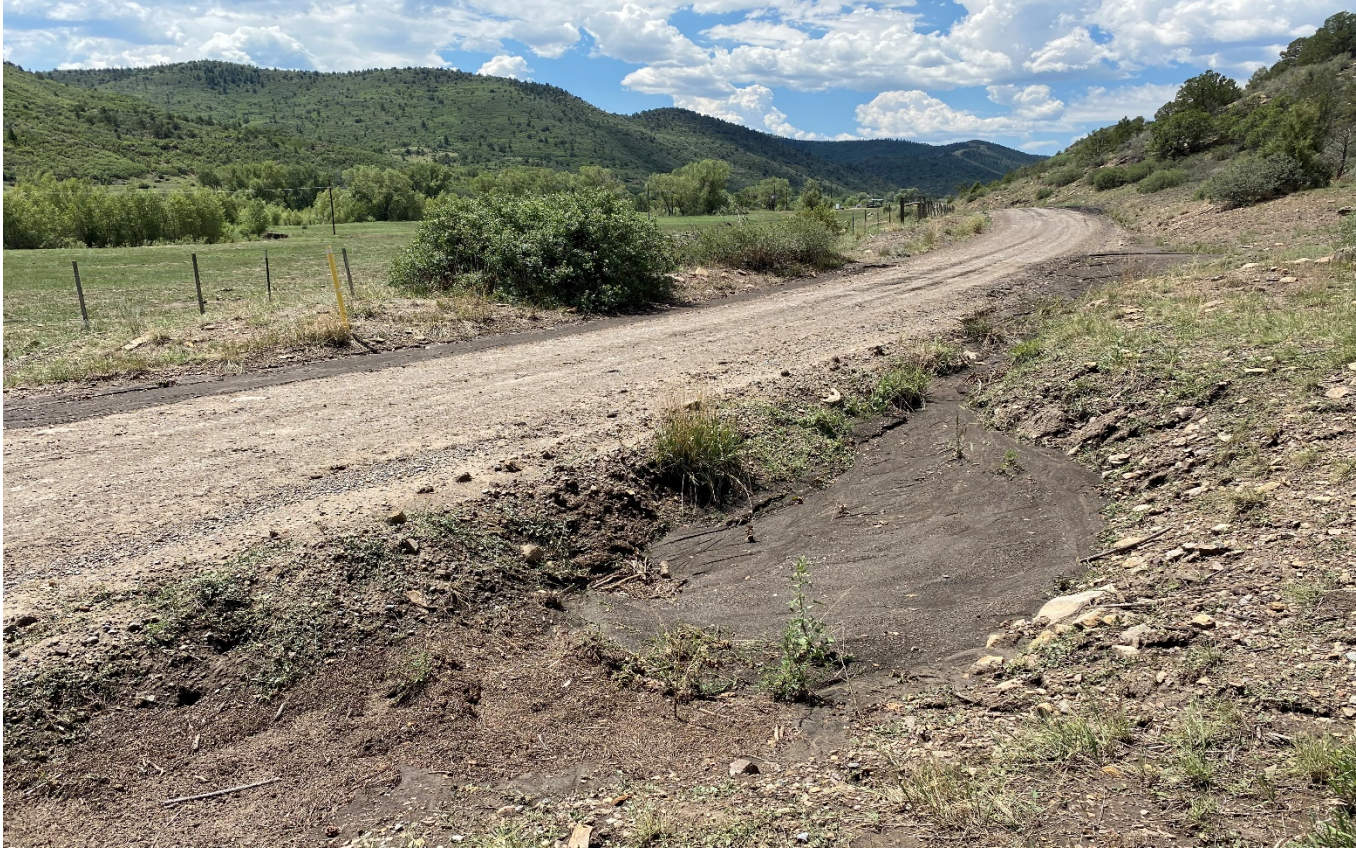
Photo 3. Further along the road are additional culverts filled in with sediment as shown in this photo.

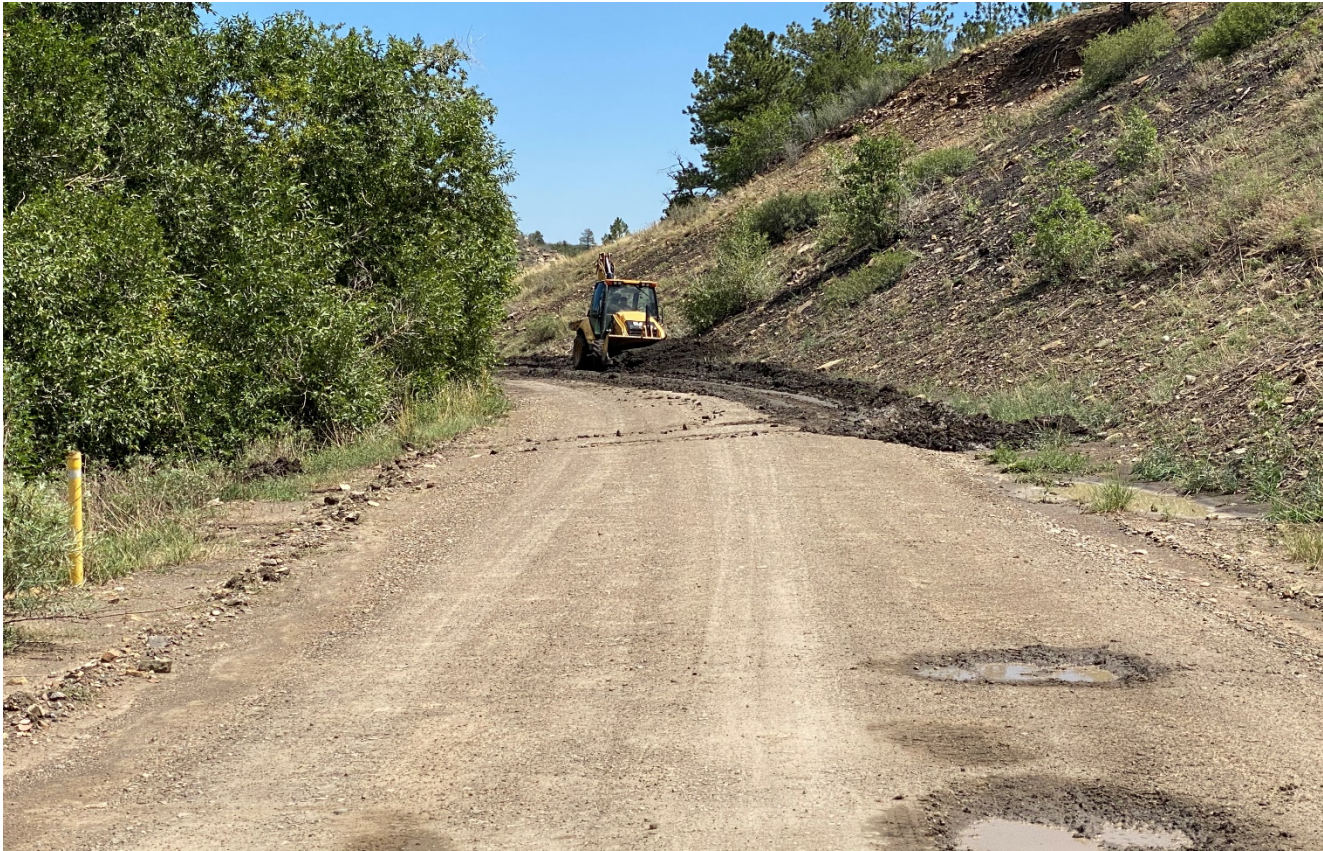
Photo 4. There was a backhoe along the main road pushing the mud and debris off the road.

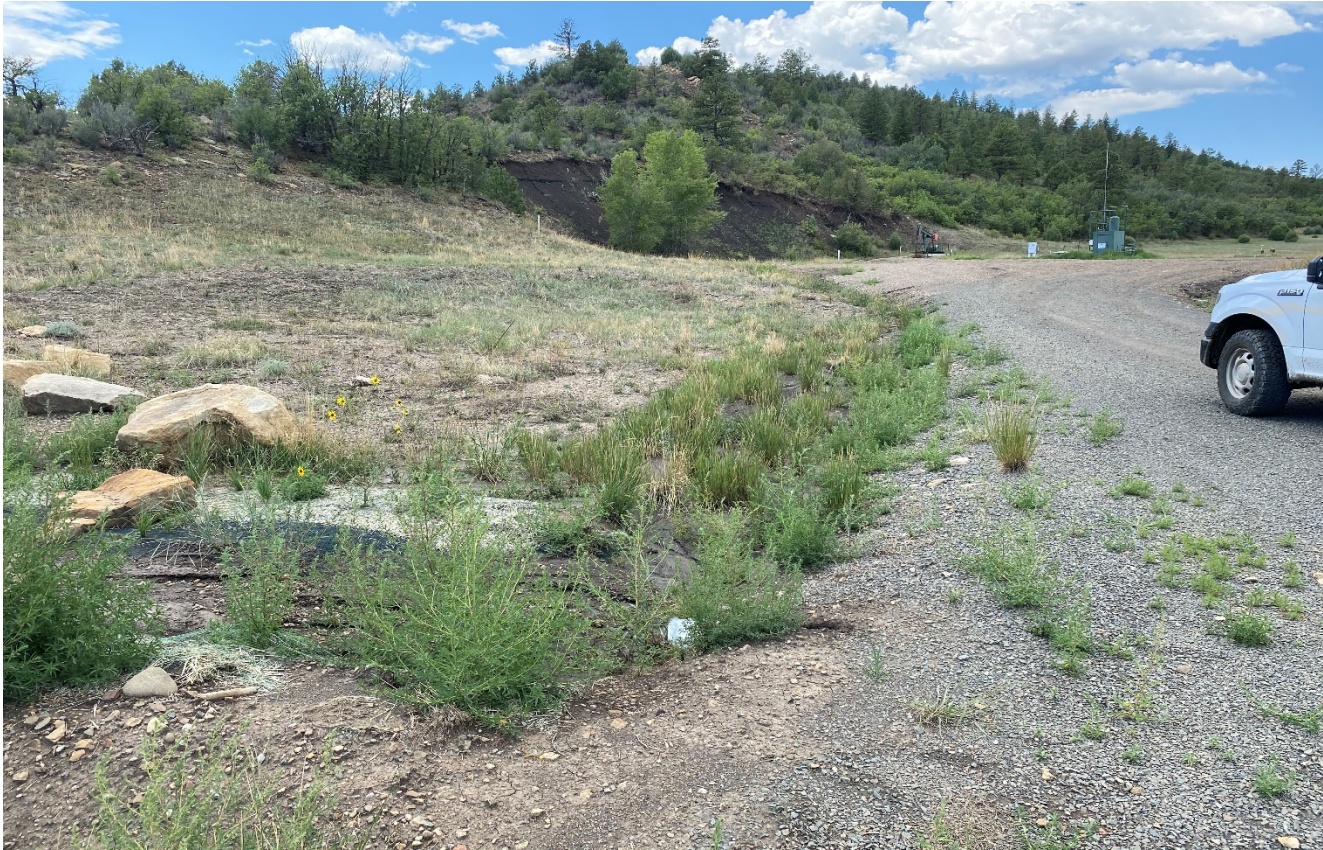
Photo 5. Facing southwest toward the location. This culvert near the location has filled in with sediment.
