Inspection Photos

Location Name: Centralized Land Treatment Facility, Noble Energy Inc. (#100322)

Facility ID: 287848

August 5, 2020

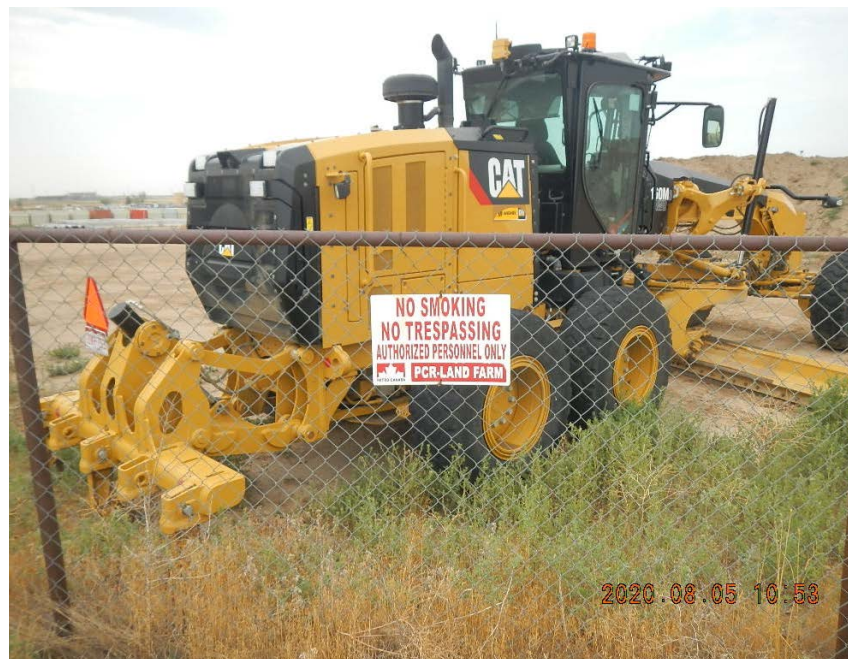
CE&P Facility ID: 287848, Gate entrance.

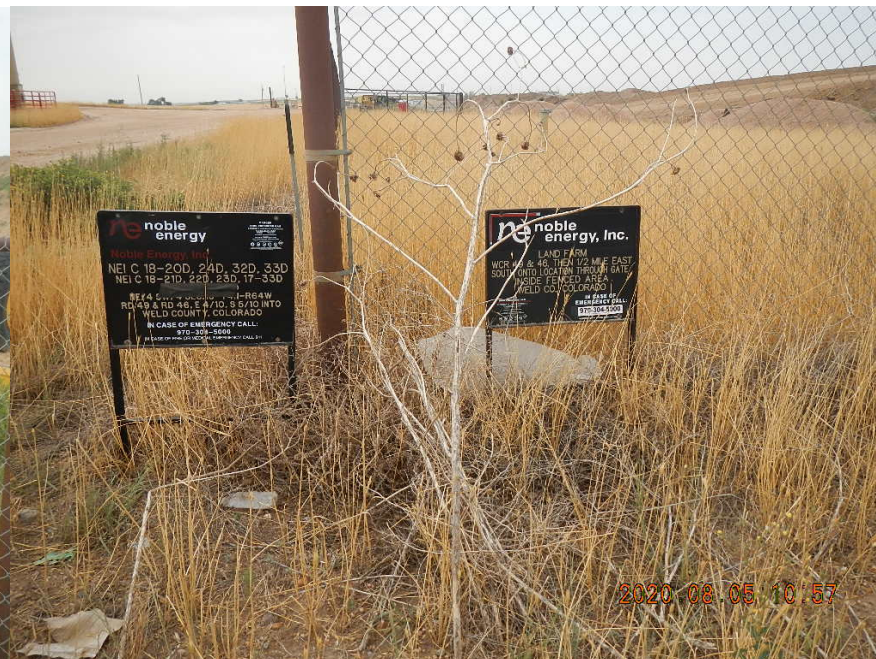
Sign from CR 46.

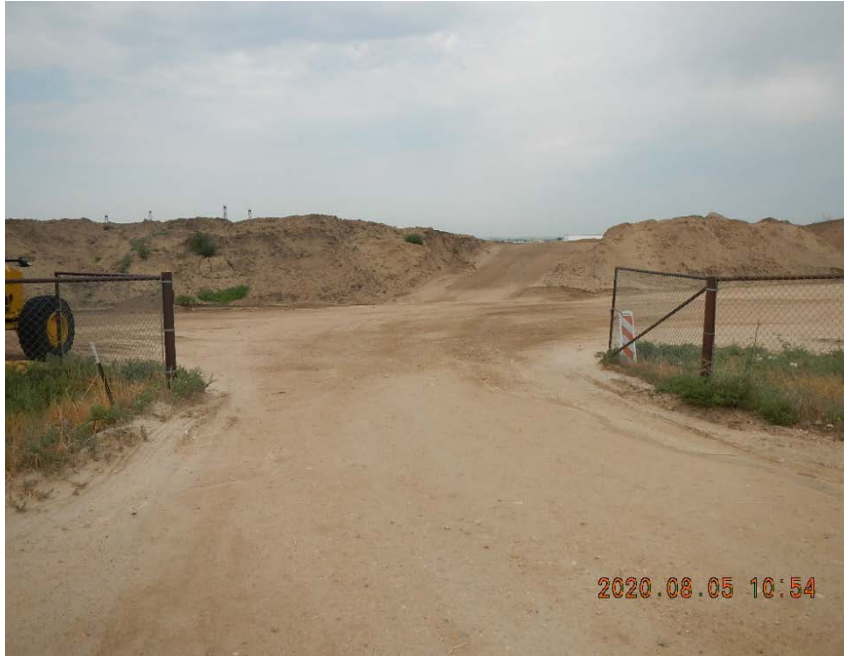
Entrance to CE&P Facility. Note: unsecured and evidence of storm water runoff of the CE&P Facility. Looking at soil/material mound in the SE corner of the facility.

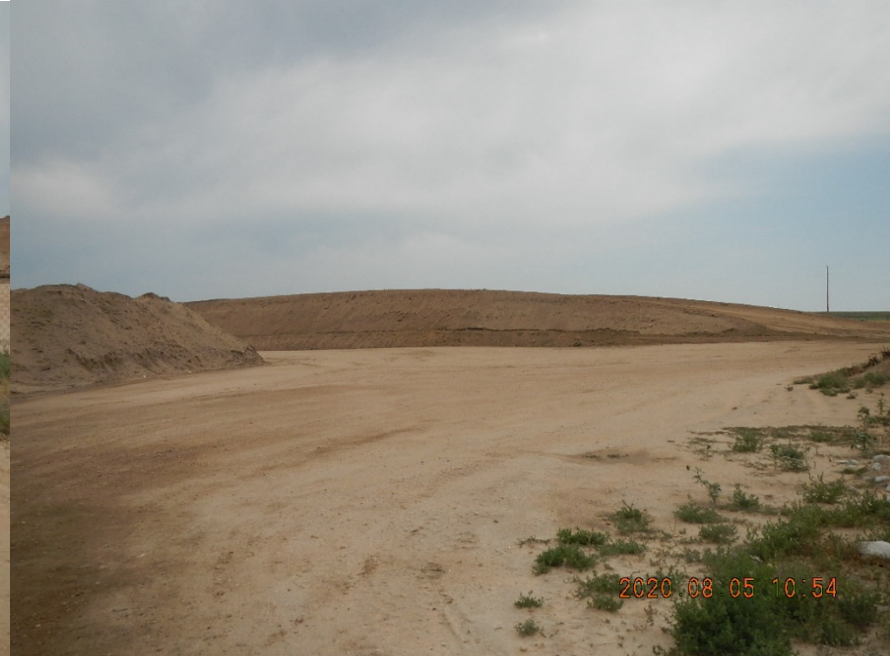
Soil/material mound on the north half of the CE&P facility.

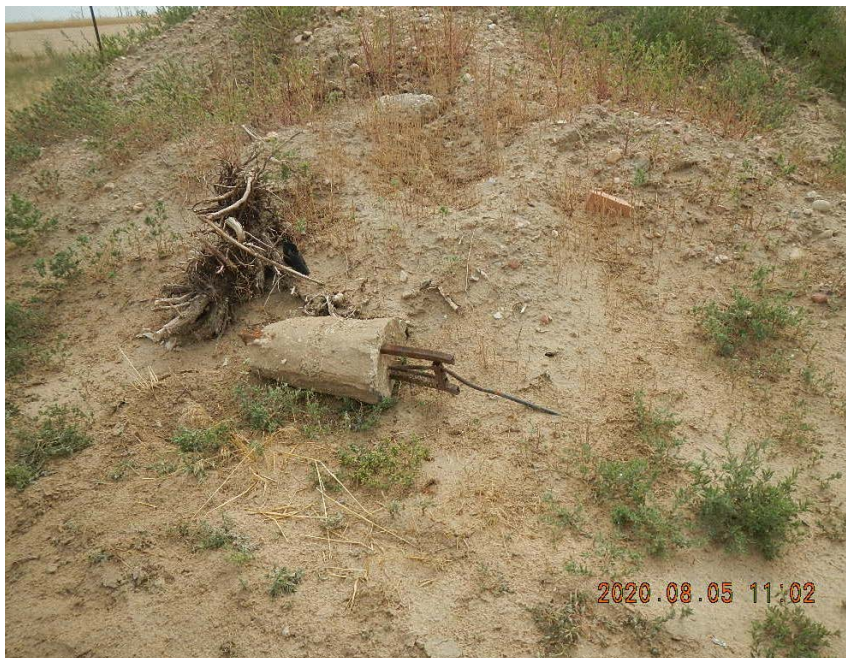
Trash and debris.

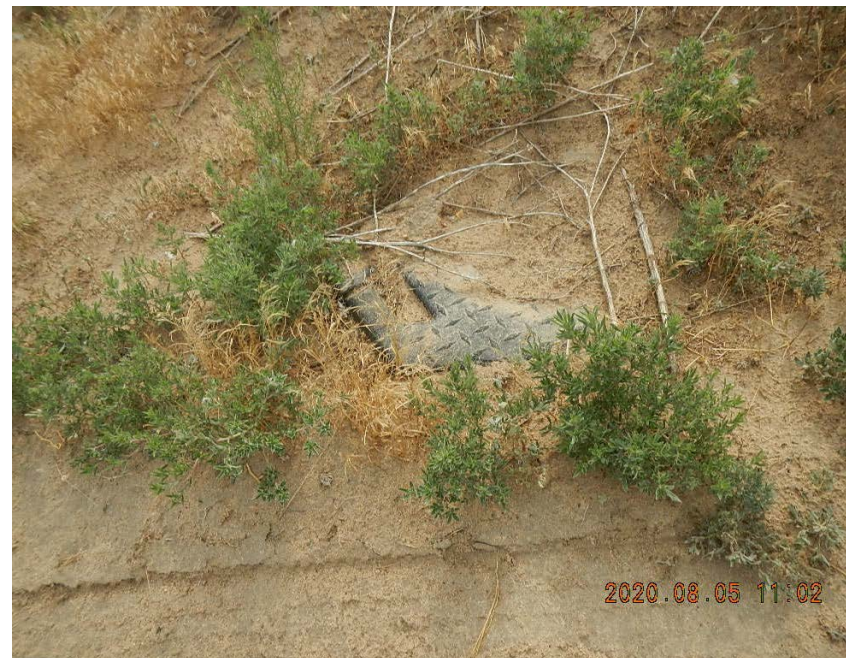
Trash and debris.

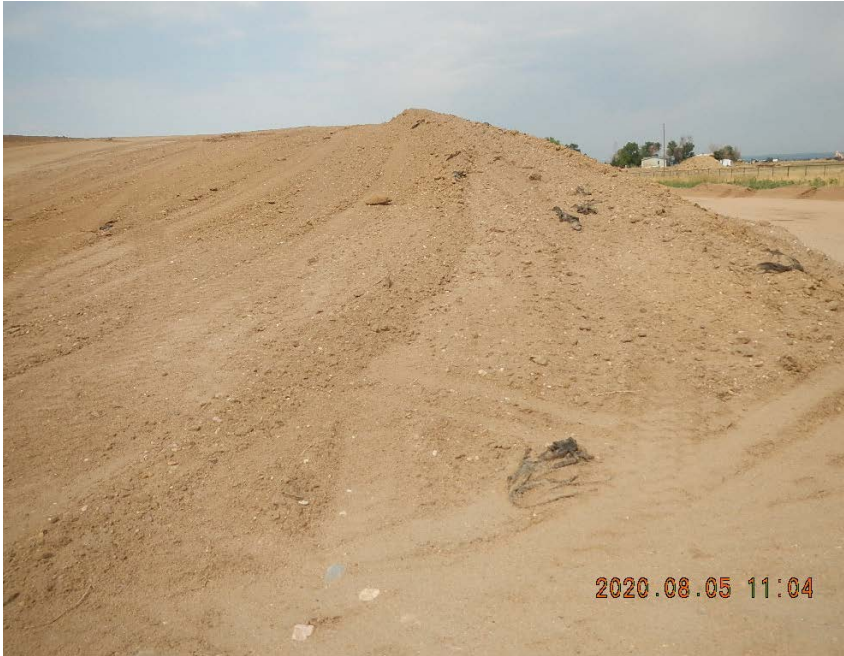
Felt liner incorporated into soil/material mound.

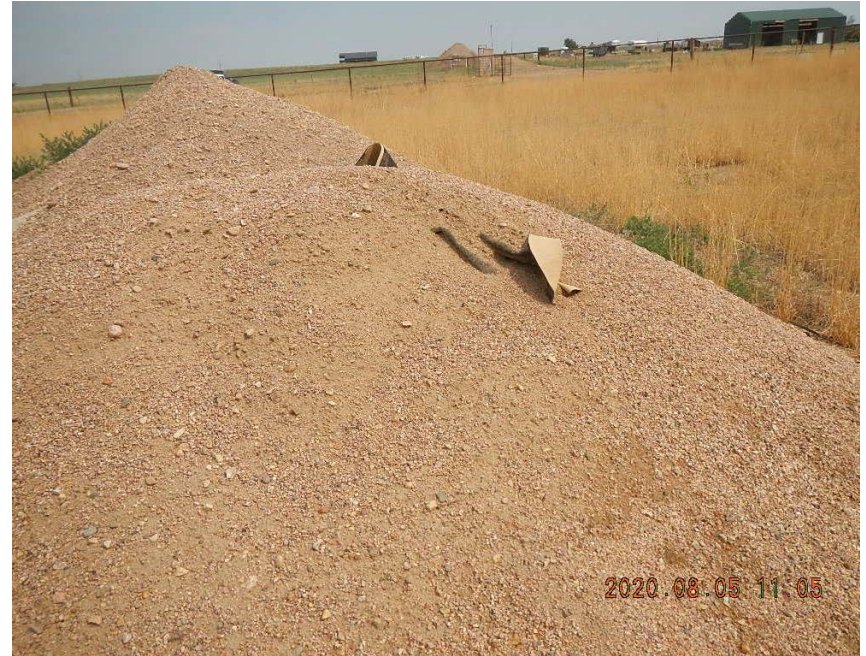
Pea-gravel stock pile with liner.

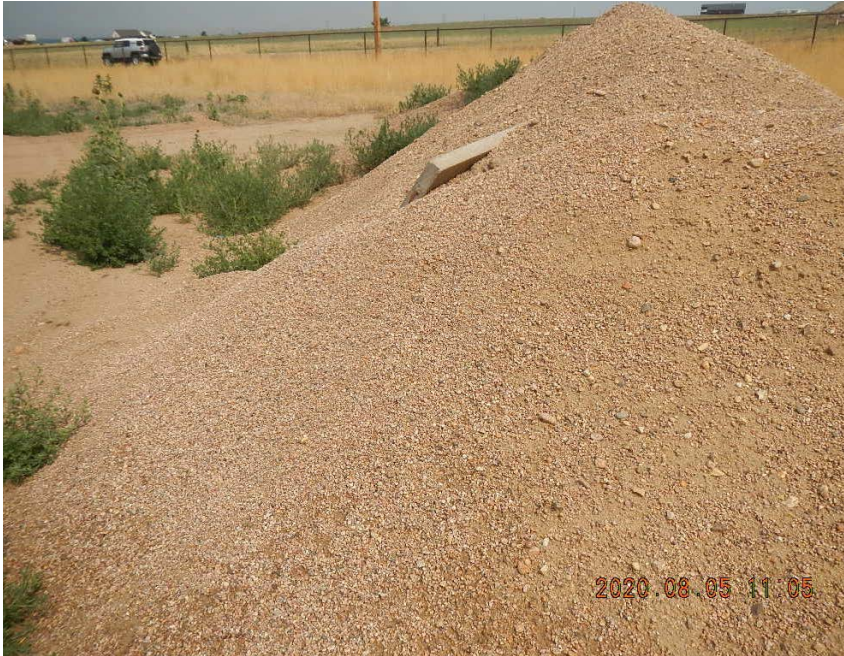
Pea-gravel with concrete.

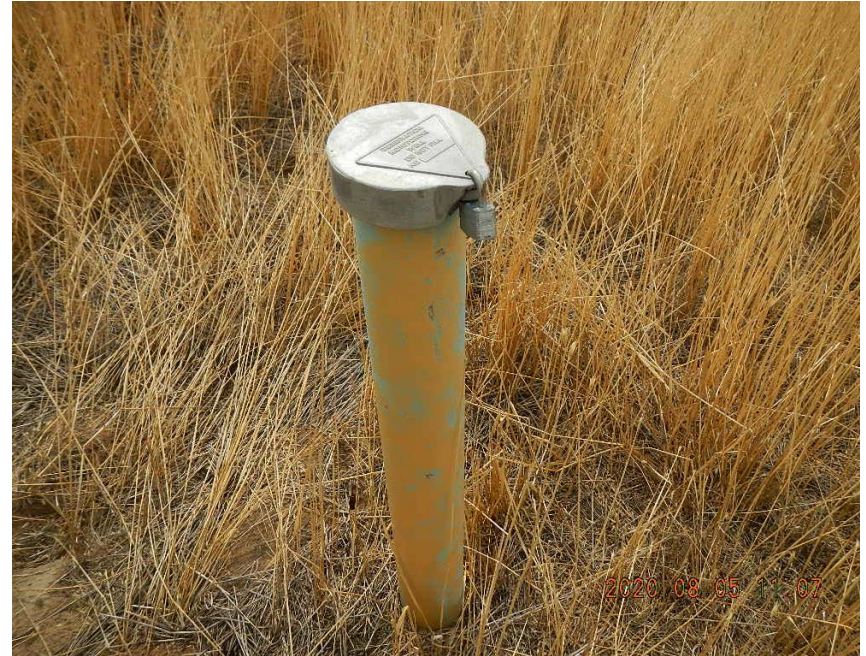
MW located in the NE corner of the facility. This is the only MW that was secured with a lock.

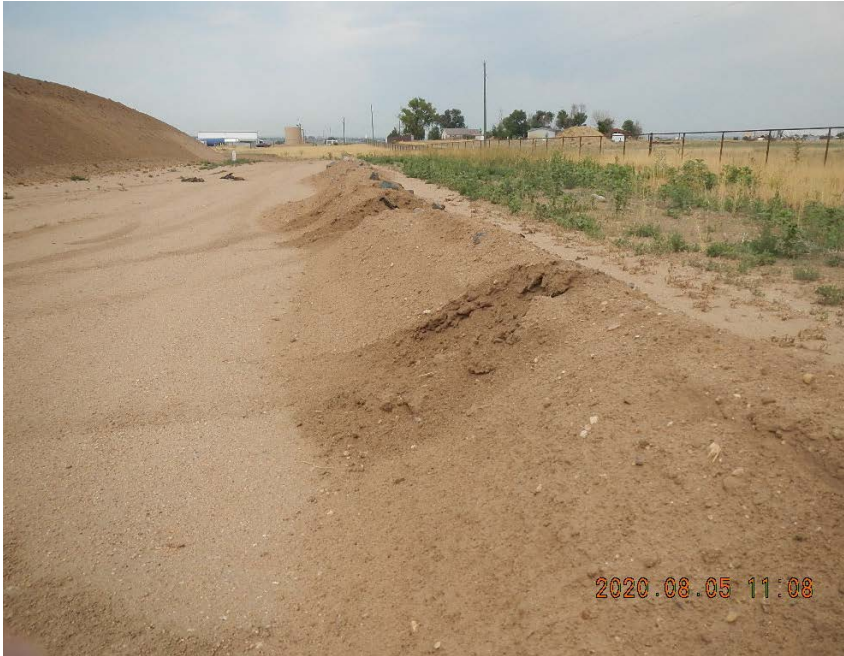
Trash and debris throughout facility.

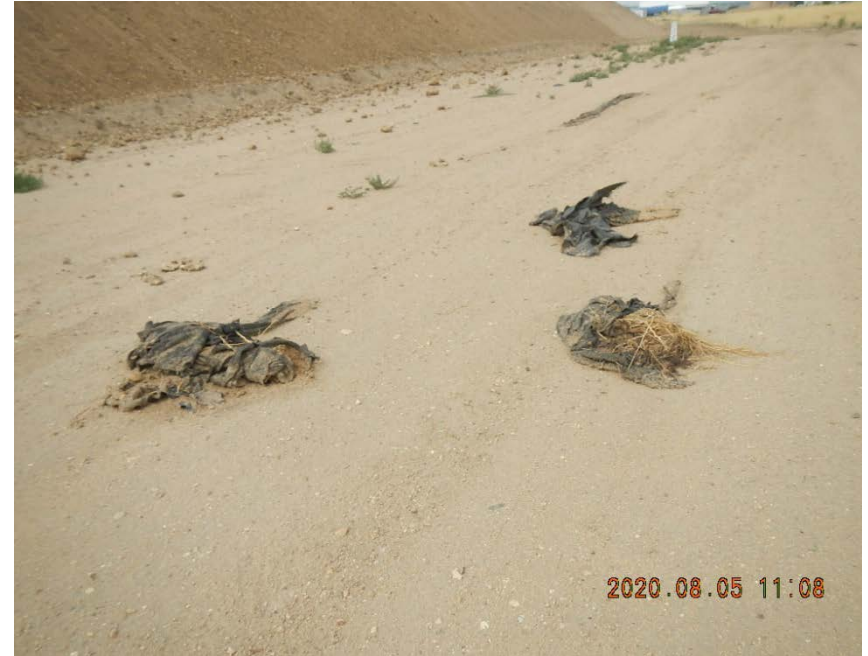
Trash and debris throughout facility.

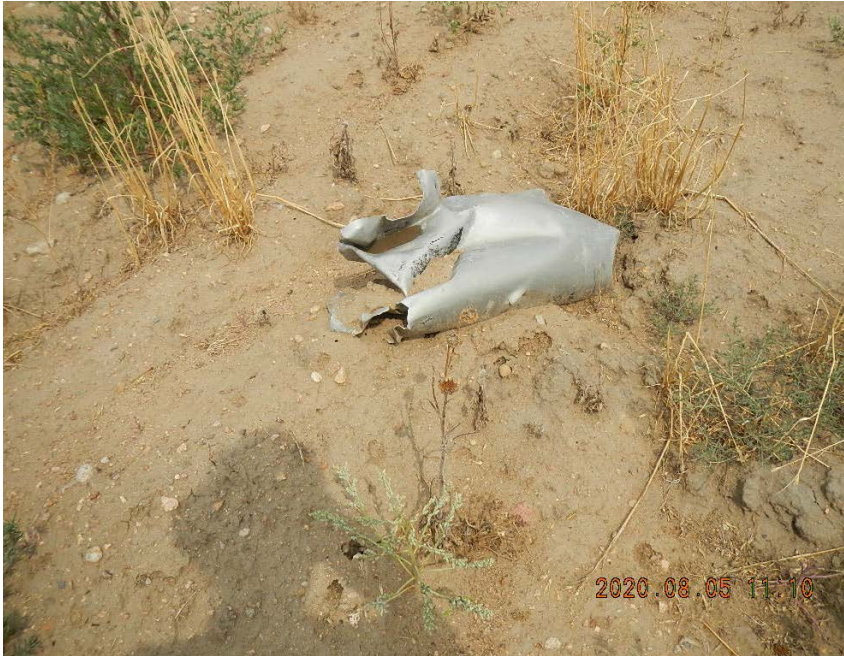
Trash and debris throughout facility.

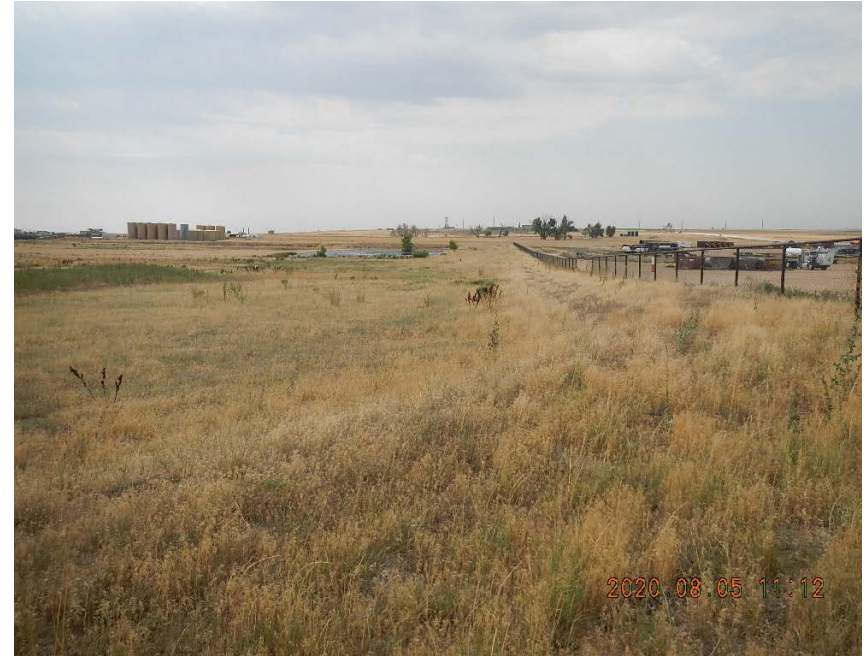
Looking south across the Facility from NW corner of the facility. Note hole in fence midway down.

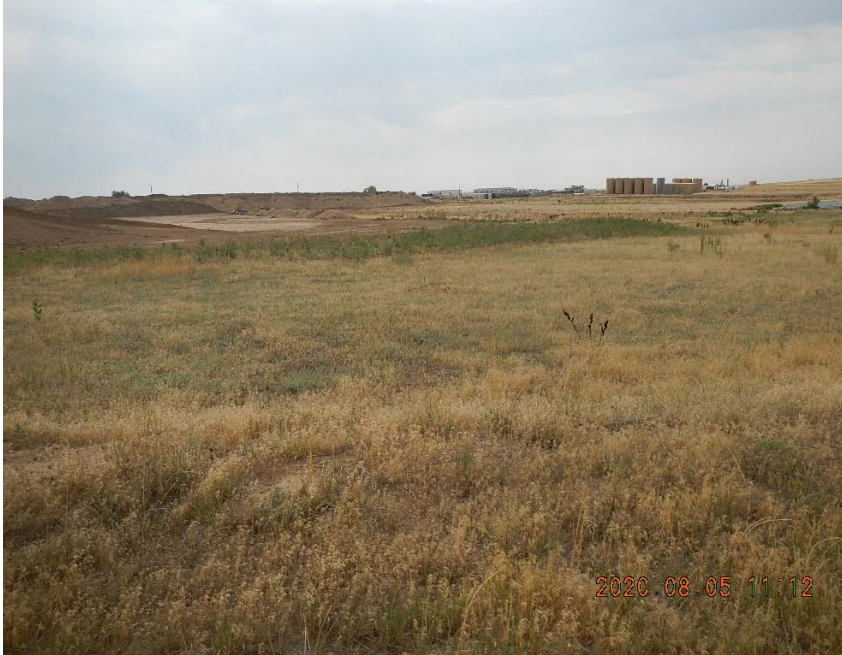
Looking south to southeast across the facility. .

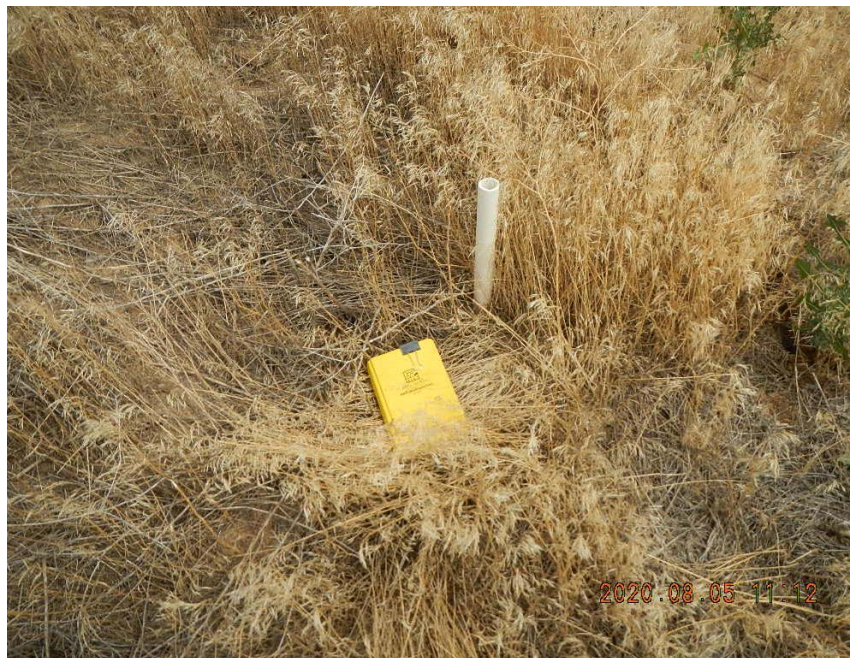
One-inch PVC stick up.

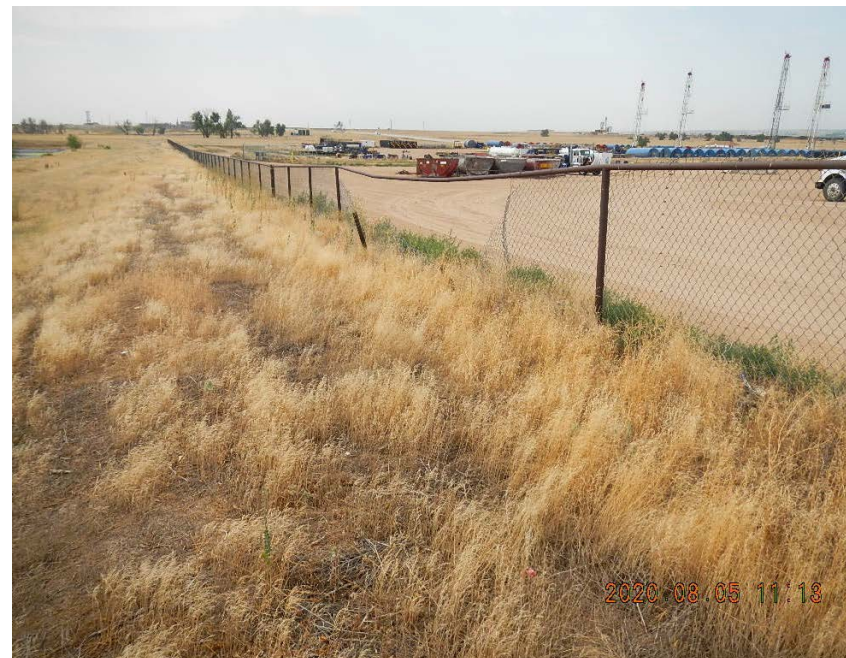
Damaged fence.

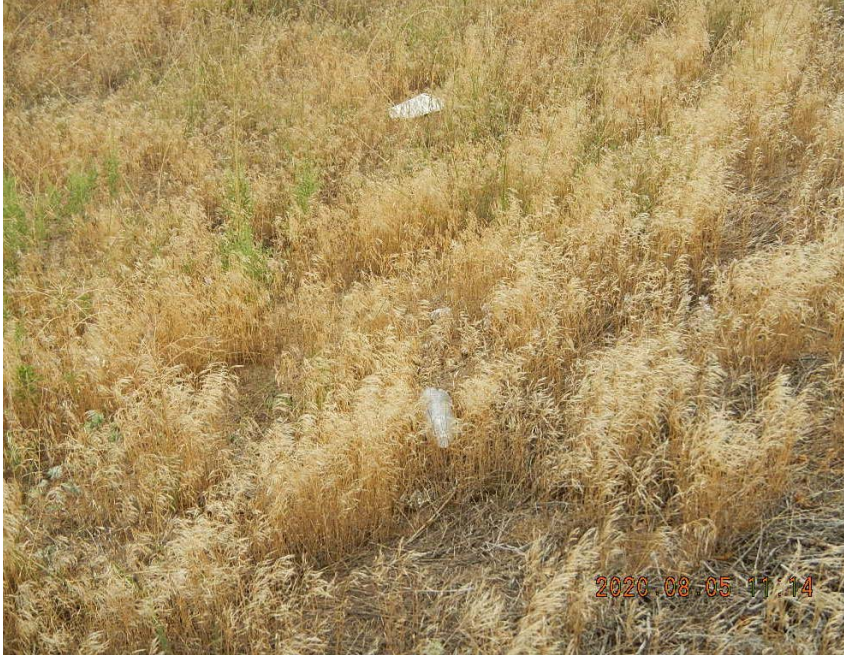
Trash.

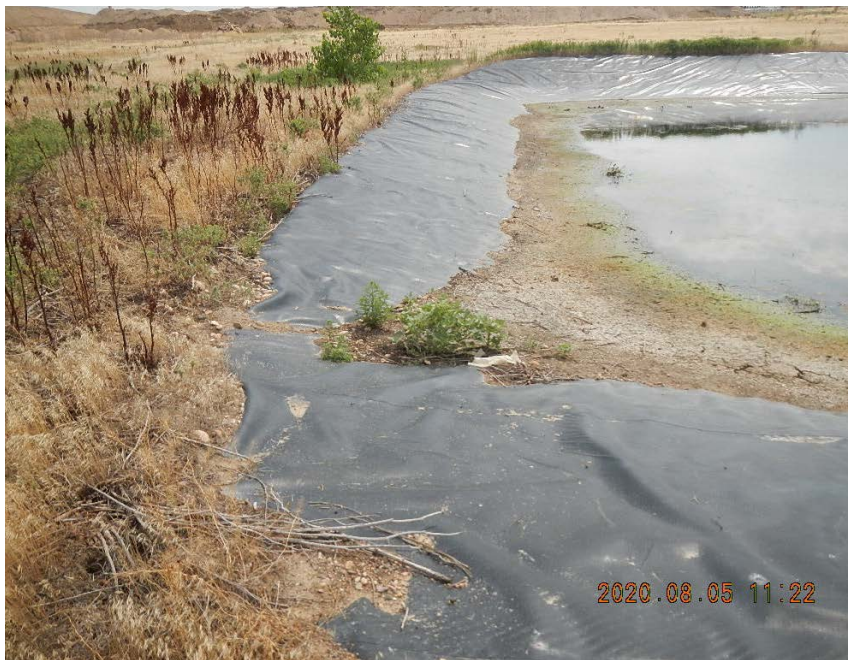
Vegetation and sediment encroachment on liner.

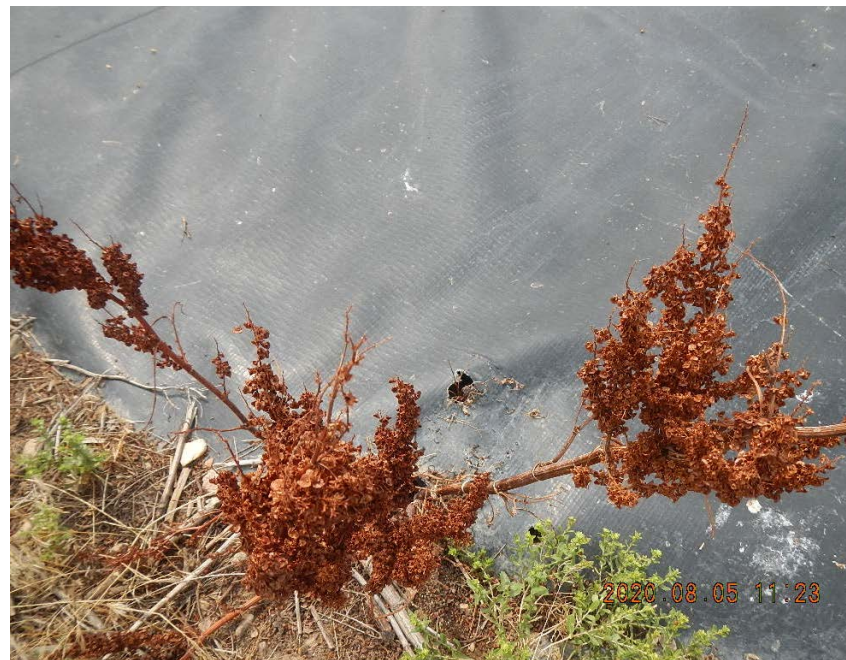
Holes in liner.

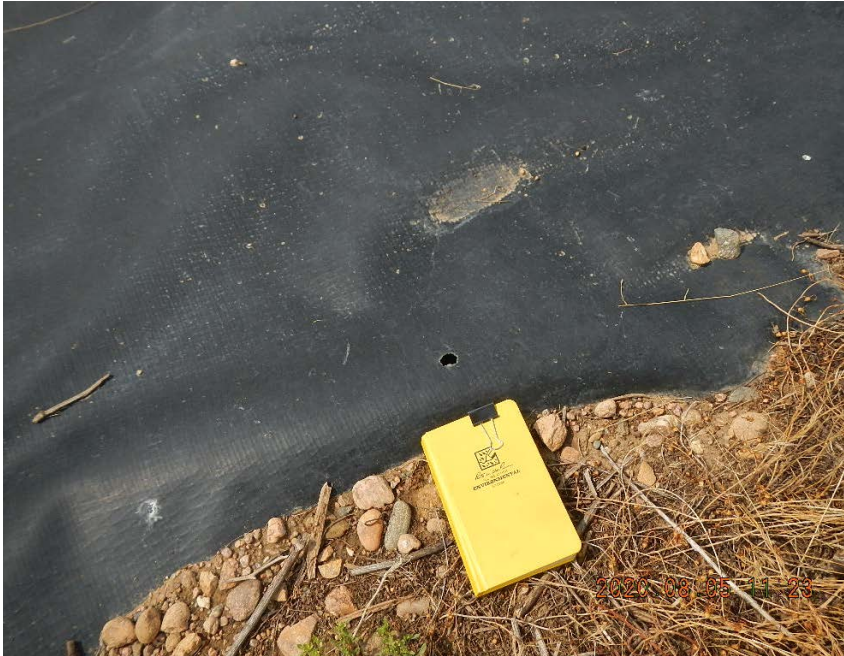
Holes in liner.

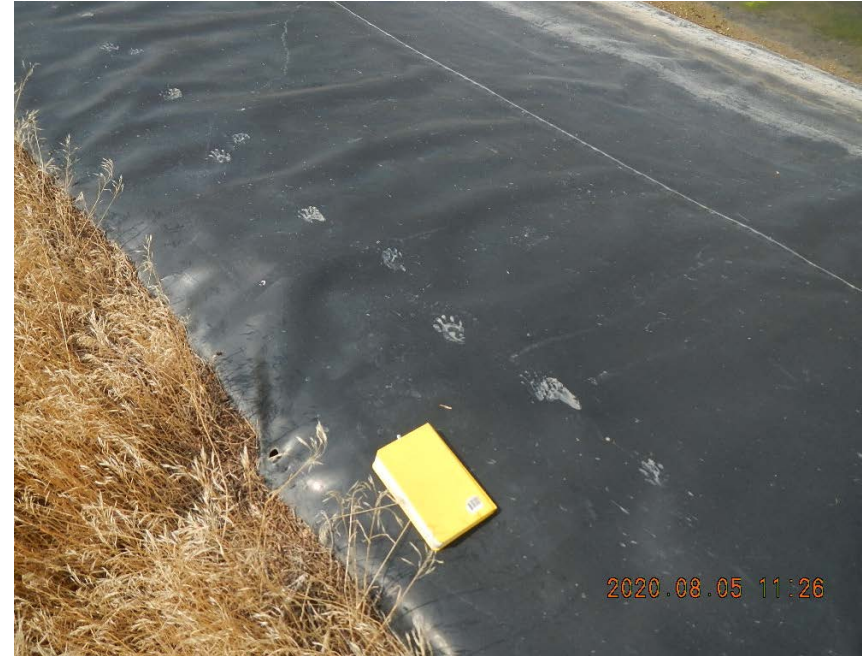
Wildlife tracks.

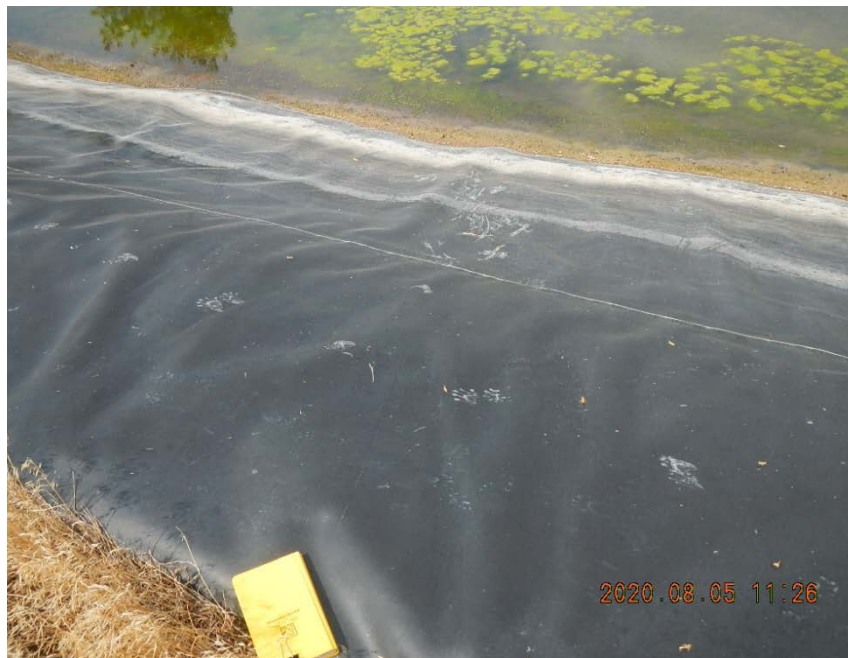
Wildlife tracks.

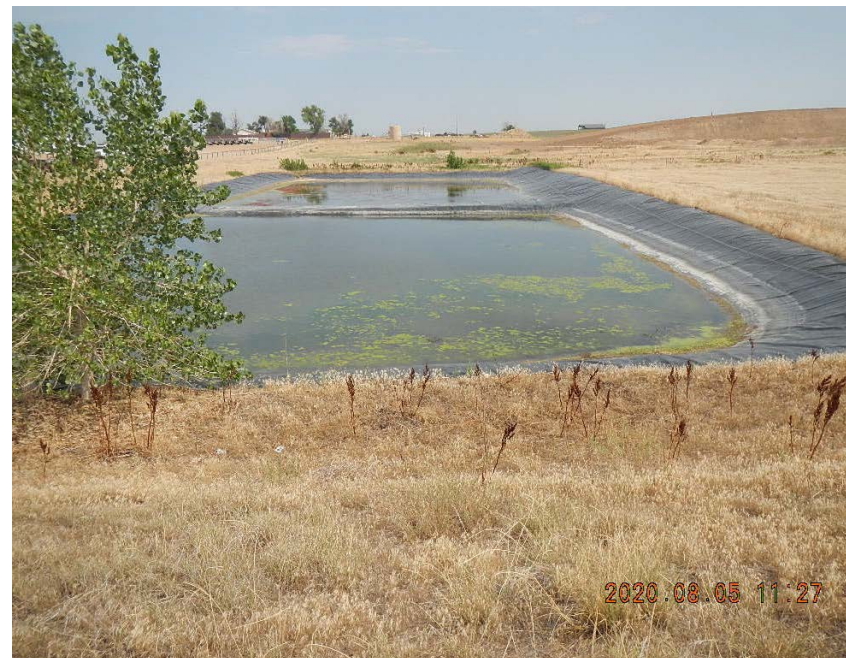
Detention pond looking north.

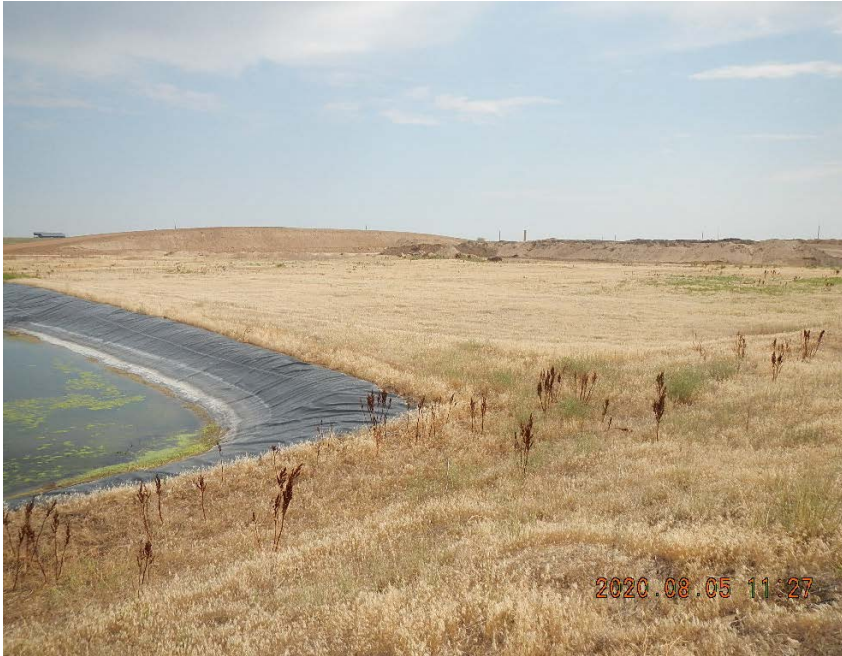
Overview of the two large soil/material mounds.

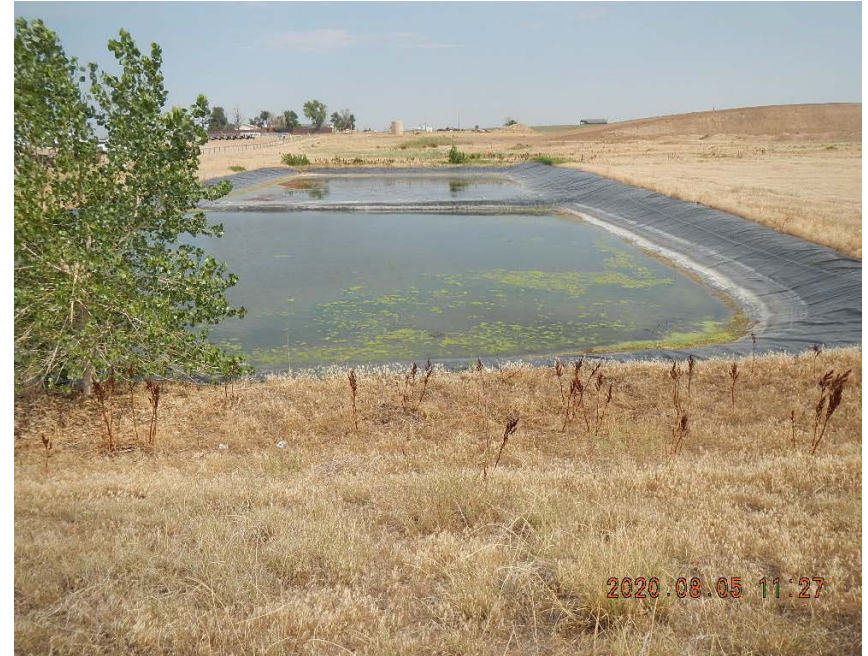
Detention pond looking north.

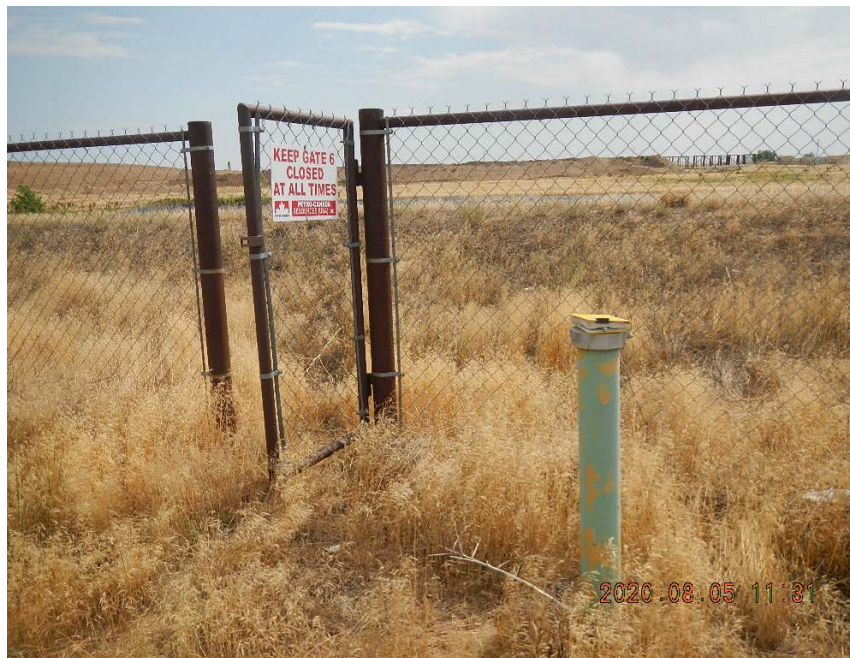
Open access with outdated sign.

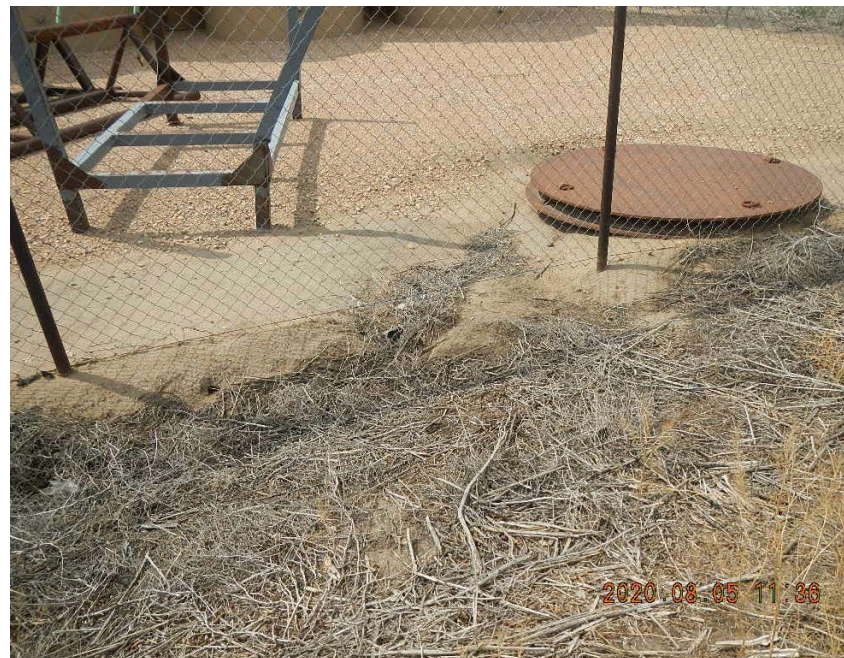
Evidence of sediment leaving the CE&P facility.

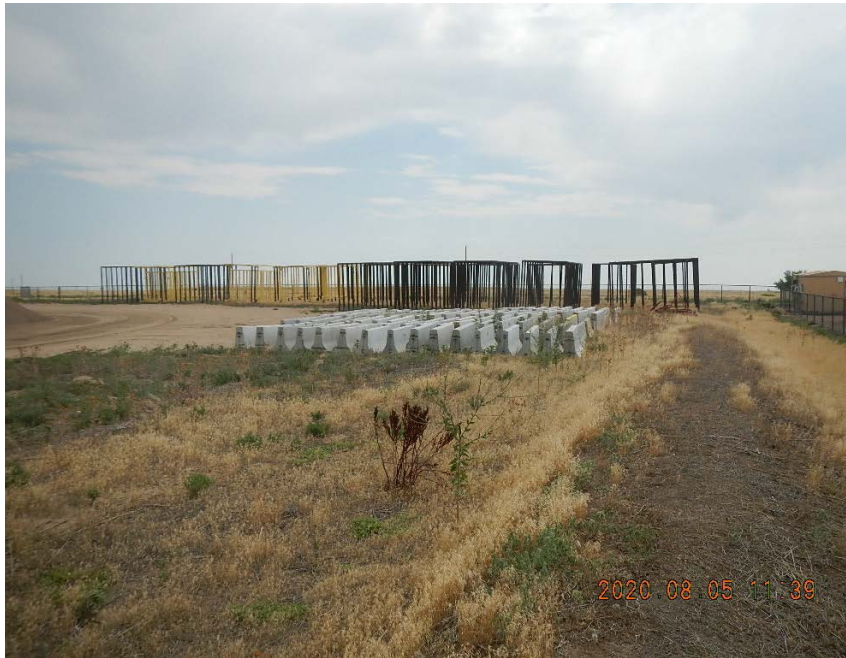
Equipment storage.

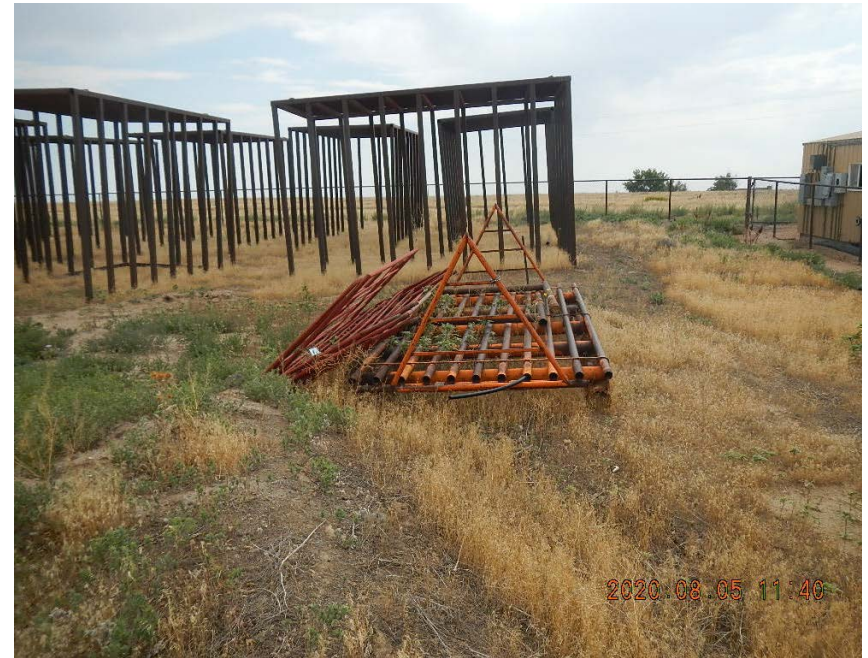
Equipment storage.

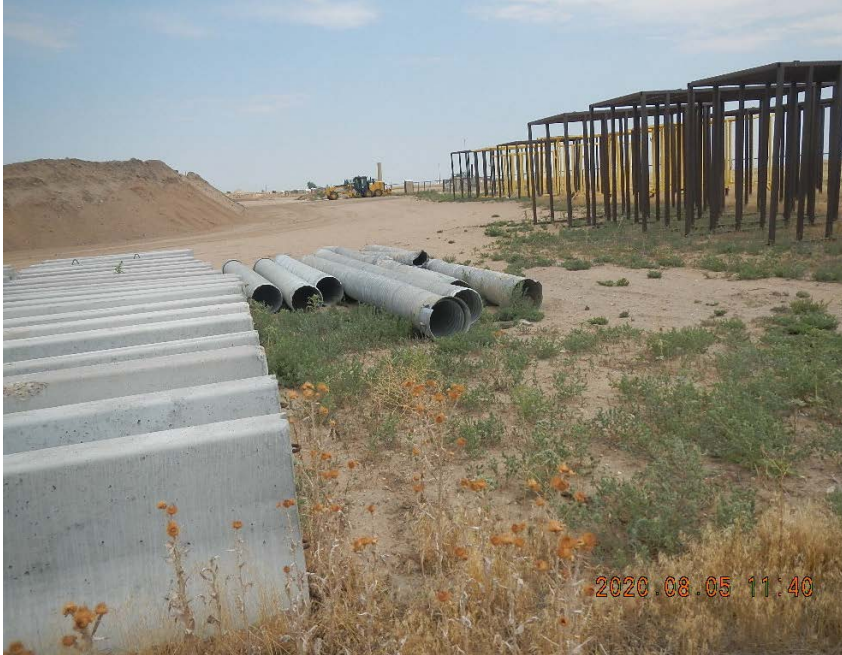
Equipment storage.

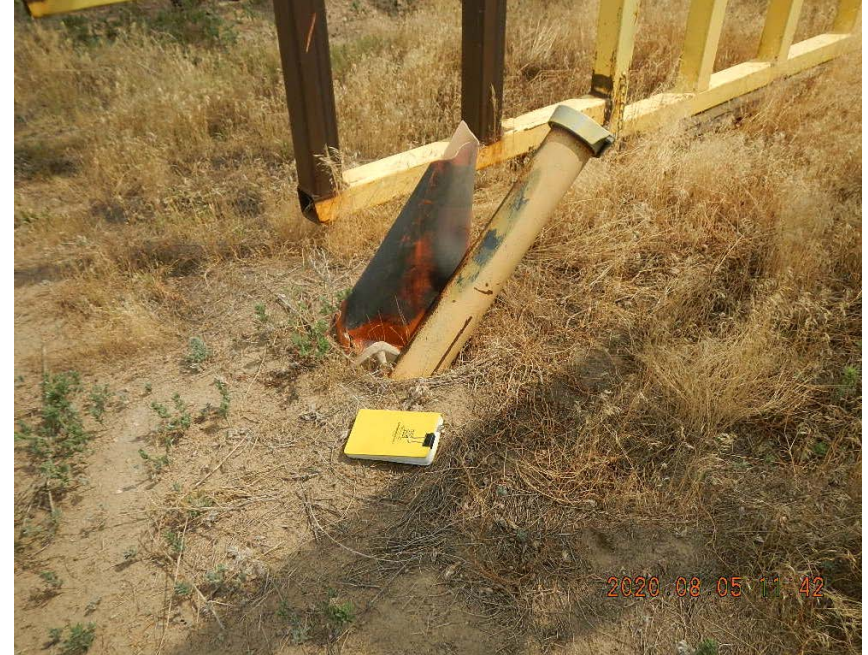
Damaged monitoring well.

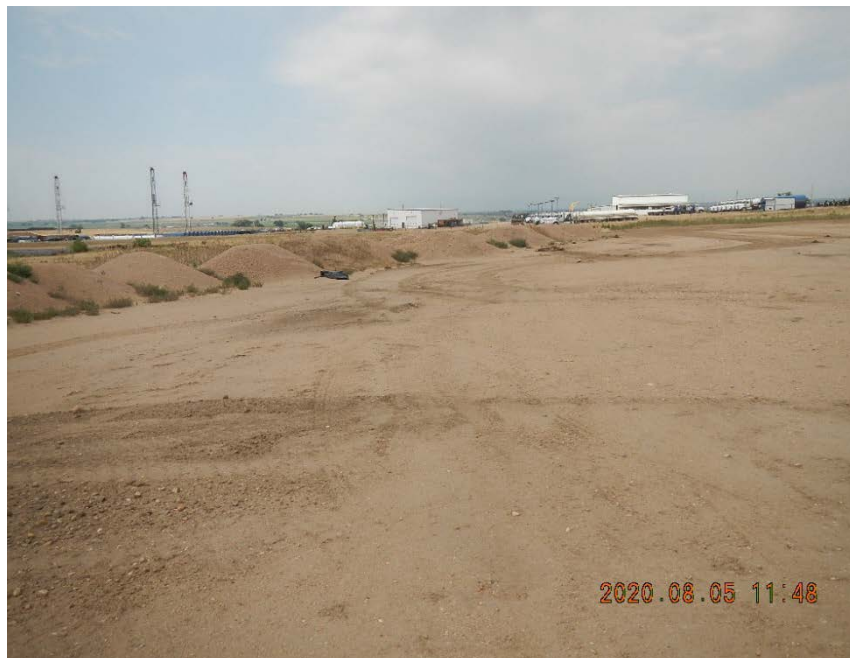
Pea gravel mounds.

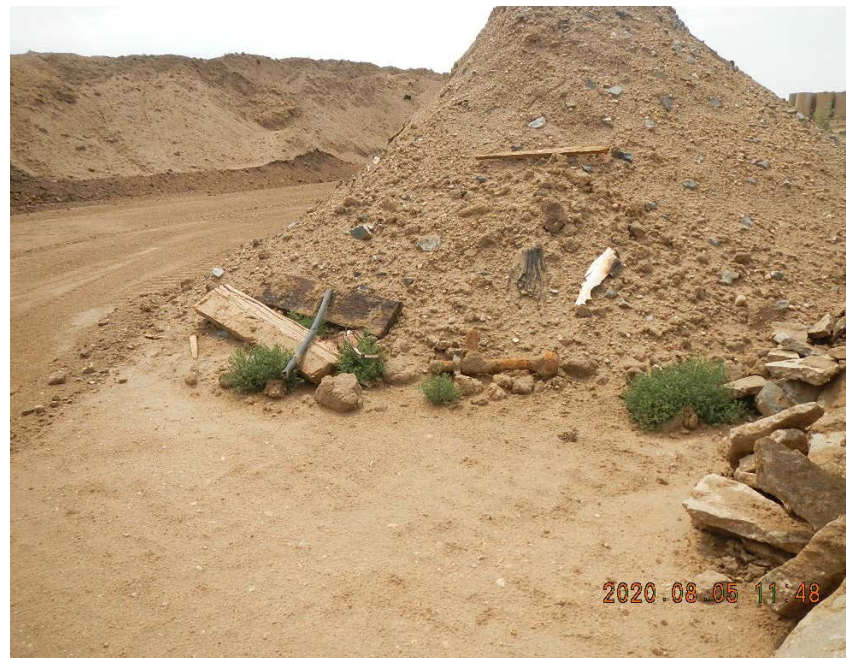
Trash and debris.

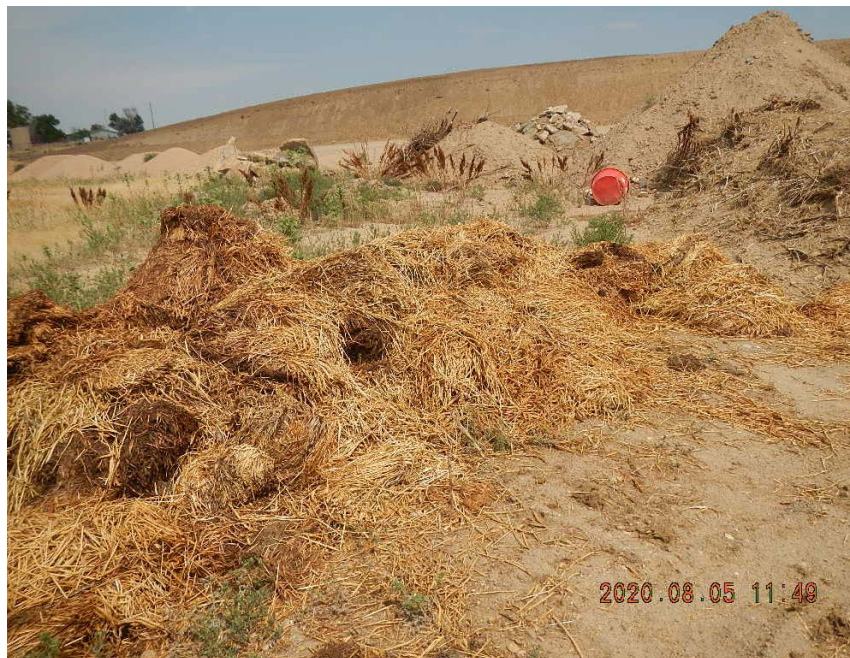
Trash and debris.

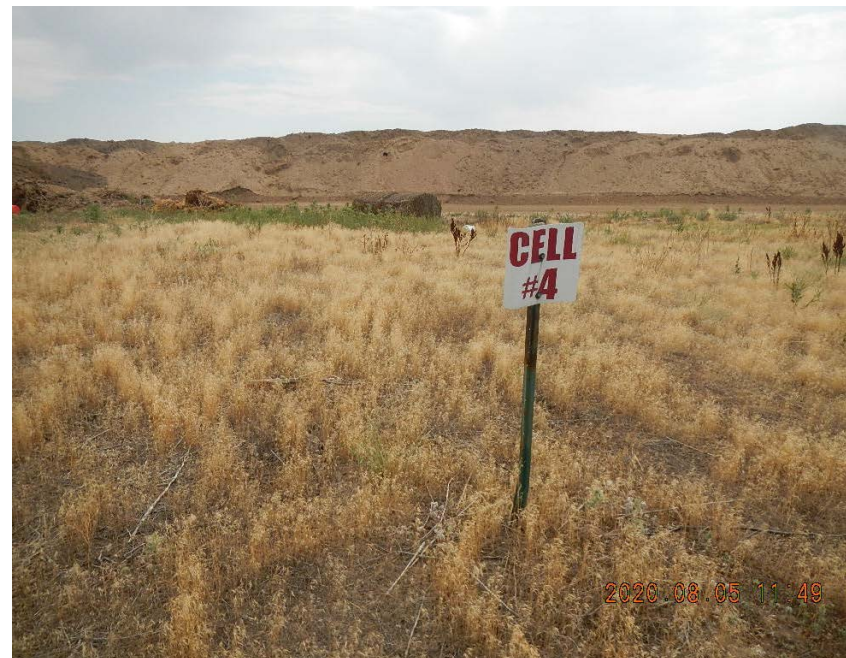
Former treatment cell.

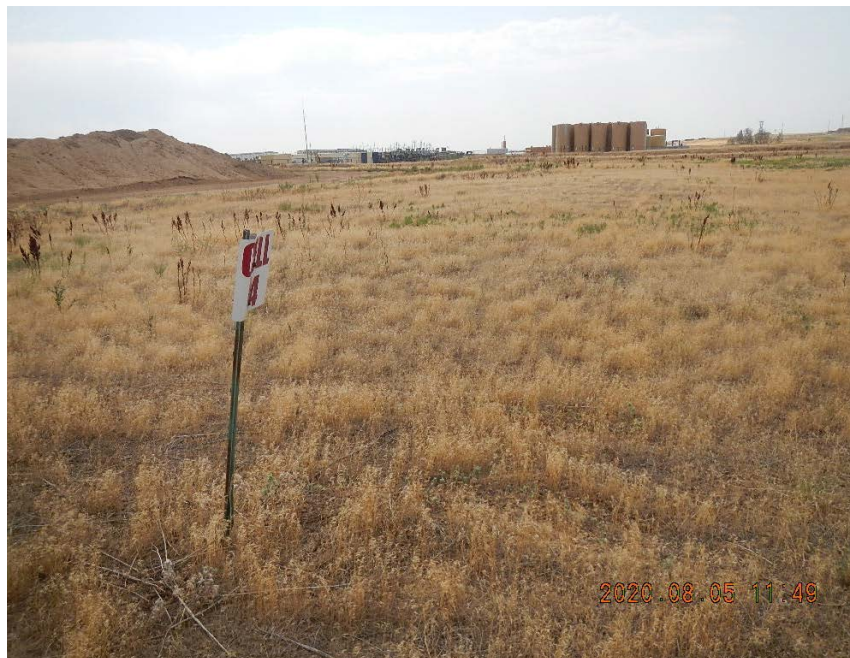
Former treatment cell.

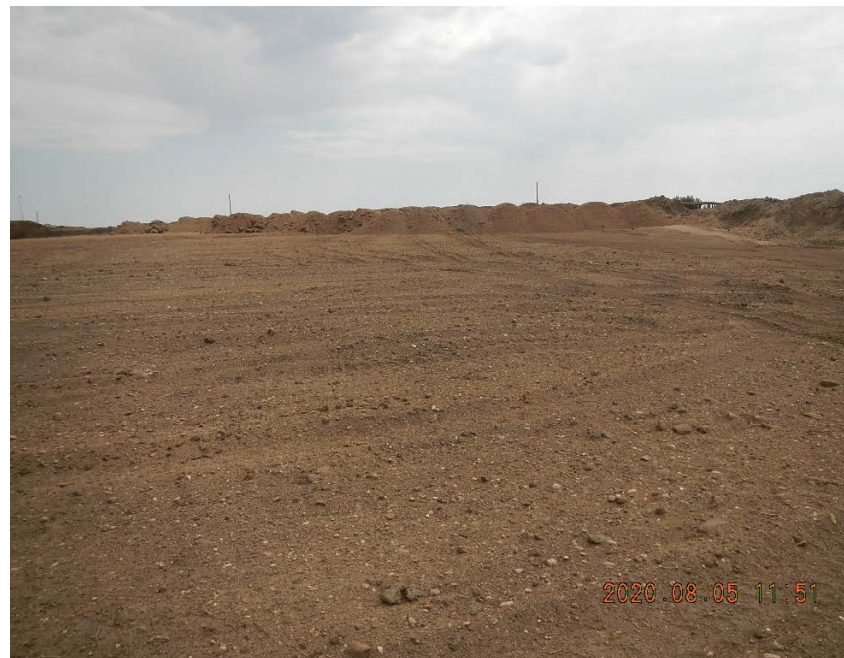
Material dumping.

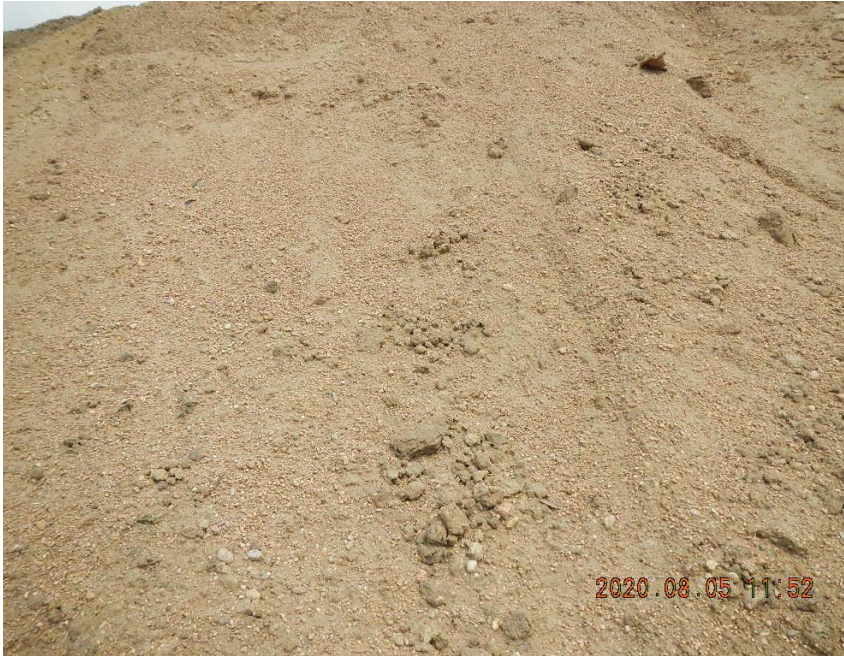
Appears to have pea gravel incorporated into the soil/material.

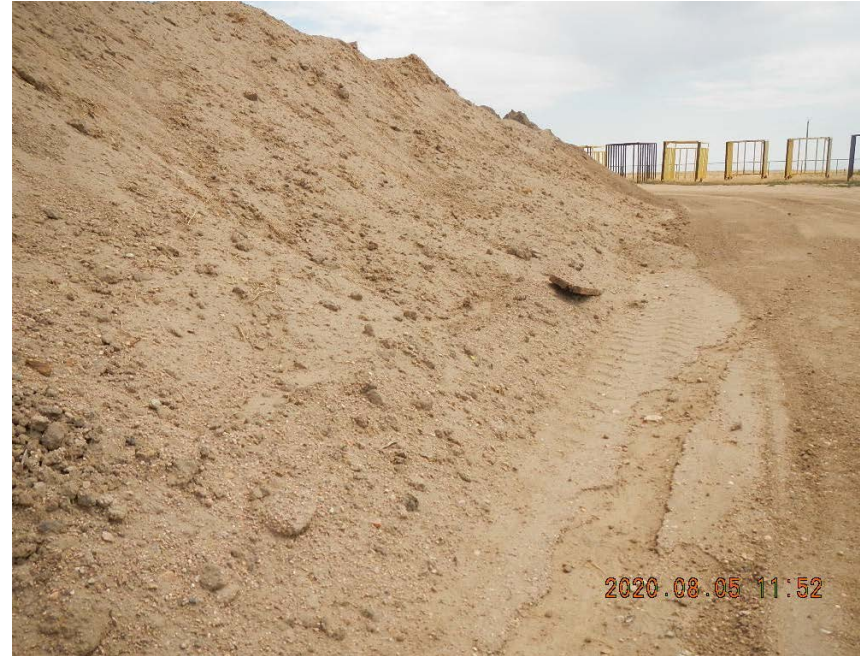
Appears to have pea gravel incorporated into the soil/material.

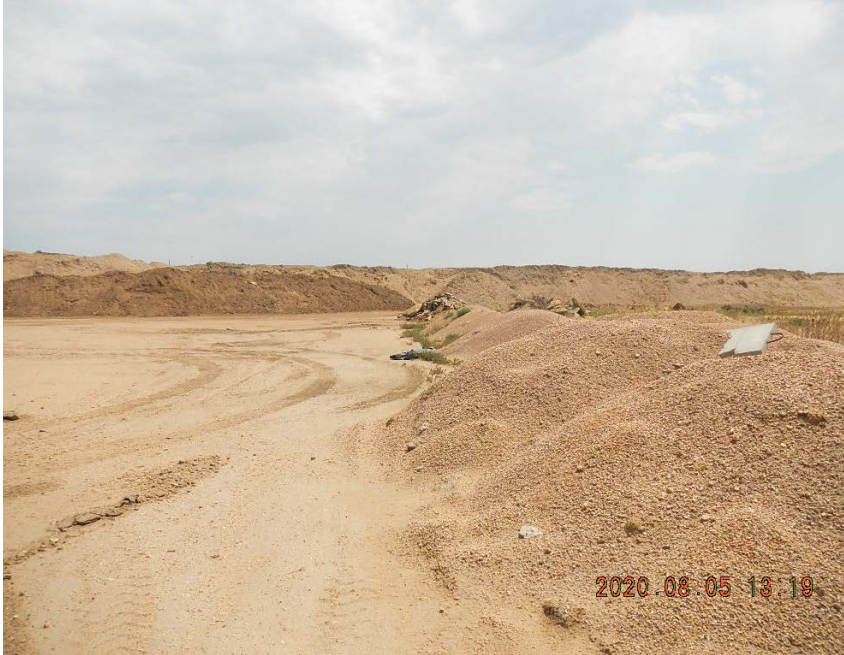
Pea gravel mounds with concrete.
