Inspection Photos

Location Name: Centralized Land Treatment Facility, Noble Energy Inc. (#100322)

Facility ID: 287848

August 5, 2020

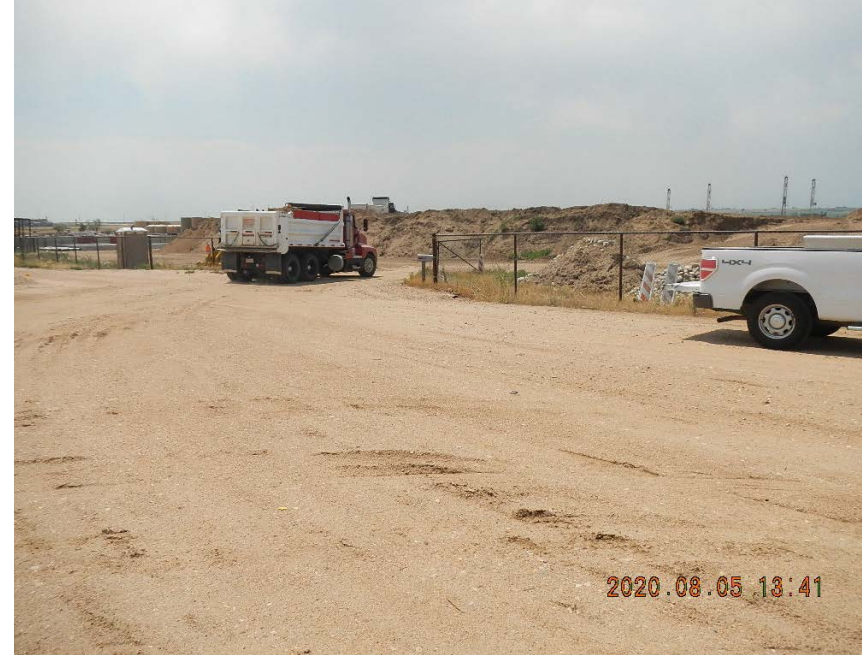
One of three trucks when inspector was on location.

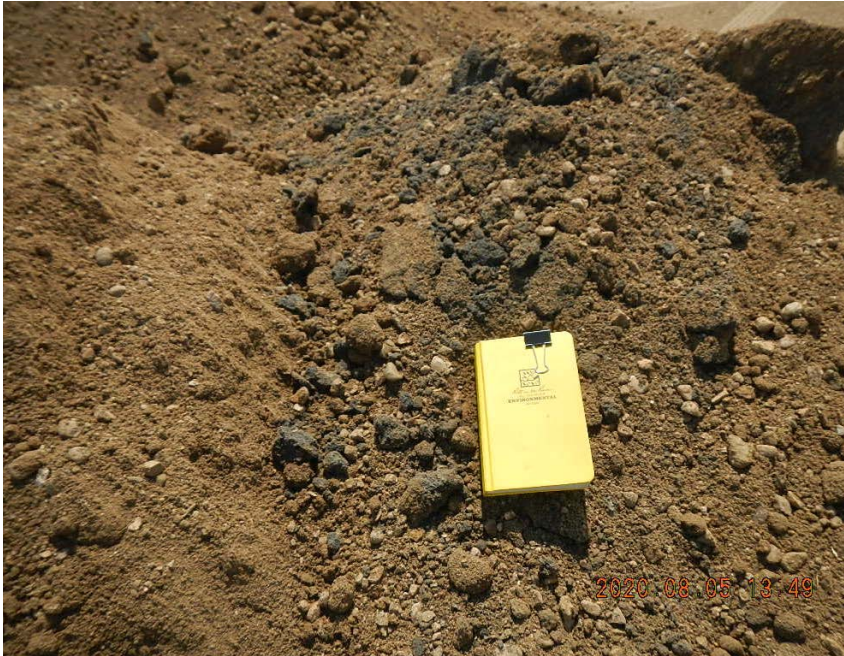
Alleged impacted material had strong HC odor.

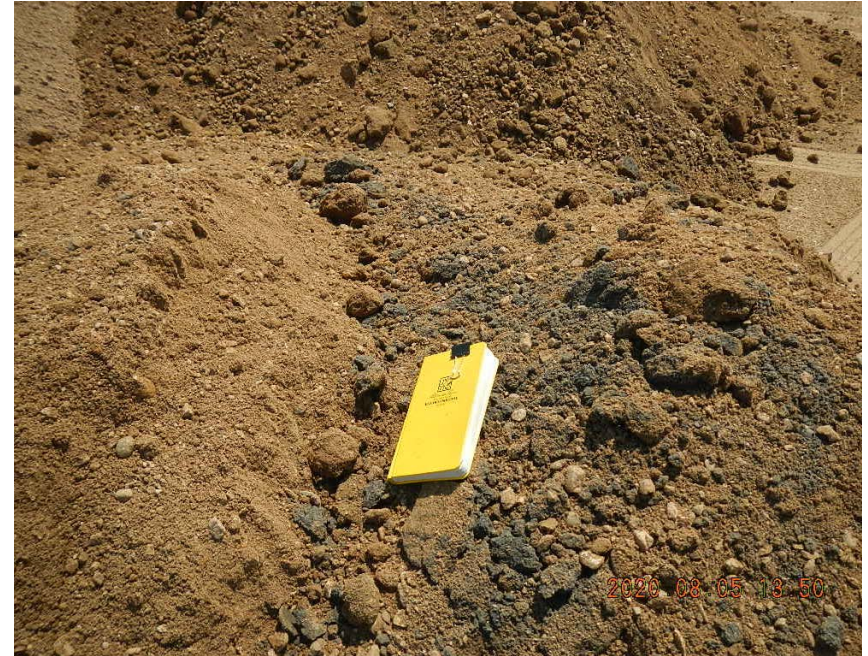
Alleged impacted material had strong HC odor.
