KP Kauffman - COGCC Follow-up Inspection Photos
Location: Nessu Consolidation OLF Release
Spill ID # 476987 Date 8/05/2020

Location: Nesssu Consolidation OLF Release

Spill ID # 476987 Date 8/05/2020

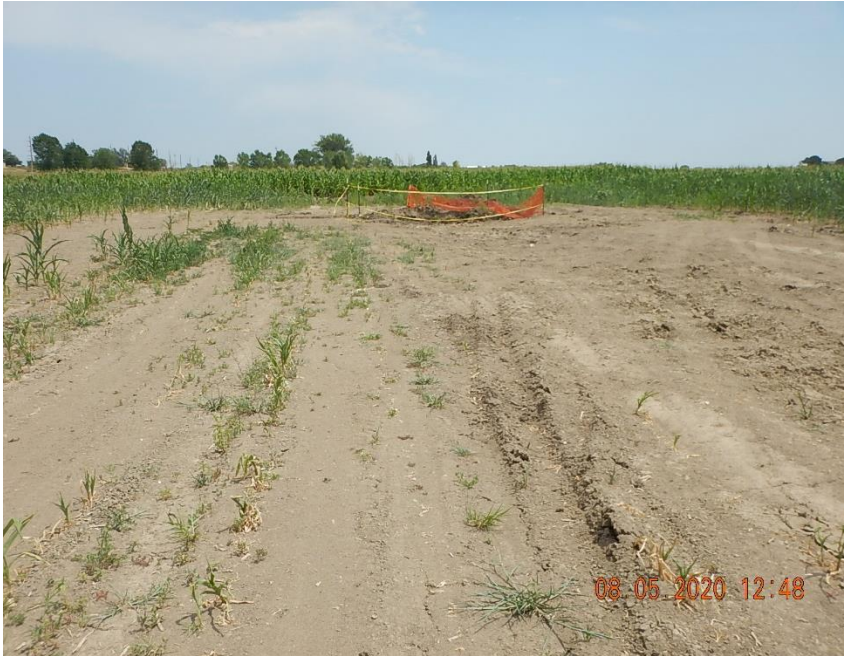
View of excavation observed at spill id #476987; to the east.

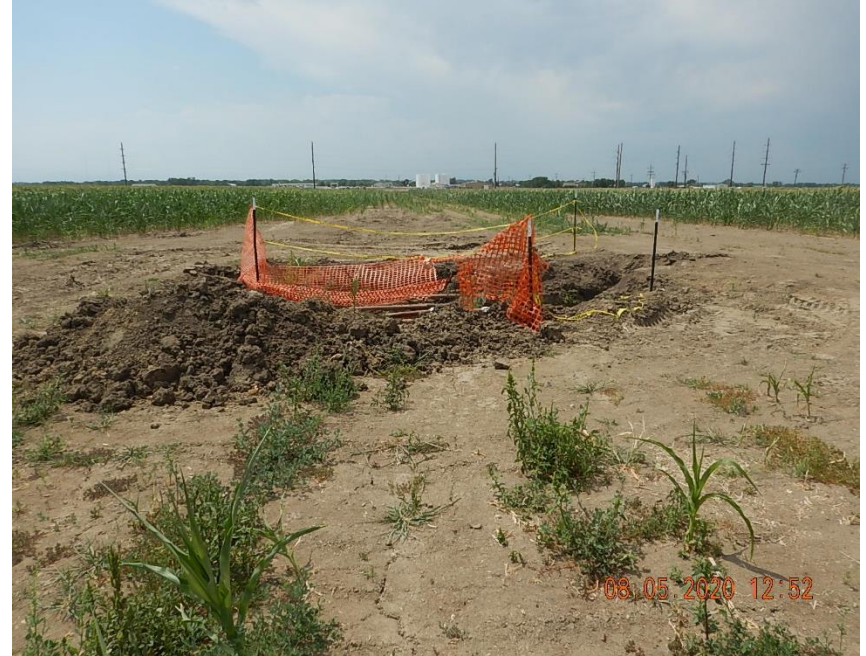
View of excavation observed at spill Id #476987; to the west.

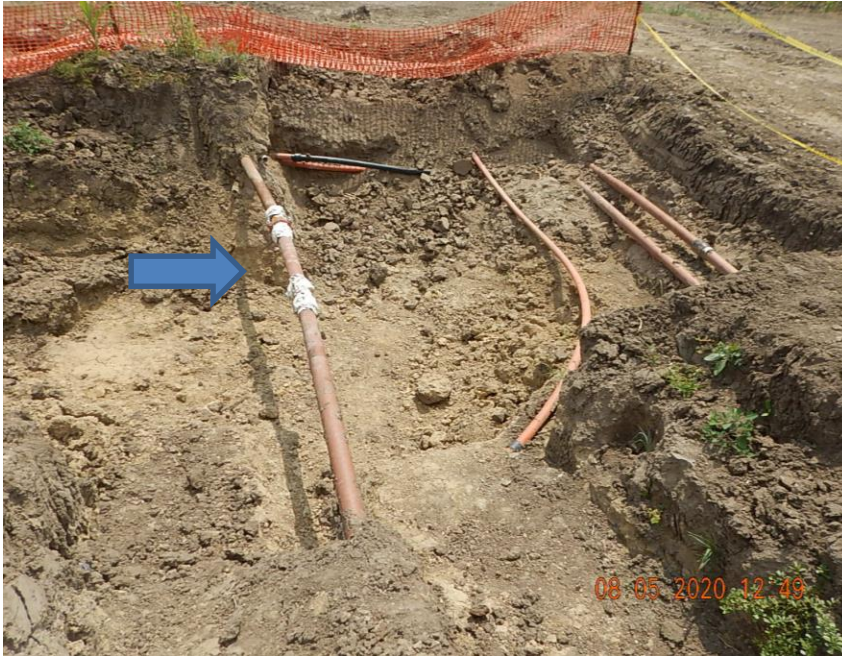
Excavation and flowlines exposed; The recently repaired section (2nd repair) of the 3" fiberglass Nesssu Consolidation off location flowline is shown right of the arrow.

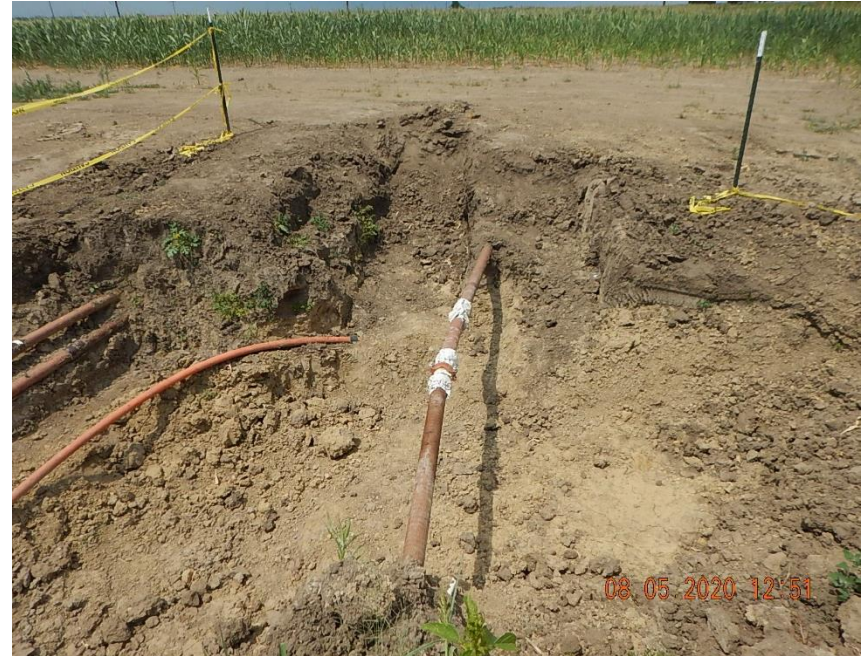
View of repair completed to Nesssu Consolidation OLF; Bend/ bow can be seen in the repaired section of flowline; cut ends/ repair stub section do not appear to align.

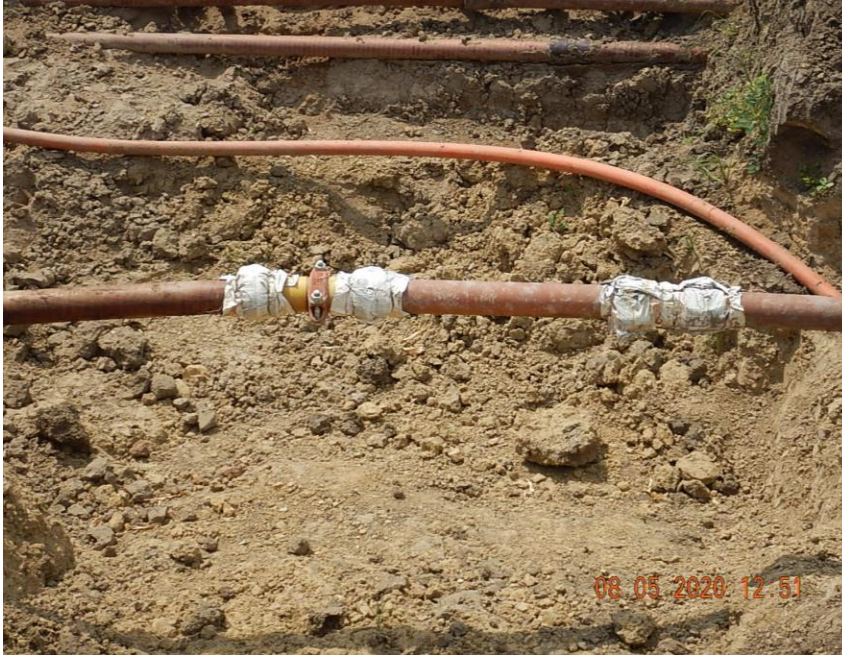
View of repair completed to Nesssu Consolidation off location flowline; a bolted clamp has been used as part of the flowline repair where the existing pipe and replacement pipe stub do not appear to properly align.

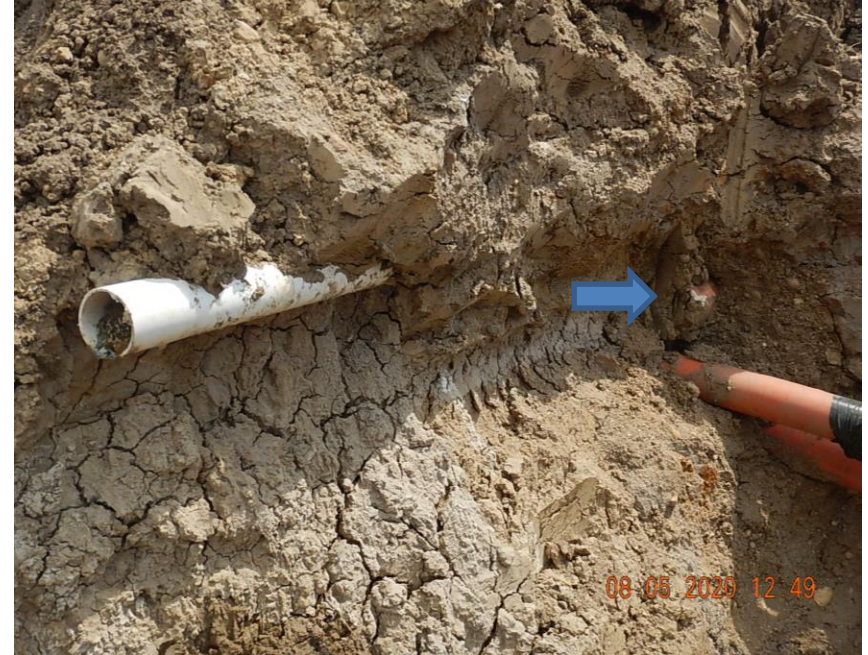
(3) improperly abandoned flowlines were observed exposed from the south wall of excavation at Spill ID # 476987 (only 2 are shown in this photo); flowline cut ends are not sealed per 1105.e.4.

Note the open cut end of a 3" fiberglass flowline to right of the arrow.
