Inspection Photos
Operator: BP America
API: 067-07155
Date: 8/5/2020

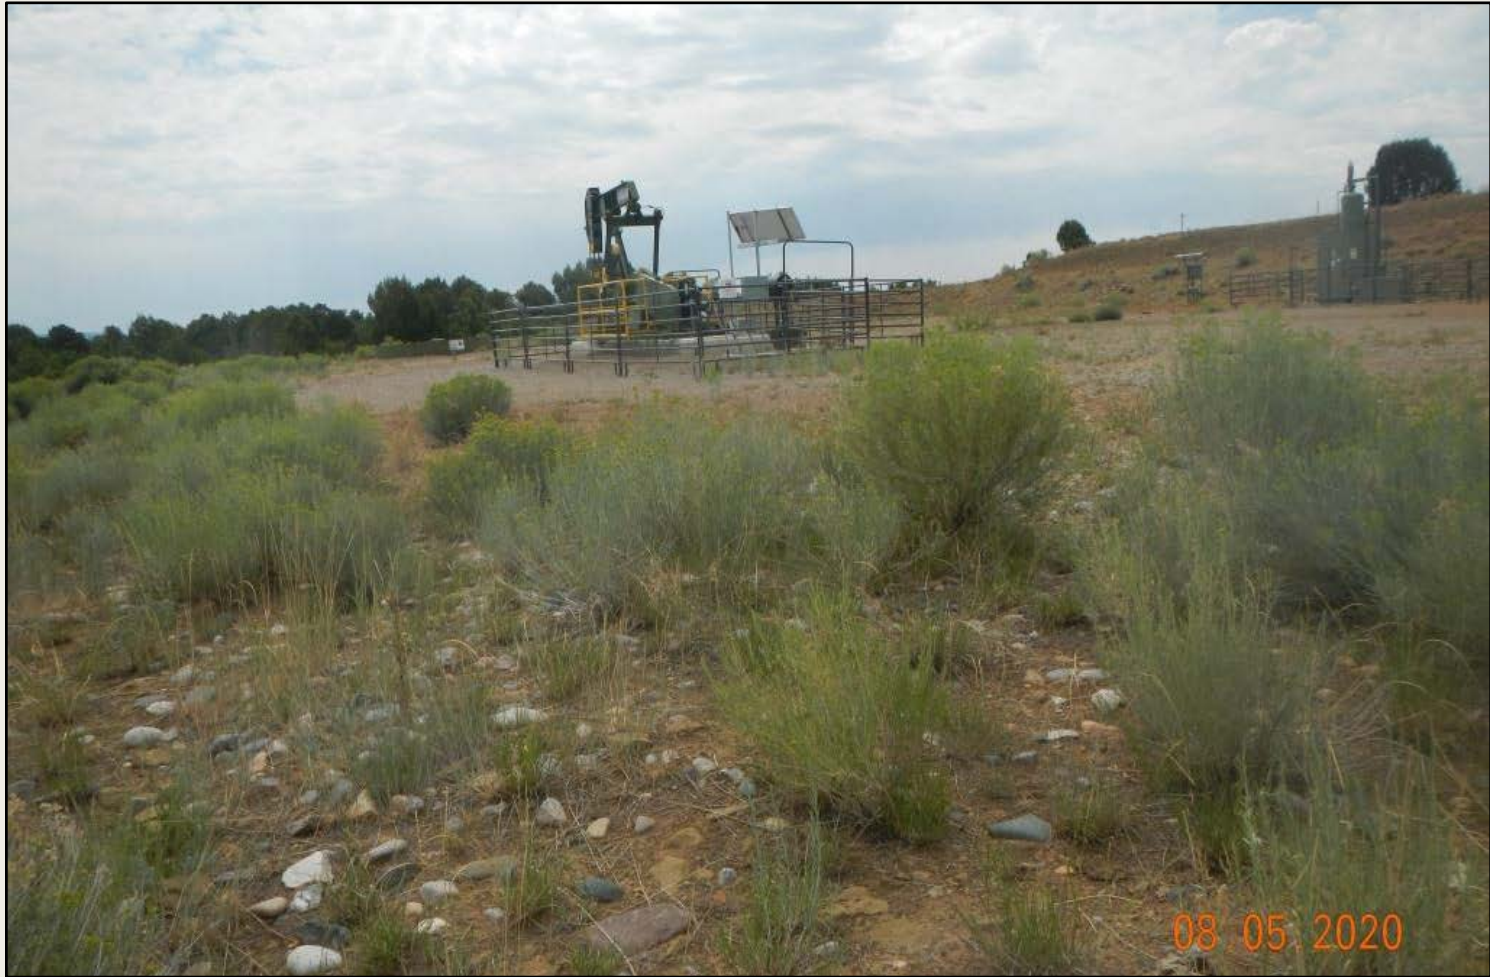
Photo 1. View of the project area from the northwestern corner facing center.

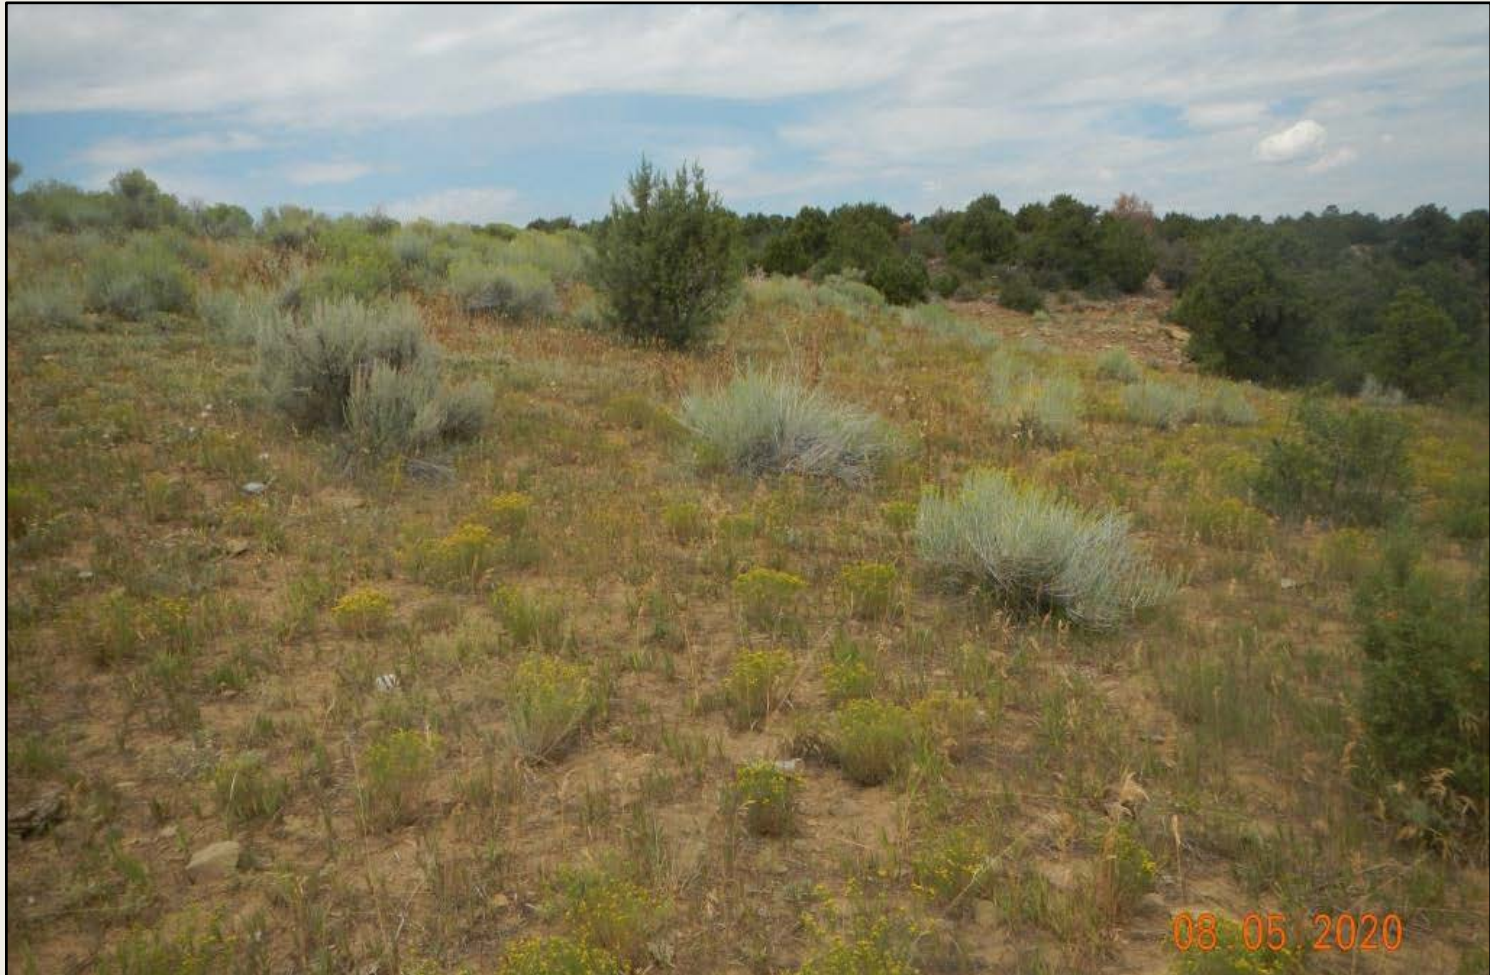
Photo 2. View of the northern portion of the project area from the northeastern corner facing westward. Revegetation is progressing with western wheatgrass, snakeweed, rubber rabbitbrush, and crested wheatgrass.

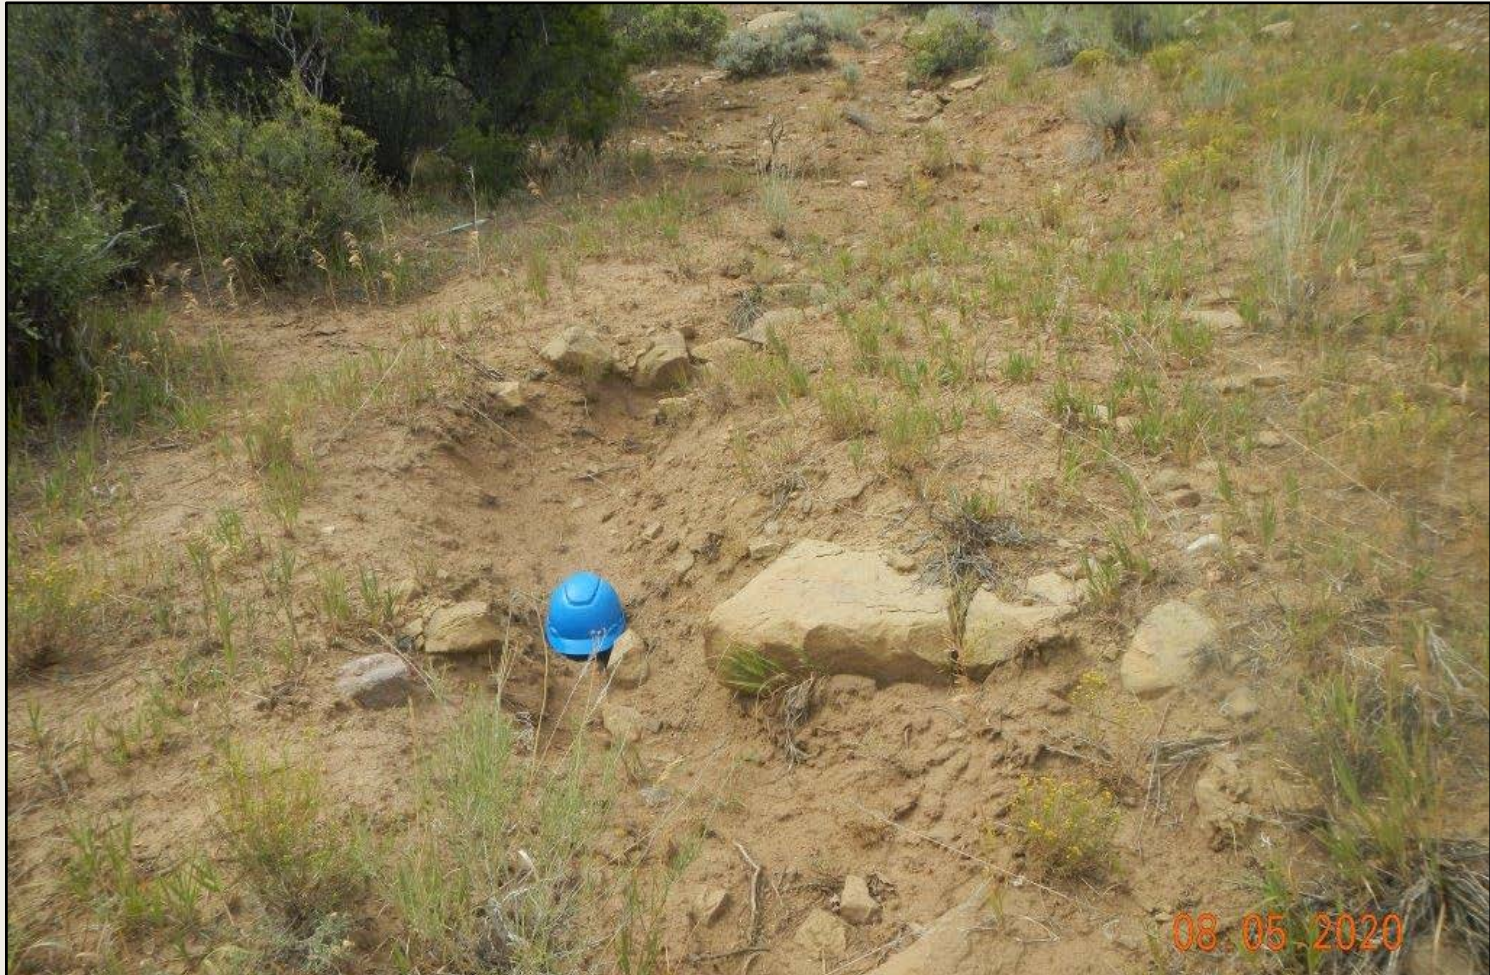
Photo 3. View of erosional channel approximately 3 feet wide and 2 feet deep in the eastern project area.

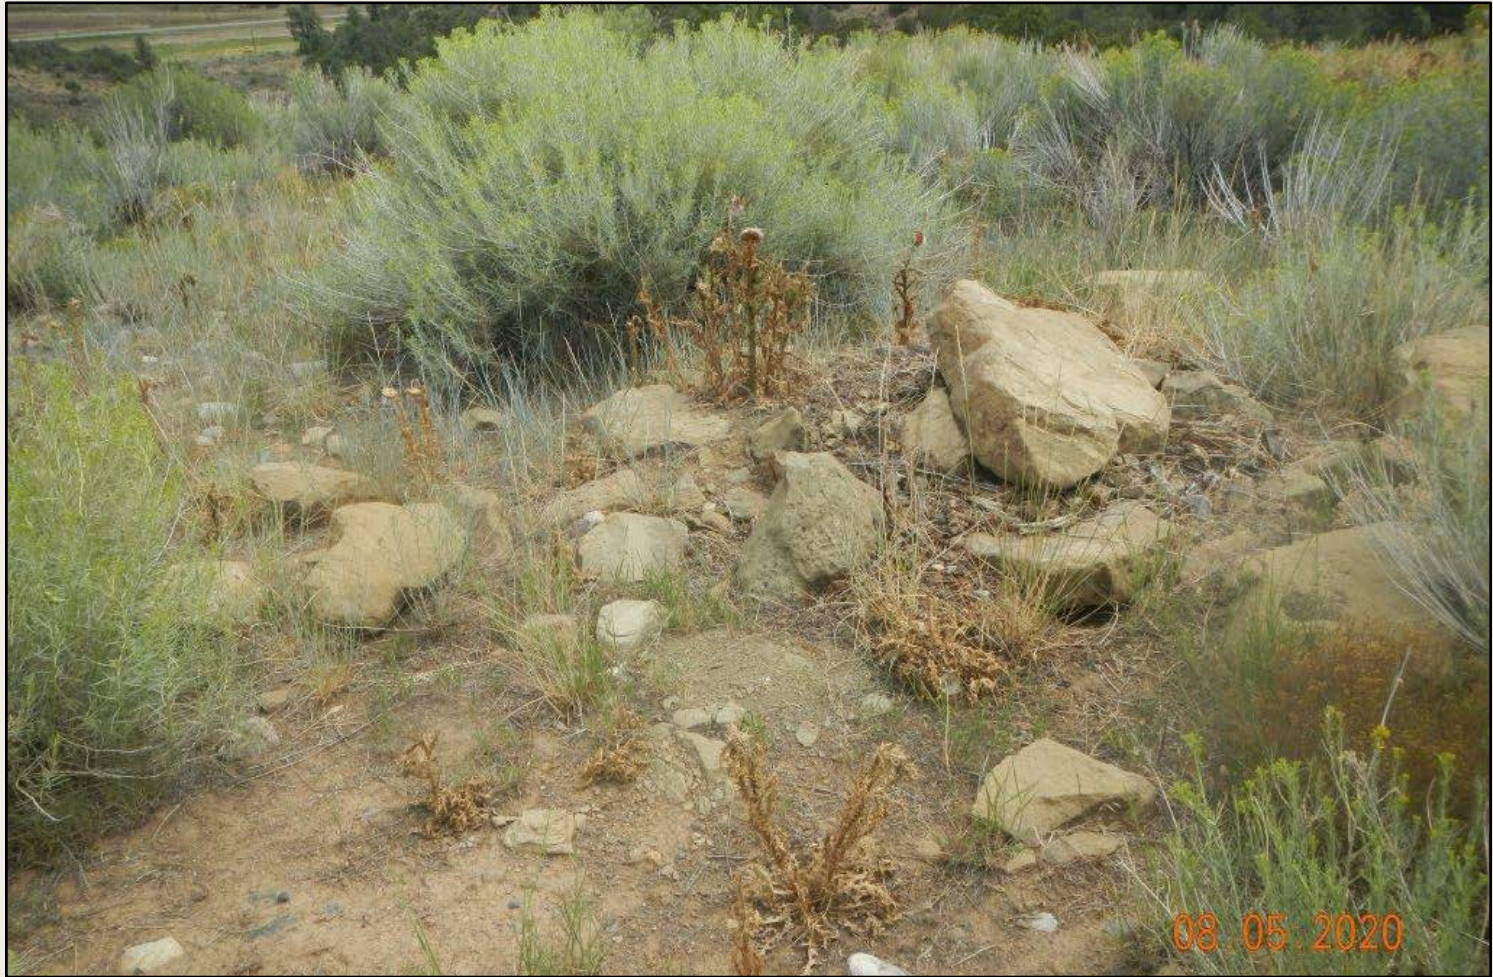
Photo 4. View of musk thistles within the project area that appear to be herbicide-treated (approx. 150 individuals observed).
