Inspection Photos  
Operator: BP America  
API: 067-07124  
Date: 8/5/2020

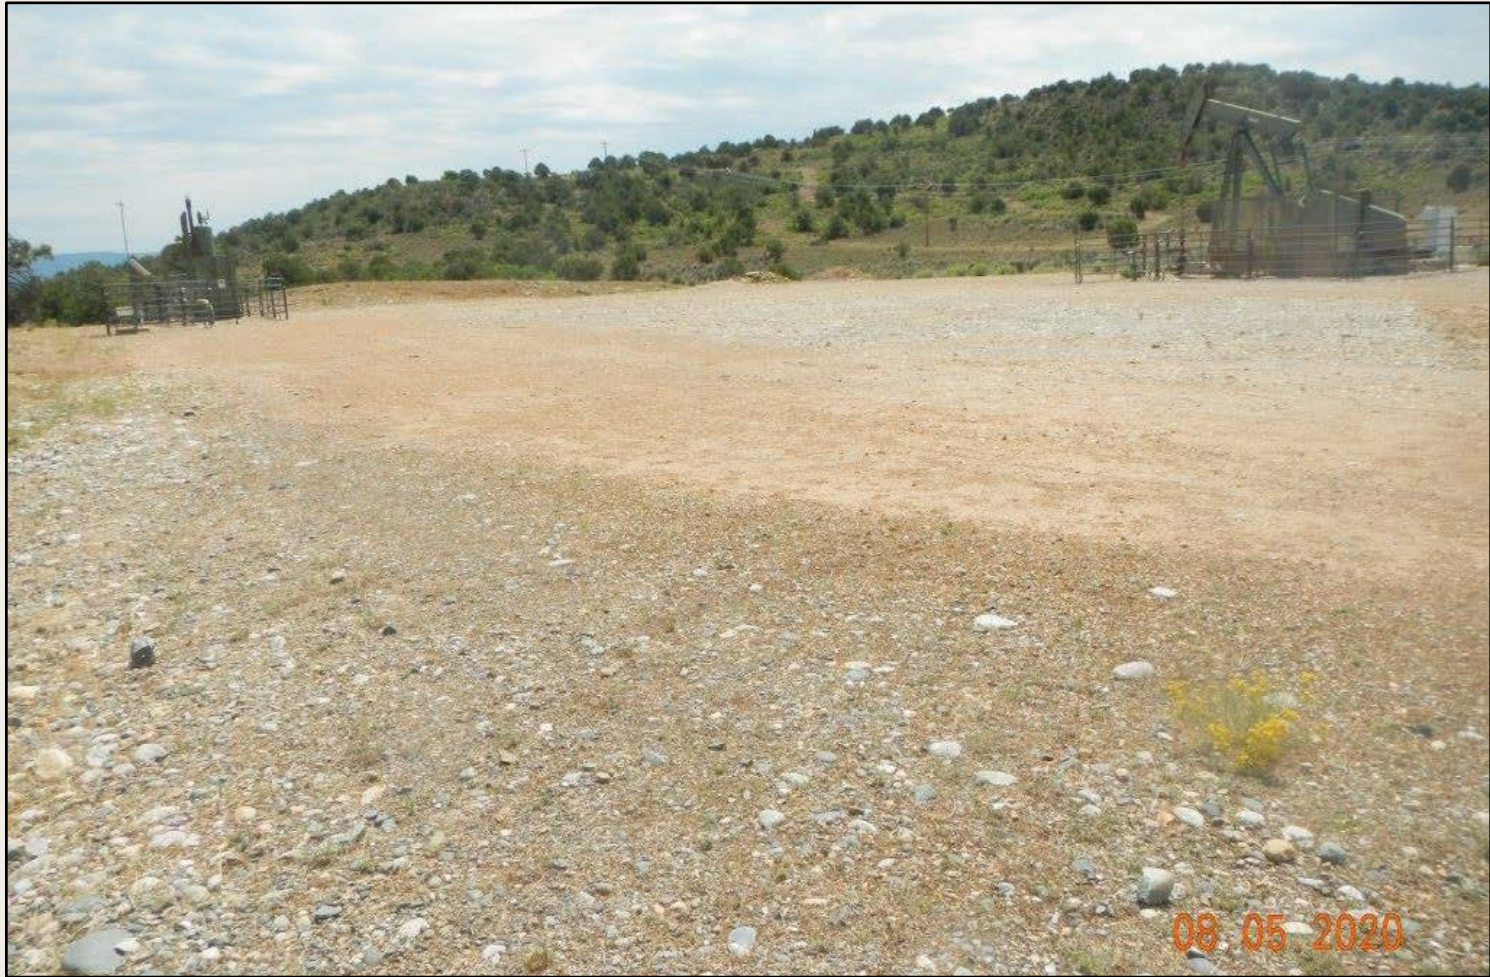
Photo 1. View of the project area from the northwestern corner facing center.

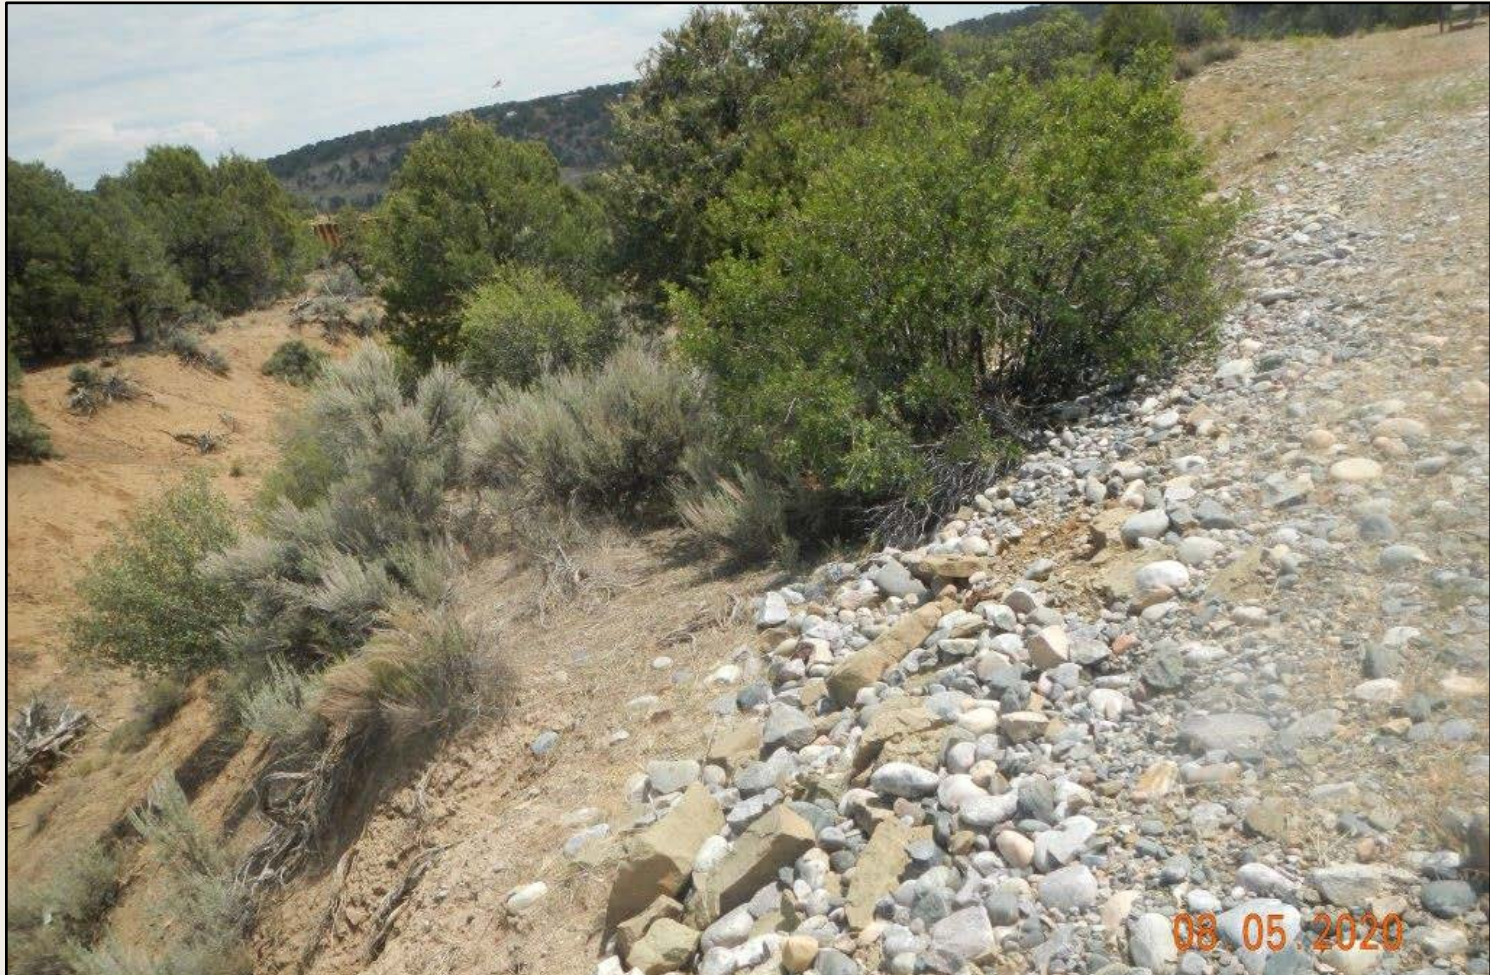
Photo 2. View of the northern portion of the project area from the northwestern corner facing eastward.

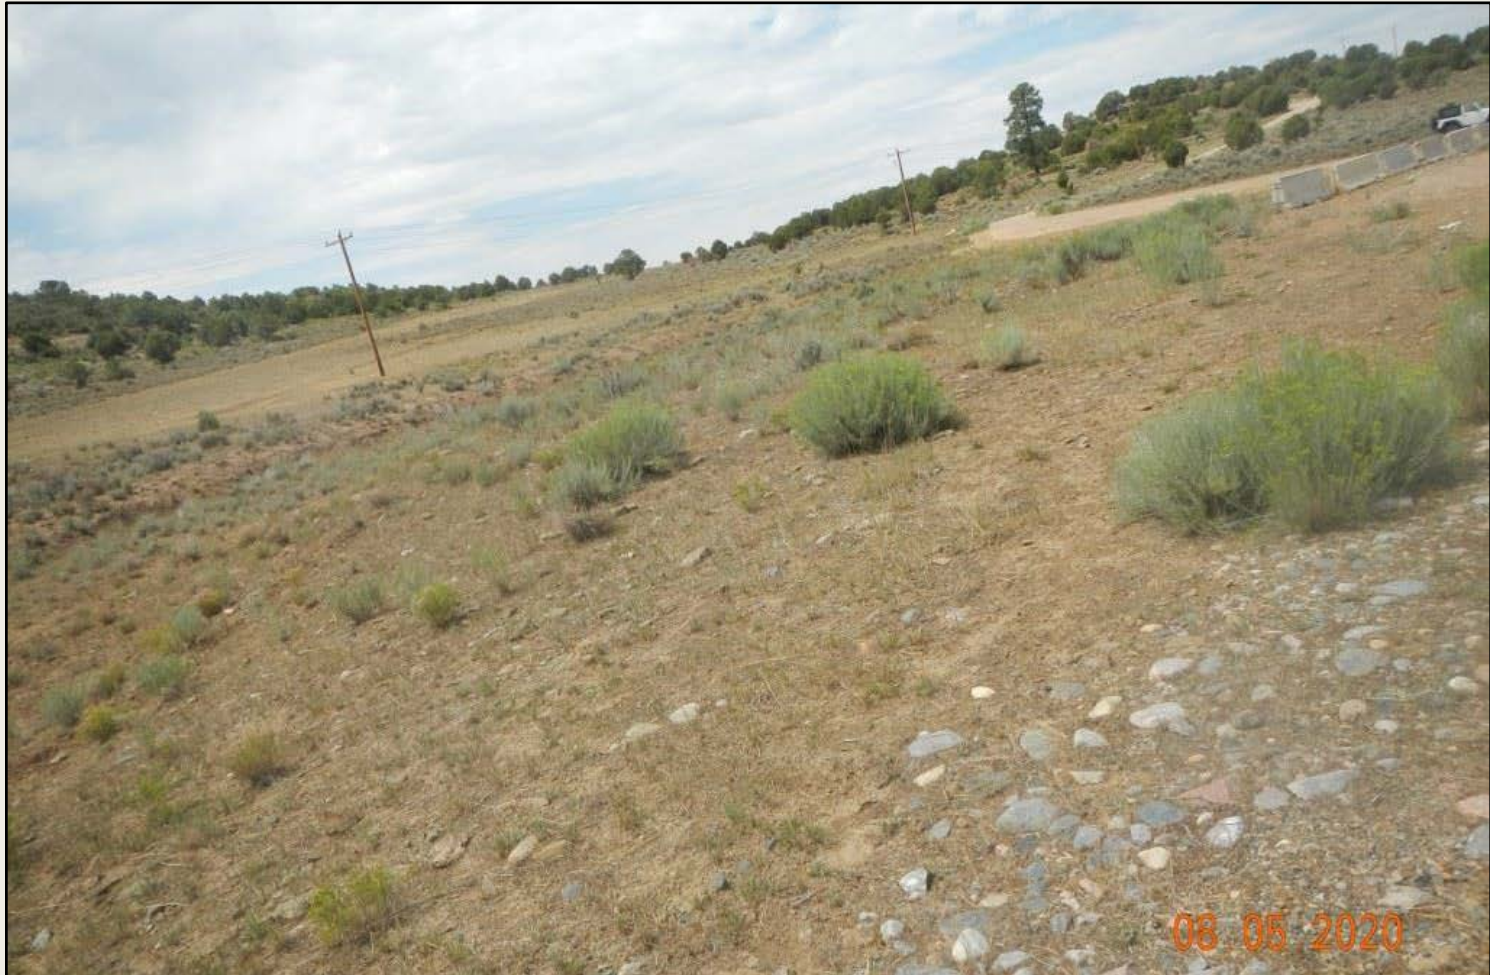
Photo 3. View of the southern portion of the project area from the southeastern corner facing westward. Revegetation is progressing with grasses in a grazed condition, as well as rubber rabbitbrush.

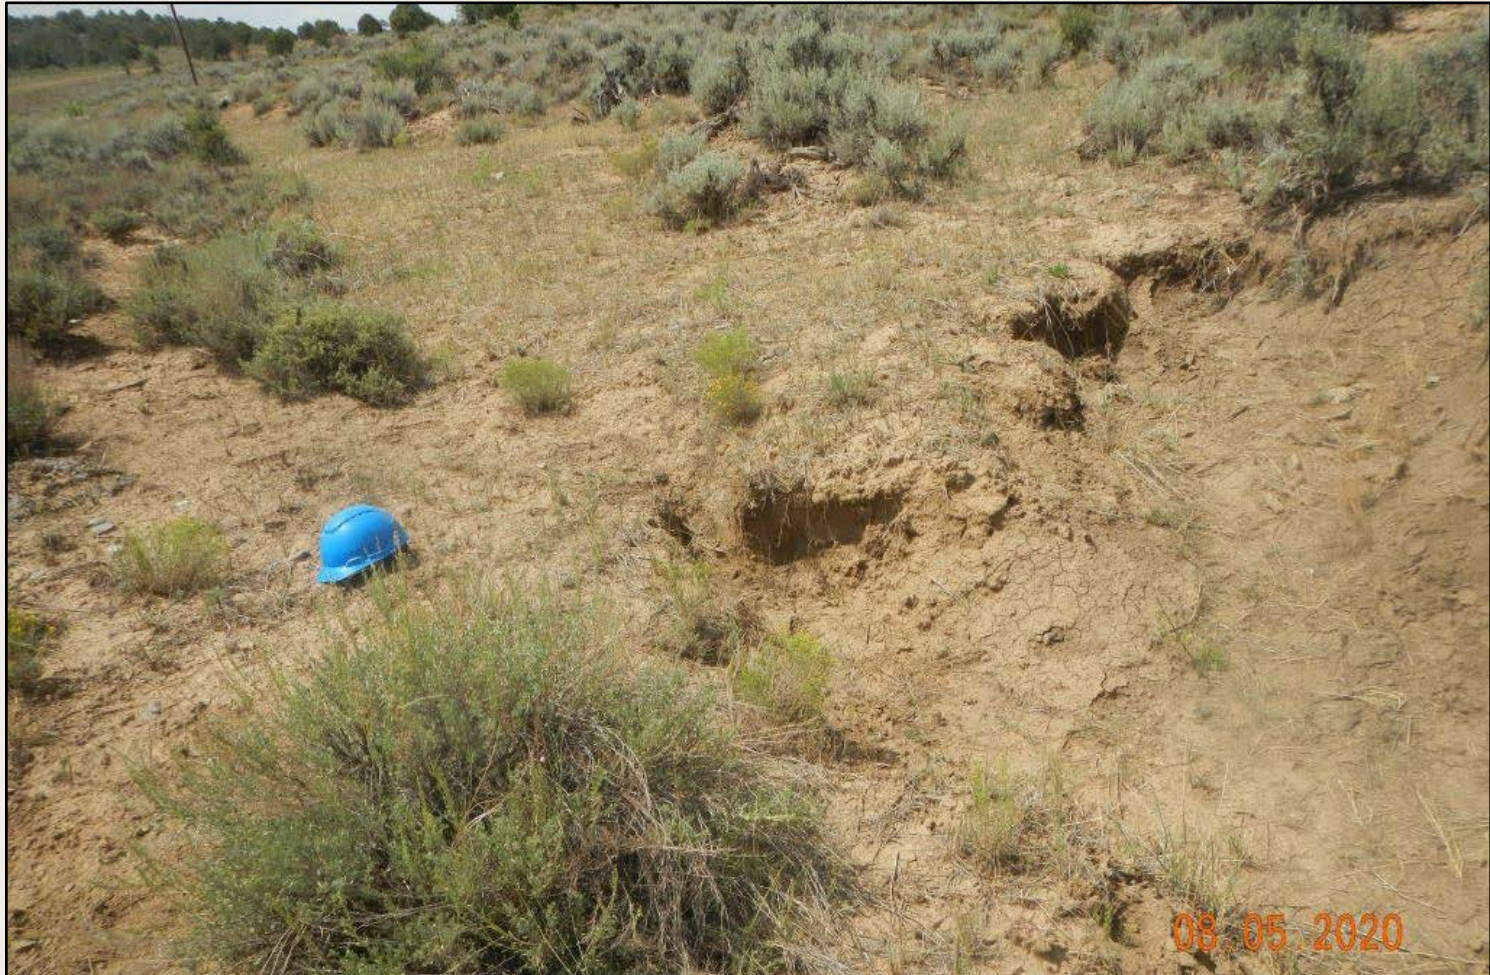
Photo 4. View of erosional headcut at the western edge of the project area, where concentrated flows from the access culvert and a drainage swale converge at the well pad.
