Inspection Photos
Operator: Hilcorp Energy
API: 067-07799
Date: 8/11/2020

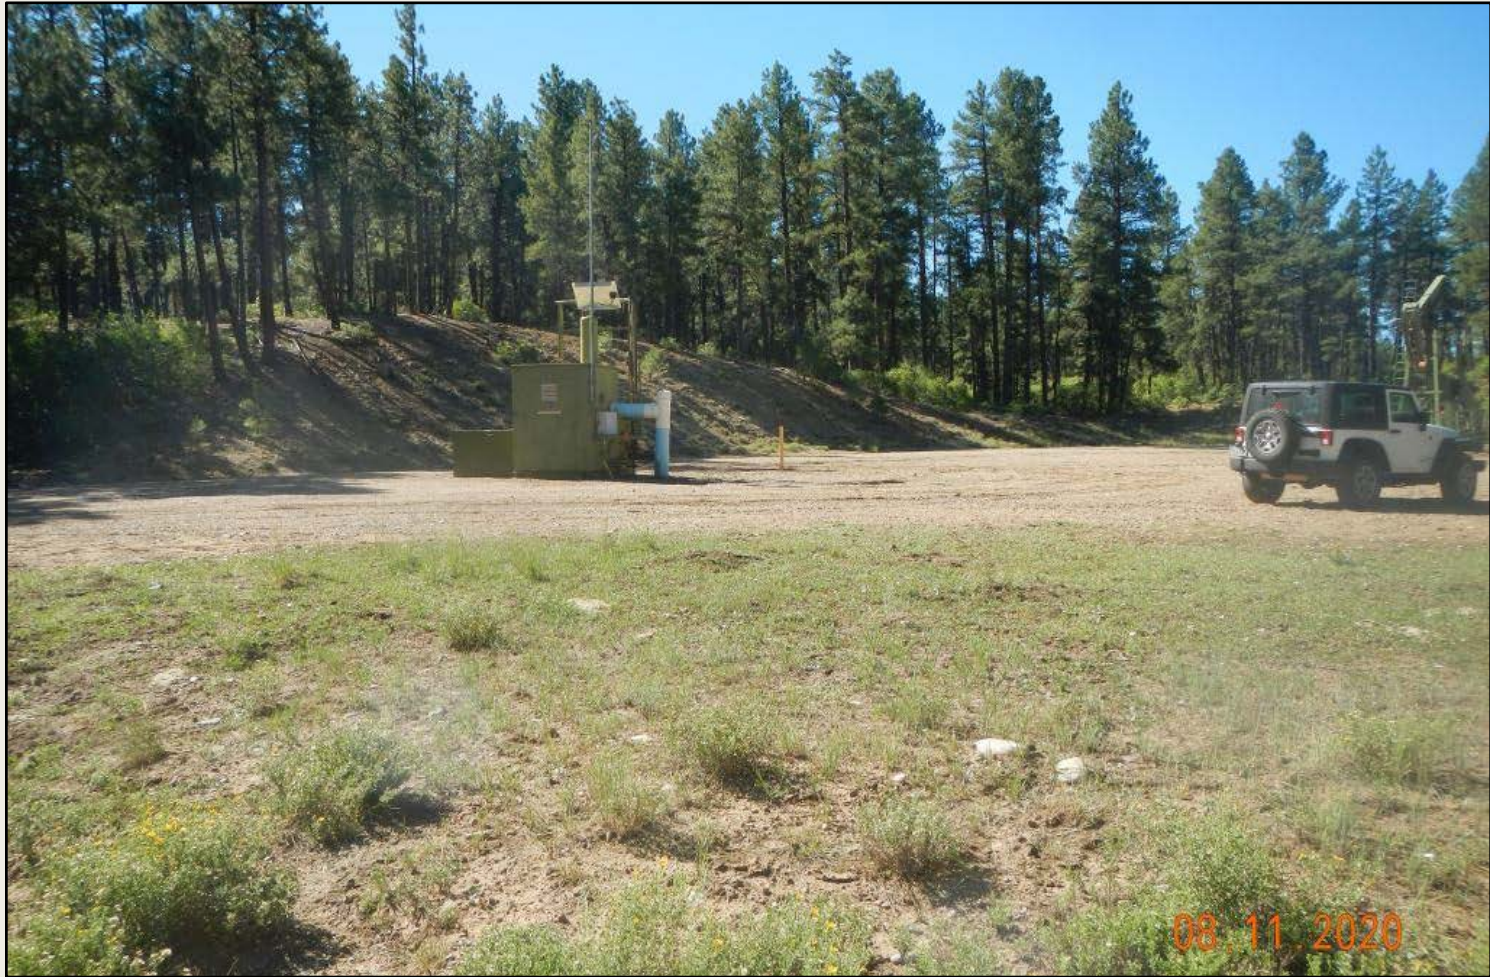
Photo 1. View of the project area from the northeastern corner facing center.

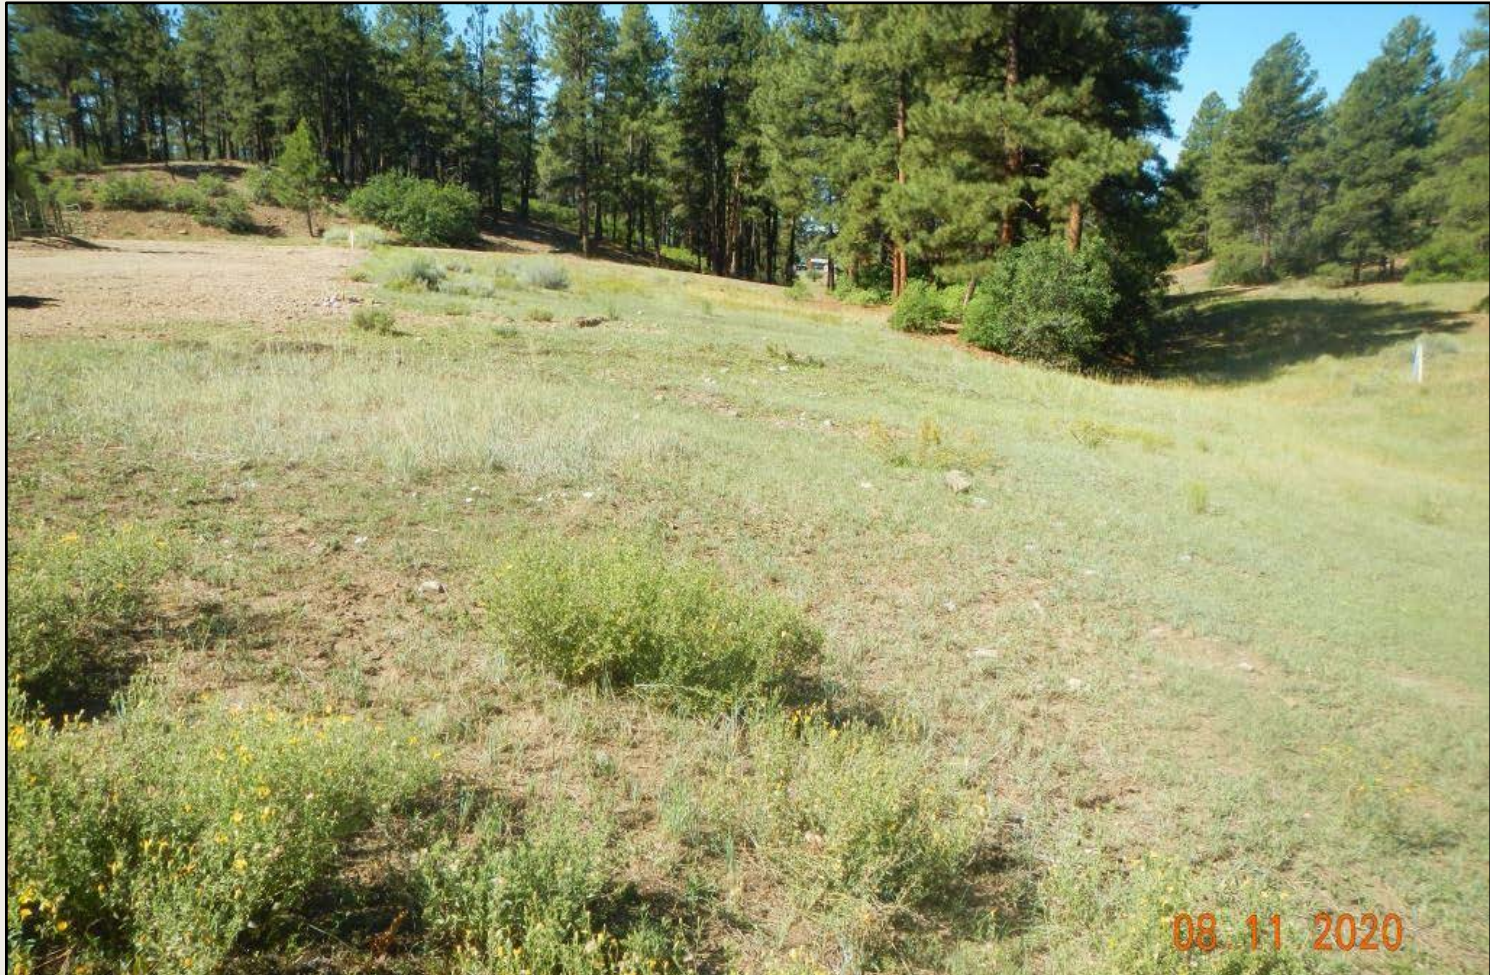
Photo 2. View of the northern portion of the project area from the northeastern corner facing westward.

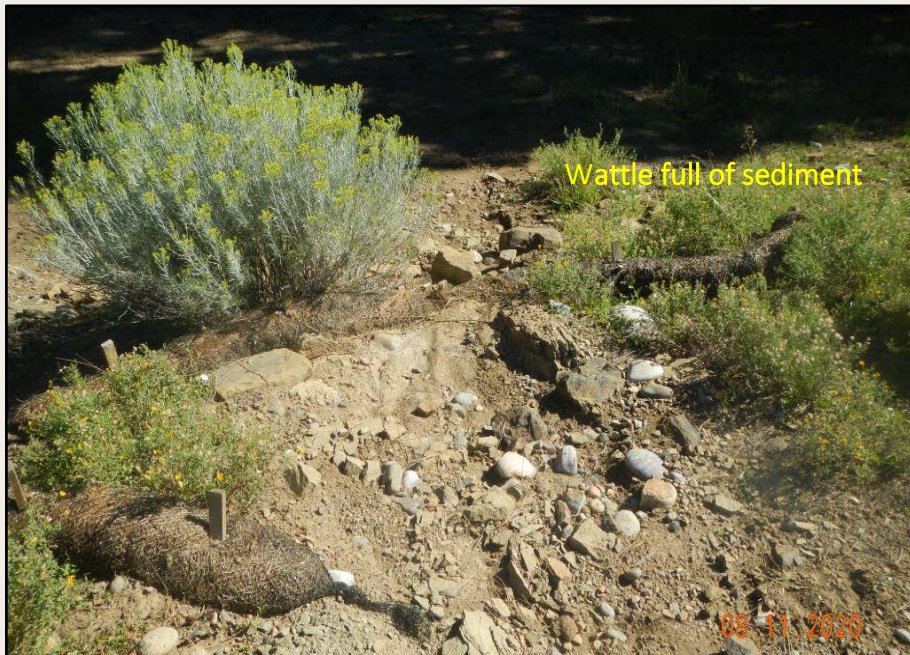
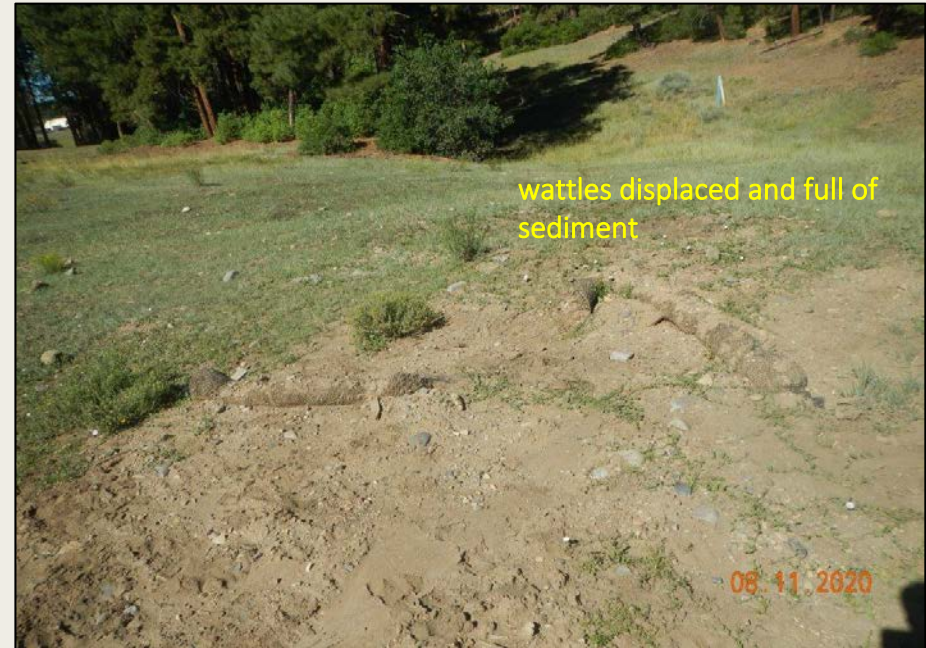
Photos 3/4. View of wattles in the northern and northeastern project area that are full of sediment, displaced, and no longer functioning. Wattles are not adequate BMPs in these areas.

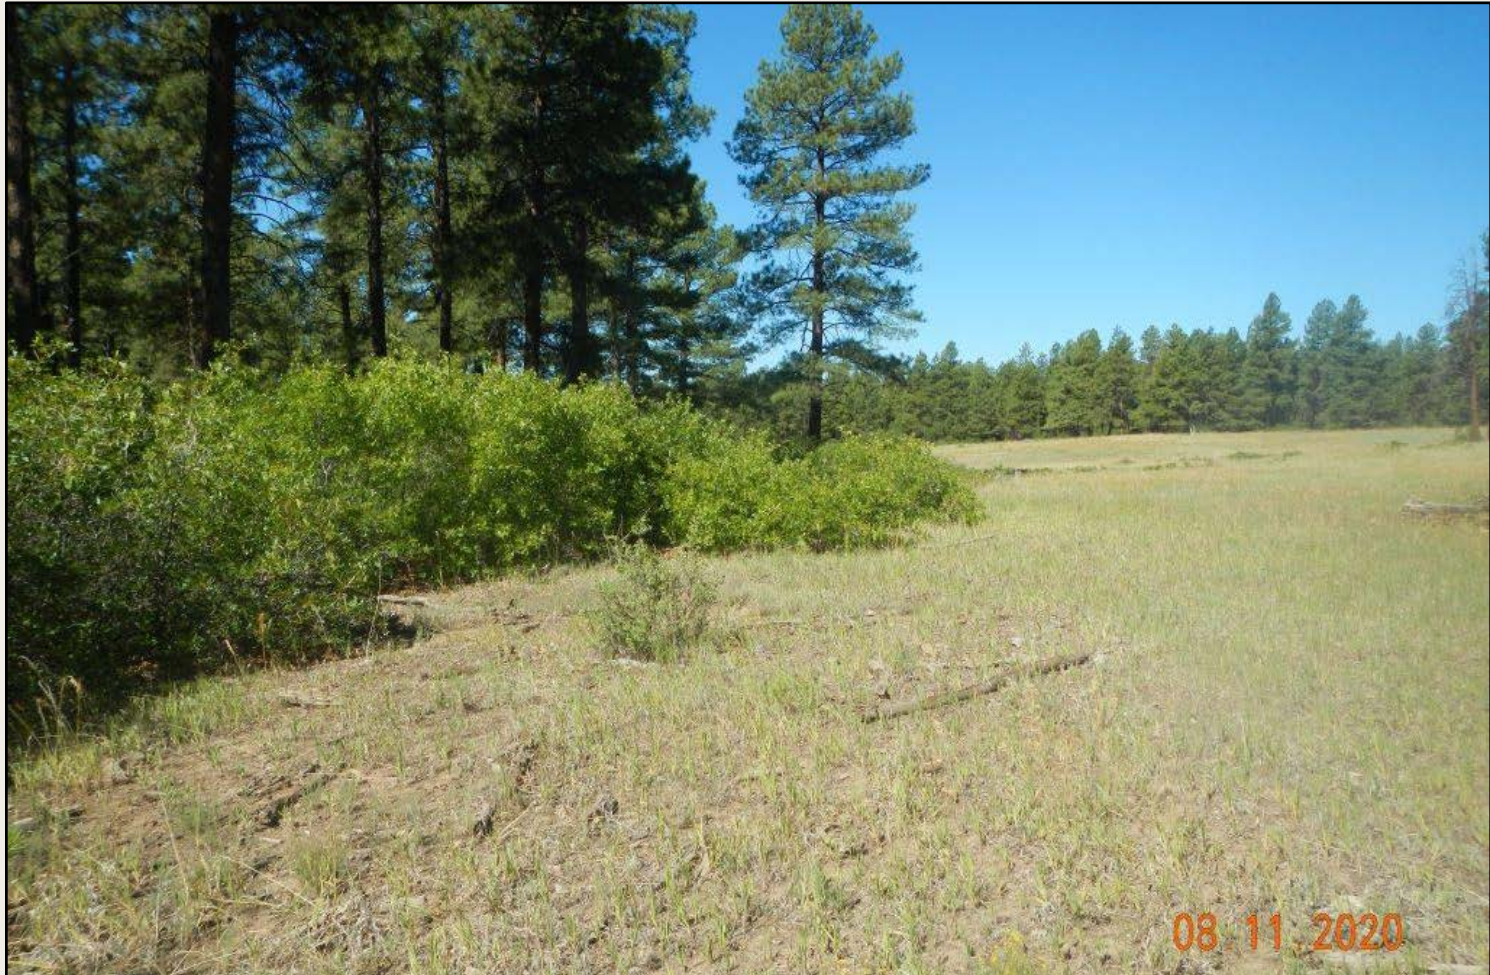
Photo 4. View of reference area comprised of ponderosa pine woodland with gambel oak understory, with a mosaic of open grassland largely comprised of smooth brome and western wheatgrass.
