Inspection Photos

API: 071-07584

Operator: EVERGREEN NATURAL RESOURCES

Inspection Date: 8/10/2020

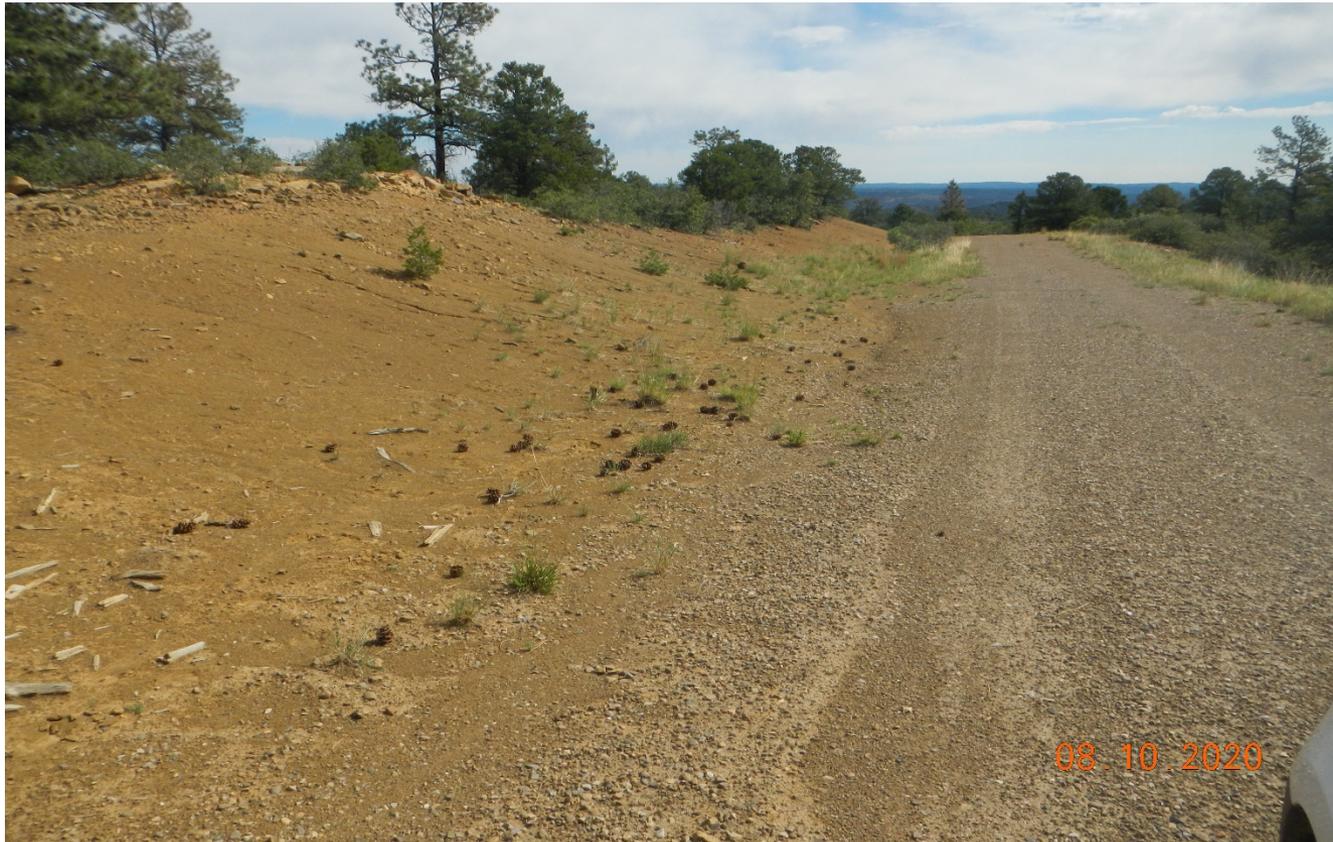
Photo 1. Facing northeast along the access road. The cut slope along the access road has not established vegetation for long term stabilization.

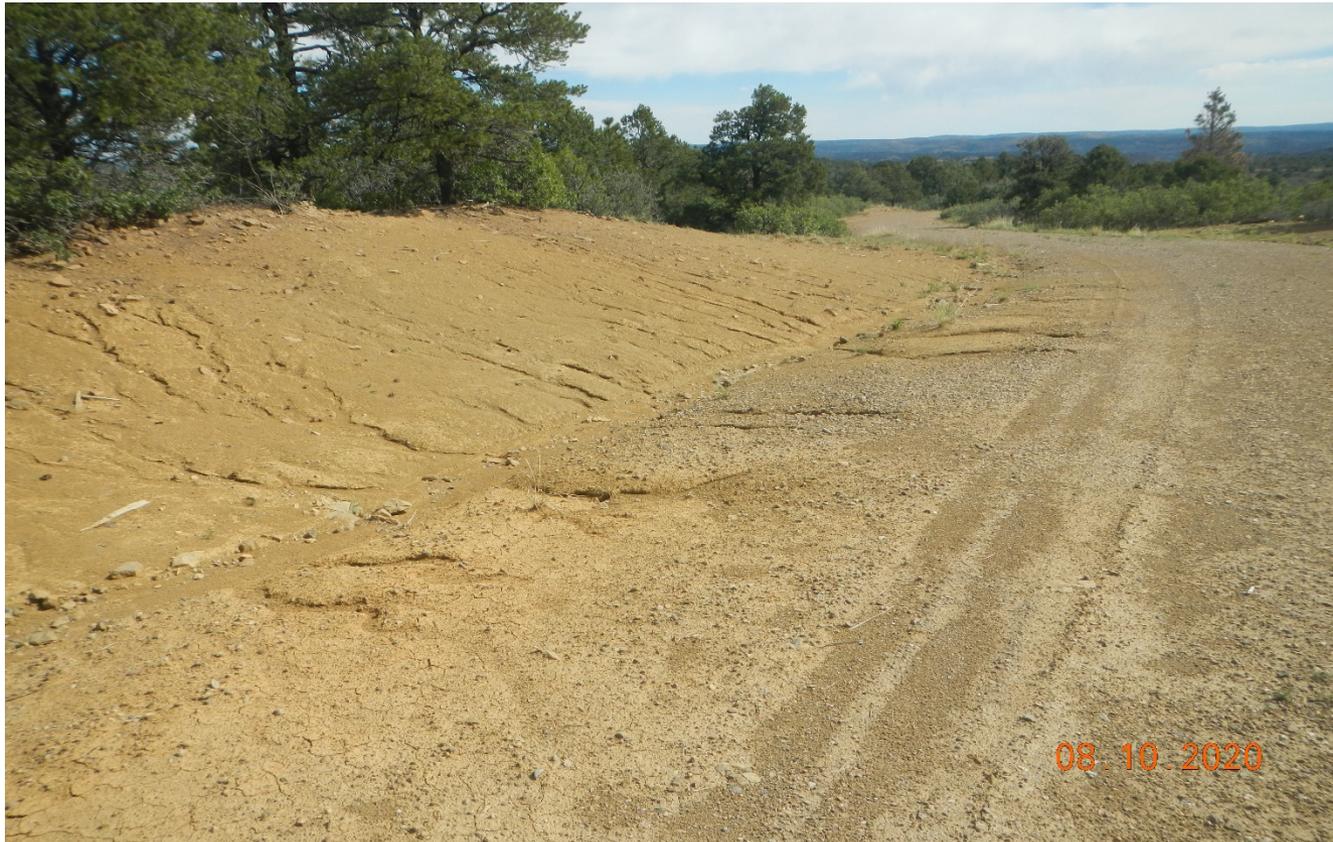
Photo 2. The cut slope along the access road has not established vegetation for long term stabilization. There are signs of erosion along this area.

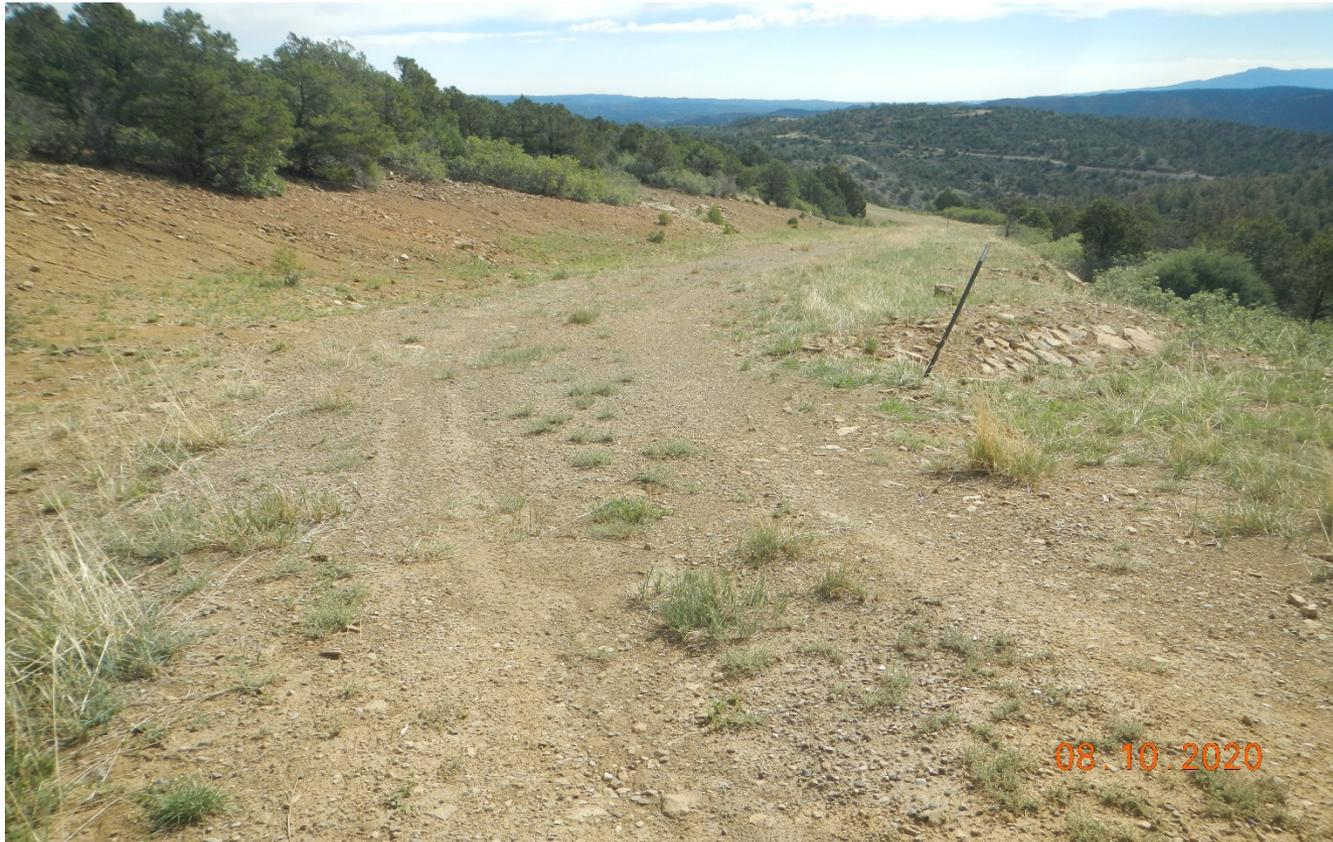
Photo 3. Facing northeast along the access road.

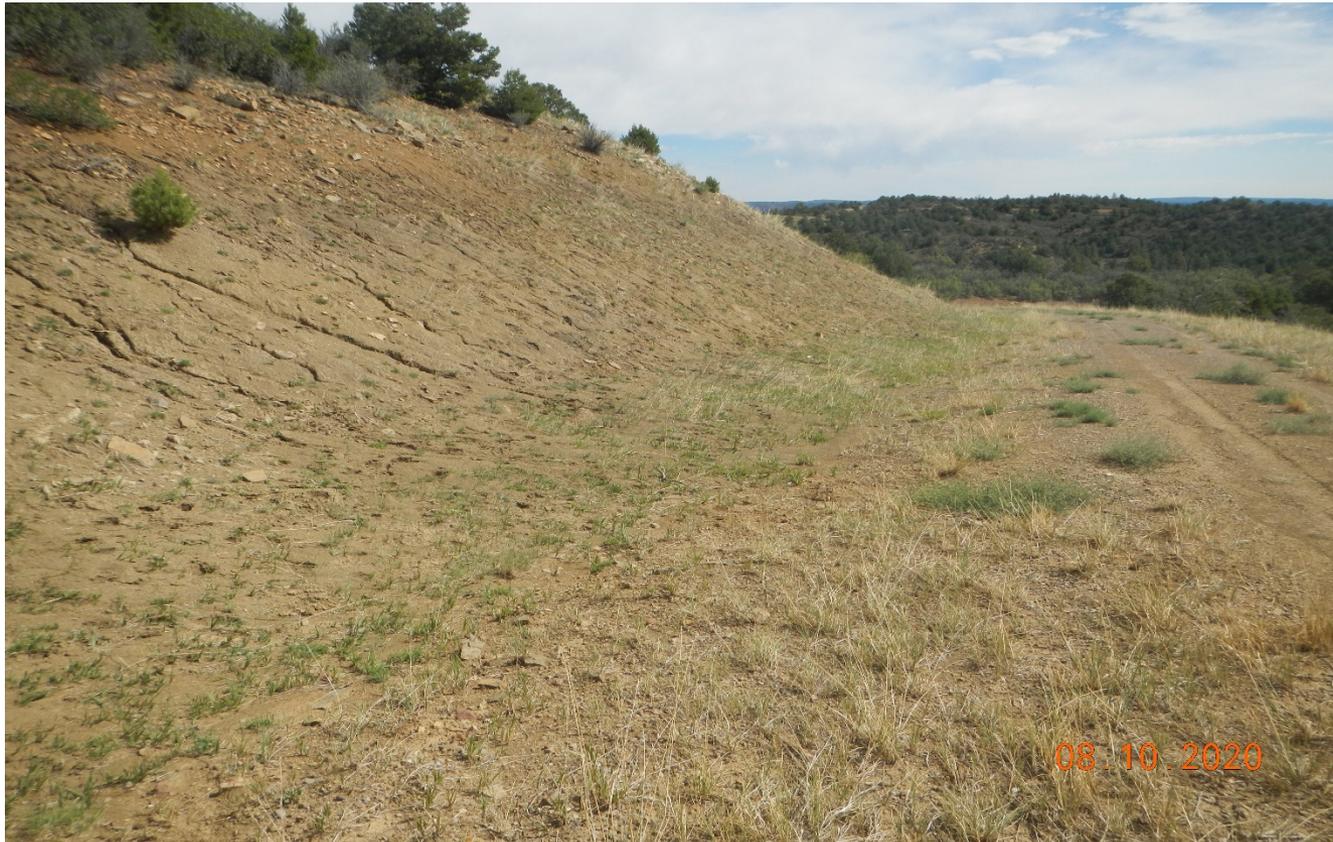
Photo 4. The cut slope along the access road has not established vegetation for long term stabilization. There are signs of erosion along this area.

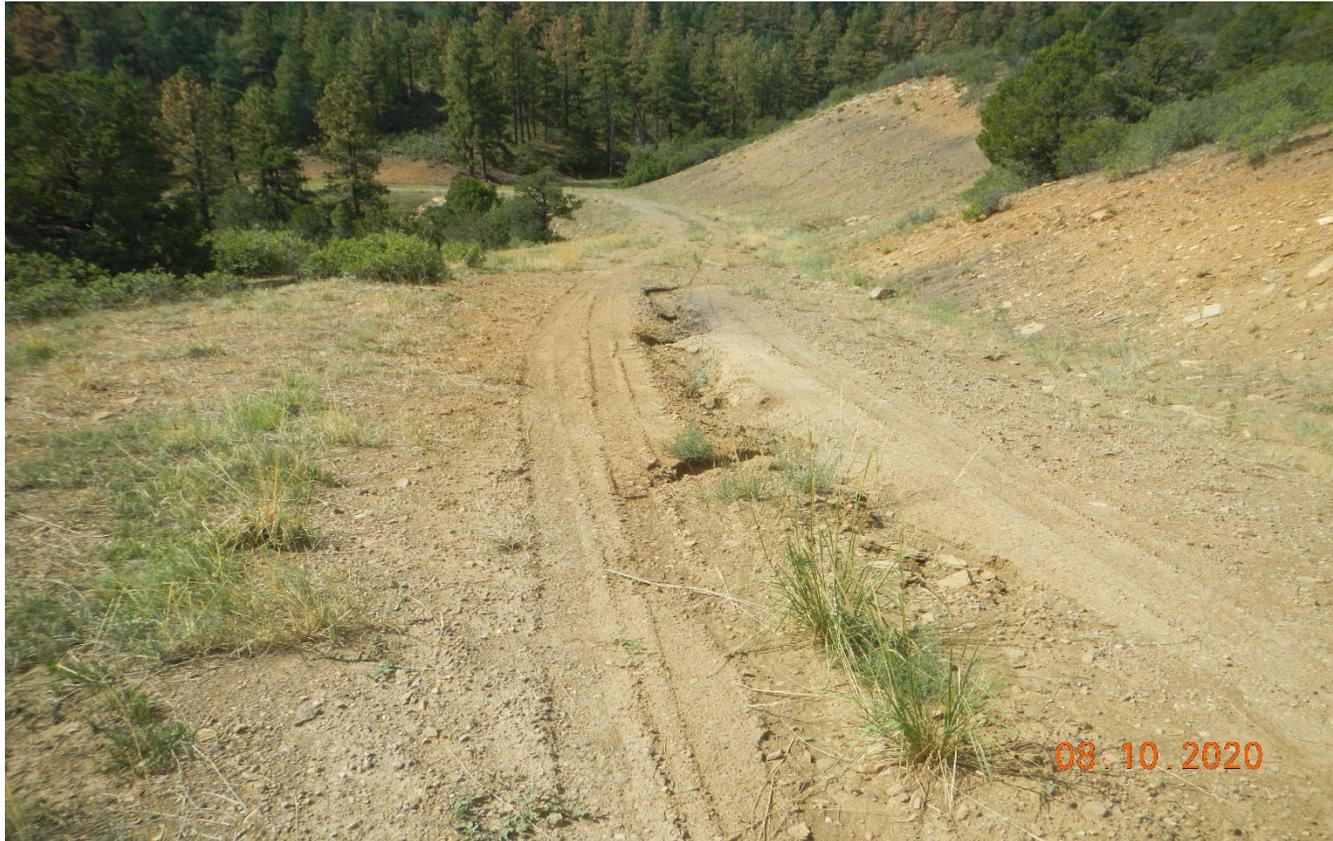
Photo 5. Facing south along the access road. There is an erosion channel along the center of the road ascending down the hillside.

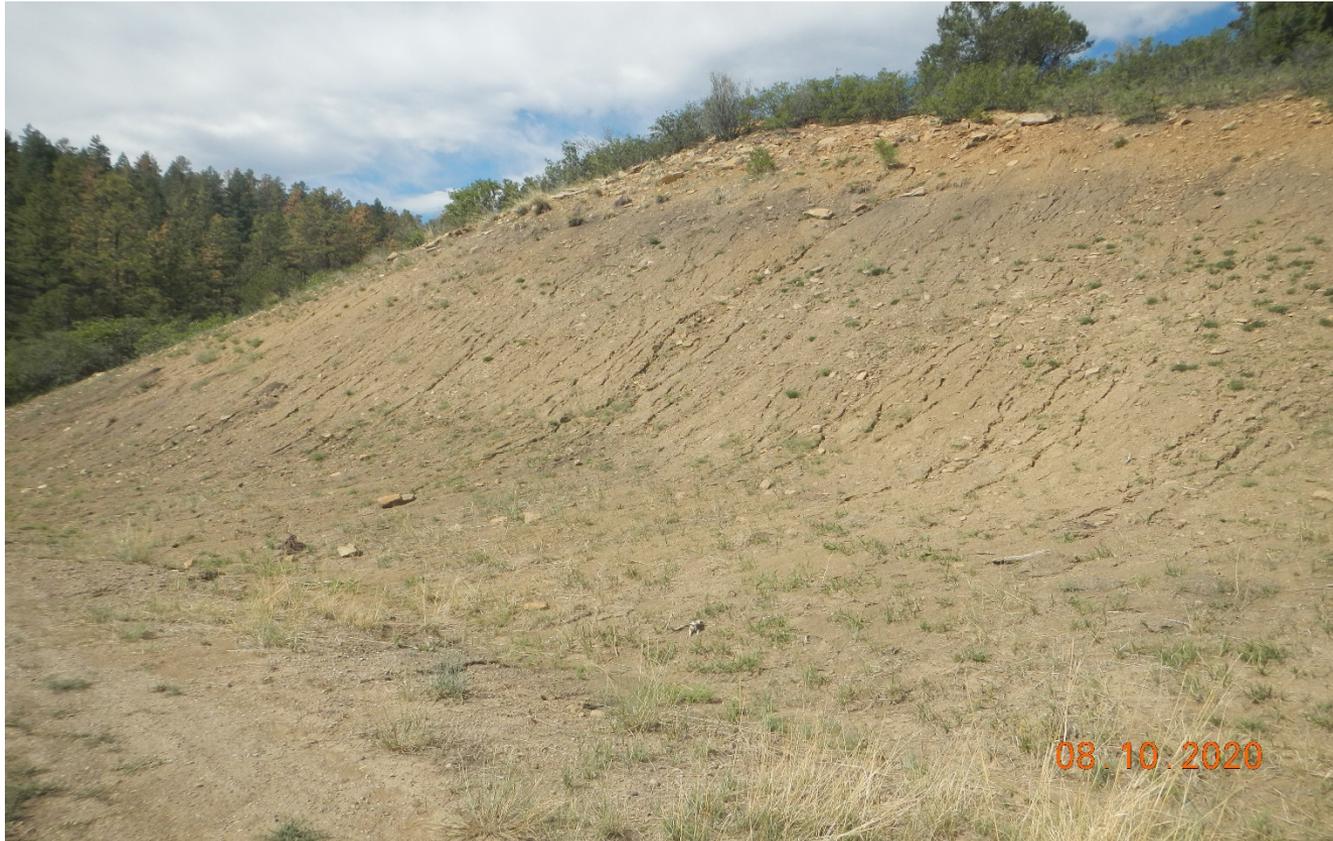
Photo 6. The cut slope along the access road has not established vegetation for long term stabilization. There are signs of erosion along this area.

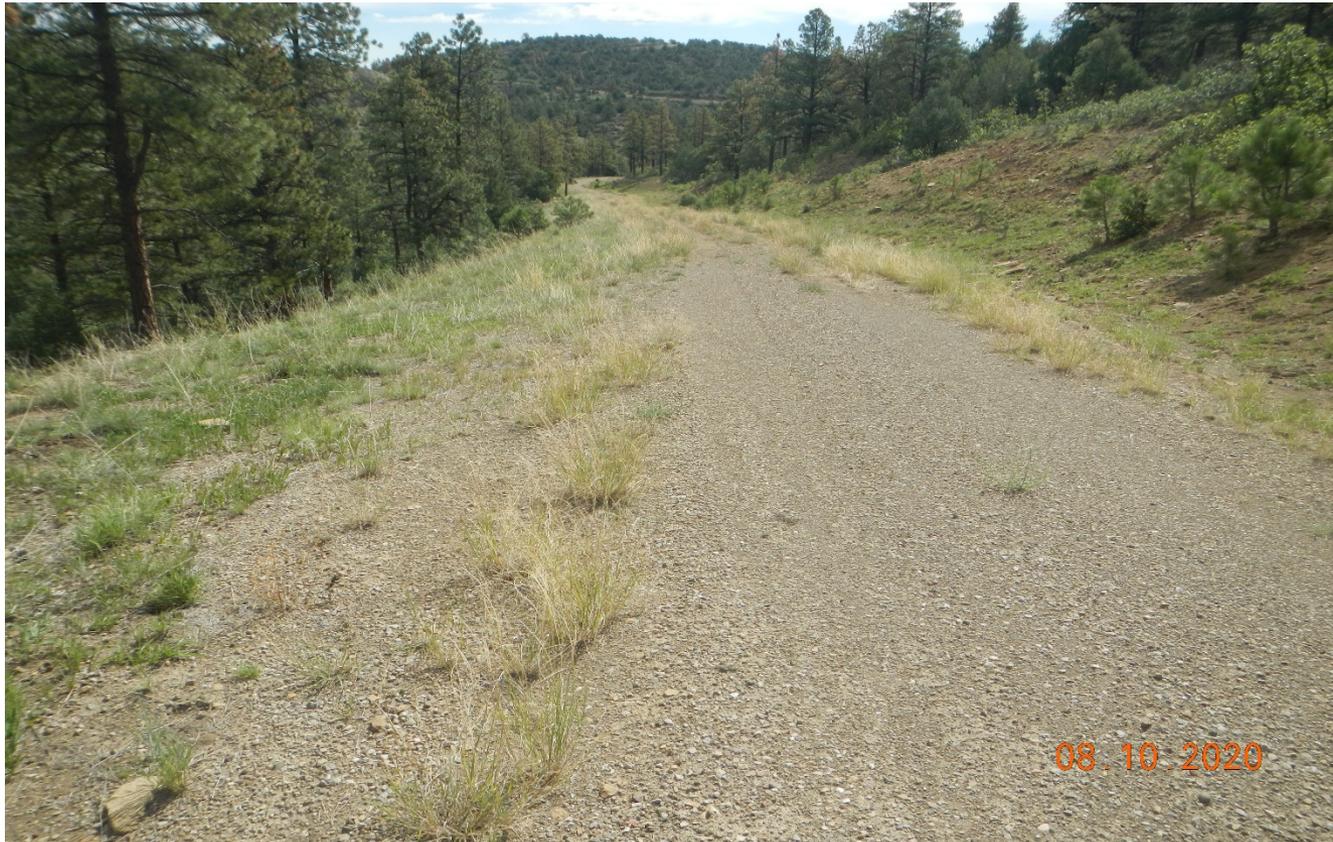
Photo 7. Facing northeast along the access road. This portion of the road is stabilized.

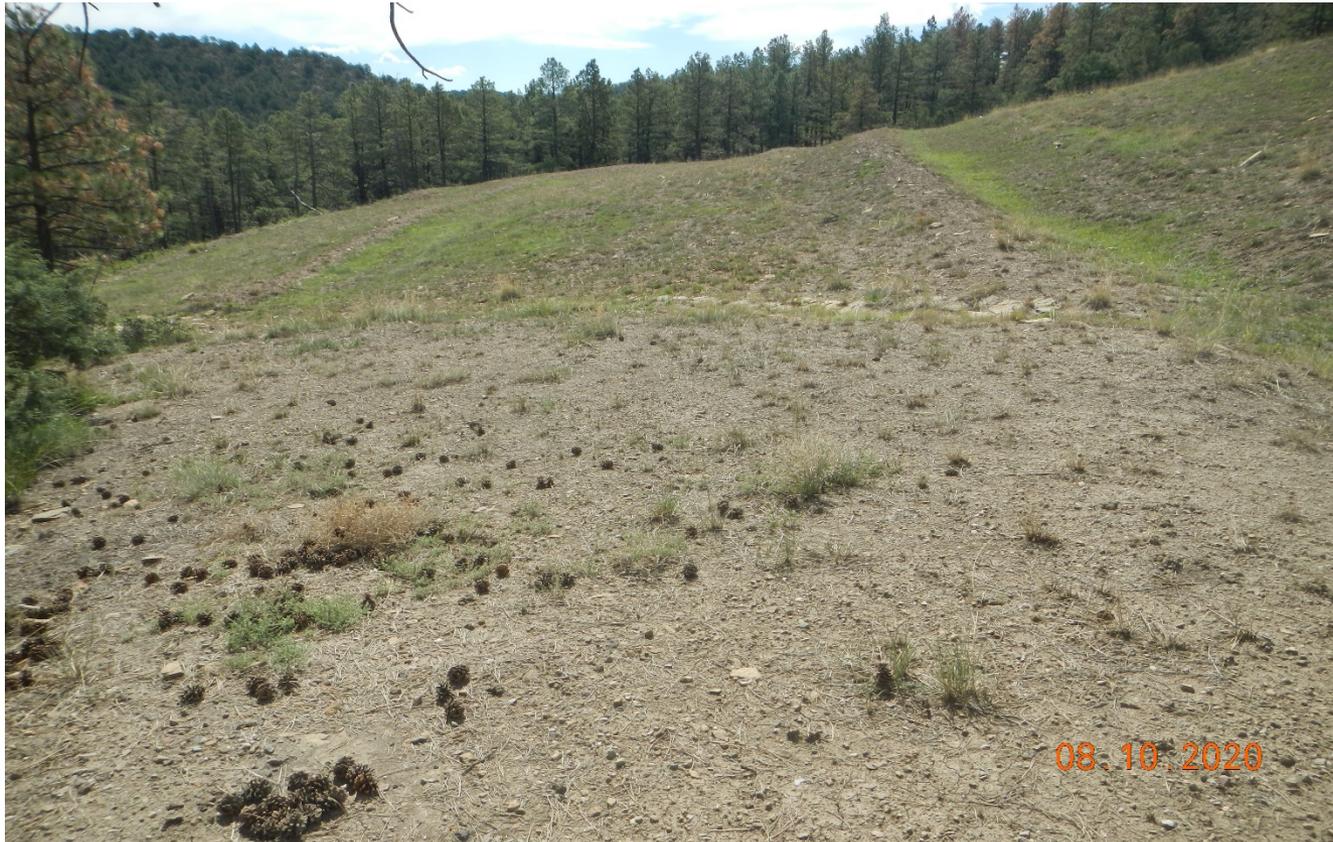
Photo 8. Facing east toward the location.

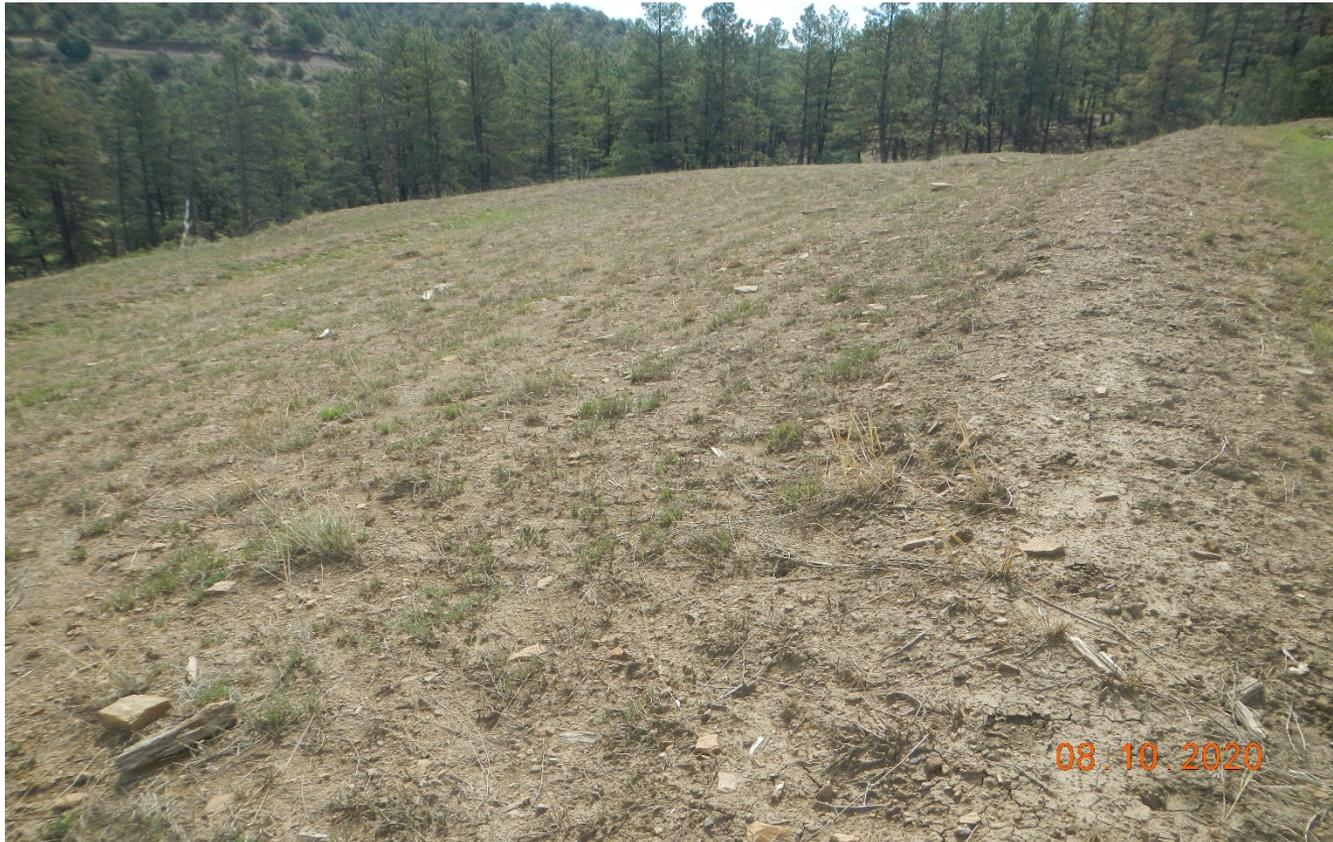
Photo 9. Facing northeast at the location. The vegetation has not adequately re-established.

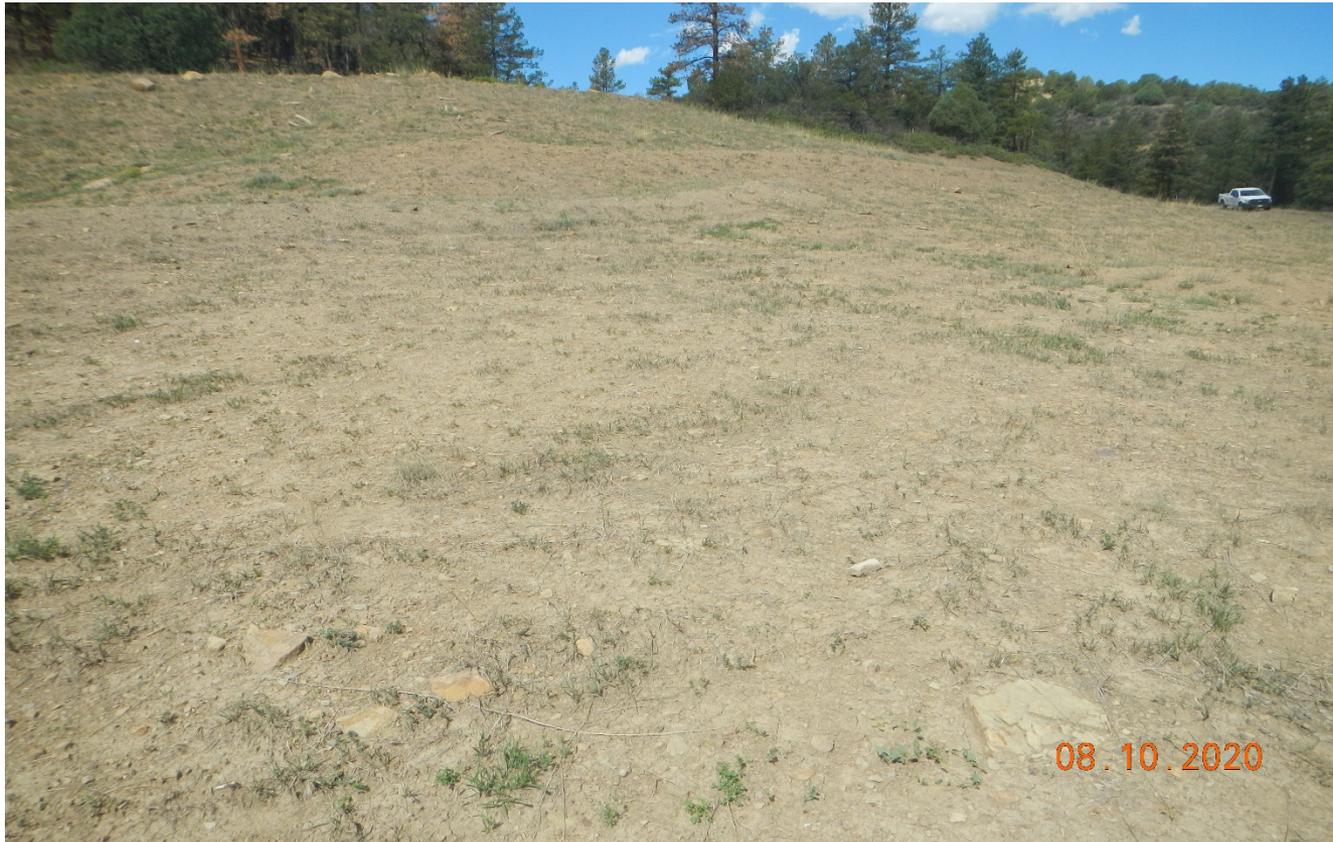
Photo 10. Facing southwest toward the location. There are areas bare of vegetation and additional reseeding will need to be performed.

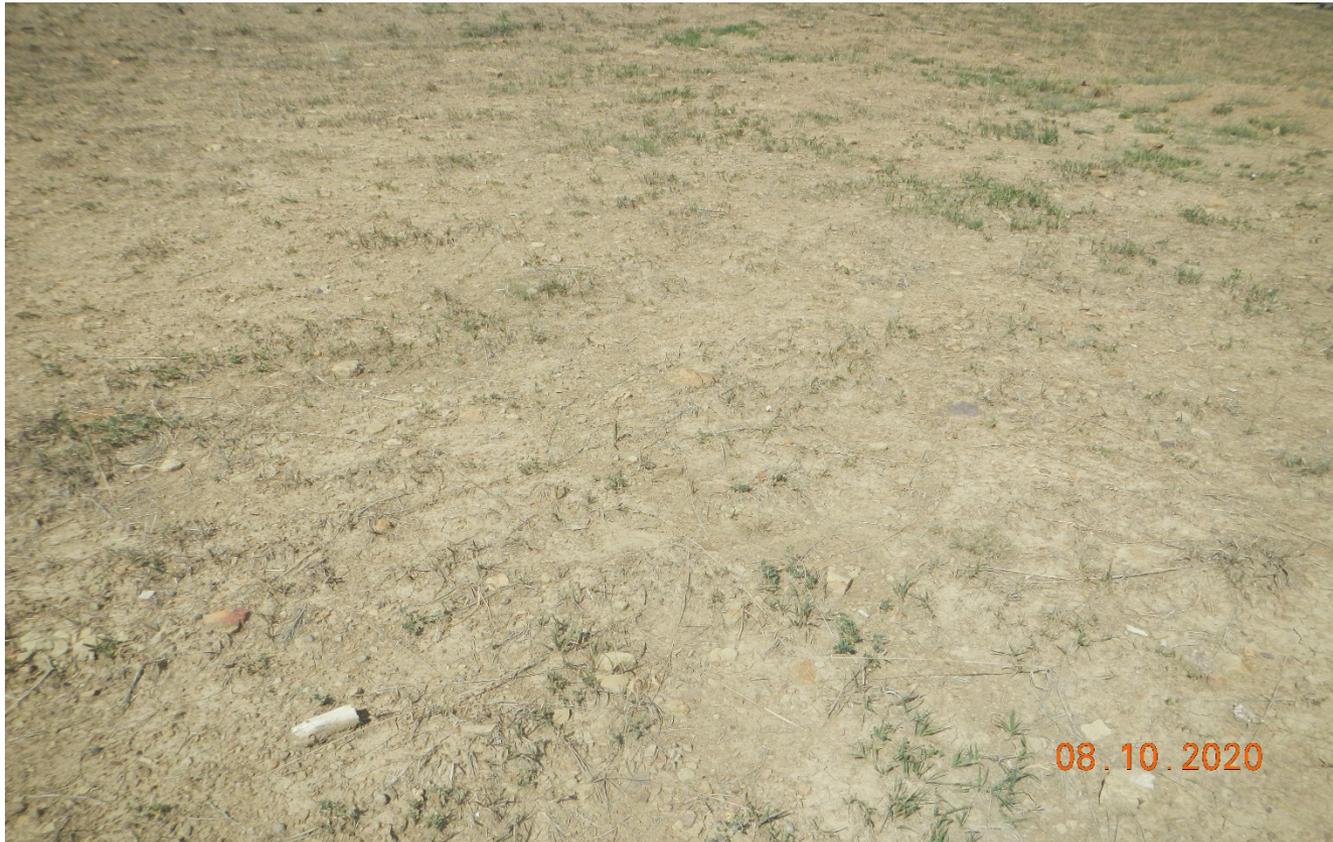
Photo 11. View of ground cover shows sparse vegetation cover.

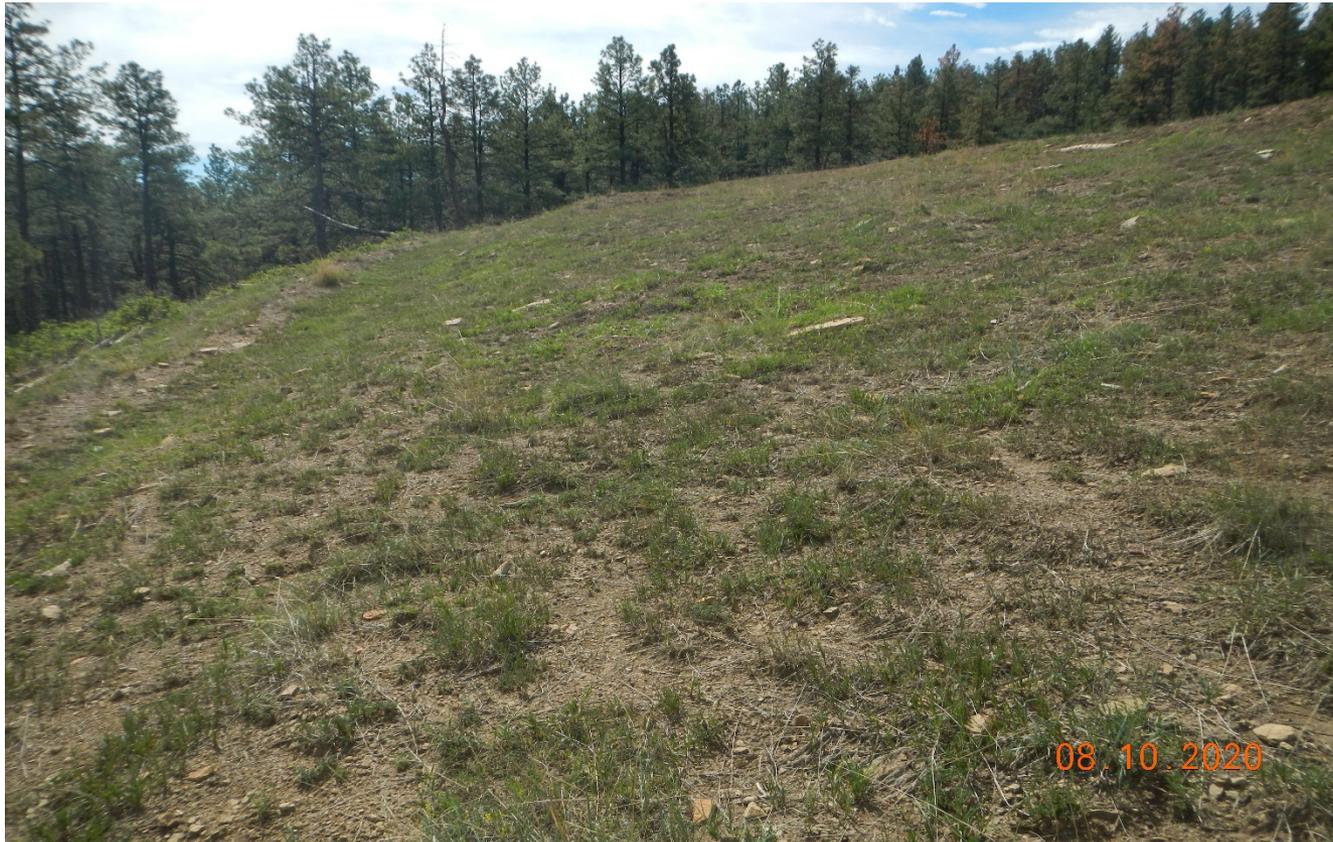
Photo 11. Facing southeast at the bottom portion of the location. There is better vegetation growth in this area of the location.

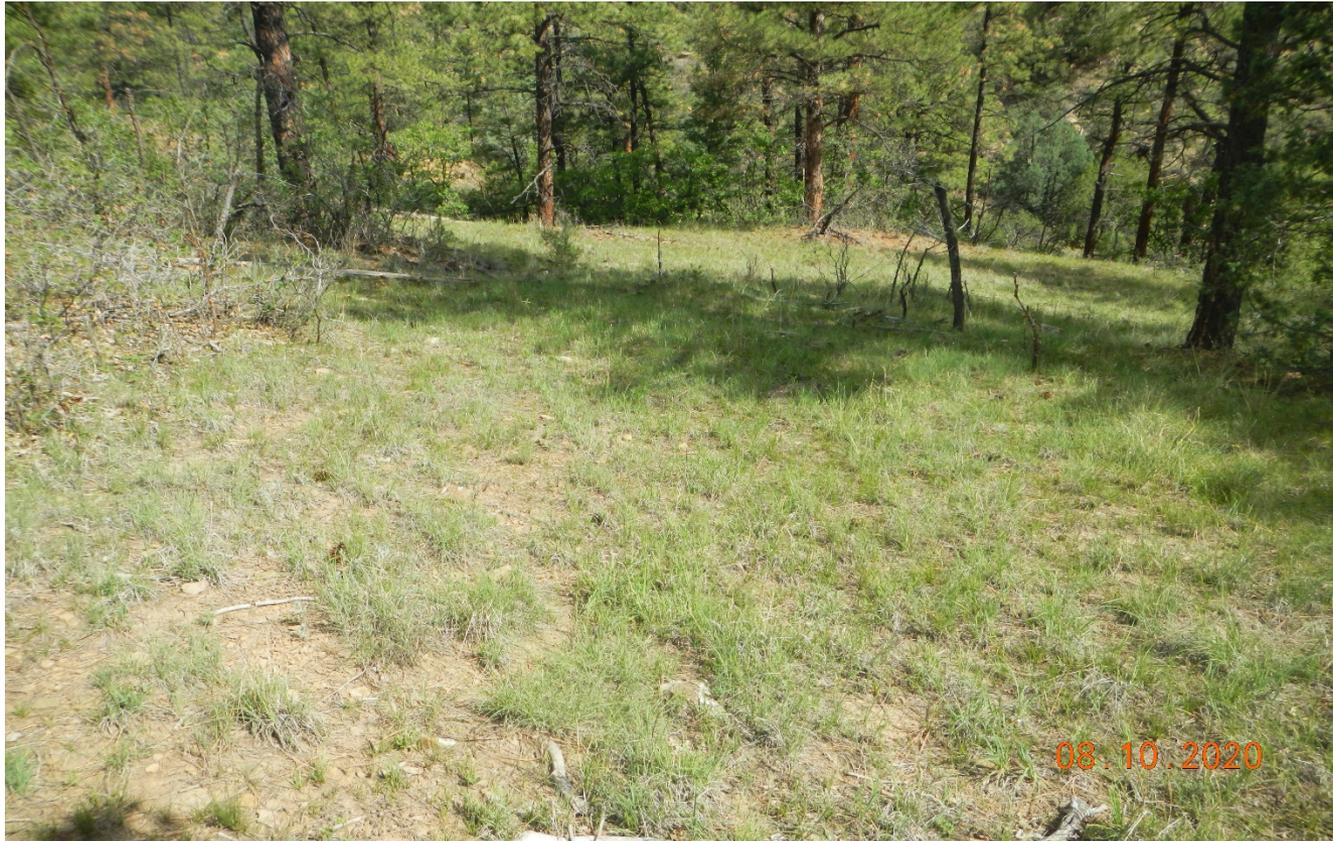
Photo 11. Facing southwest at the undisturbed reference area vegetation which consists of Blue grama, Western wheat, Sand dropseed, Mtn. Muhly, among other species.

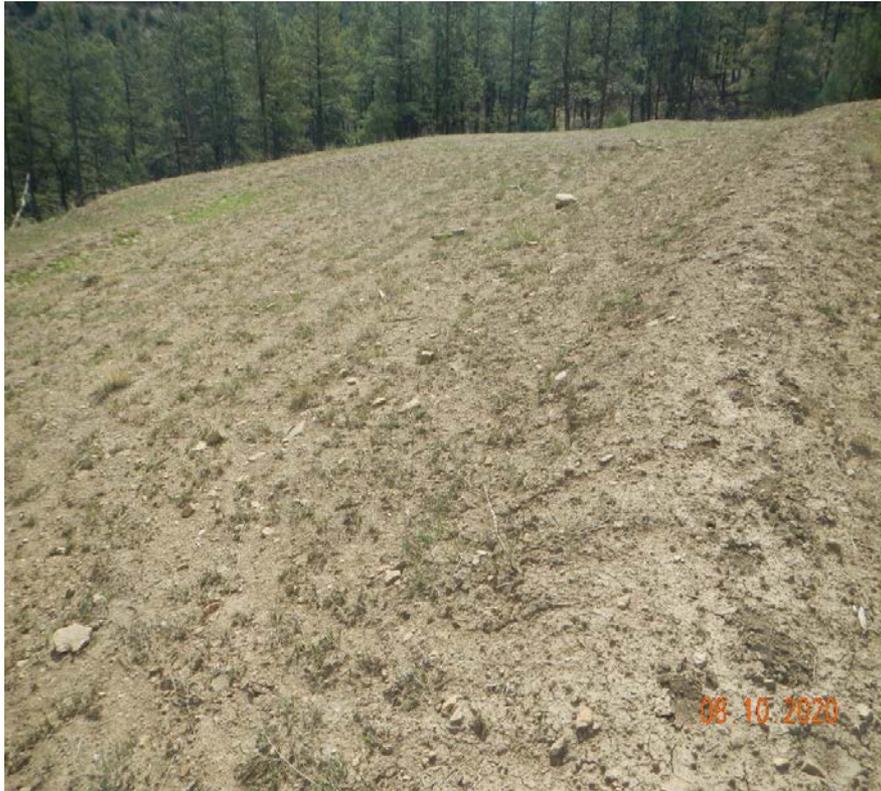
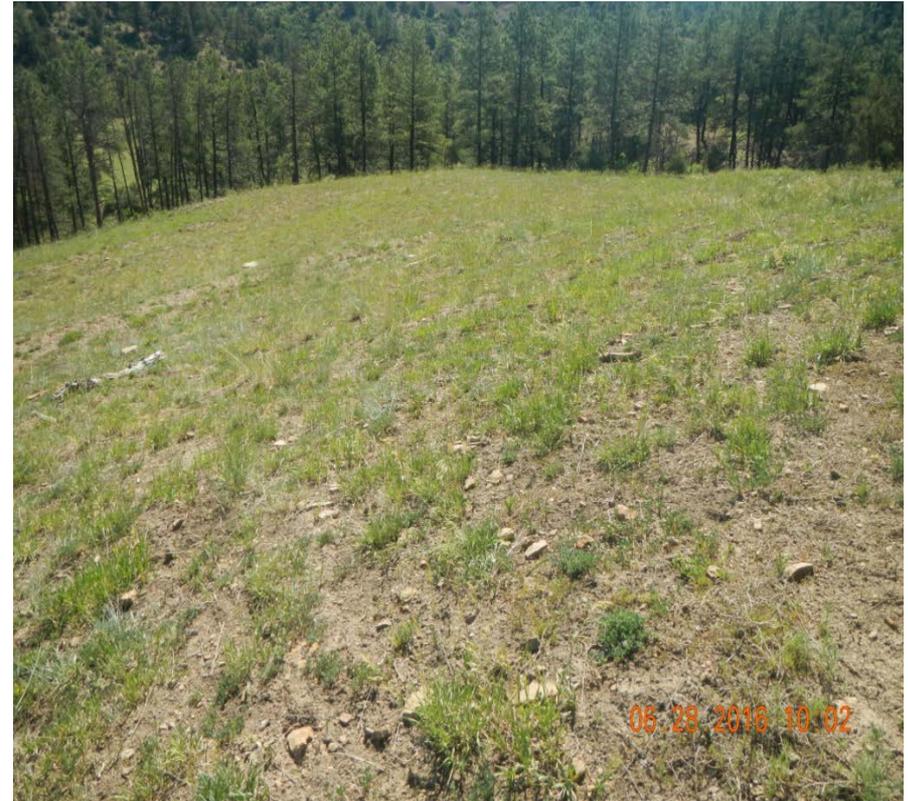
Photo 11. The photo on the left taken in 2020 compared to the right photo taken in 2016 shows the regression of vegetation at the location. As stated in the 2016 inspection, “There is a dominance of alfalfa and yellow clover growing at the location which may not withstand drought conditions and may not be persistent over time.”
