Inspection Photos  
Operator: Hilcorp Energy  
API: 067-07550  
Date: 8/11/2020

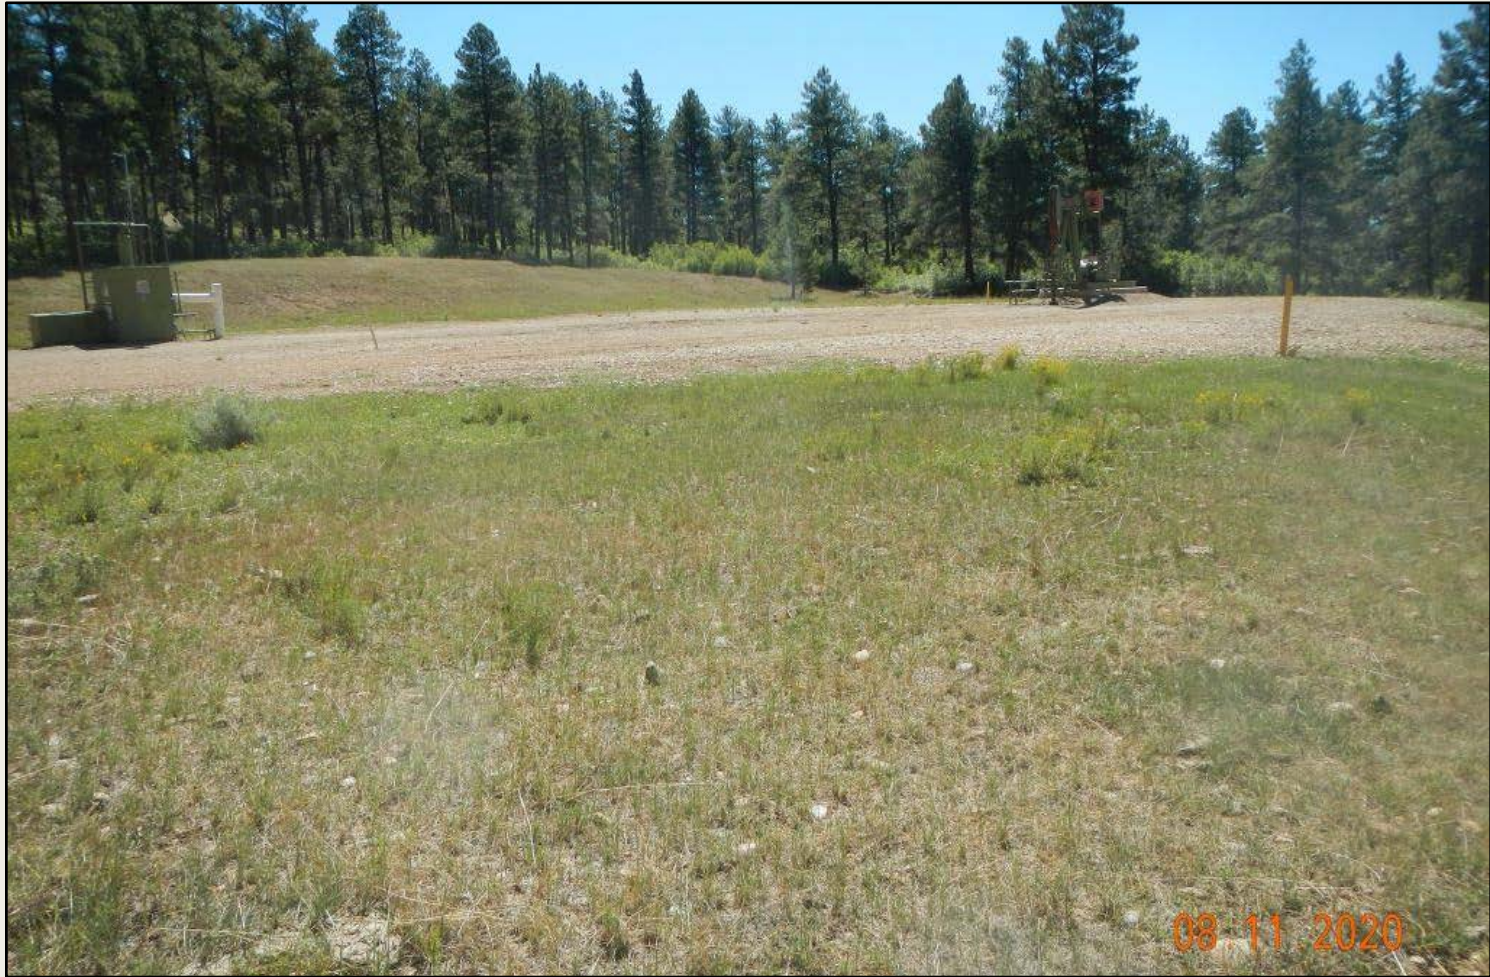
Photo 1. View of the project area from the northwestern corner facing center.

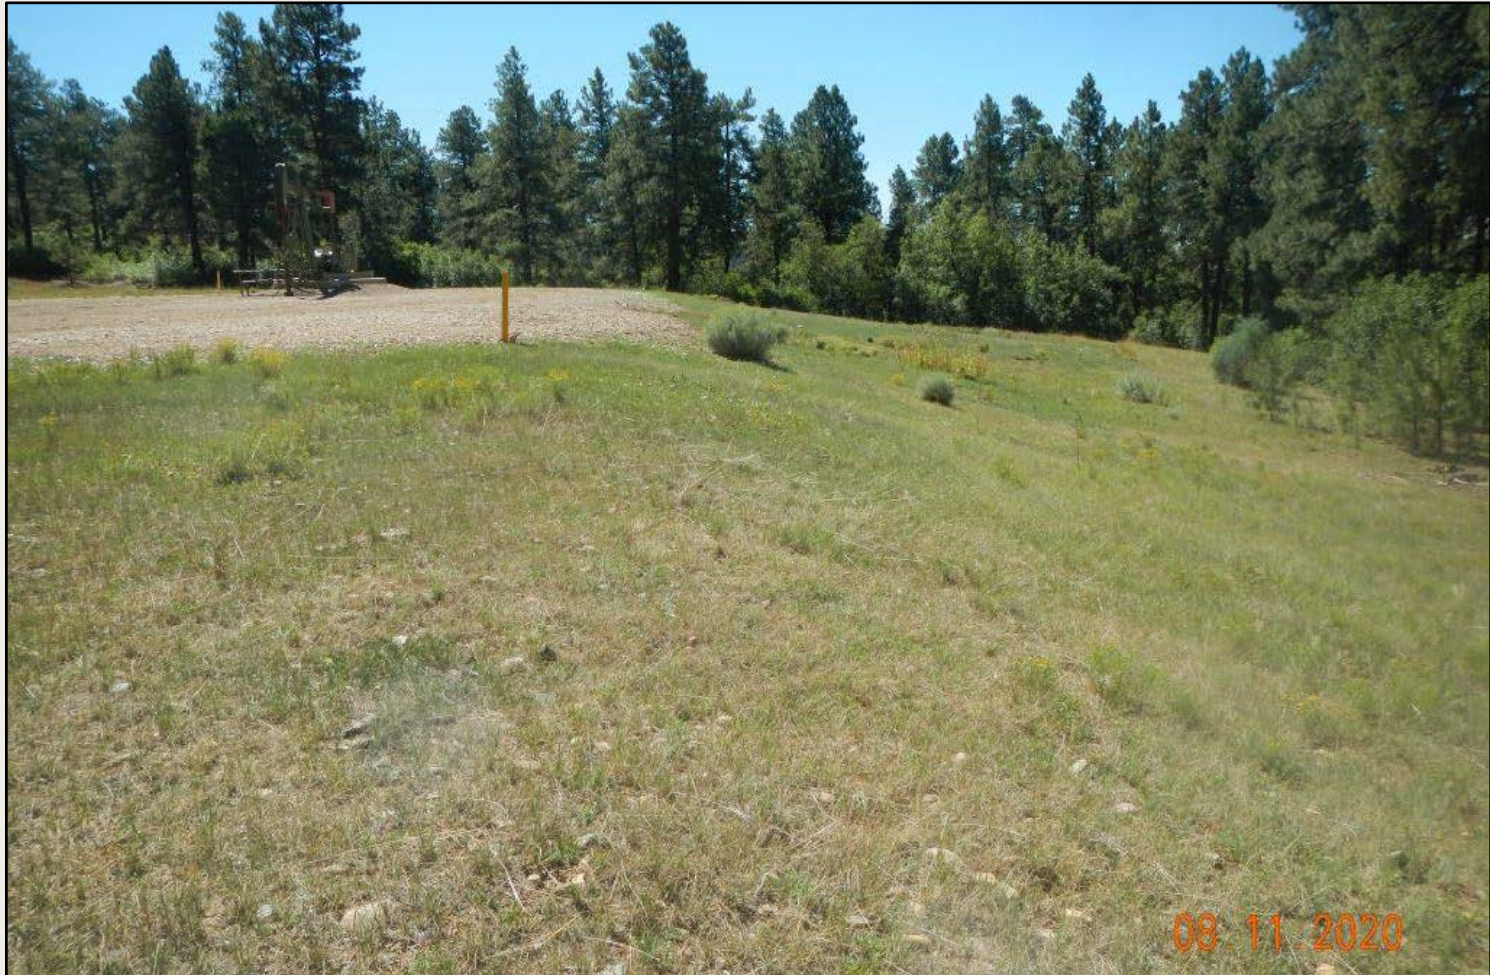
Photo 2. View of the western portion of the project area from the northwestern corner facing southward. Revegetation is progressing with western wheatgrass, smooth brome, and sand dropseed.

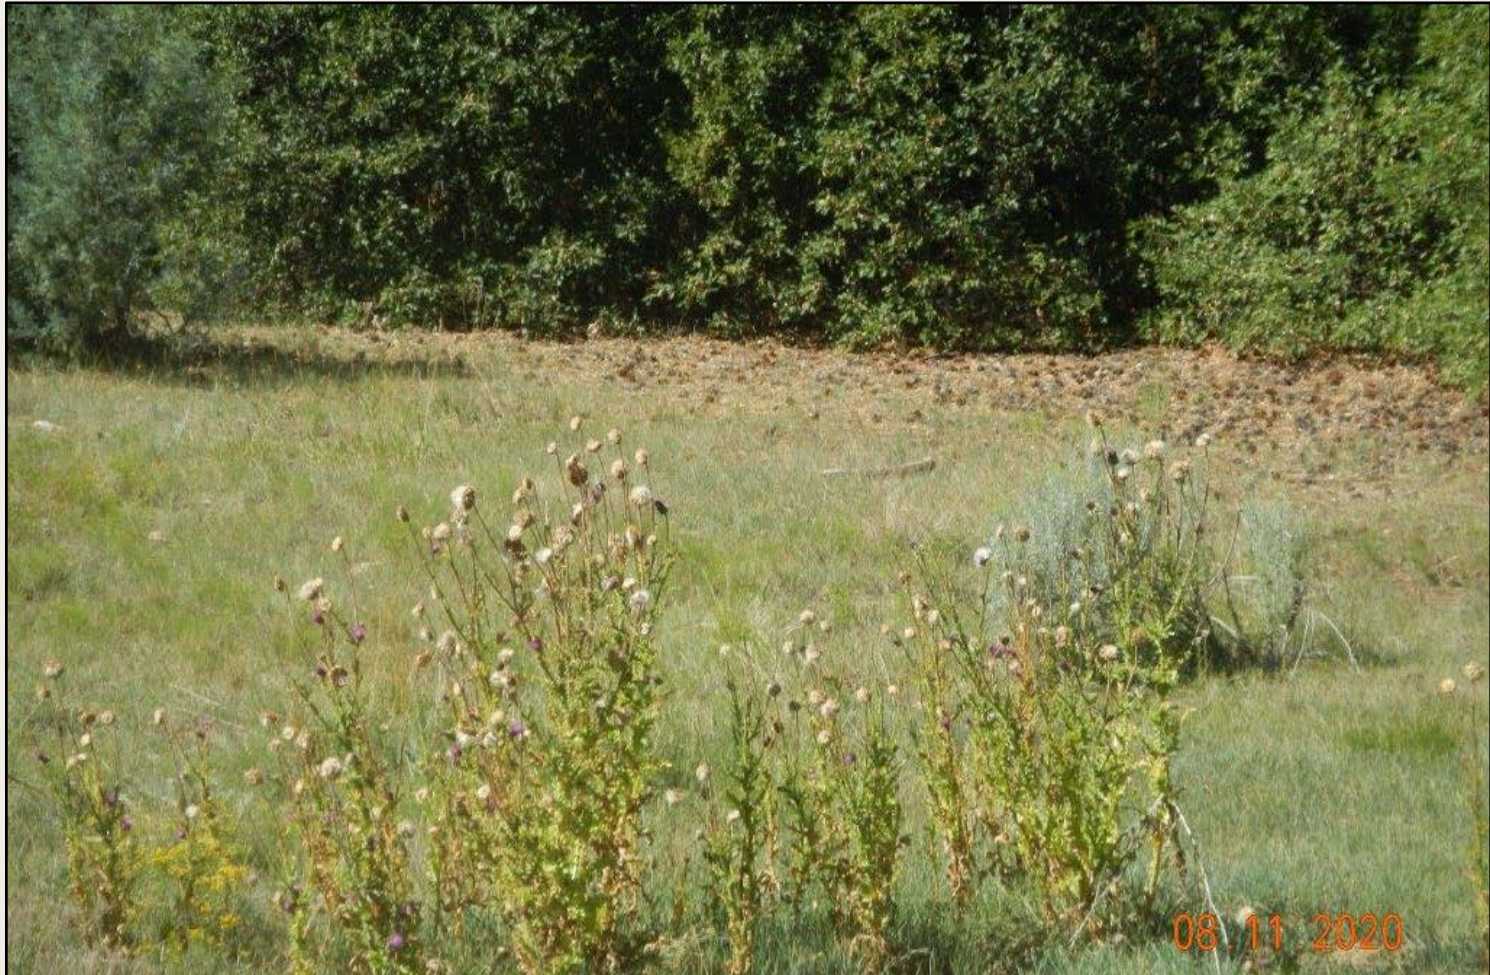
Photos 3. View of musk thistles (approx. 25) in a flowering/seeding condition within the western project area.

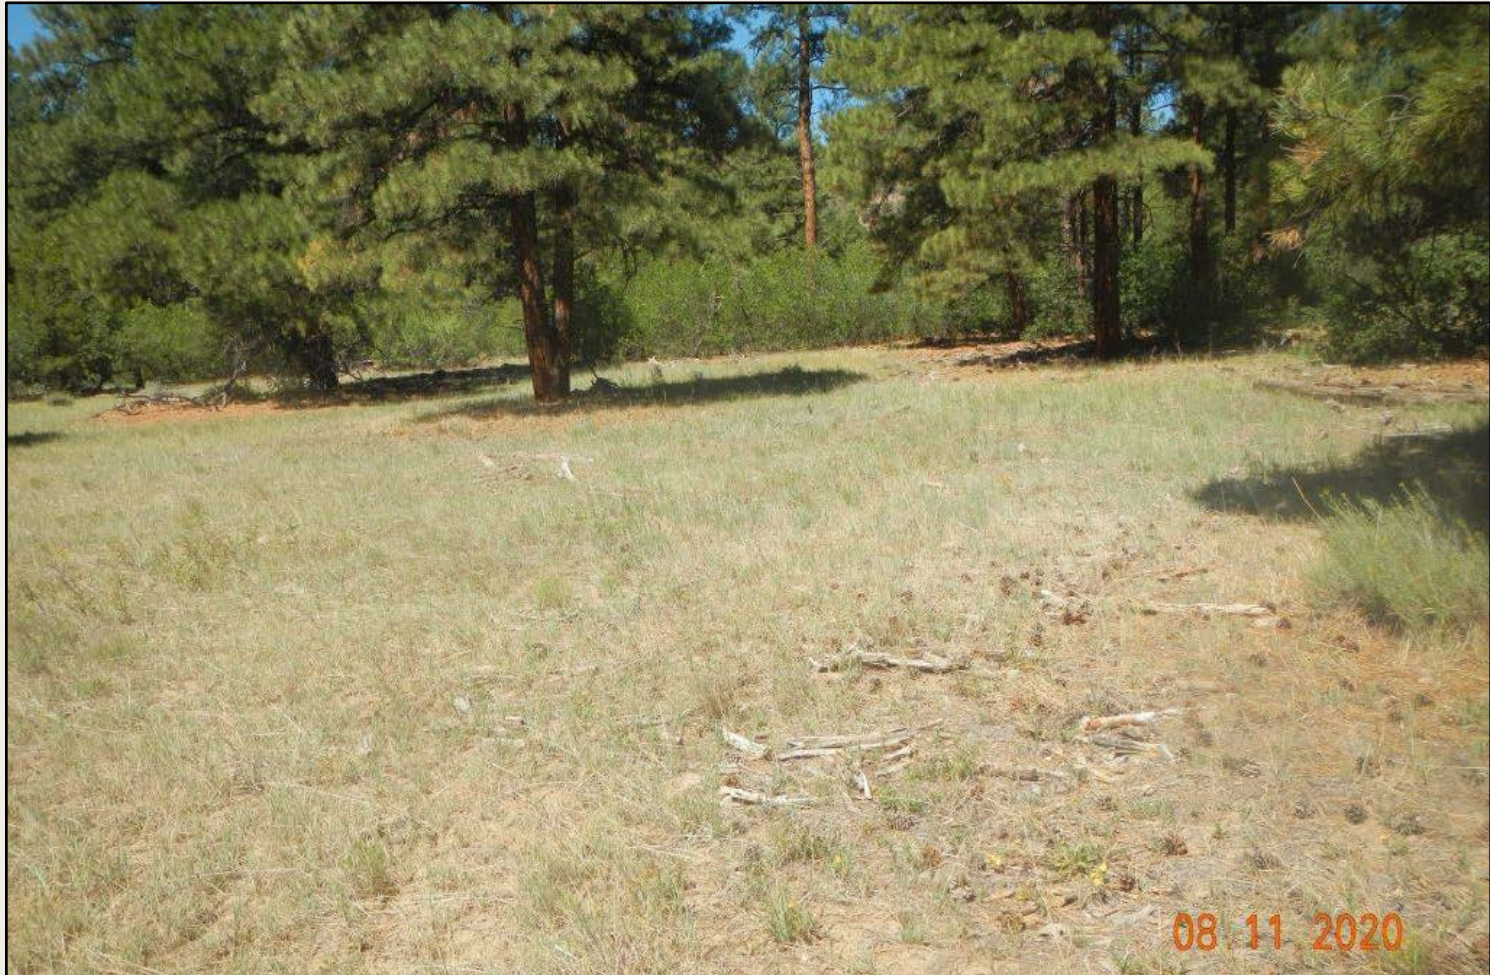
Photo 4. View of reference area comprised of ponderosa pine woodland and gambel oak shrubland, with a mosaic of sagebrush shrubland and open grassland comprised of fringed sage, black sage, smooth brome, and western wheatgrass.
