Inspection Photos
Operator: BP America
API: 067-06800
Date: 8/13/2020

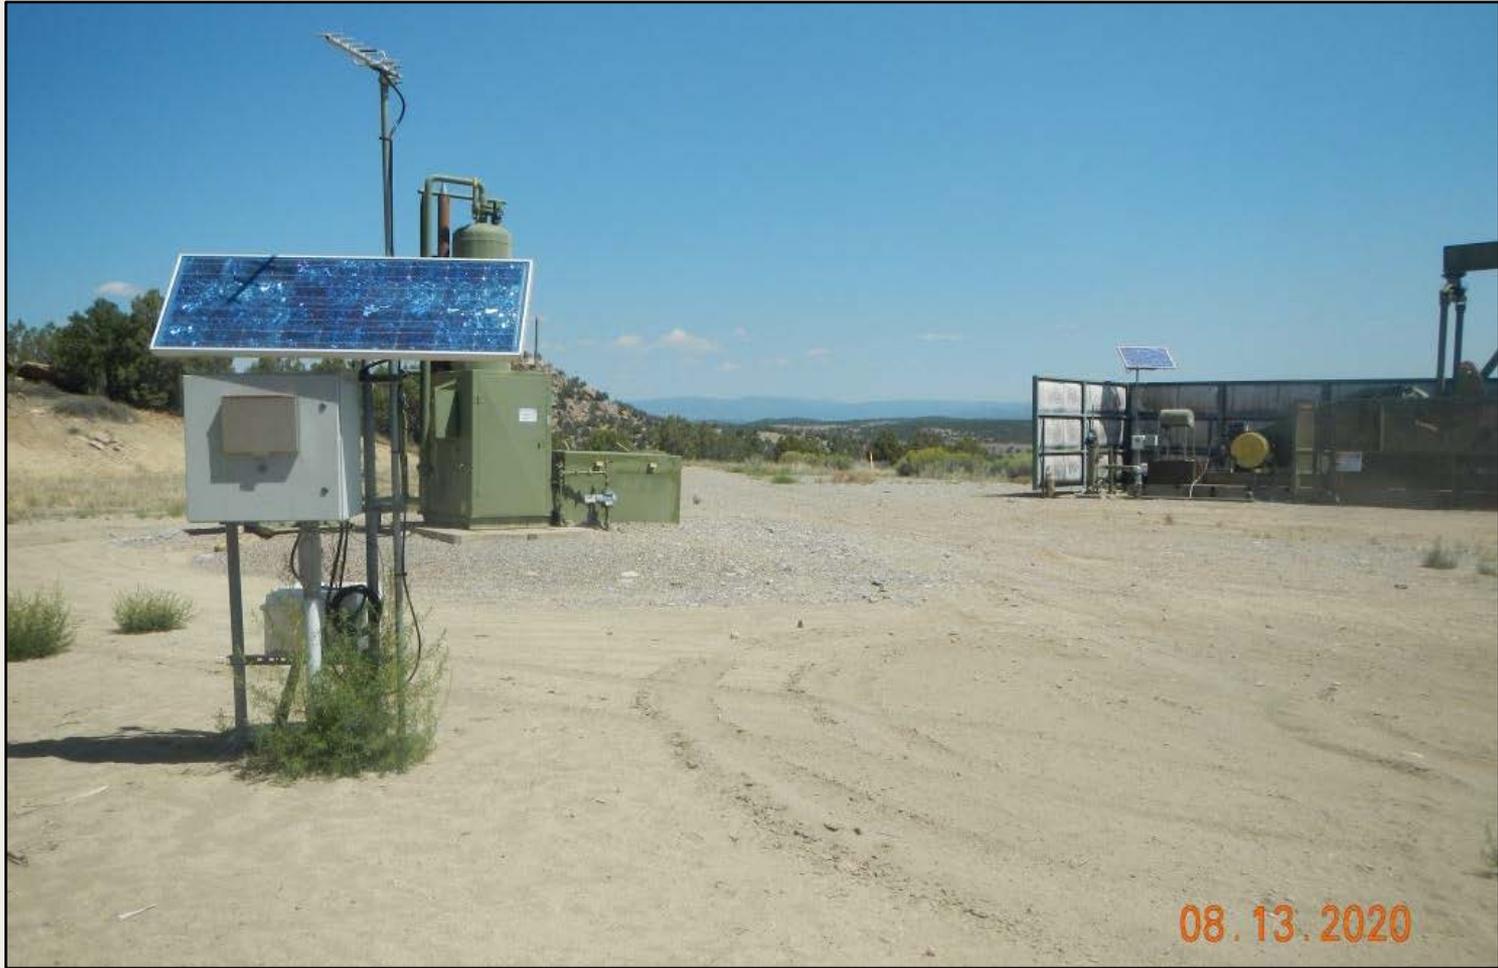
Photo 1. View of the project area from the southwestern corner facing center.

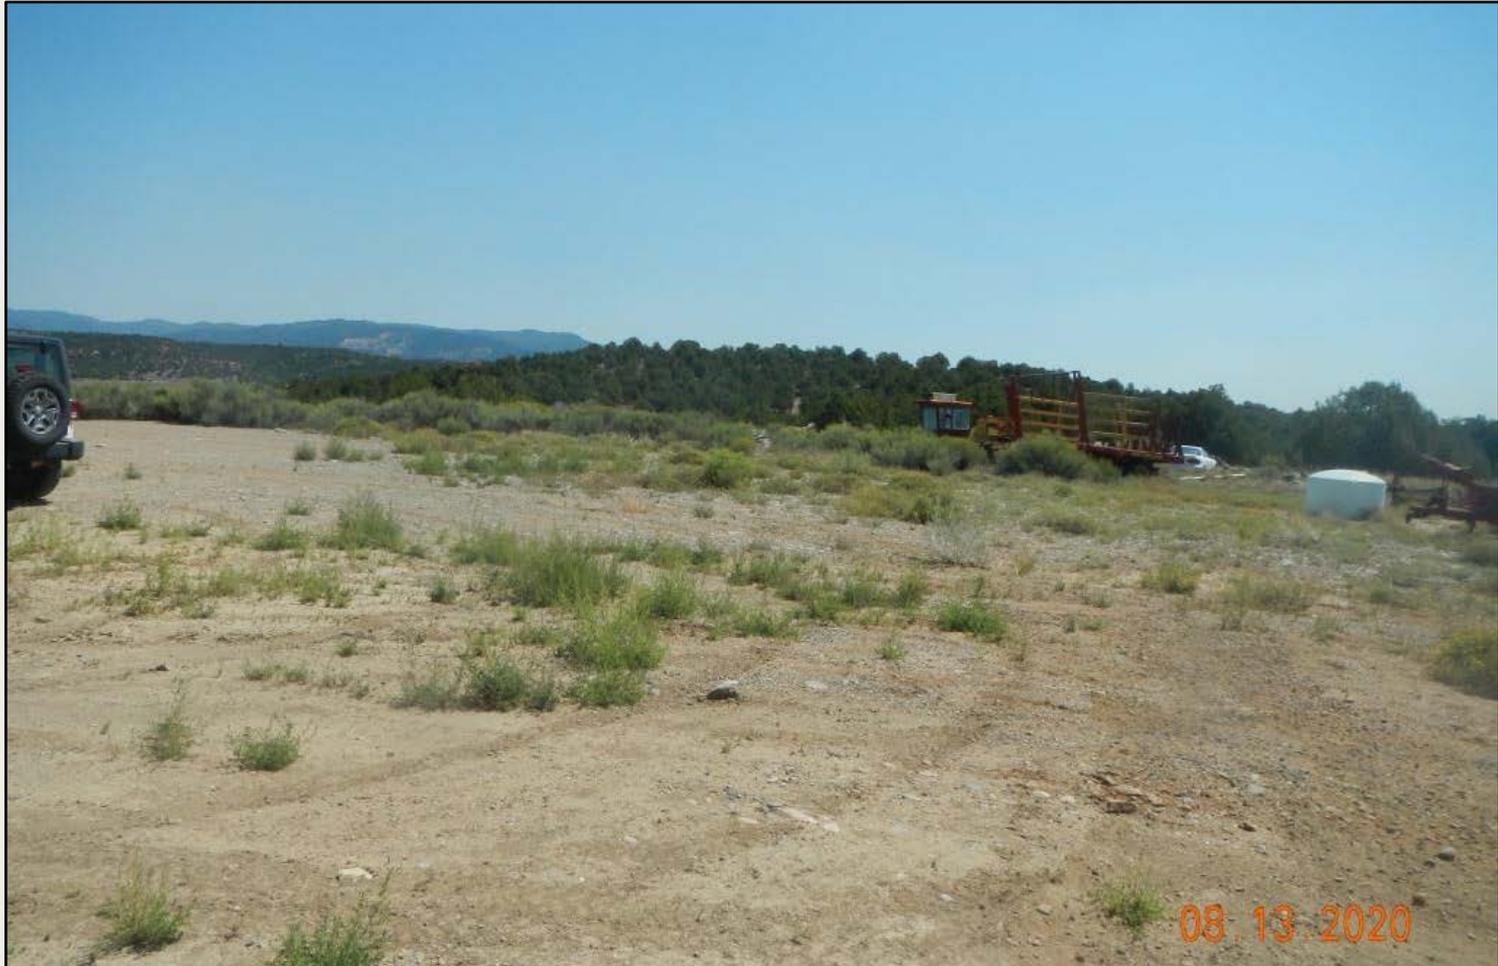
Photo 2. View of the southern project area from the southwestern corner facing eastward. Surface owner equipment and materials are moved southward, away from the project area.

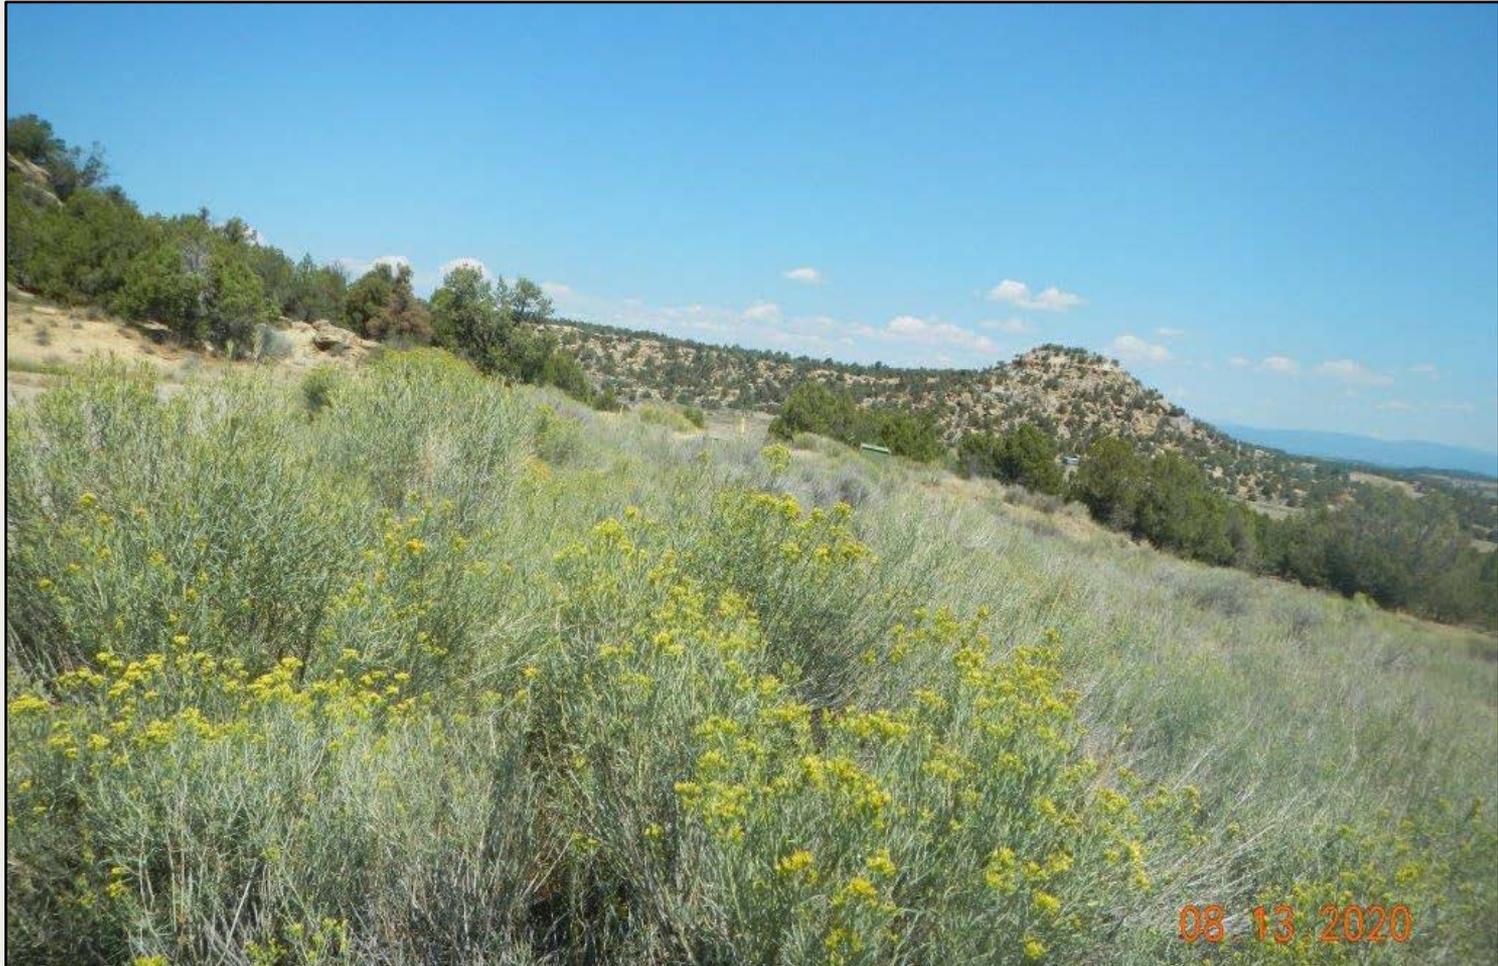
Photos 3. View of the eastern project area from the southeastern corner facing northward. Revegetation is progressing, largely with dense rubber rabbitbrush.

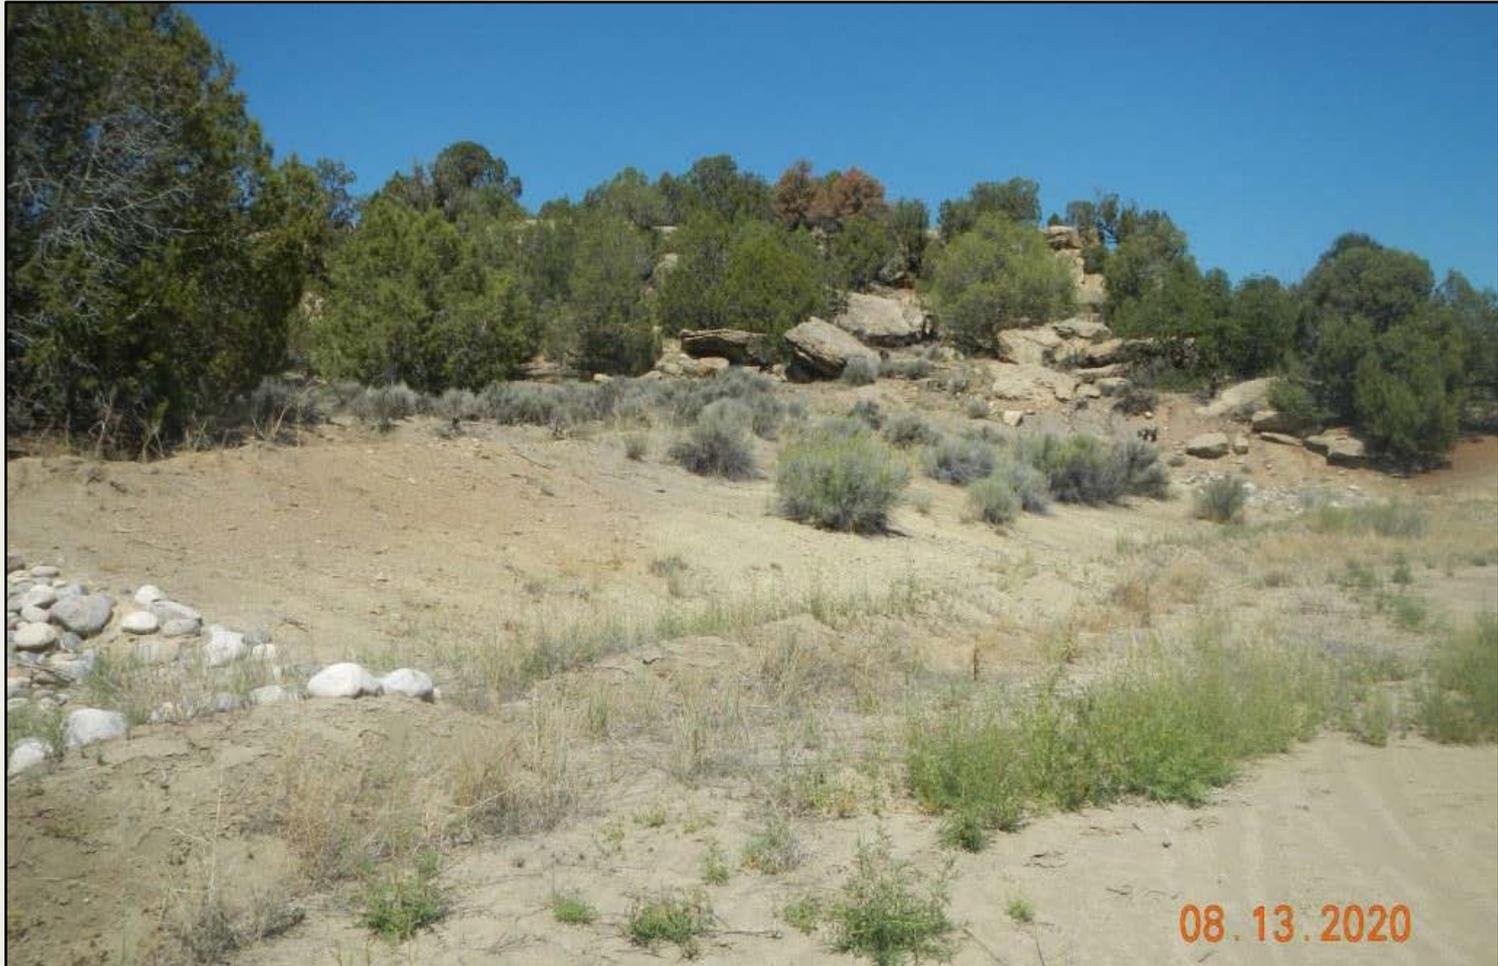
Photo 4. View of the western cut-slope facing northward. Berm is installed and seeded since 2017 reclamation inspection, diversion channel above slope, and cobble run-down. BMPs appear to be functioning. Monitoring needs to continue on slopes where bare soils persist.

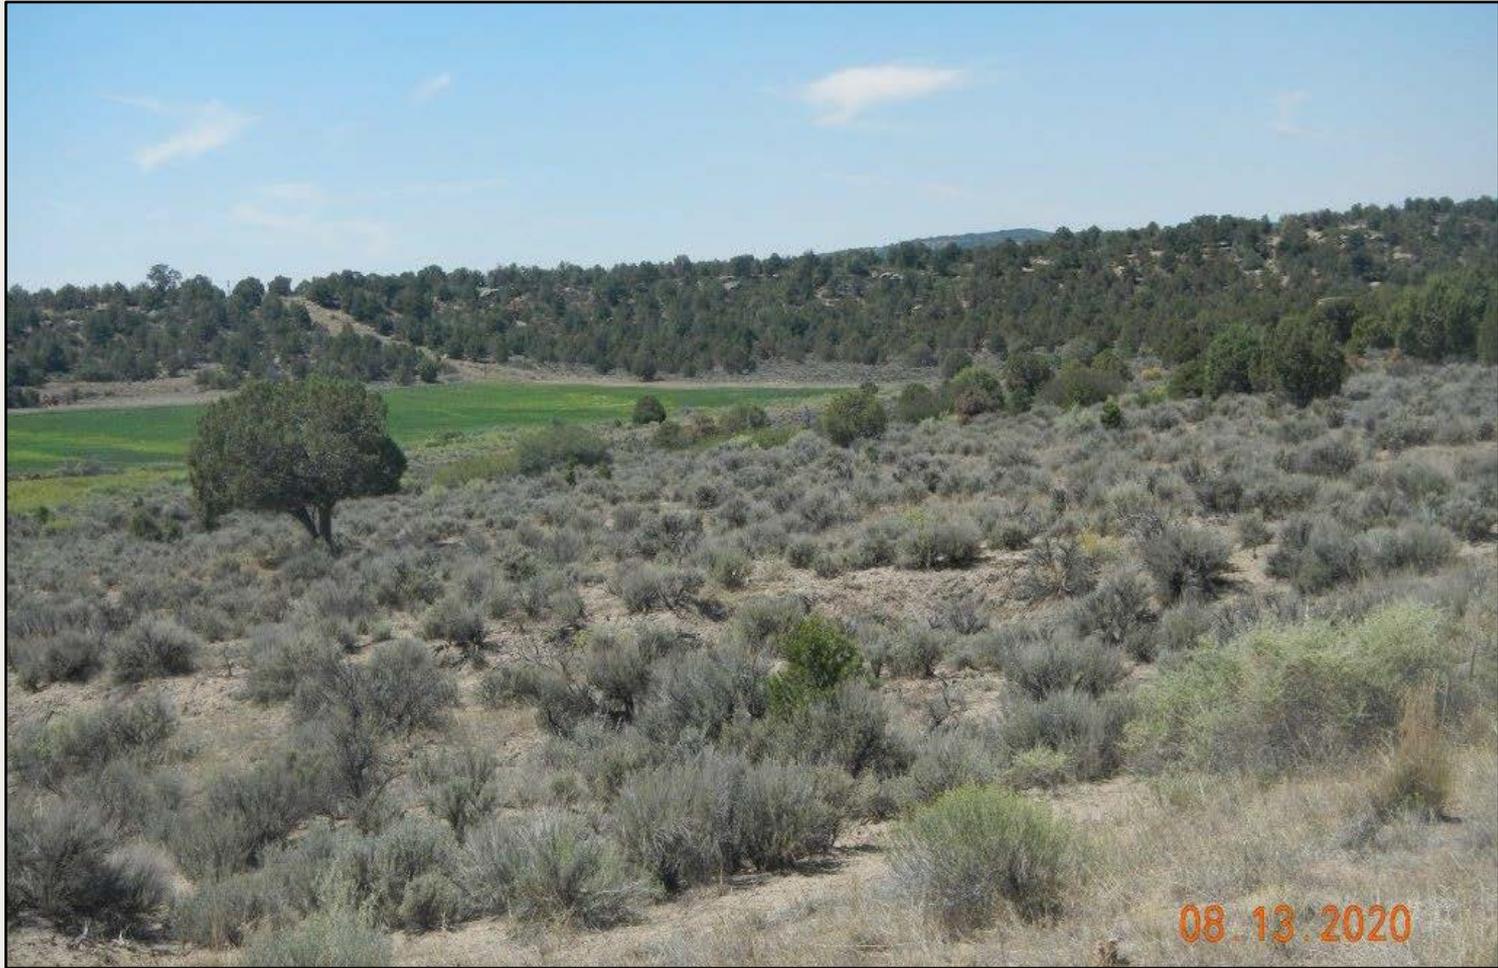
Photo 5. View of reference area comprised of sagebrush shrubland and pinyon/juniper woodland vegetation with grasses such as James galleta, blue grama, and forbs such as rock goldenrod.
