Inspection Photos
Location Name: VPR C NO. 41
API#: 05-071-07276
INSP. #: 695103166

Inspection Photos

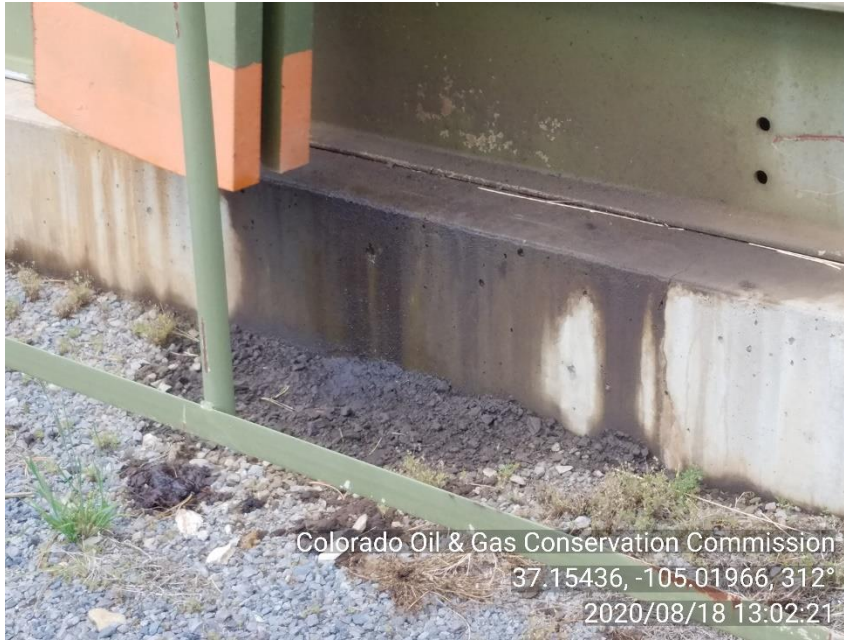
PHOTO 3: APPREARS THAT GEAR BOX ON PUMP JACK IS LEAKING OIL. REMOVE AND DISPOSE OF IMPACTED SOIL, Securely fasten all valves, pipes, and fittings to ensure good mechanical condition, inspect at regular intervals and maintain in good mechanical condition per Rule 605.d. CA DATE 11-18-20.

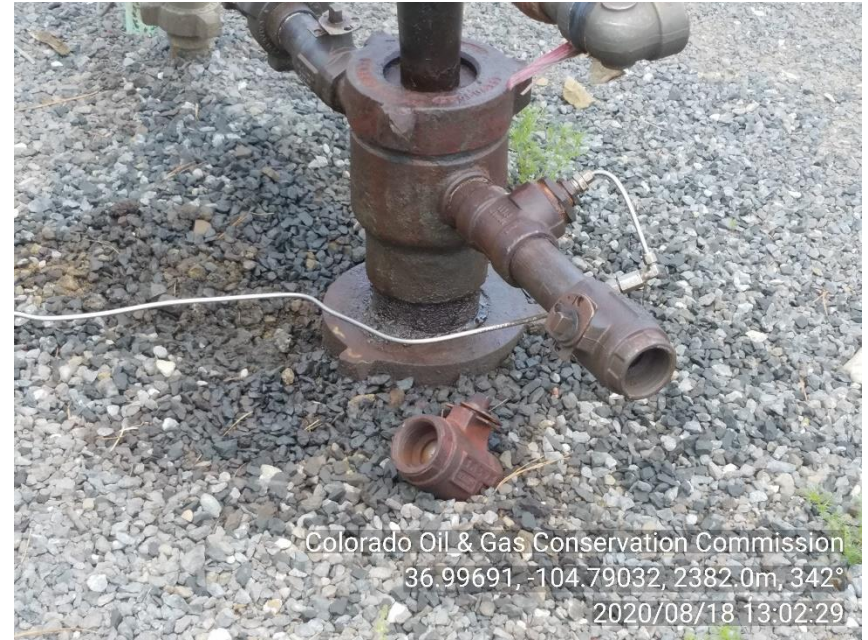
PHOTO 4: AREA OF IMPACTED SOIL AROUND WELLHEAD. REMOVE IMPACTED SOIL, Non E&P Waste not properly stored, handled, transported, treated, or disposed per Rule 907A. CA DATE 11-18-20.
