## Issue Report

# Pelton Twin #1-SWD, 017-06482, Mull Drilling

Report created on August 14, 2020

Captured: August 7, 2020

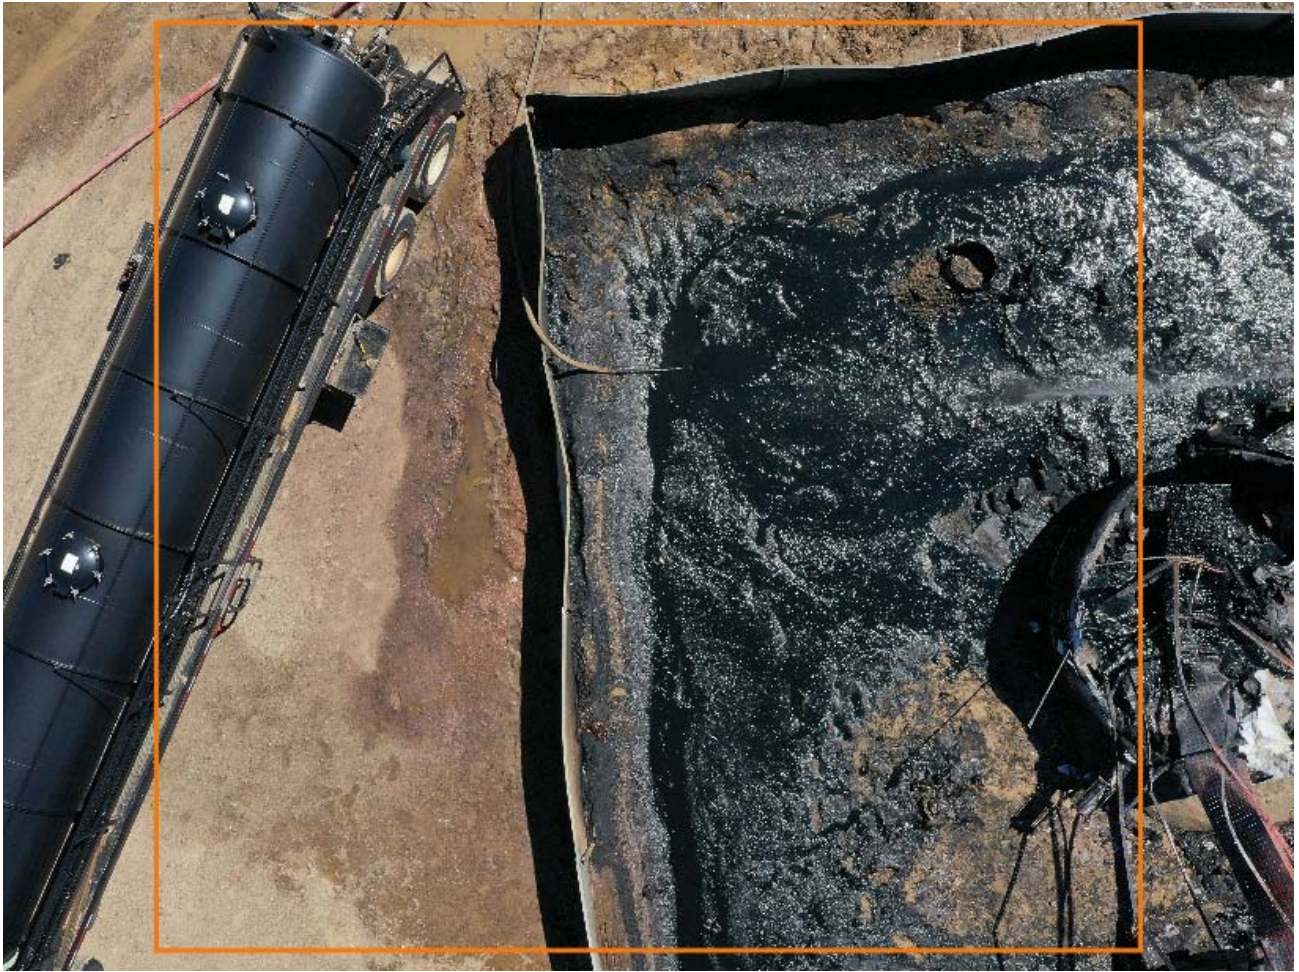
**No. 2 OPEN****Captured: Aug 7, 2020 at 2:53pm**

**Type**  
Leak**Lat/Long**  
38.87929, -102.33303**Summary**  
Oil contained inside metal berm.**Created**  
Aug 14, 2020 at 2:51pm by Craig Quint

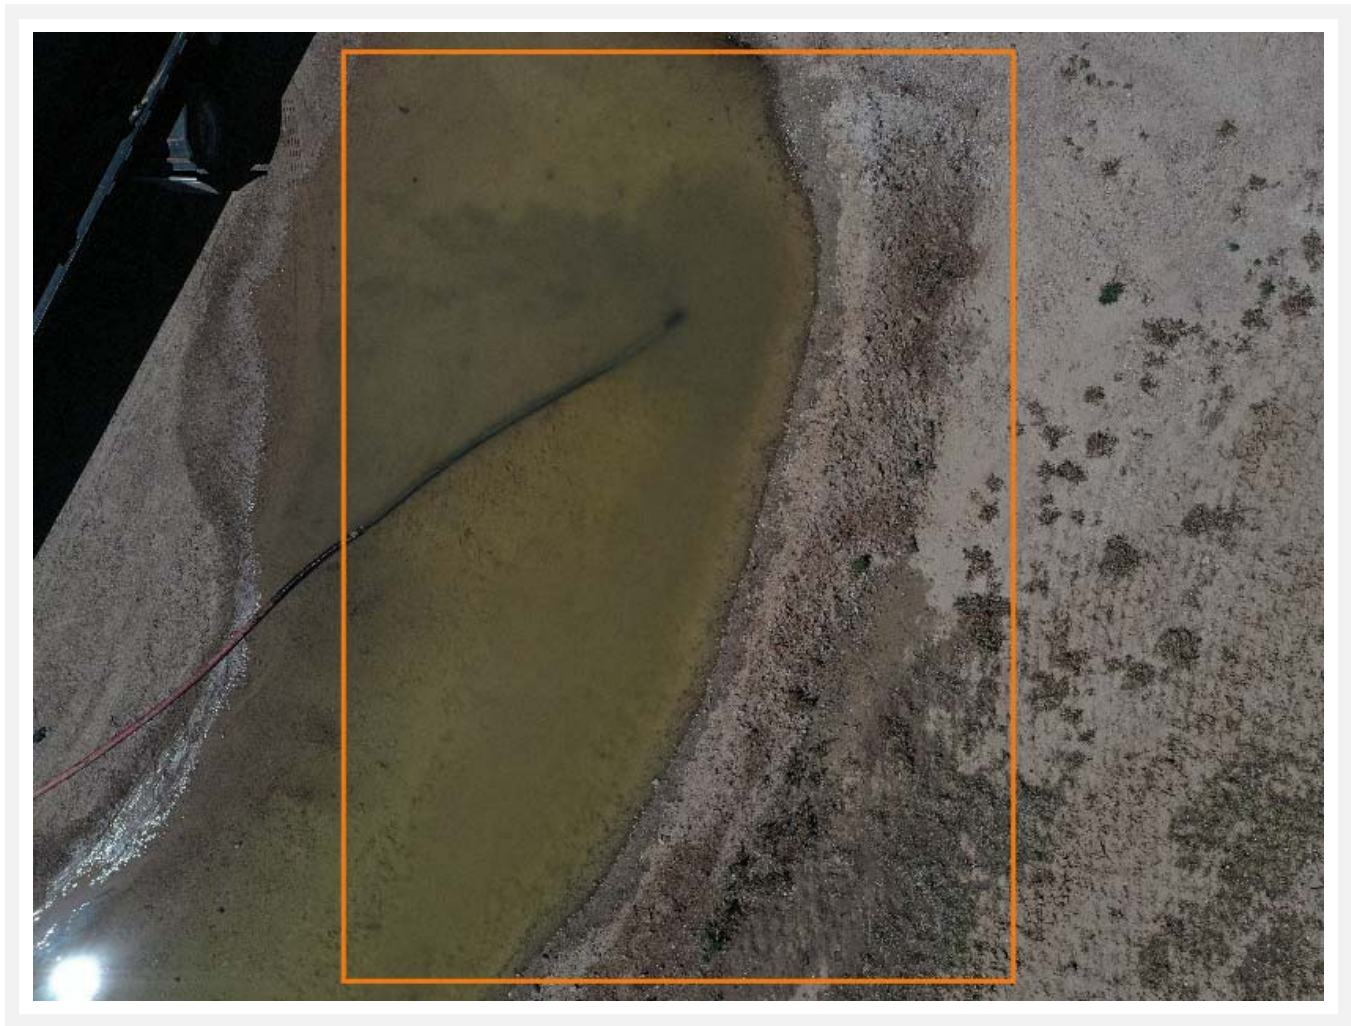
No. 3 OPEN

Summary  
Earthen berms on east side of battery filled with rain water.

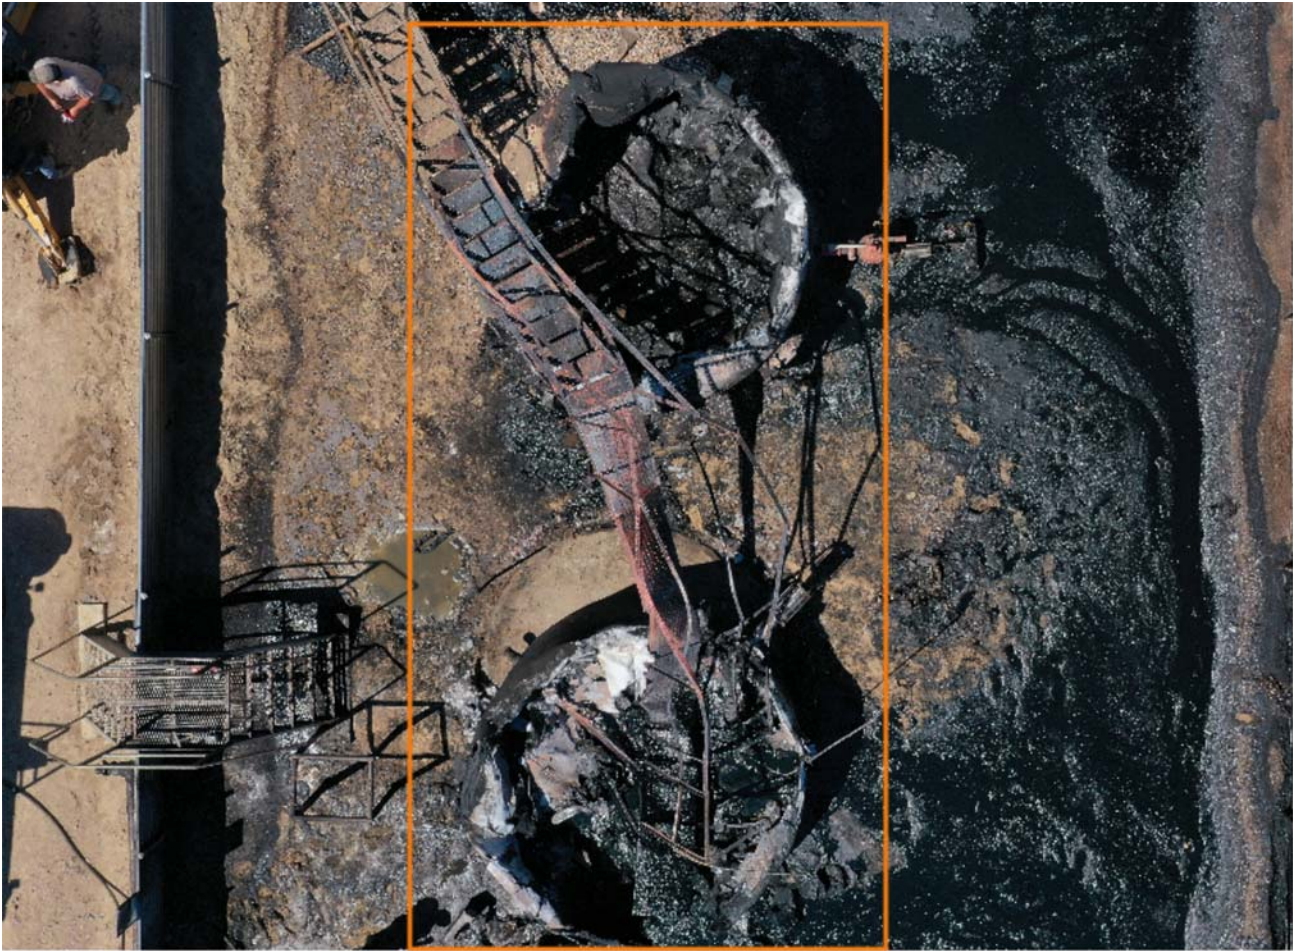
No. 1 OPEN

Lightning Strike, Remains of tanks
