Inspection Photos
Operator: Catamount Operating
API: 067-07917
Date: 8/18/2020

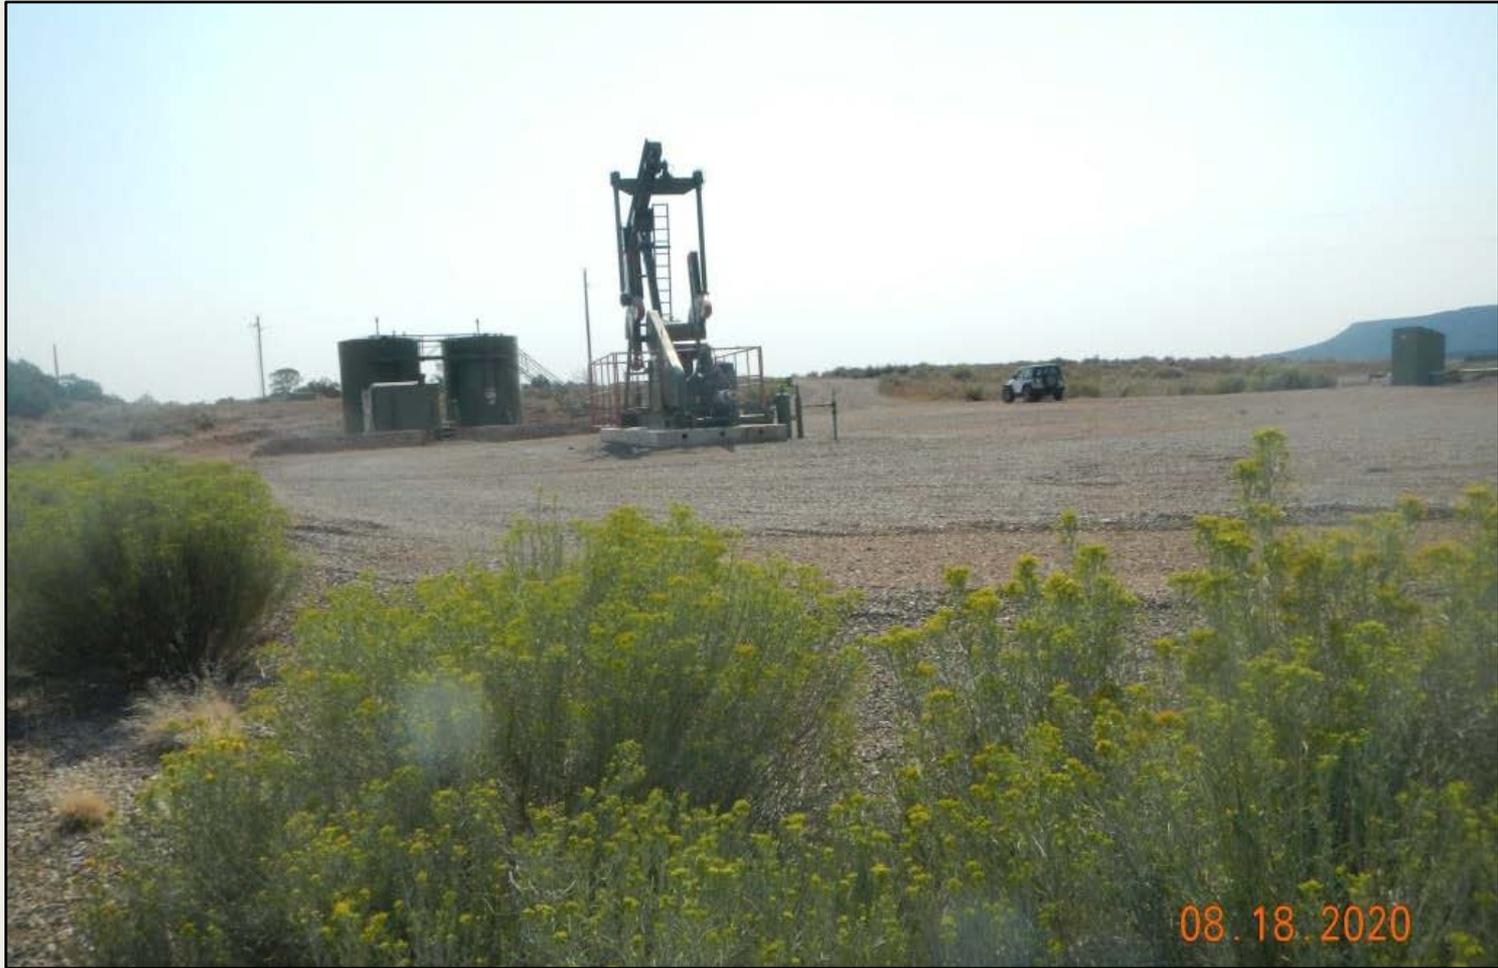
Photo 1. View of the project area from the northwestern corner facing center.

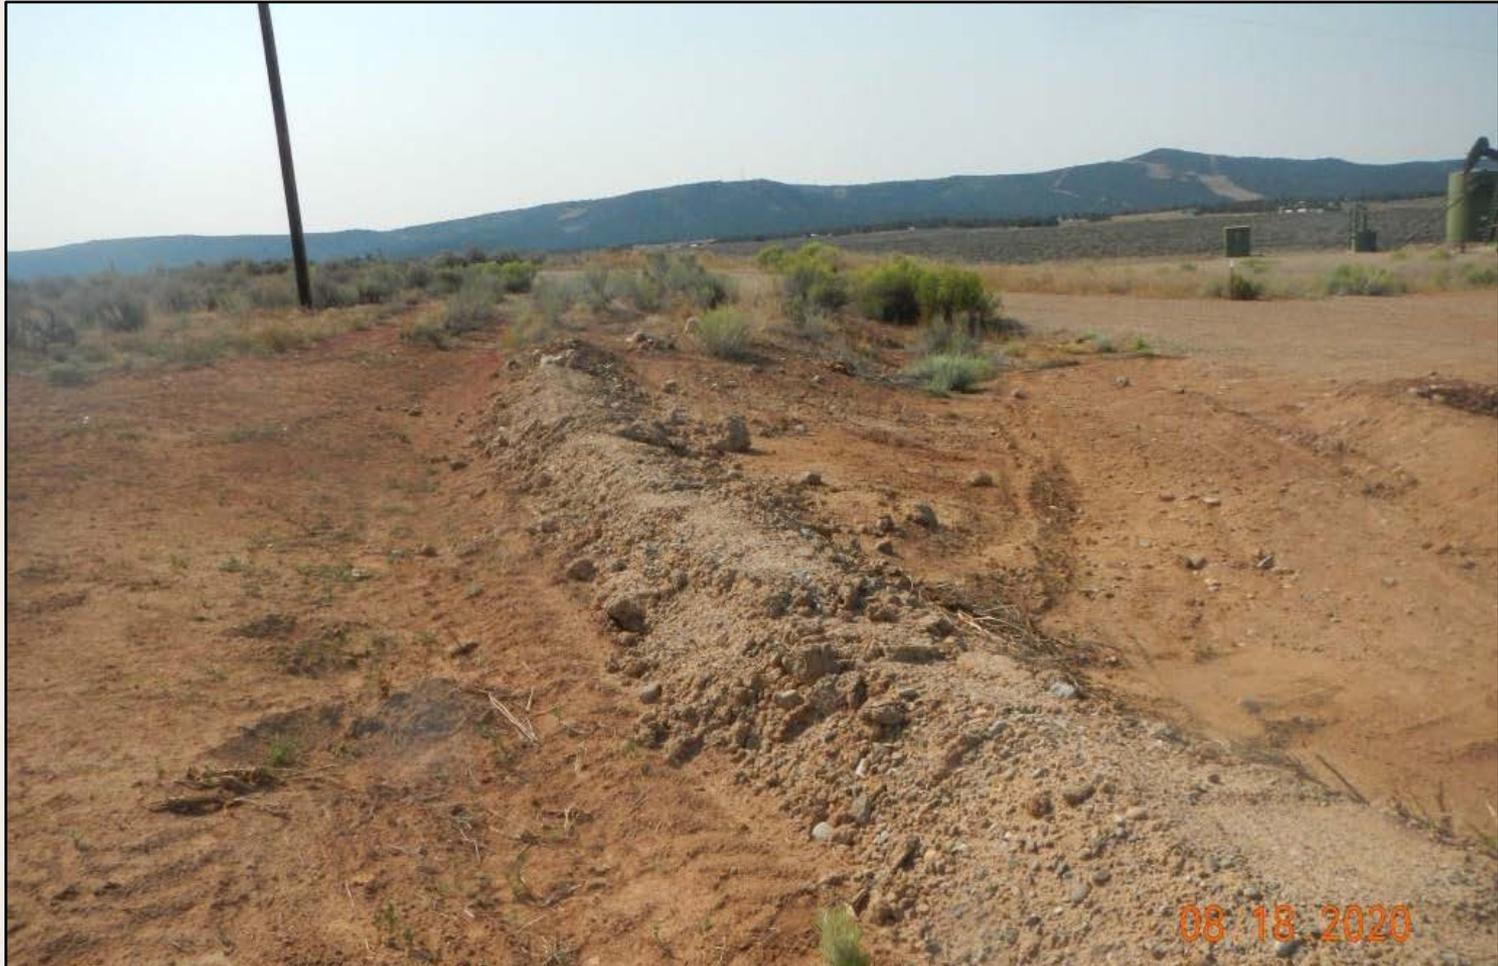
Photo 2. View of area recently disturbed for stormwater diversion. Soils need to be stabilized with mulch and vegetation.

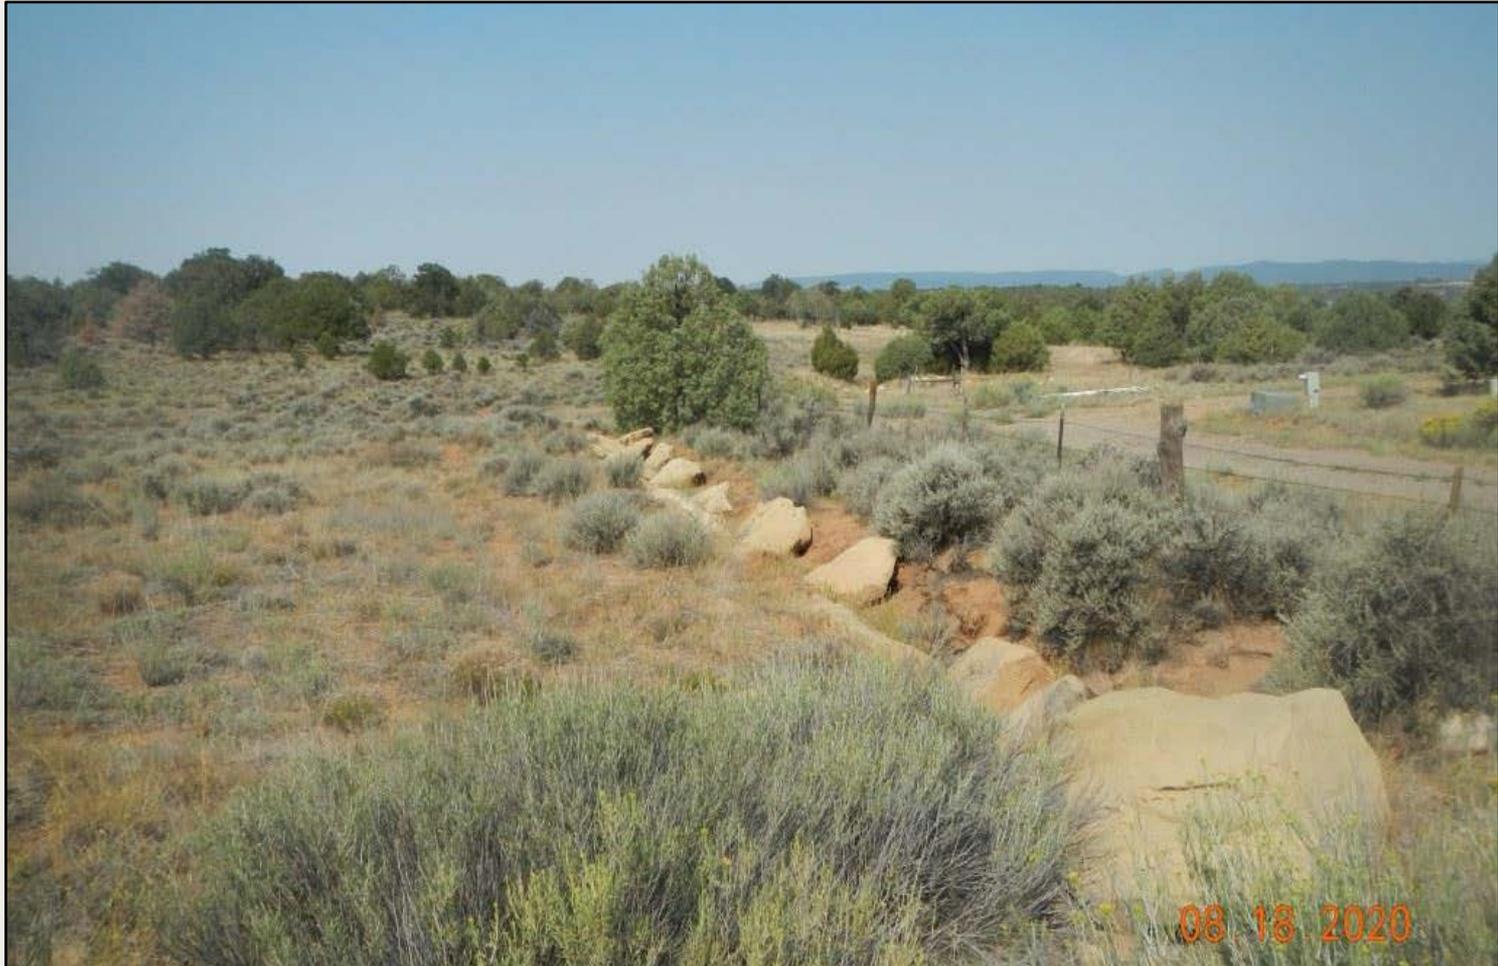
Photo 3. View of stormwater diversion northwest of the project area with boulders in place. Stormwater erosion appears to be controlled at this time.

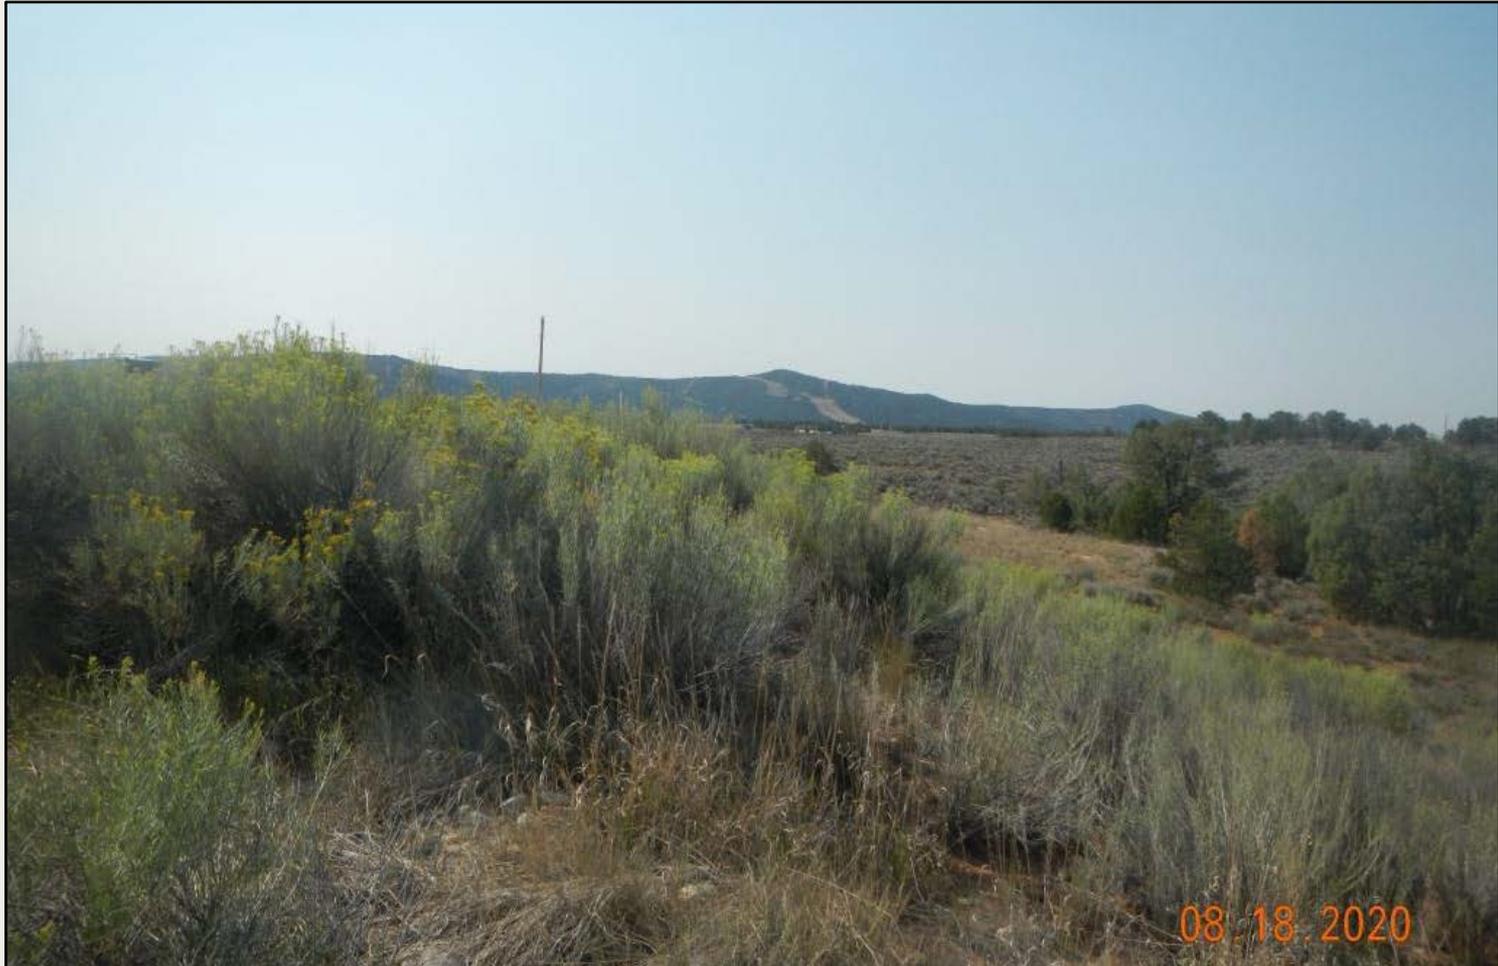
Photo 4. View of the western fill slope from the northwestern project area facing southward. Revegetation is progressing with grasses such as crested wheatgrass, rubber rabbitbrush, and smooth brome.

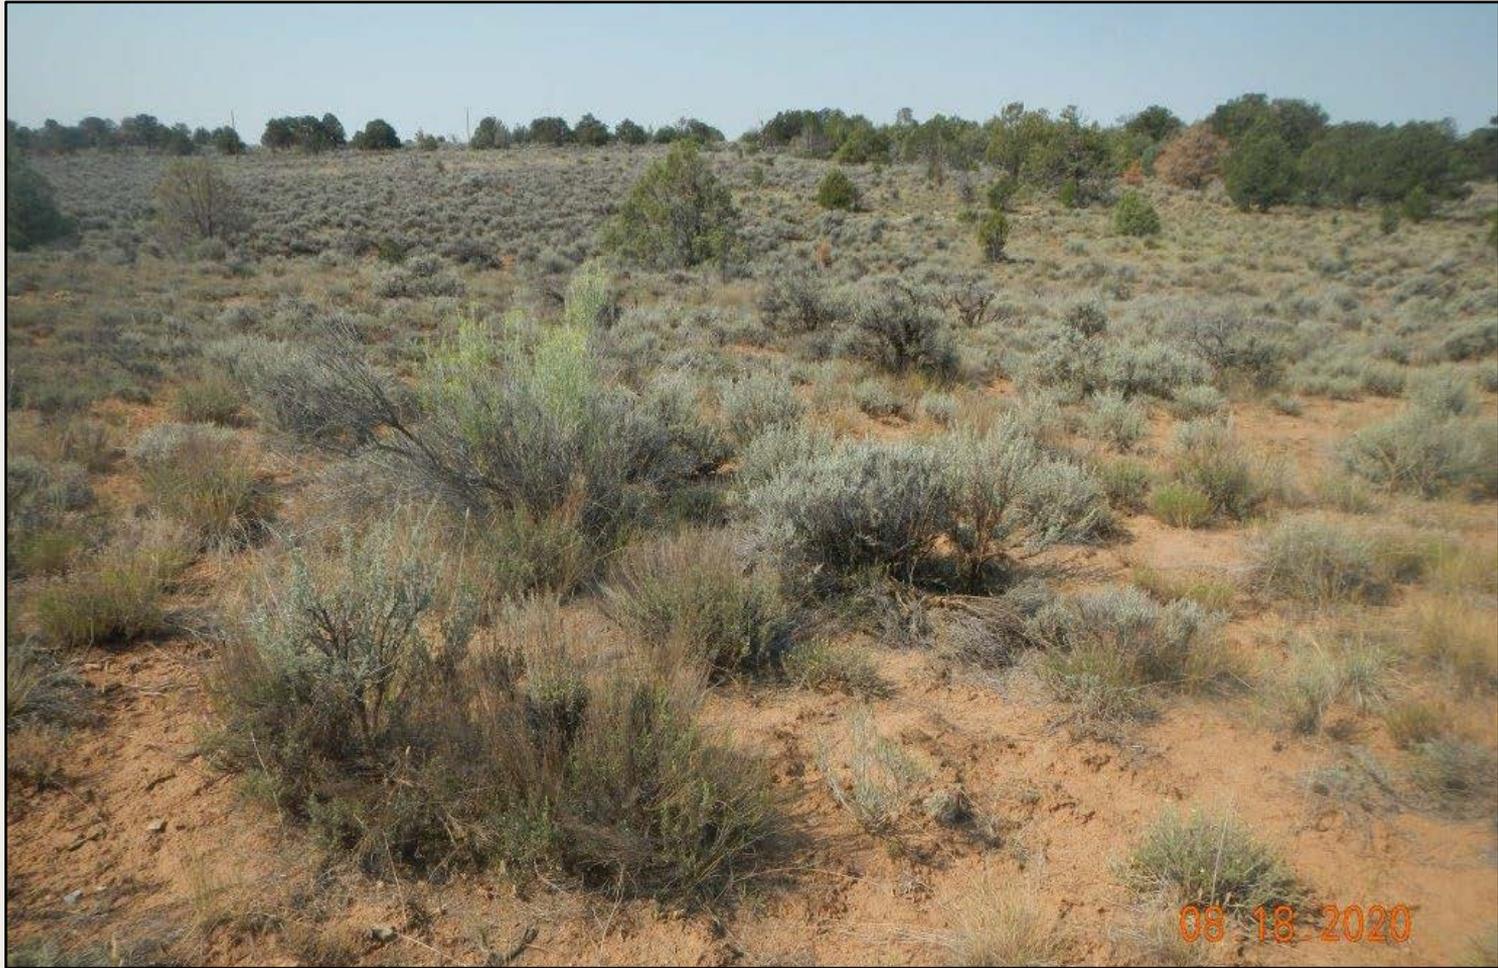
Photo 5. View of reference area comprised of sagebrush shrubland and pinyon/juniper woodland vegetation with grasses such as James galleta, blue grama, needleandthread grass and forbs such as *Heterotheca villosa* and Townsend daisy.
