**Inspection Photos**  
**Operator: Logos Operating**  
**API: 067-08161**  
**Date: 8/20/2020**

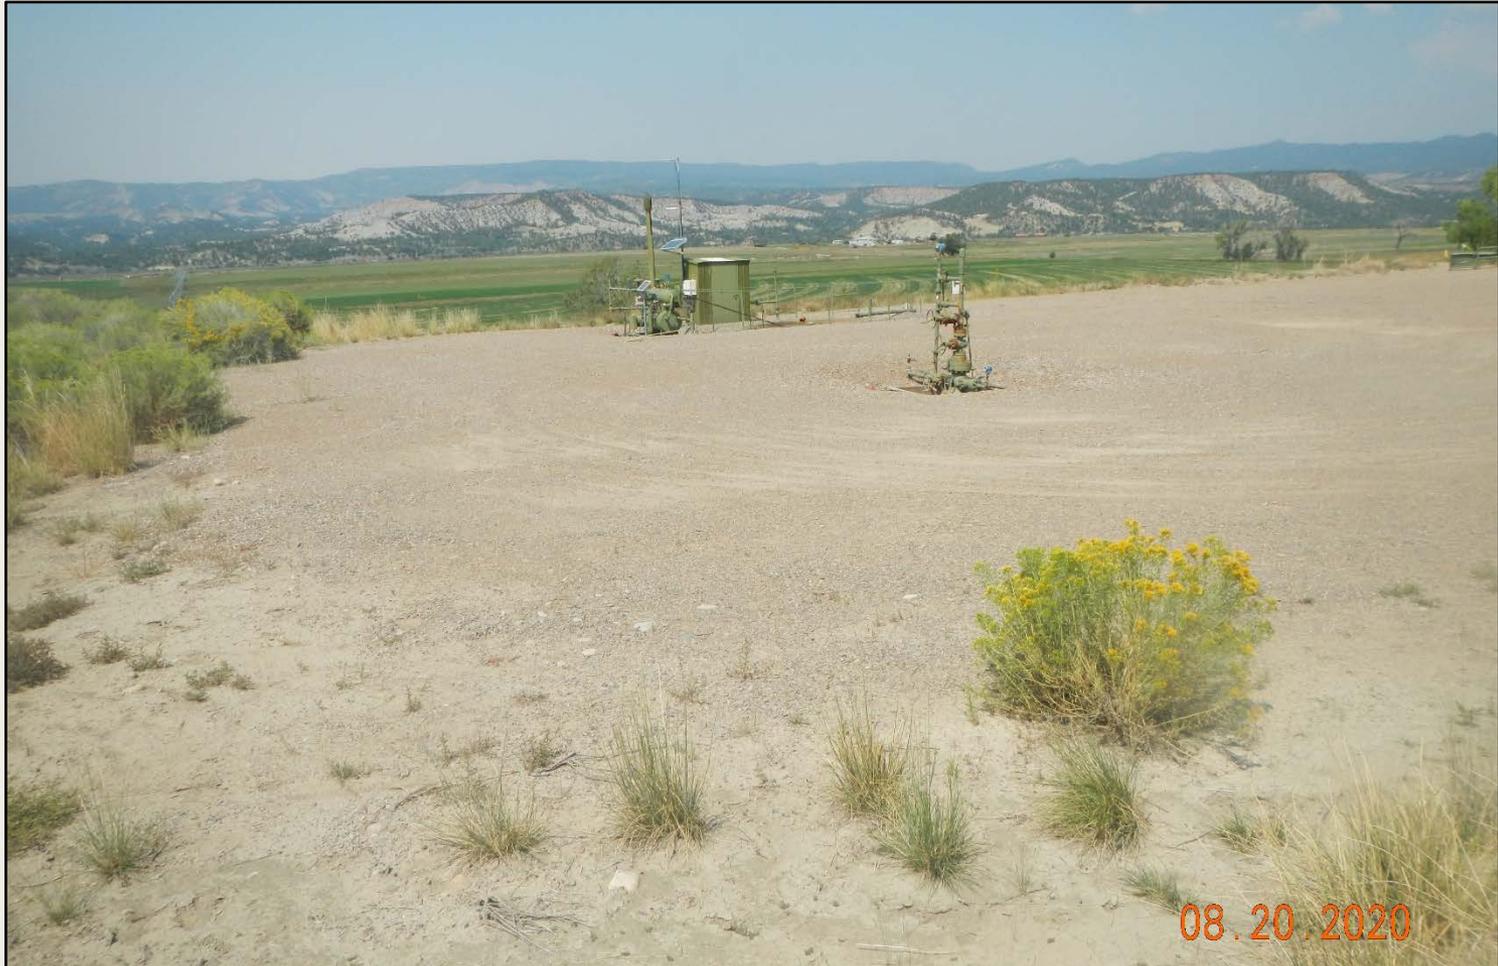
Photo 1. View of the Logos well from the southeastern corner facing center.

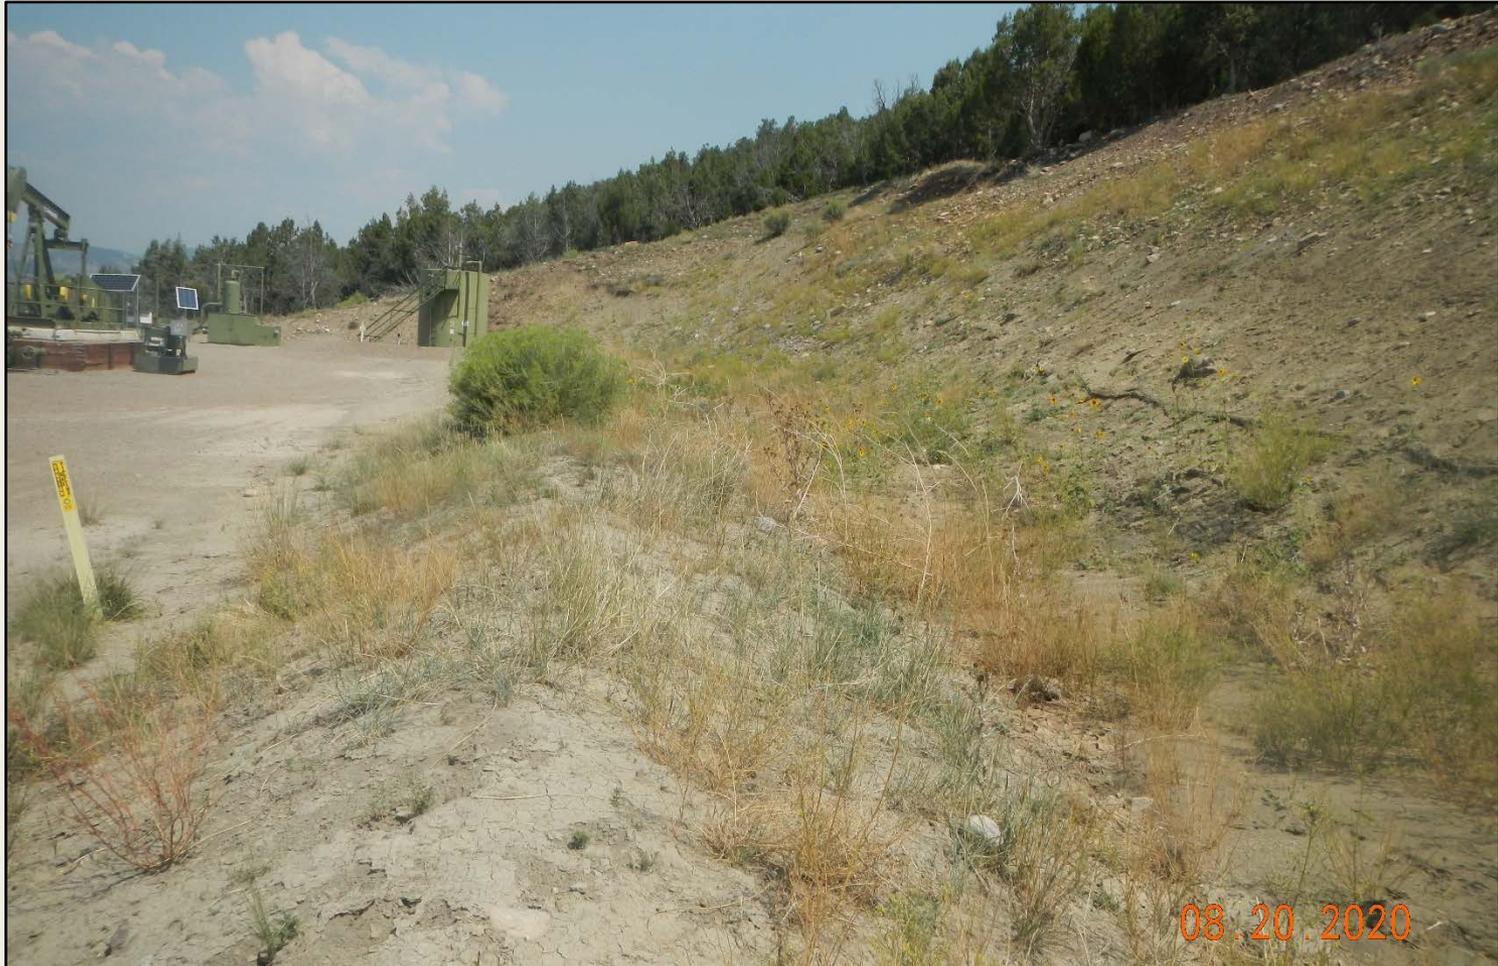
Photo 2. View of the eastern project area facing northward. Revegetation is progressing in portions of the interim reclamation area with grasses and shrubs such as western wheatgrass and rubber rabbitbrush.

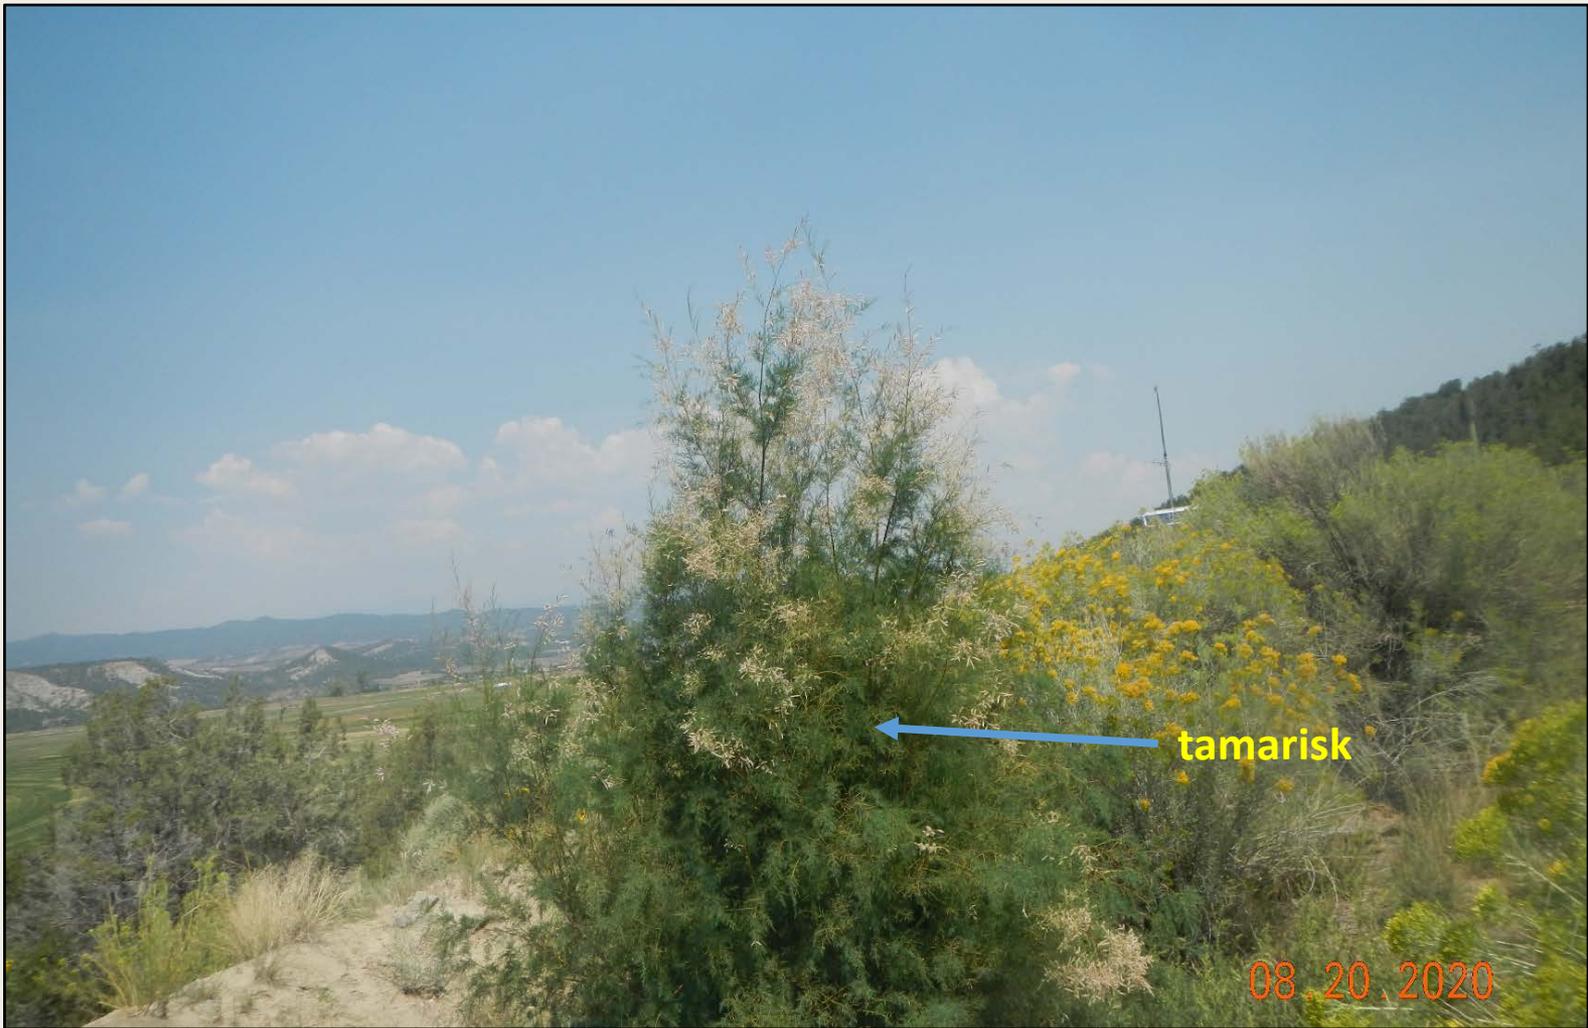
Photo 3. View of tamarisk tree in the southwestern project area. Tamarisk is a state and county-listed noxious weed.

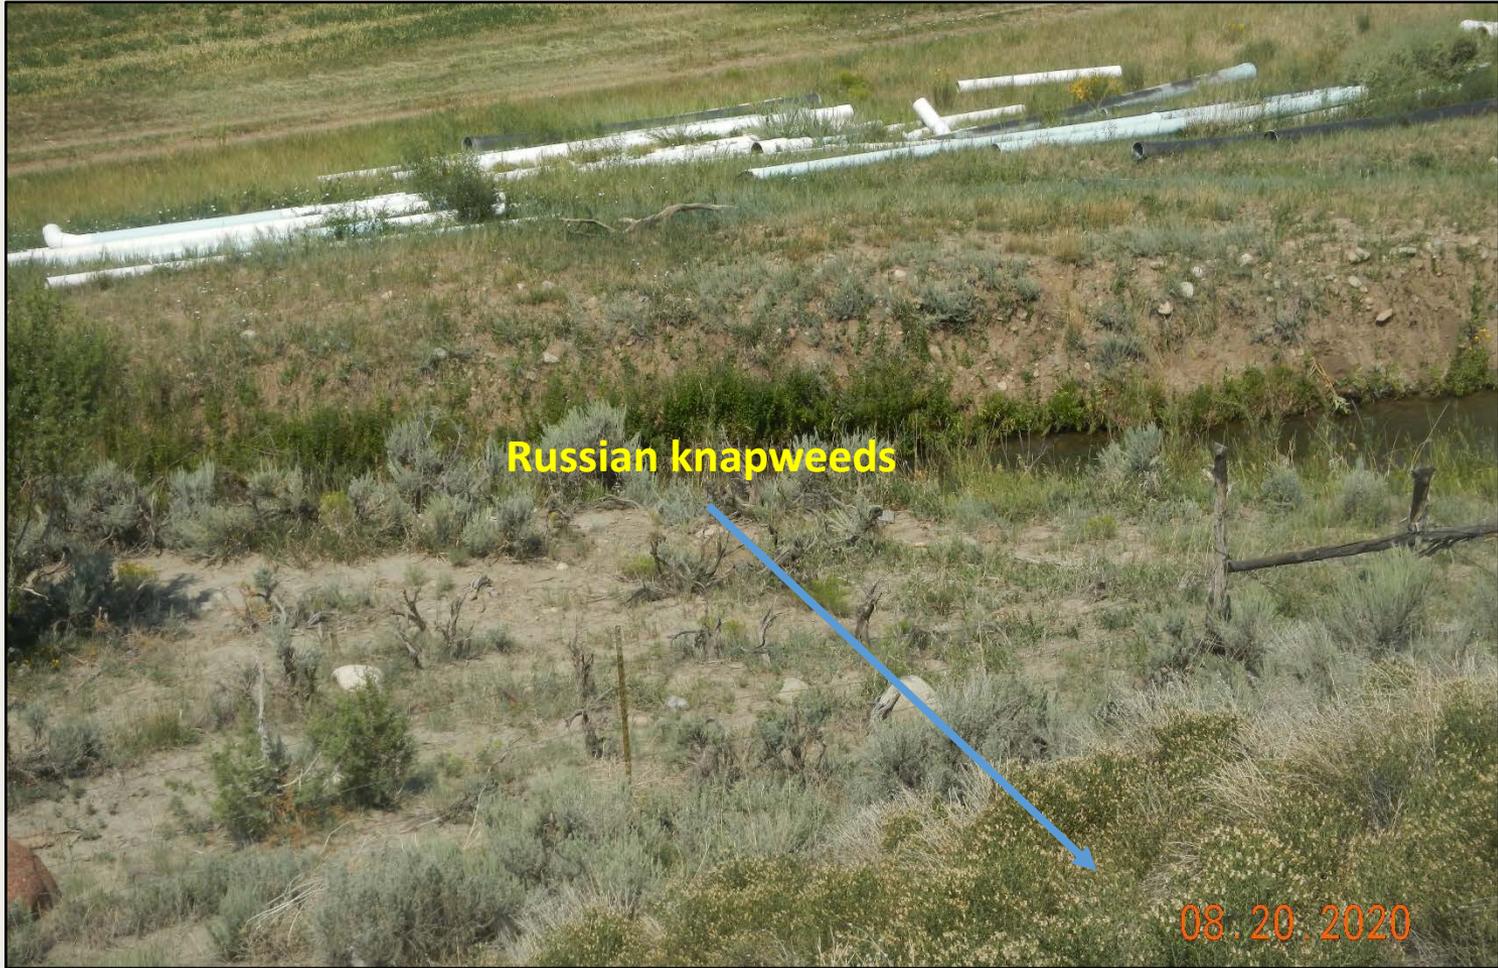
Photo 4. View of dense Russian knapweeds growing on the northwestern fill slope. Approximately 2000 individuals observed.

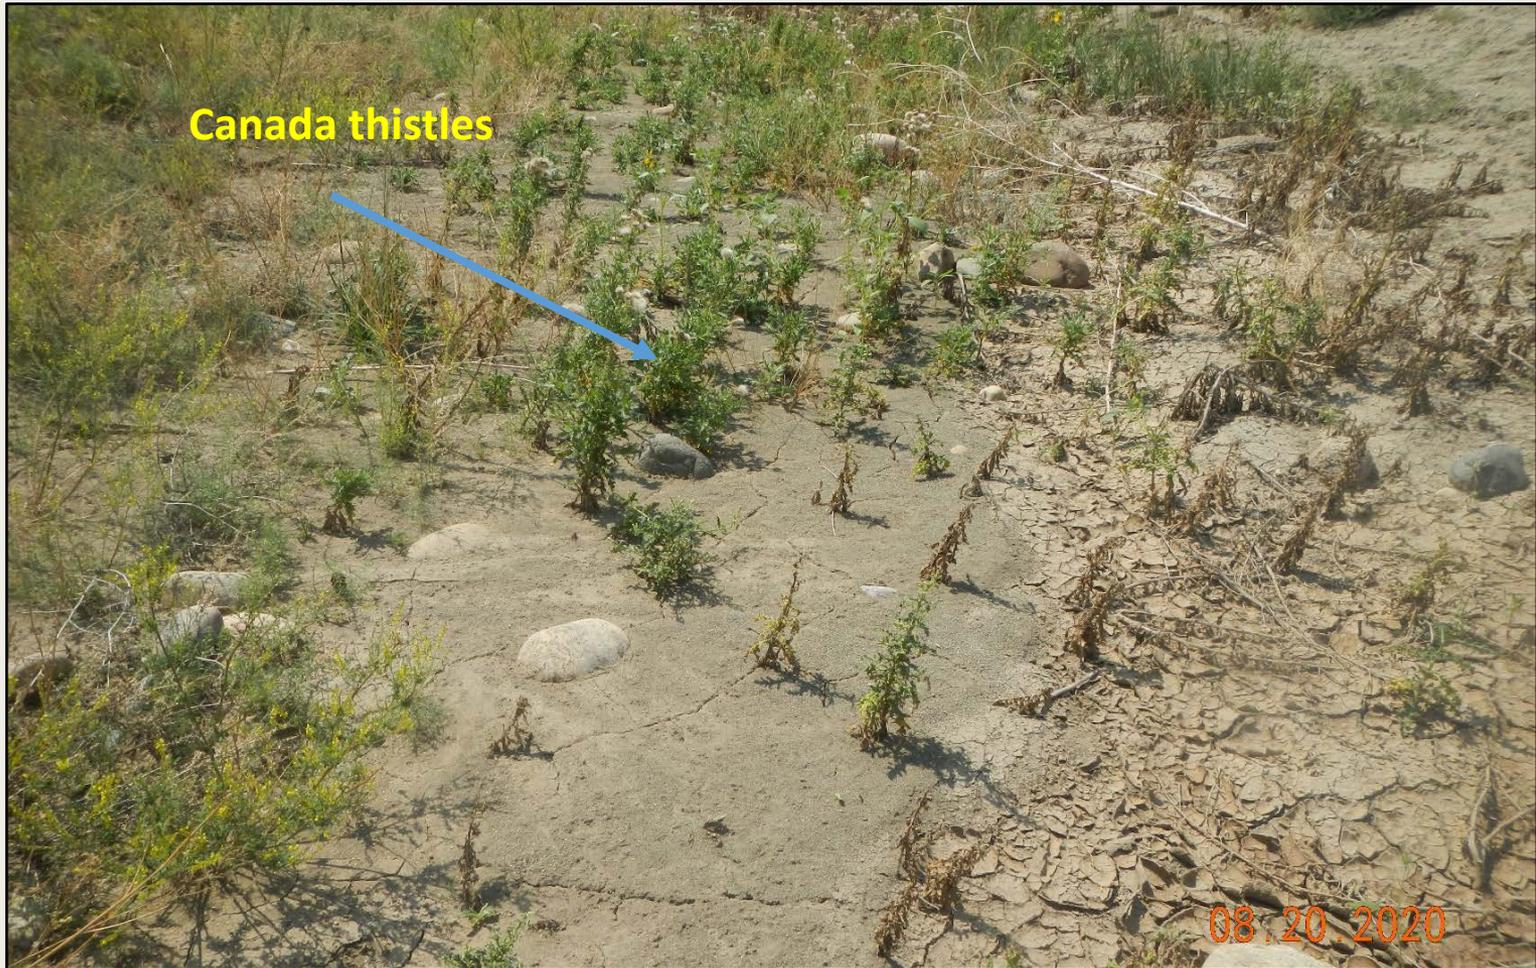
Photo 5. View of Canada thistles within the eastern fill slope. Approximately 300 Canada and Scotch thistles observed here.

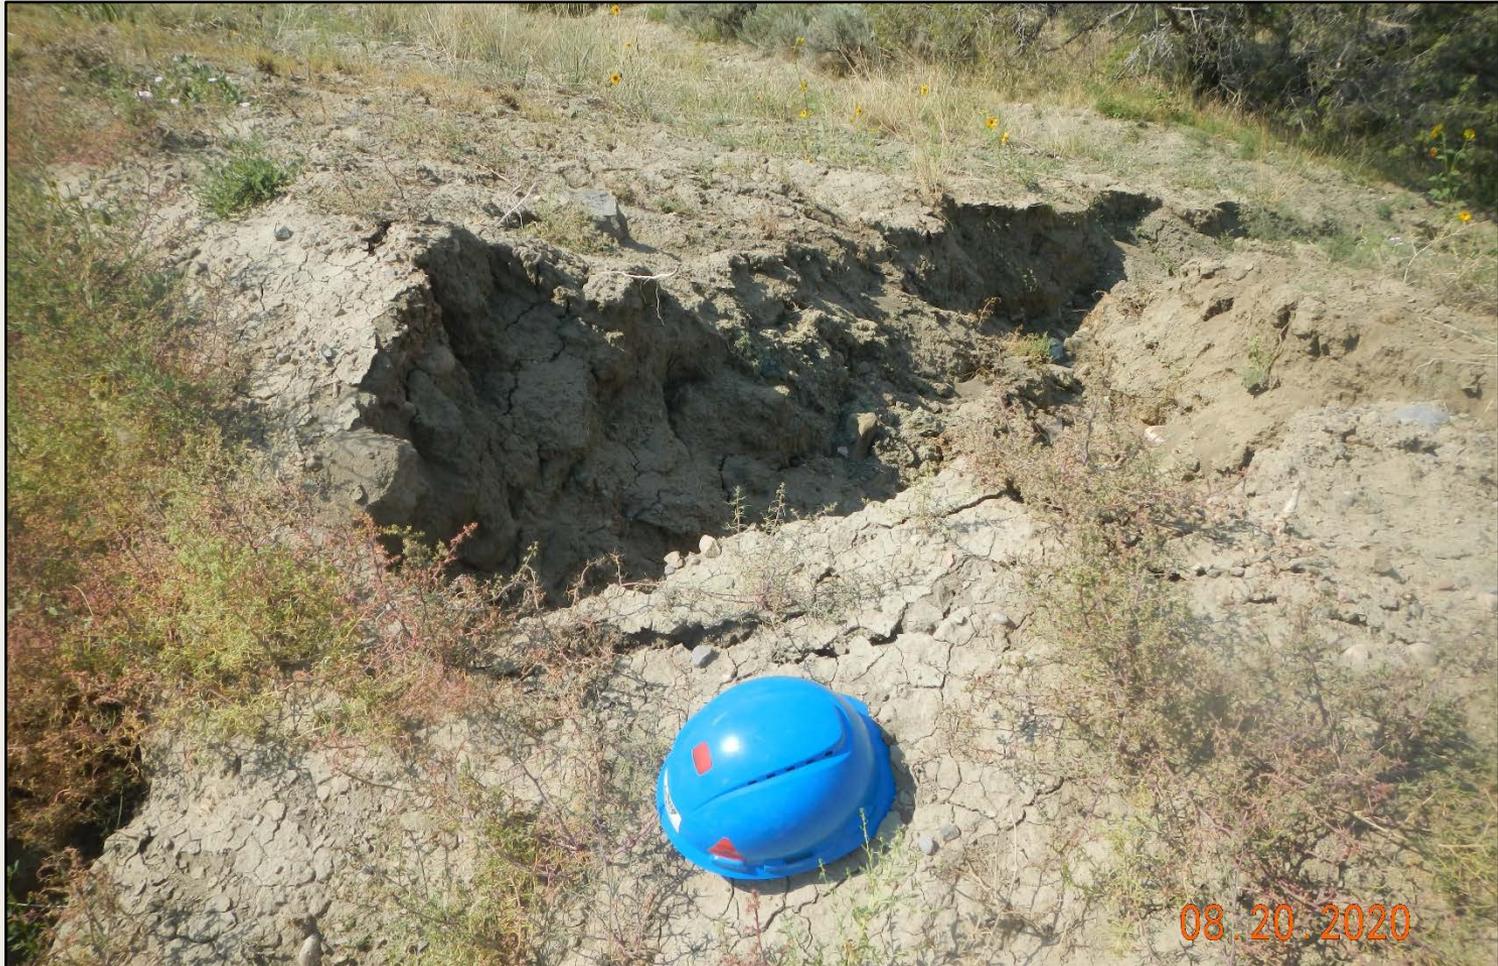
Photo 6. View of erosional gully in the western fill slope, approximately 3-4 feet wide and deep (facing down-slope from top of slope). Hard hat in place for scale.

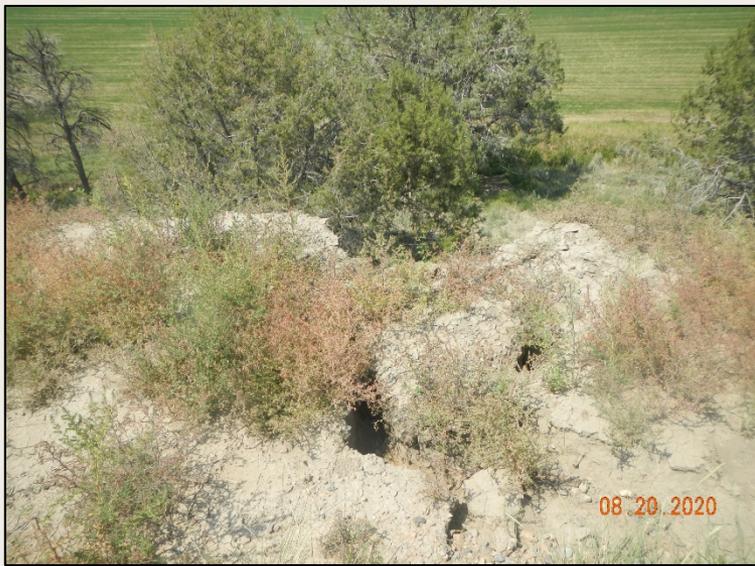
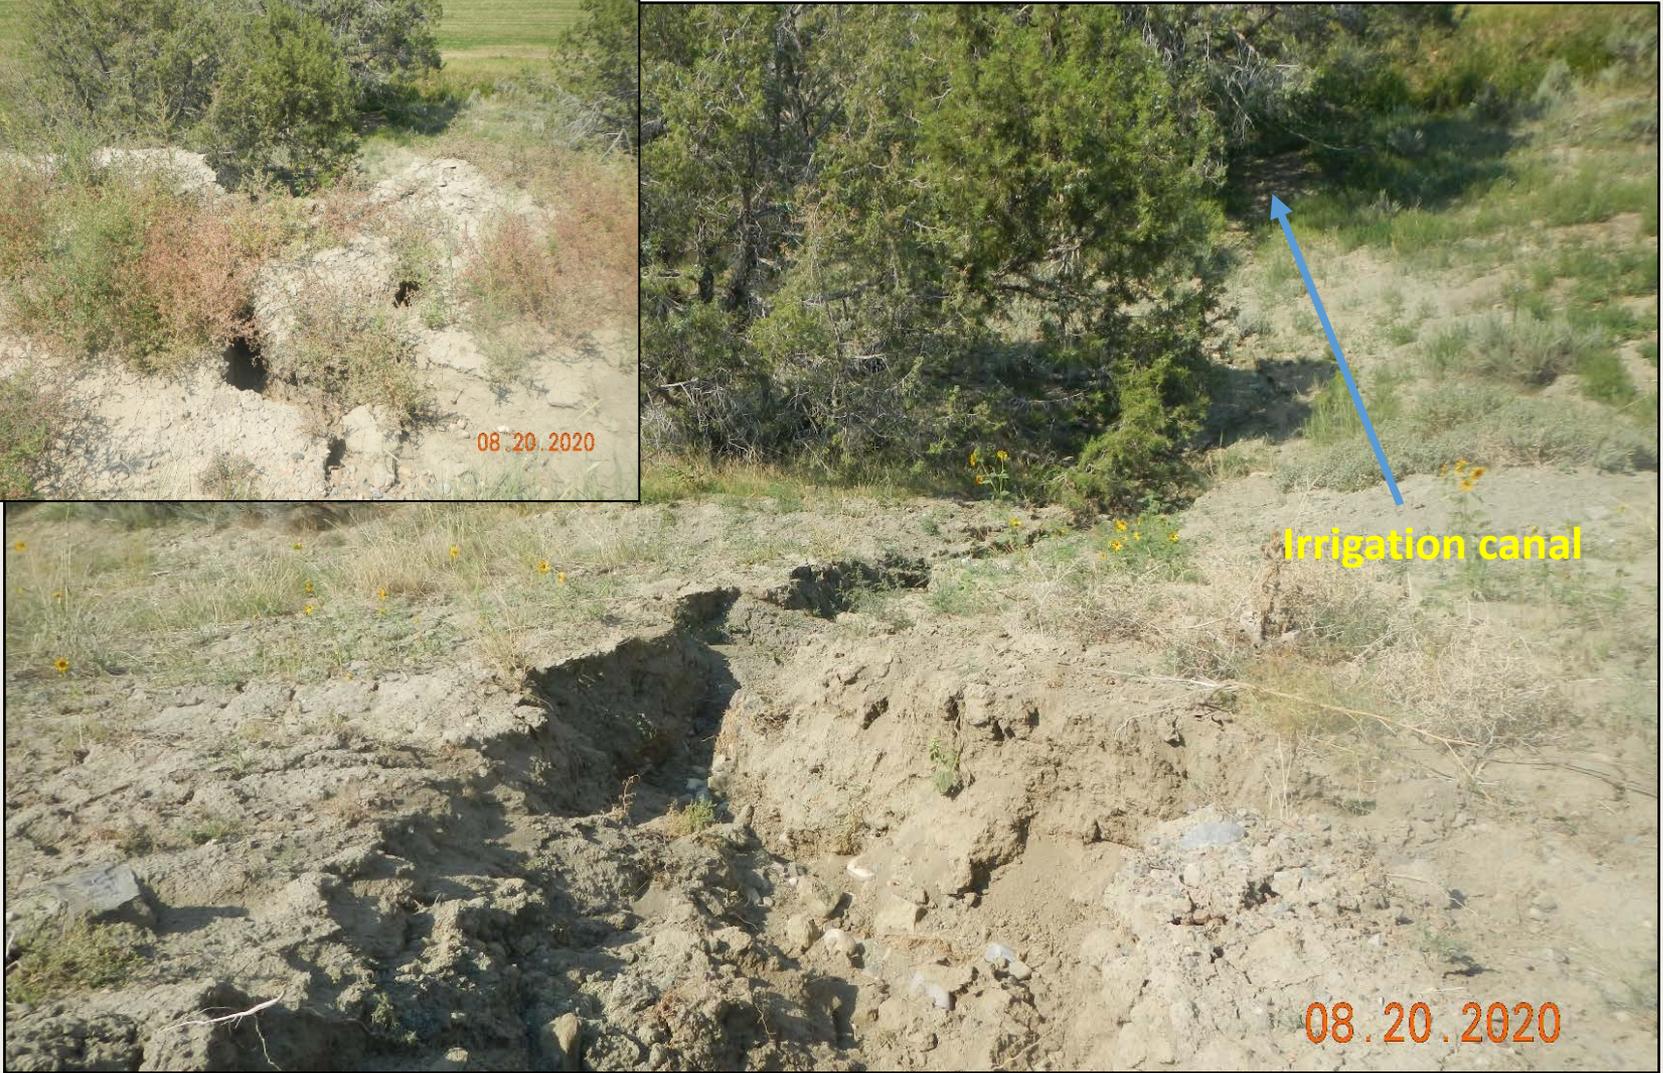
Photo 7. Downslope view of gully shown in Photo 6. Sediment from erosional events is flowing to adjacent irrigation canal. Inset shows top of slope where stormwater tunnels through the berm and eroding the slope.

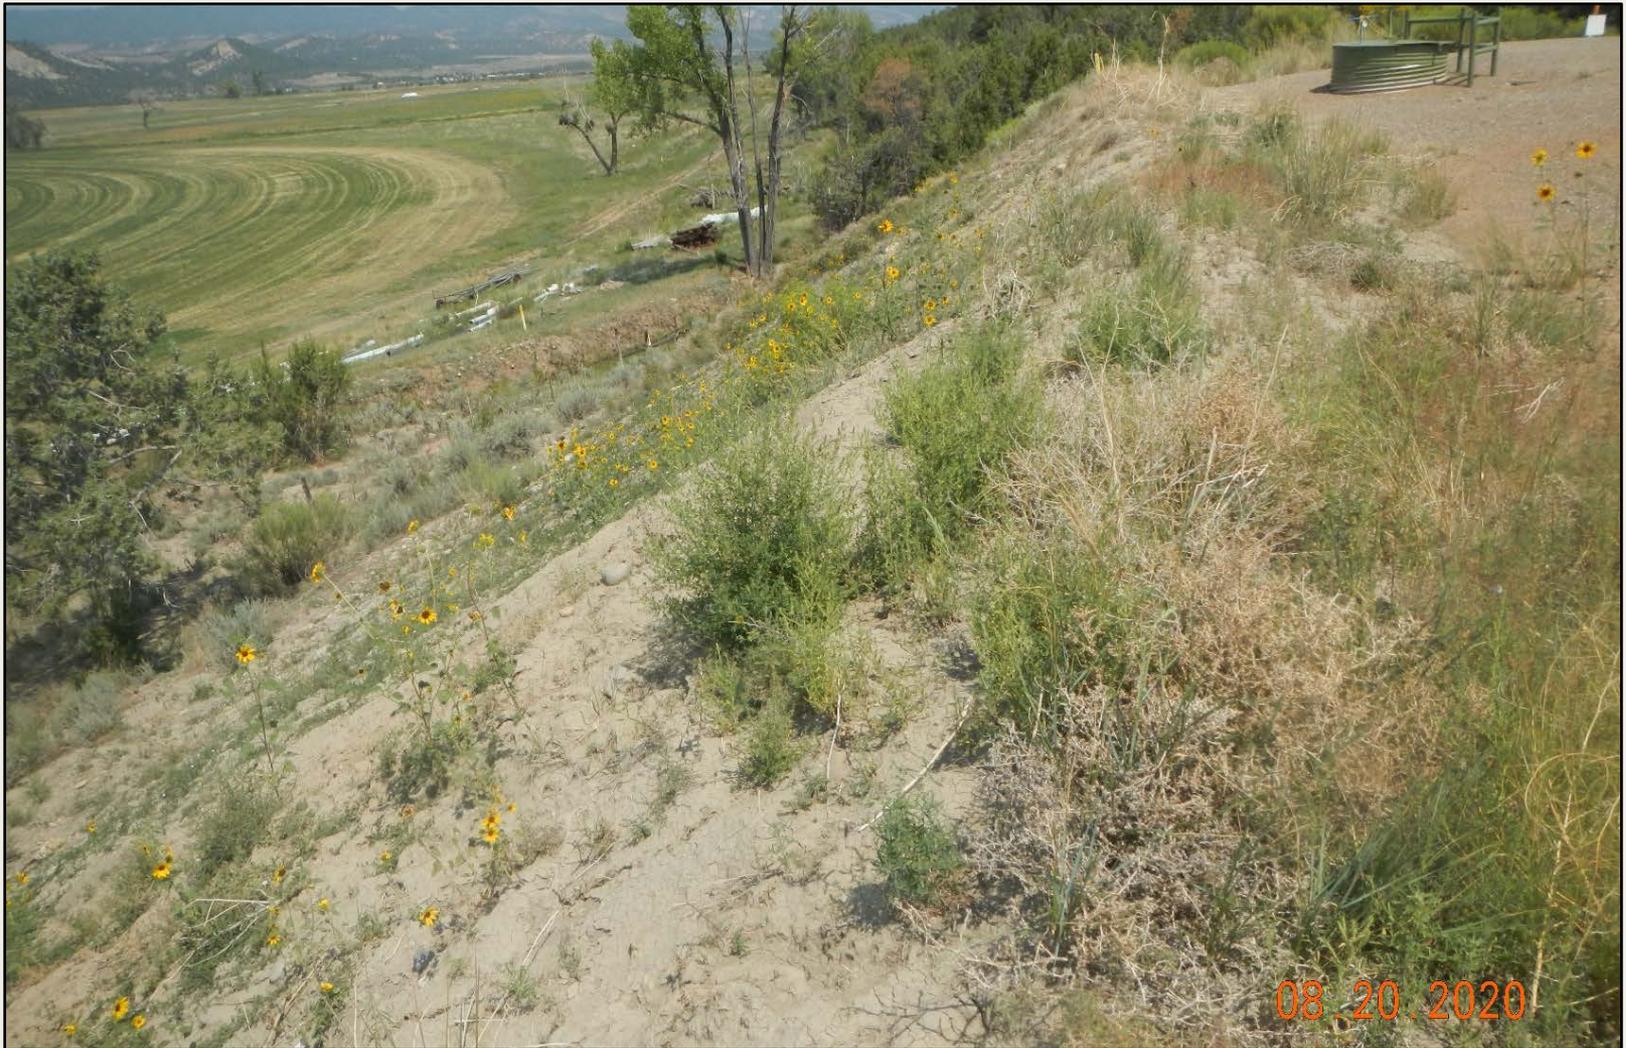
Photo 8. View of the well pad fill slope facing northward. Scattered desirable vegetation such as western wheatgrass and Indian ricegrass present, but the majority of the slope remains unstabilized with bare soils or weeds such as Russian thistle.

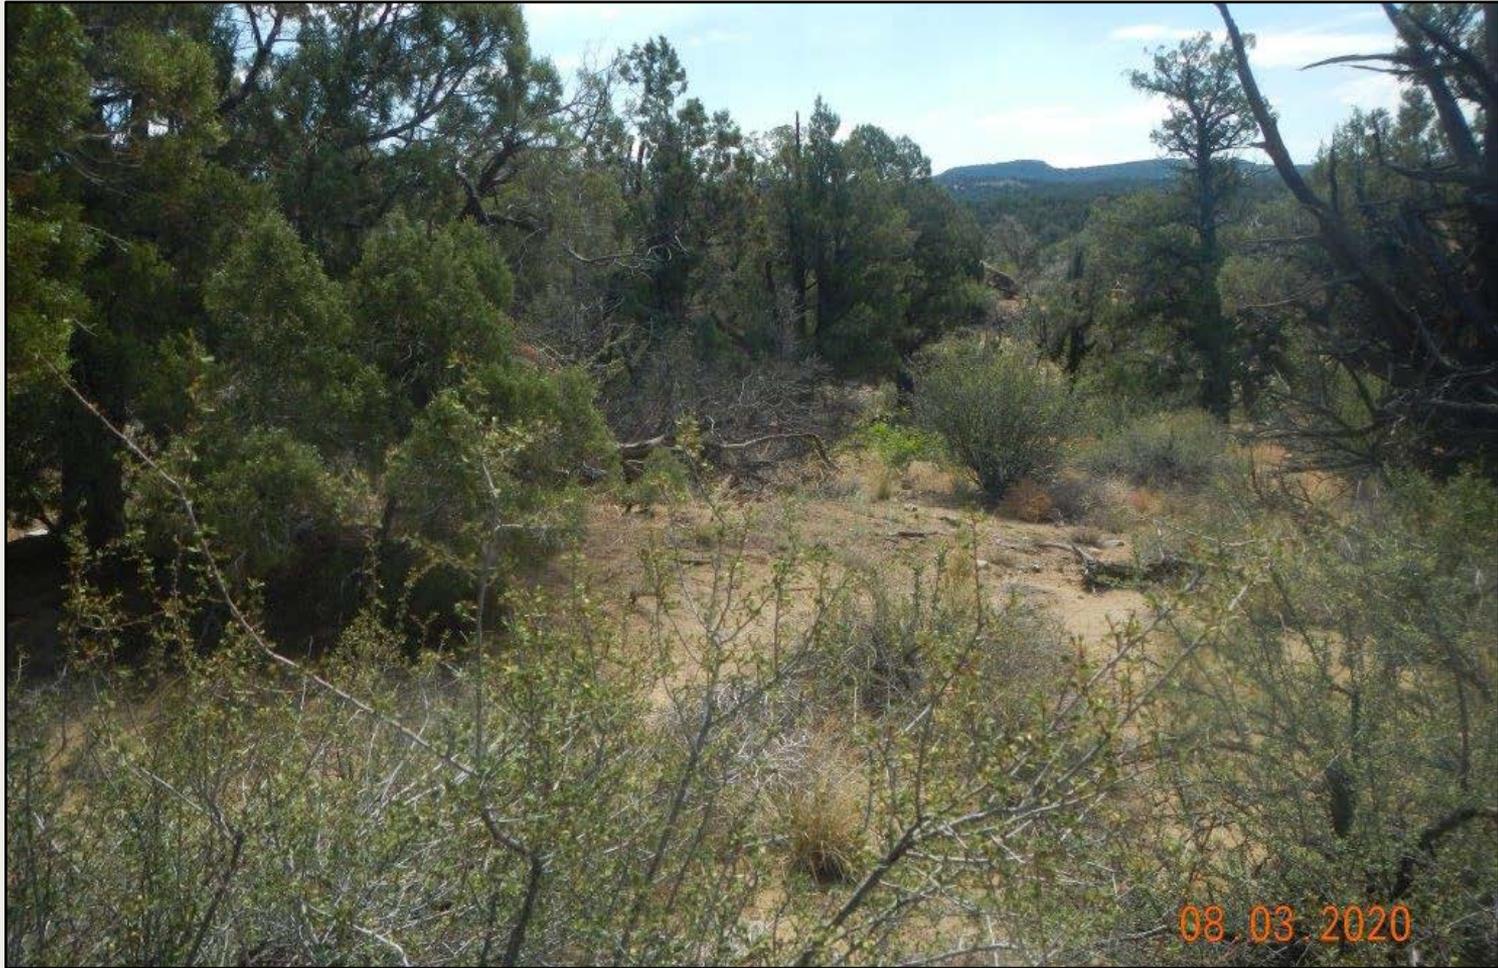
Photo 9. View of reference area comprised of pinyon/juniper woodland vegetation with understory of shrubs and grasses/forbs such as antelope bitterbrush, mountain mahogany, Indian ricegrass and *Heterotheca villosa*.
