Stormwater Inspection Report

| Operator: | Laramie Energy, LLC |
| Project: | North Vega |
| Location: | Pad 4A |

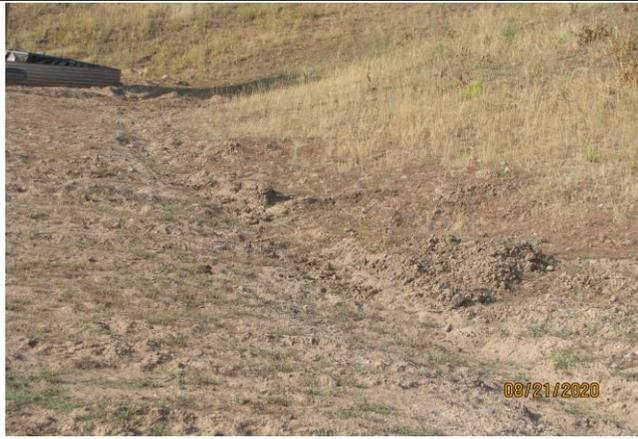
Photo 1

Dewatering Channel on the West Side of Pad 4A

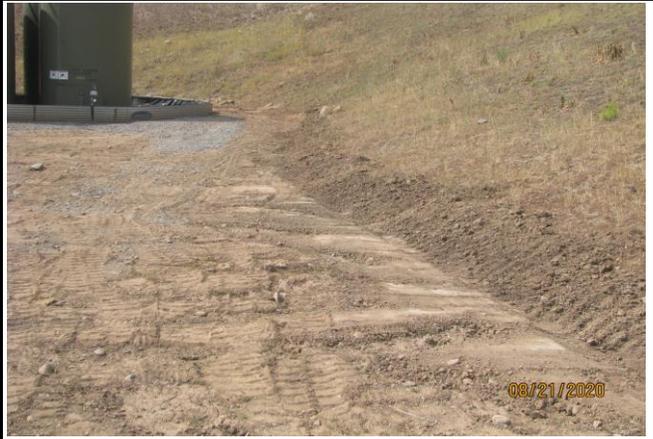
Photo 2

Dewatering Channel Maintained on the West Side of Pad 4A

| Comments / Descriptions / Explanations | |
|--|--|
| <p>One crew completed COGCC corrective actions for Pad 4A today. The dewatering channel installed along the toe of the western cut slope was maintained. Sediment that had been pushed into the channel during snow plowing operations was removed and the toe of the cut slope was maintained. The vehicle rutted area in the SW corner of the pad was graded and then road base material was installed within the low-lying areas around the tank battery. Road base material installation was continued for low-lying areas on the pad where storm water runoff has been ponding. BMPs installed on the access road and pad were maintained and additional rock armor was installed where needed.</p> | |

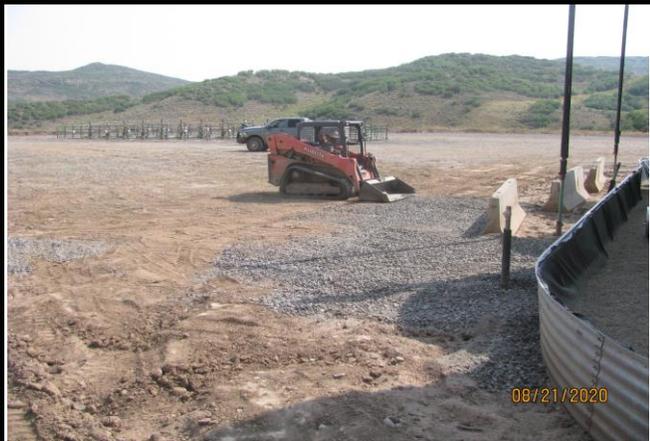
Photo 3

Road Base Installation on Pad 4A

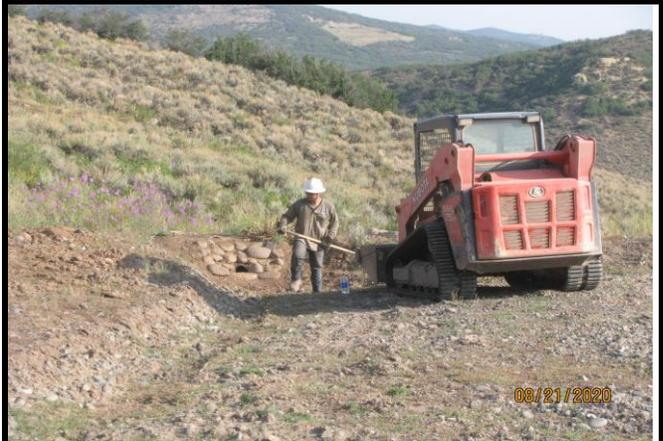
Photo 4

BMP Maintenance on Pad 4A
