Inspection Photos

Operator: Hilcorp Operating
API: 067-08319
Date: 8/20/2020

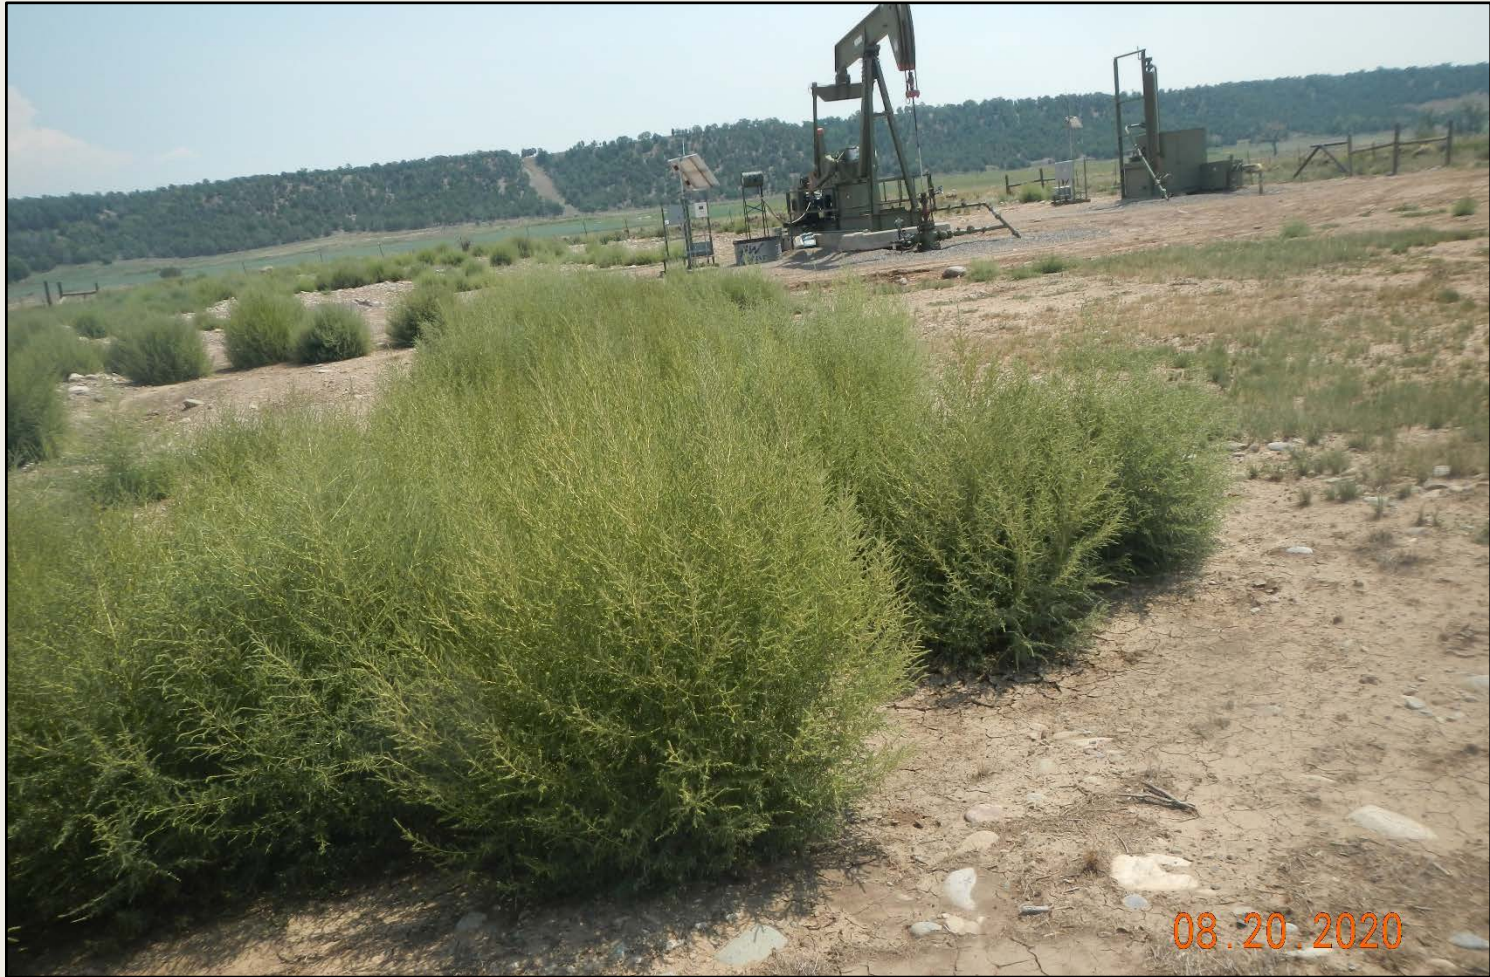
Photo 1. View of the project area from the northwestern corner facing center.

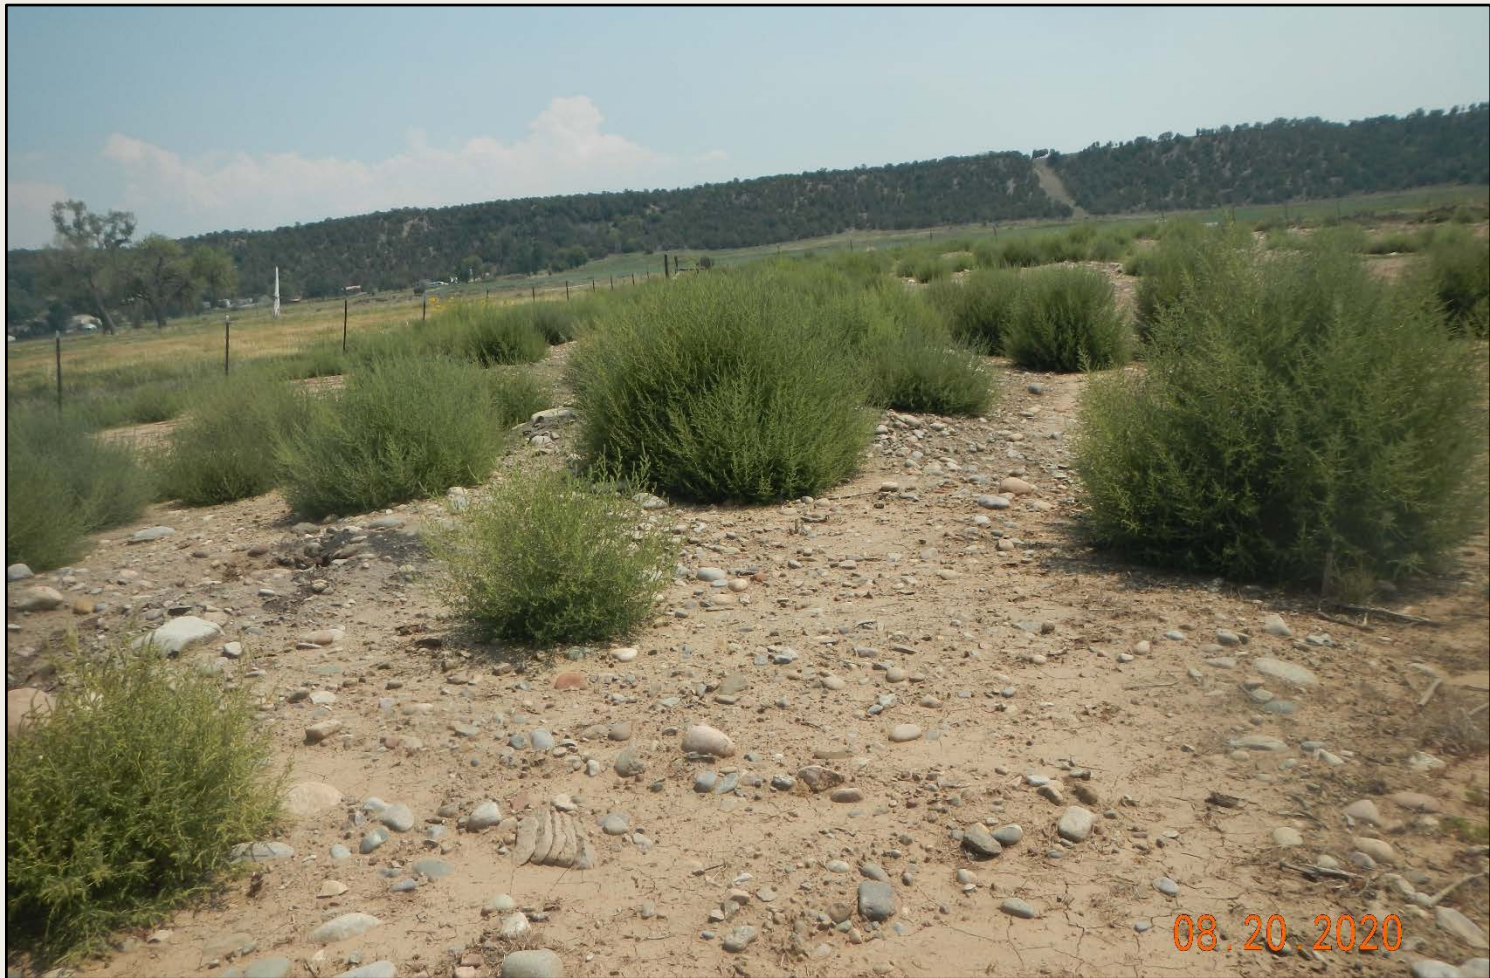
Photo 2. View of the northern project area from the northwestern corner facing eastward. Little desirable vegetation observed within the interim reclamation areas. Observable vegetation is comprised of kochia weeds up to 5 feet tall, which will dry, break off, and become weed debris.

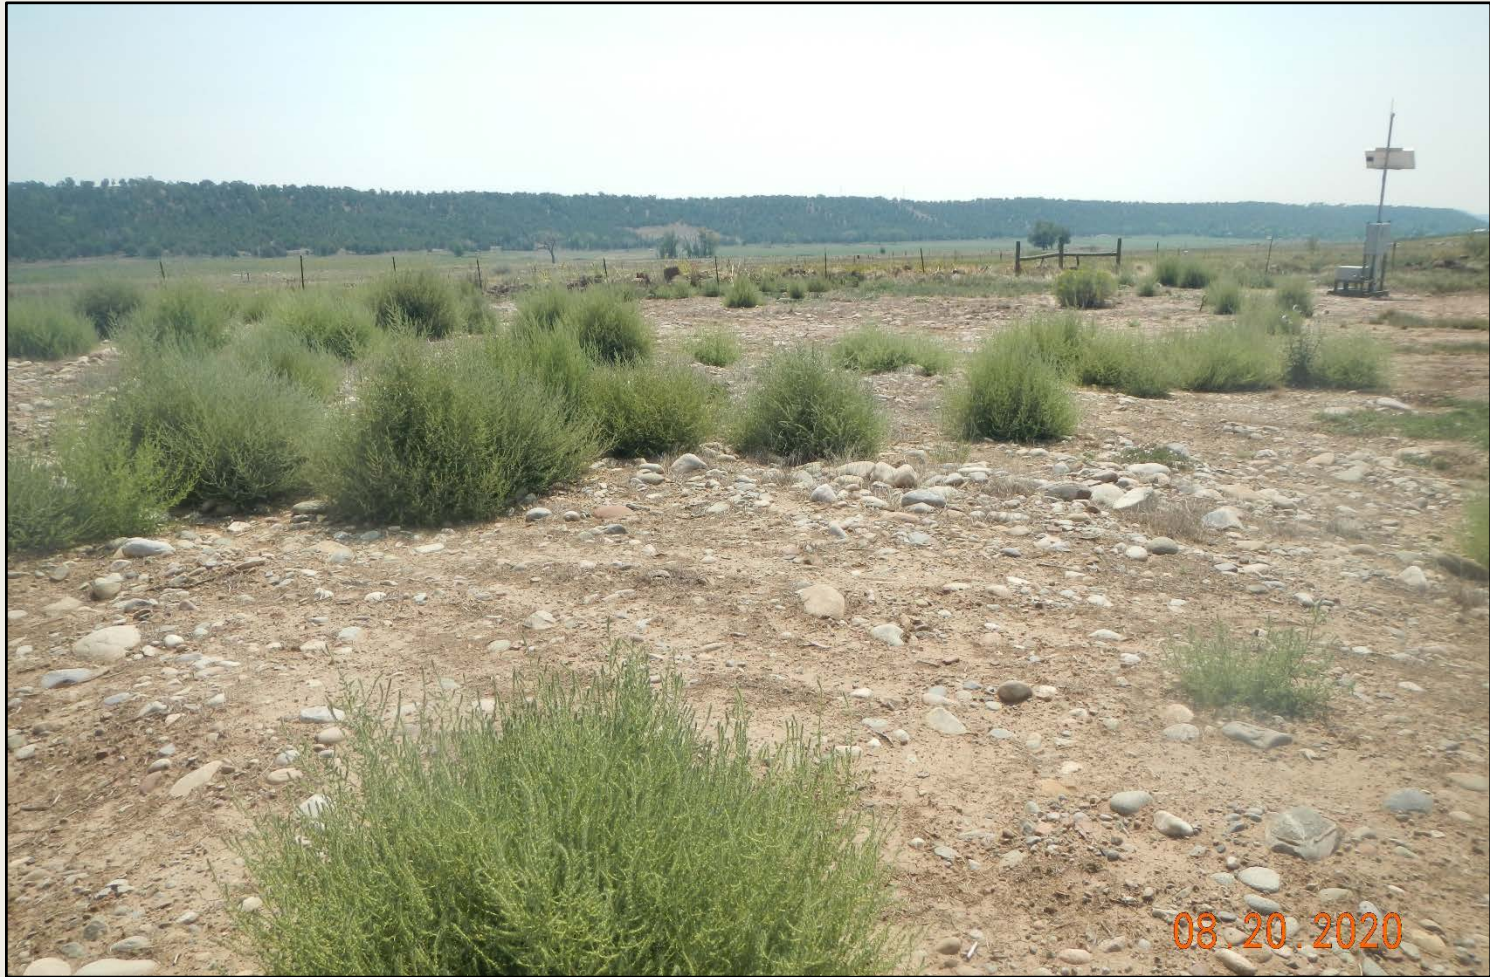
Photo 3. View of the eastern project area from the northeastern corner facing southward. Little to no desirable vegetation observed here.

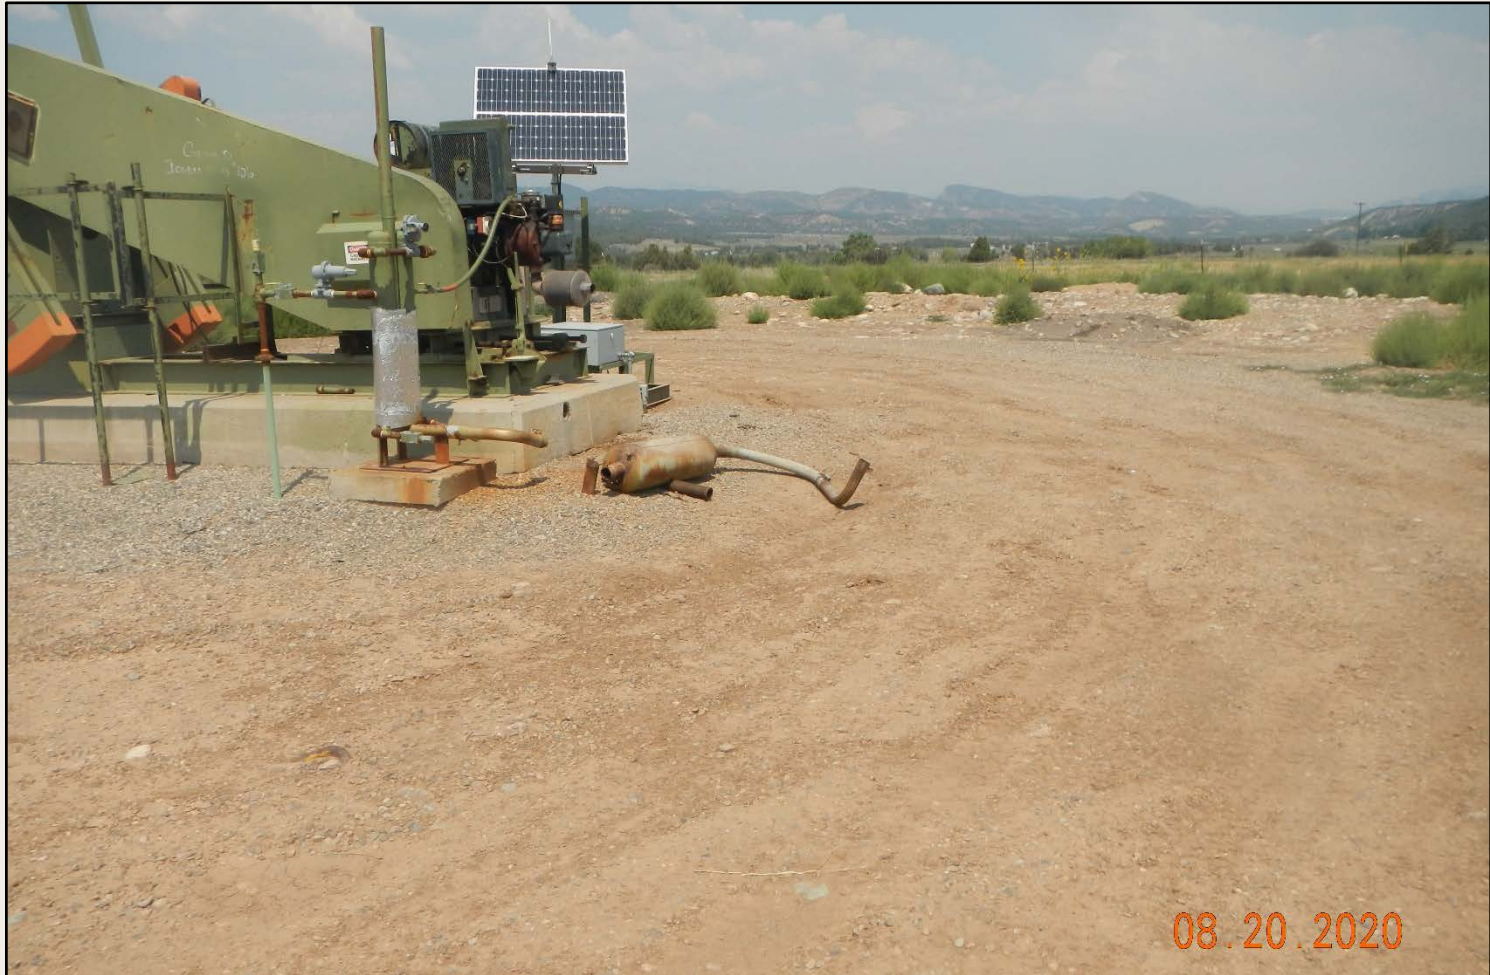
Photo 4. View of equipment that is not in service near the wellhead.

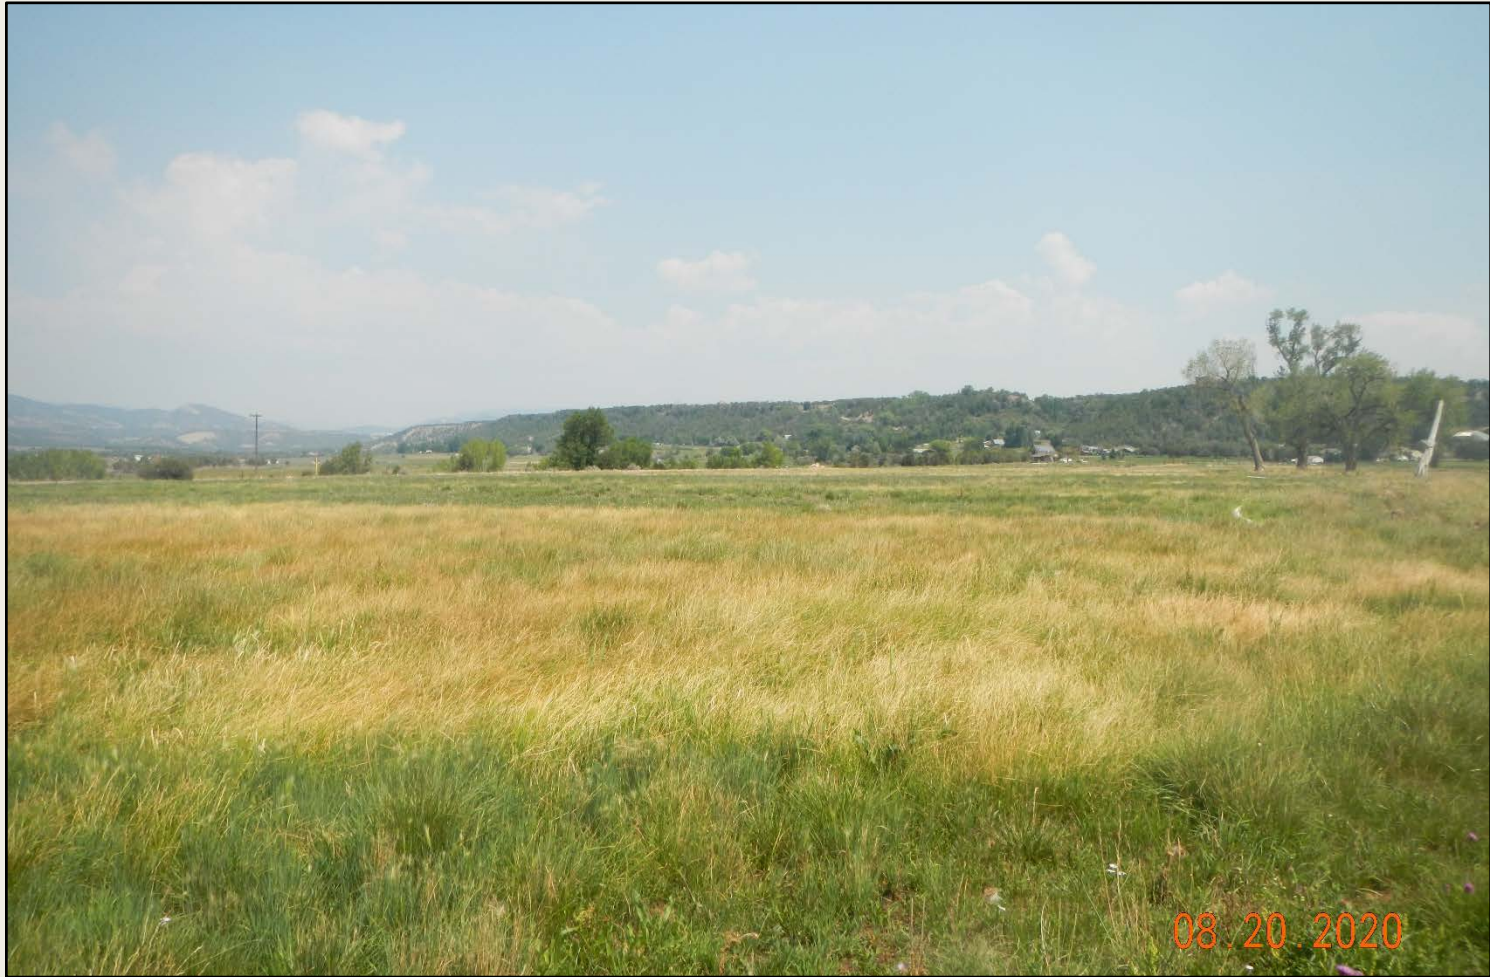
Photo 5. View of reference area comprised of irrigated grass field. Comprised of grasses such as smooth brome, foxtail barley, and wheatgrasses.
