Inspection Photos

Location Name: Aggregate State Fluid Recycling Facility Kerr-McGee (#47120)

CE&P Facility ID: 456644; Location ID: 434766

November 20, 2019

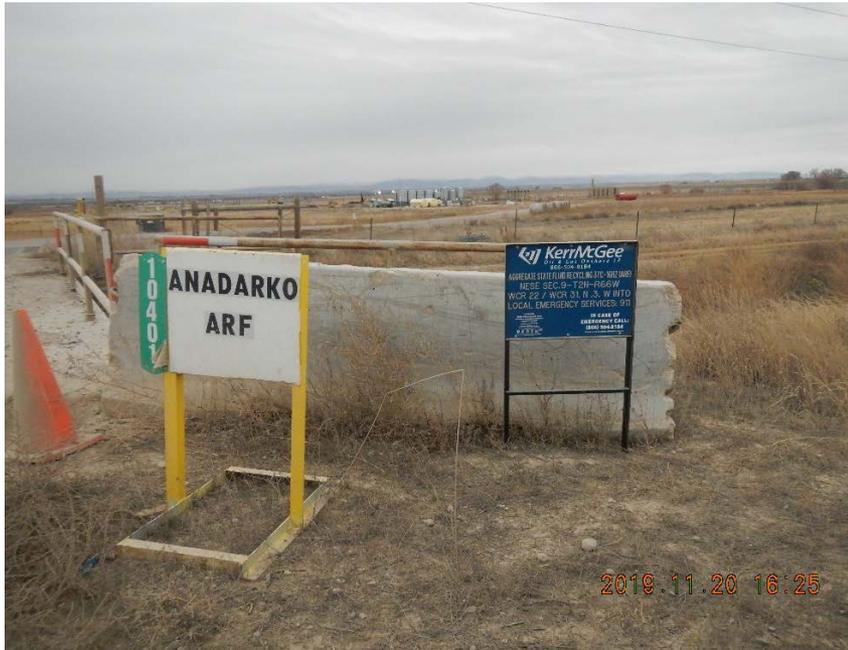
CE&P Facility ID: 456644, Entrance off of CR 31.

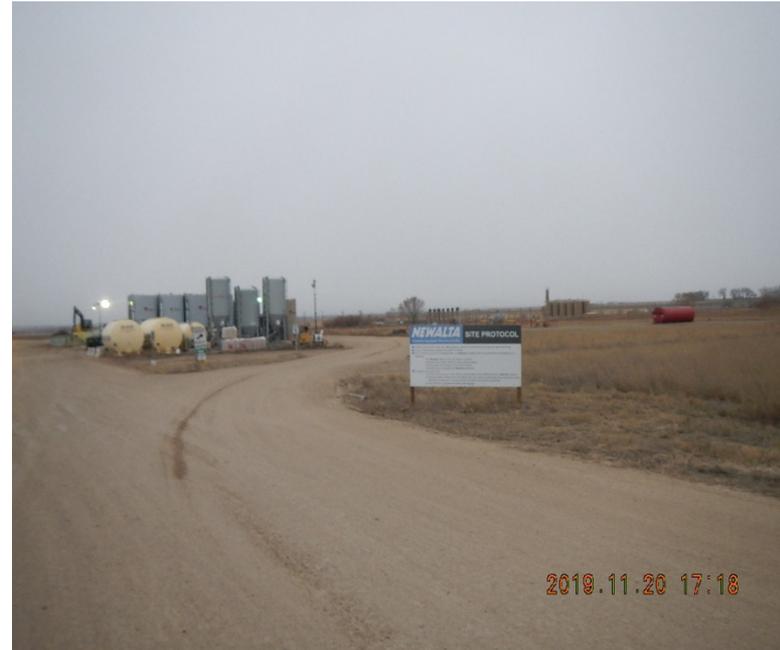
CE&P Facility ID: 456644 entrance.

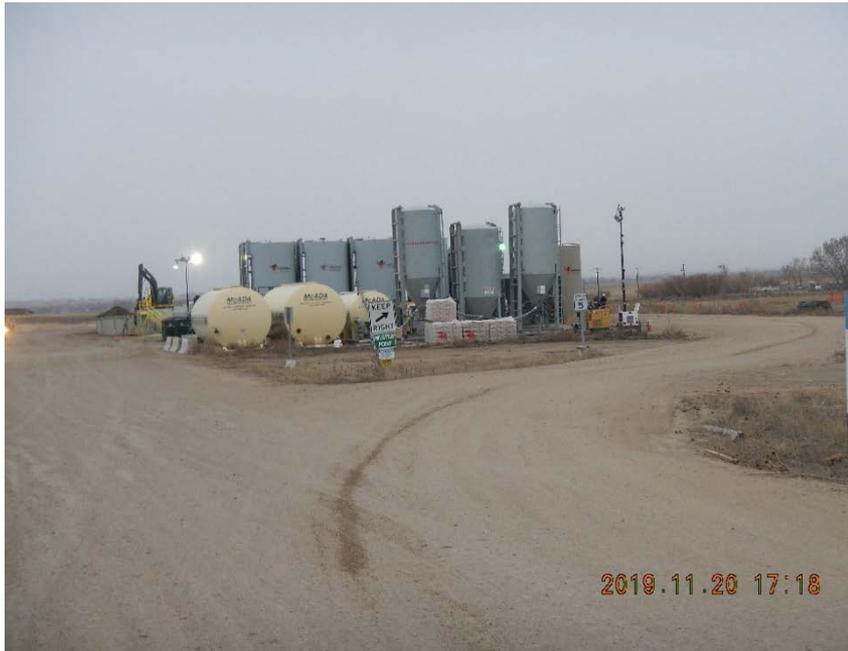
Entrance to CE&P Facility.

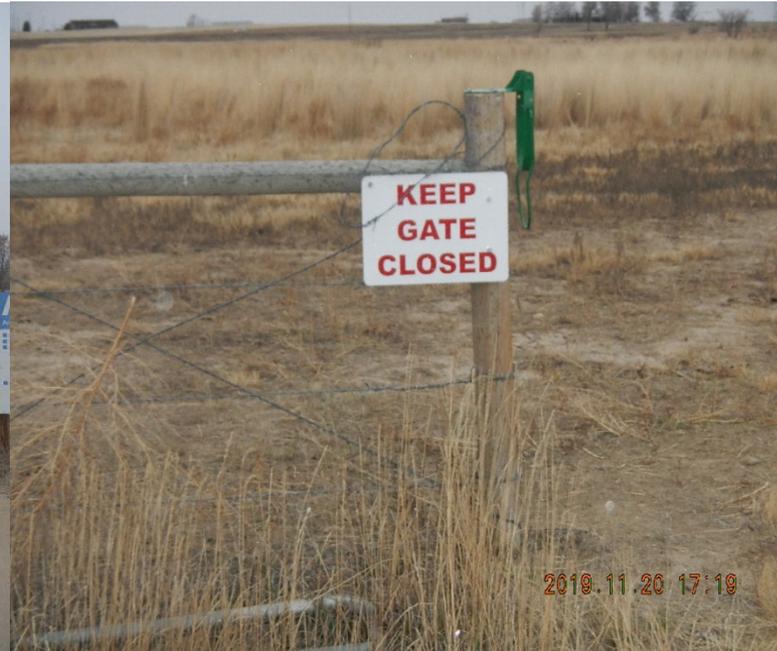
Open access.

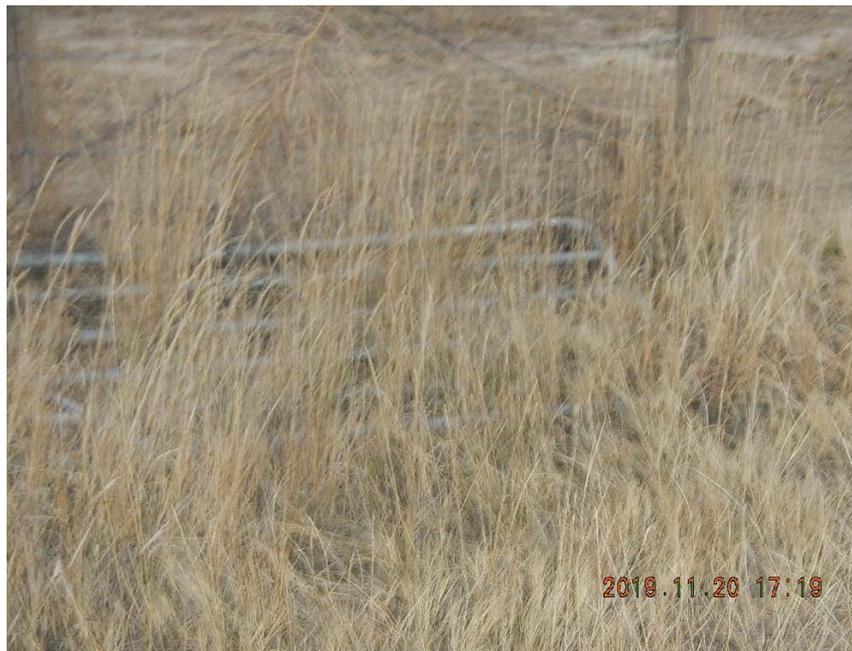
Gate lying on the ground.

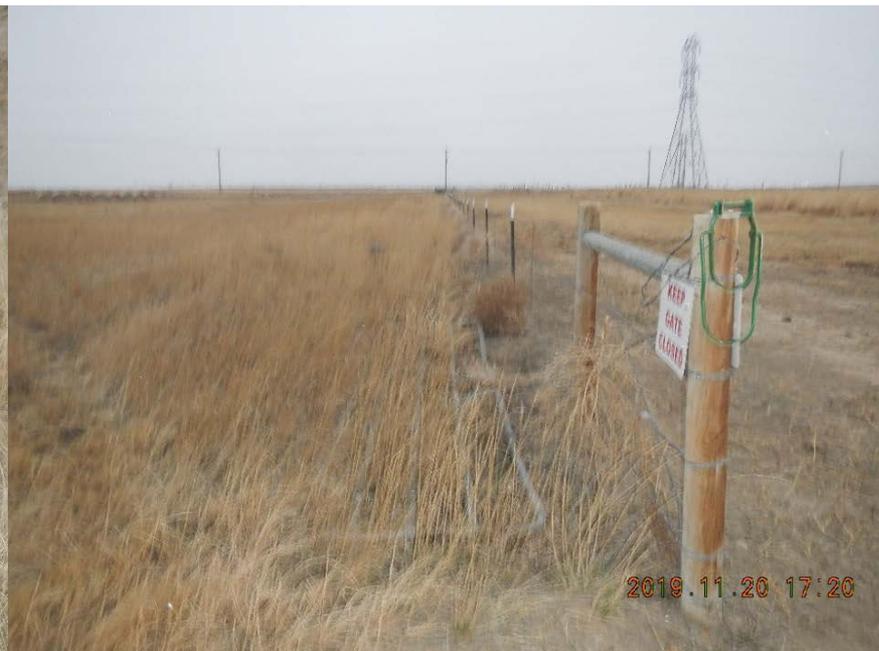
Open gate and southern perimeter fence.

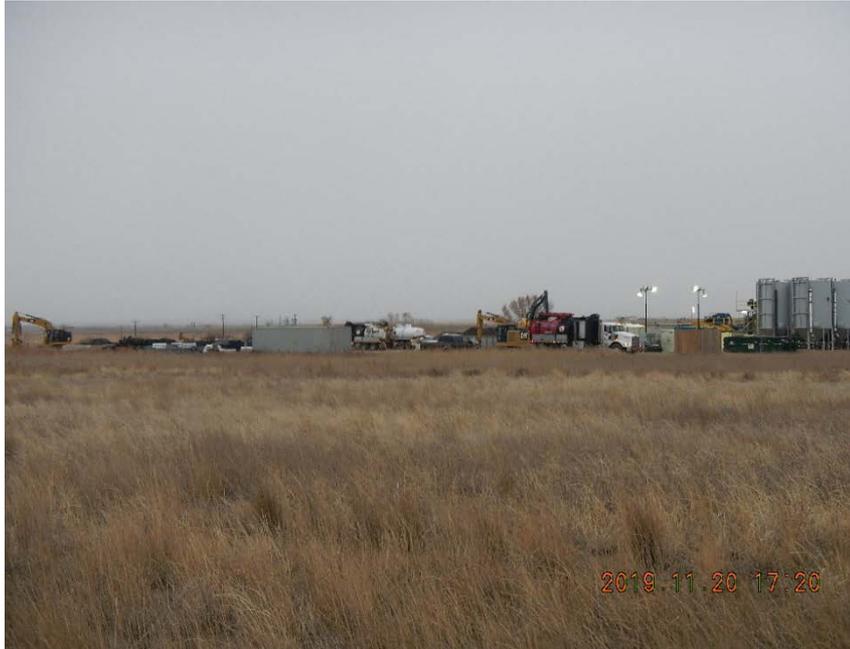
View of CE&P Facility from southern boundary looking north.

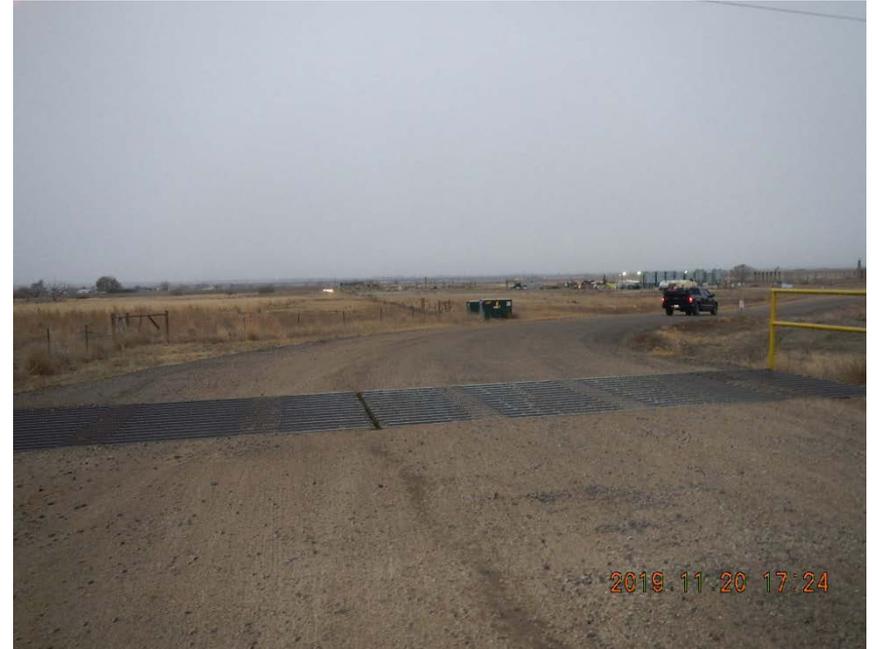
Entrance from CR 31.
