Inspection Photos
Operator: BP America
API: 067-09199
Date: 8/25/2020

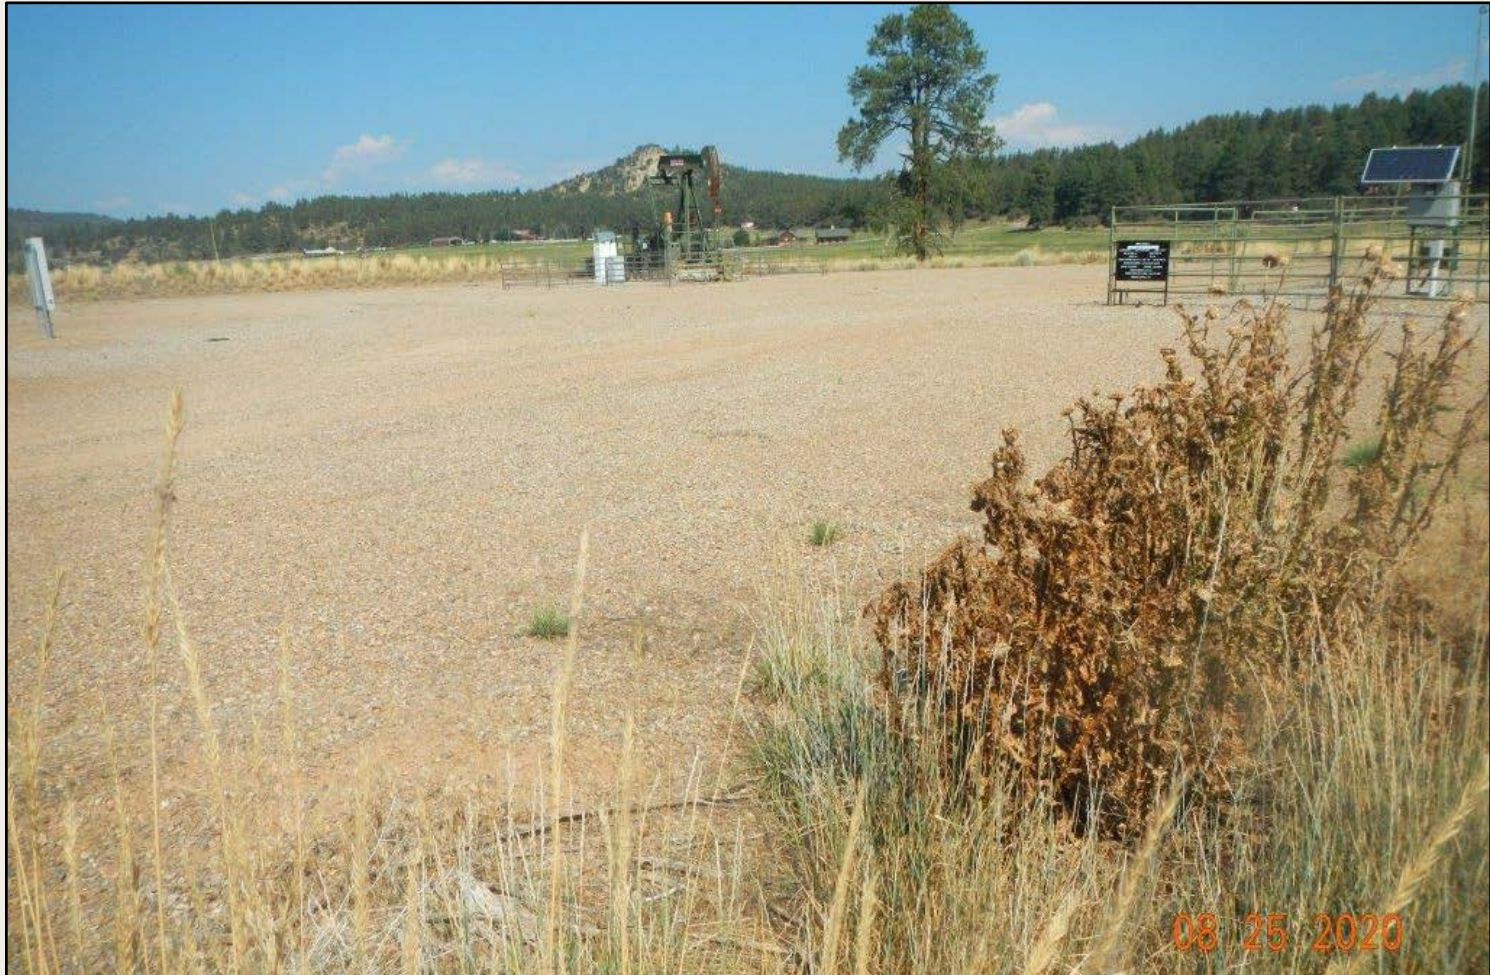
Photo 1. View of the project area from the southeastern corner facing center.

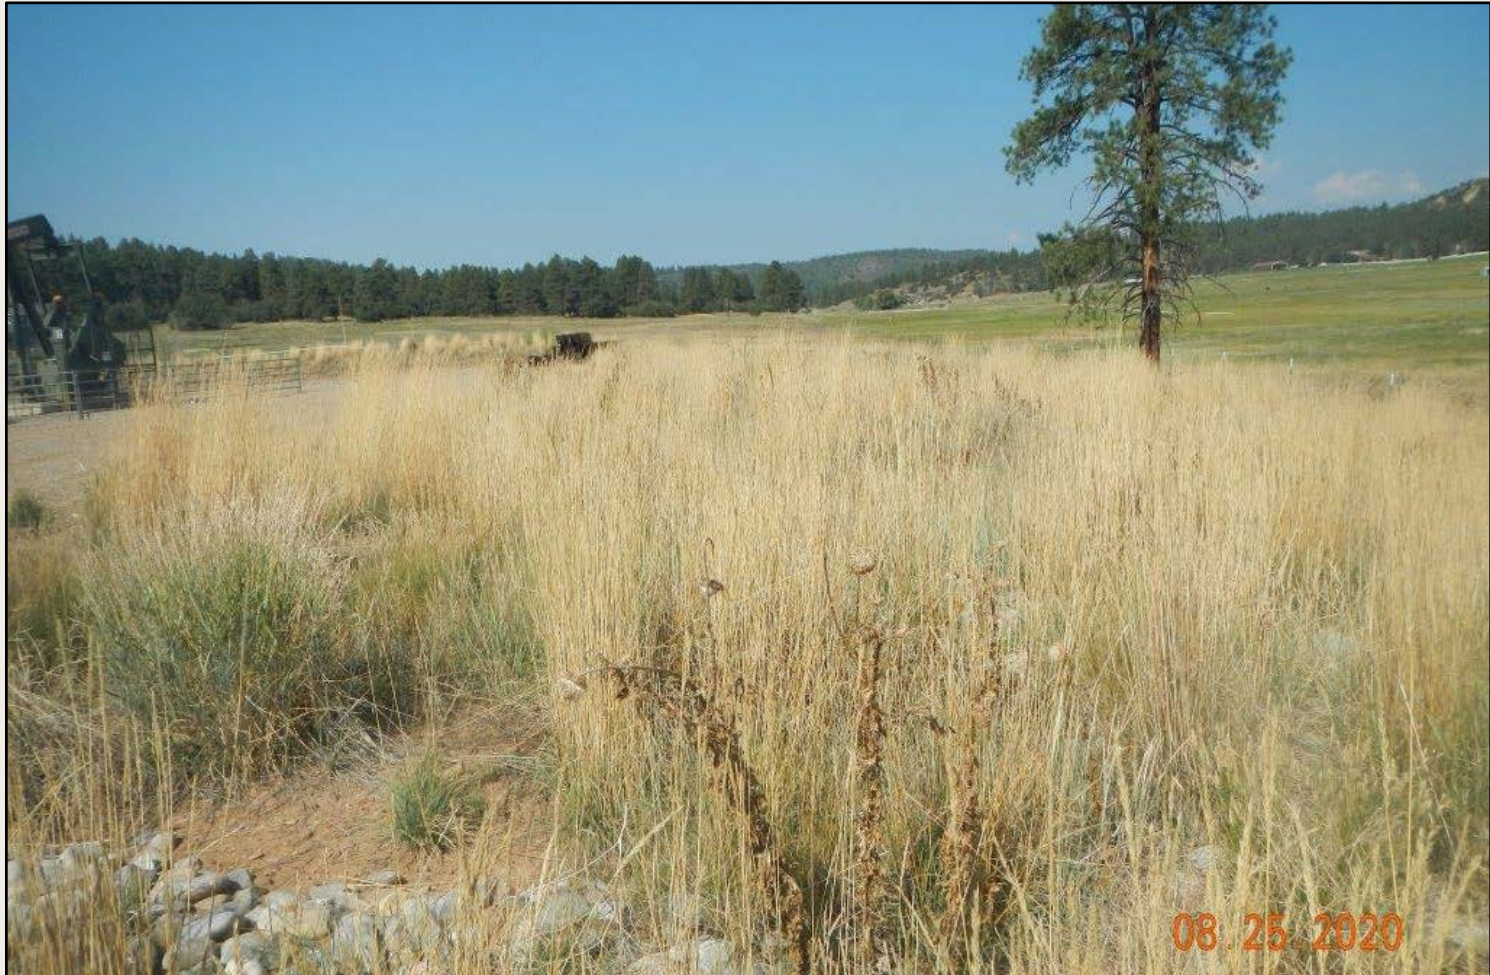
Photo 2. View of the northern project area from the northeastern corner facing westward. Revegetation is progressing with grasses such as western wheatgrass and intermediate wheatgrass. Approximately 300 musk thistles appear to be herbicide-treated within the project area.

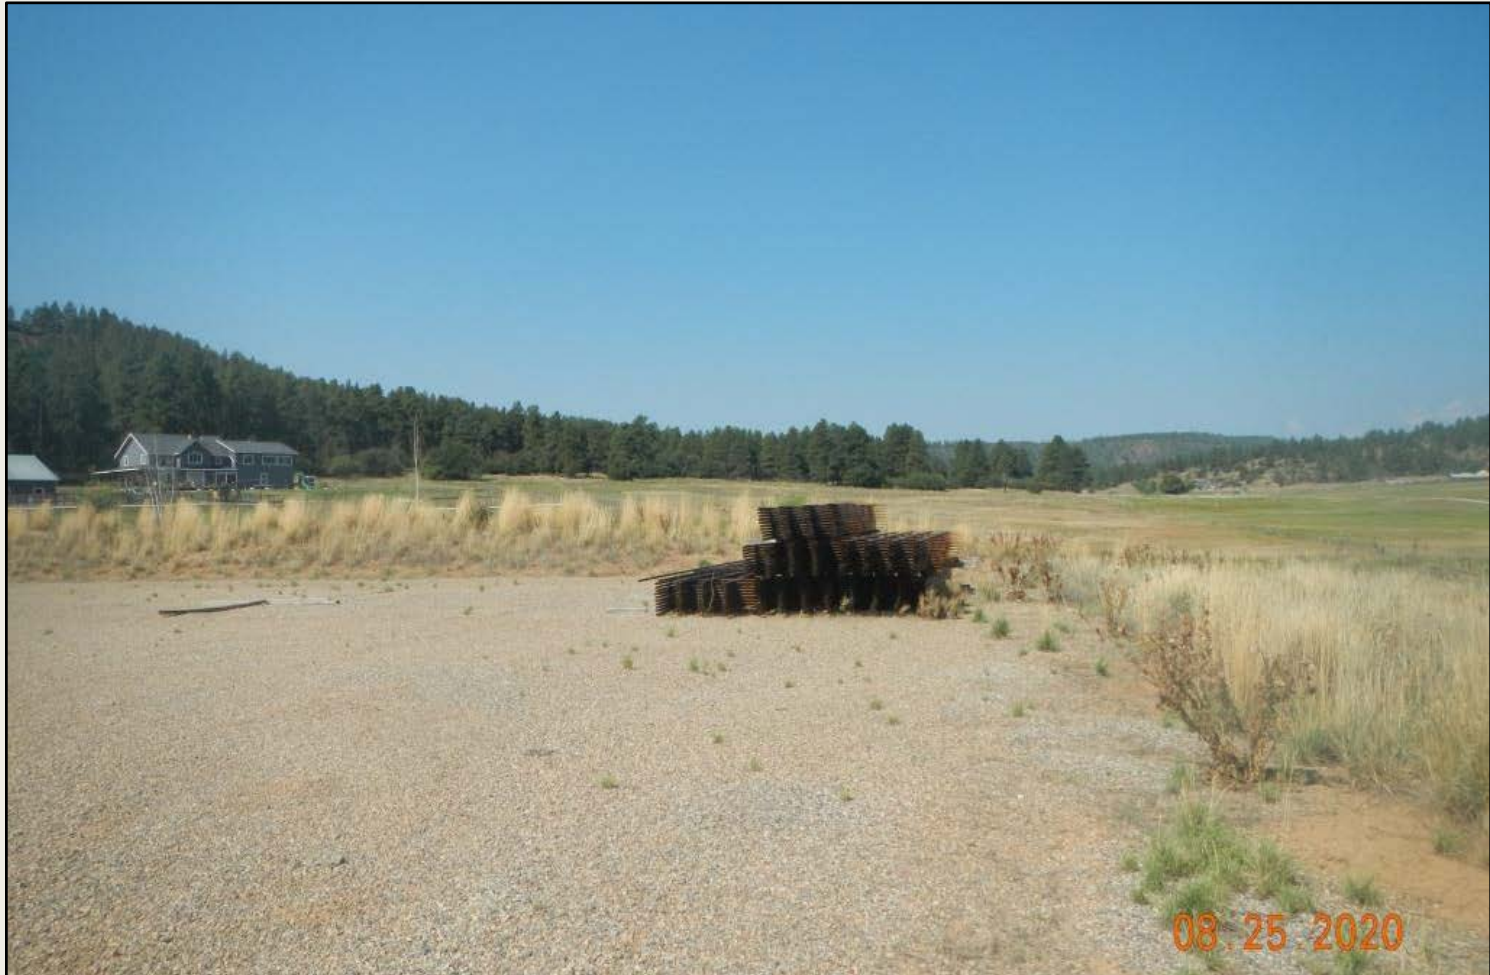
Photo 3. View of stockpiled materials stored within the northwestern corner of the well pad.

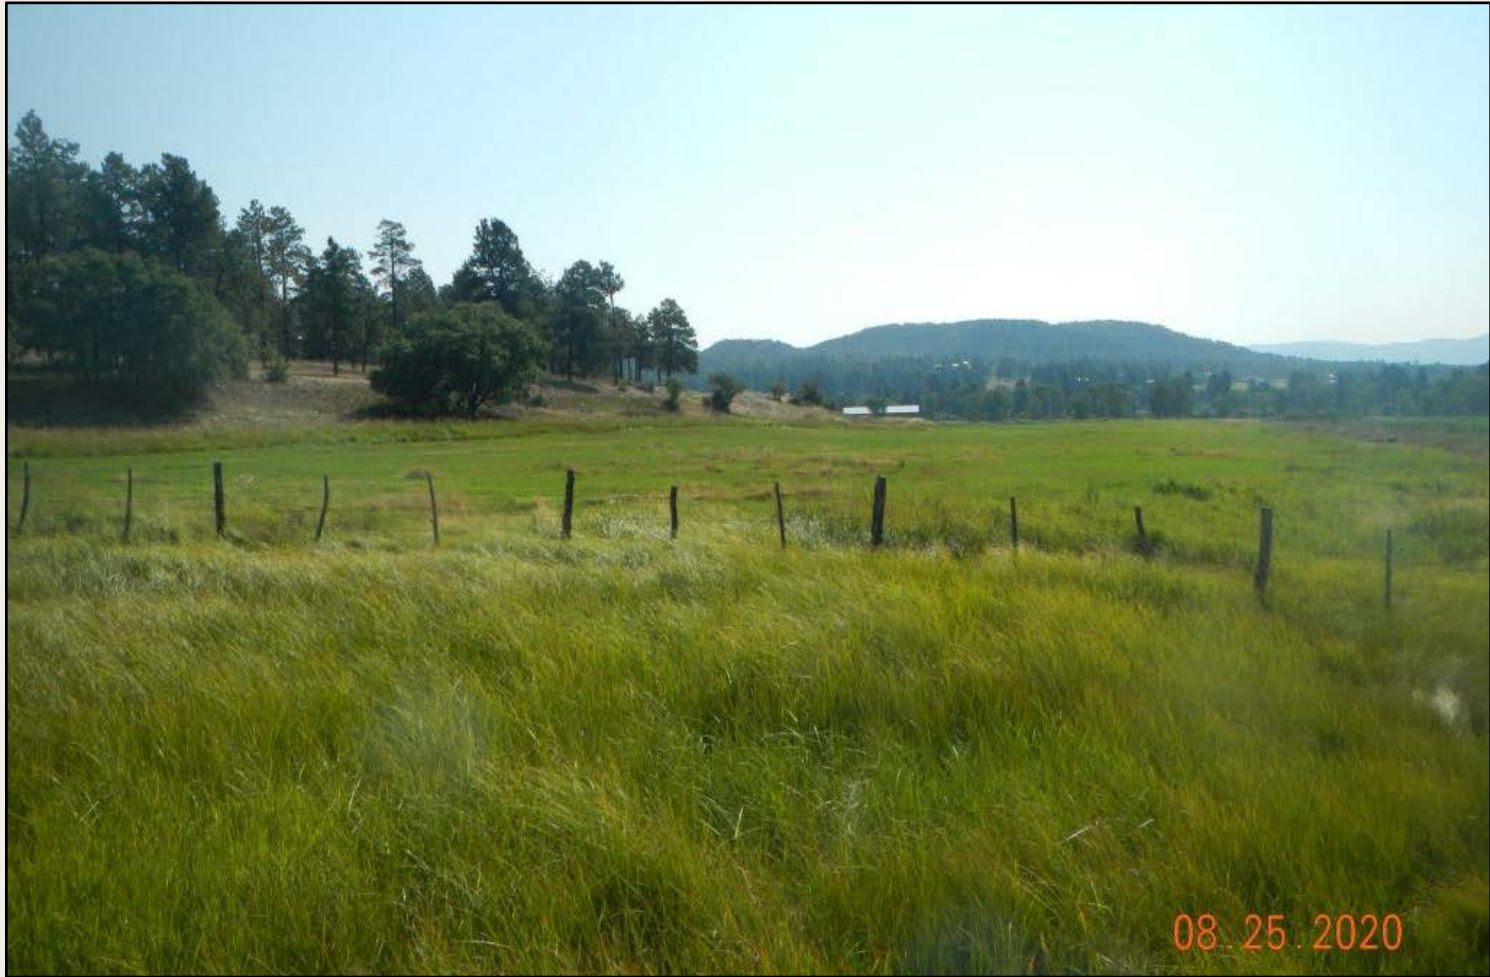
Photo 4. View of reference area comprised of irrigated field, with irrigated grasses, rushes, and sedges.
