Inspection Photos  
Operator: BP America  
API: 067-07203  
Date: 8/25/2020

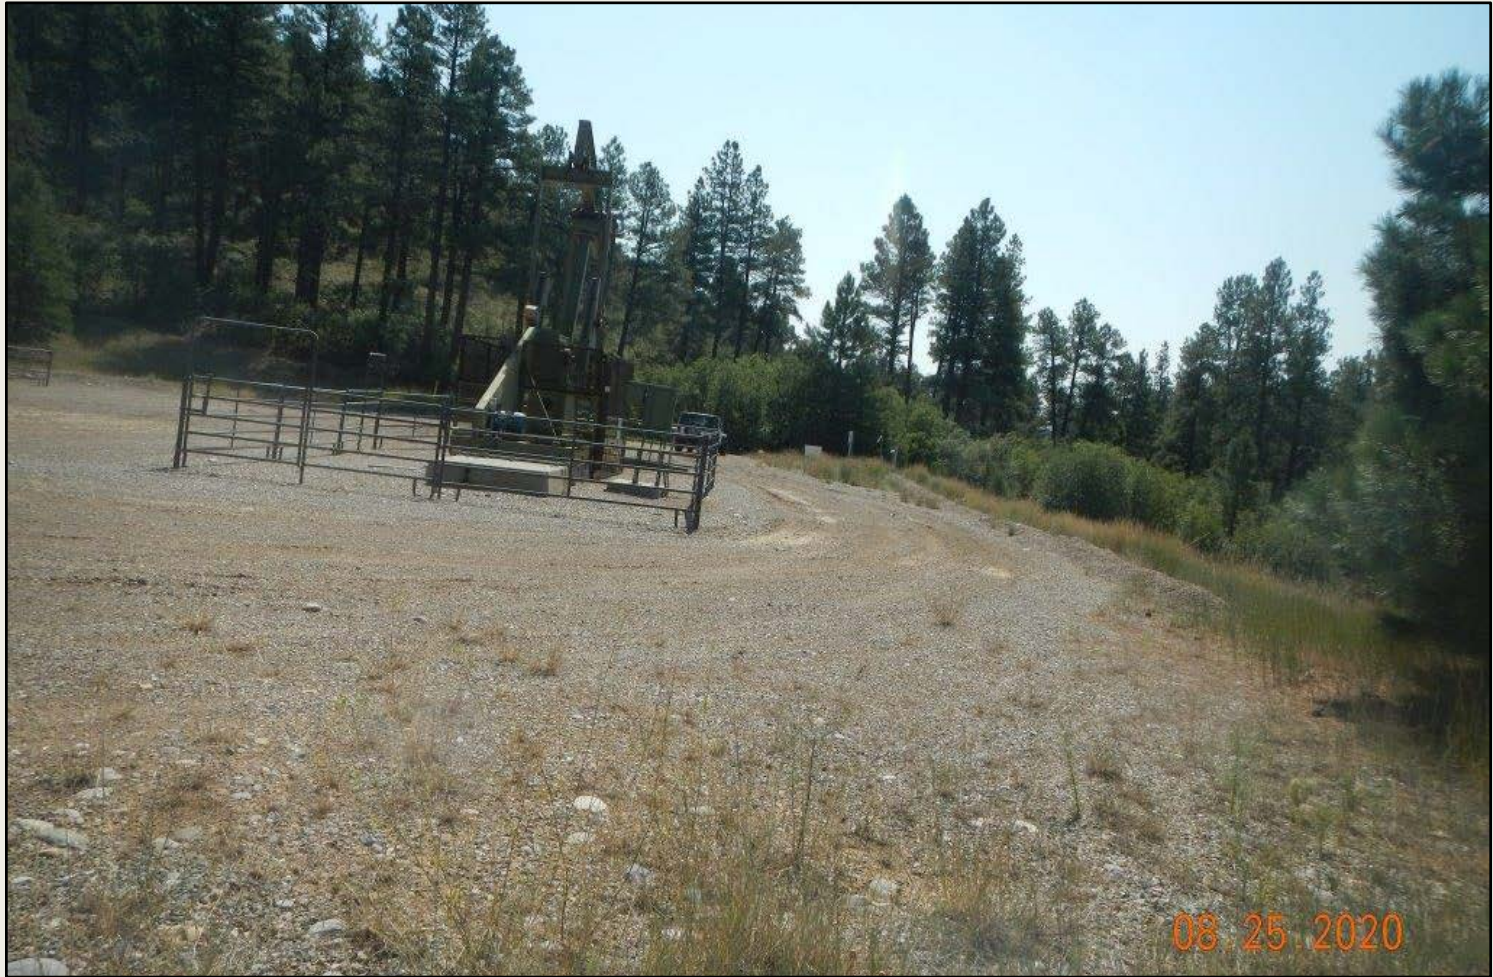
Photo 1. View of the project area from the southwestern corner facing center.

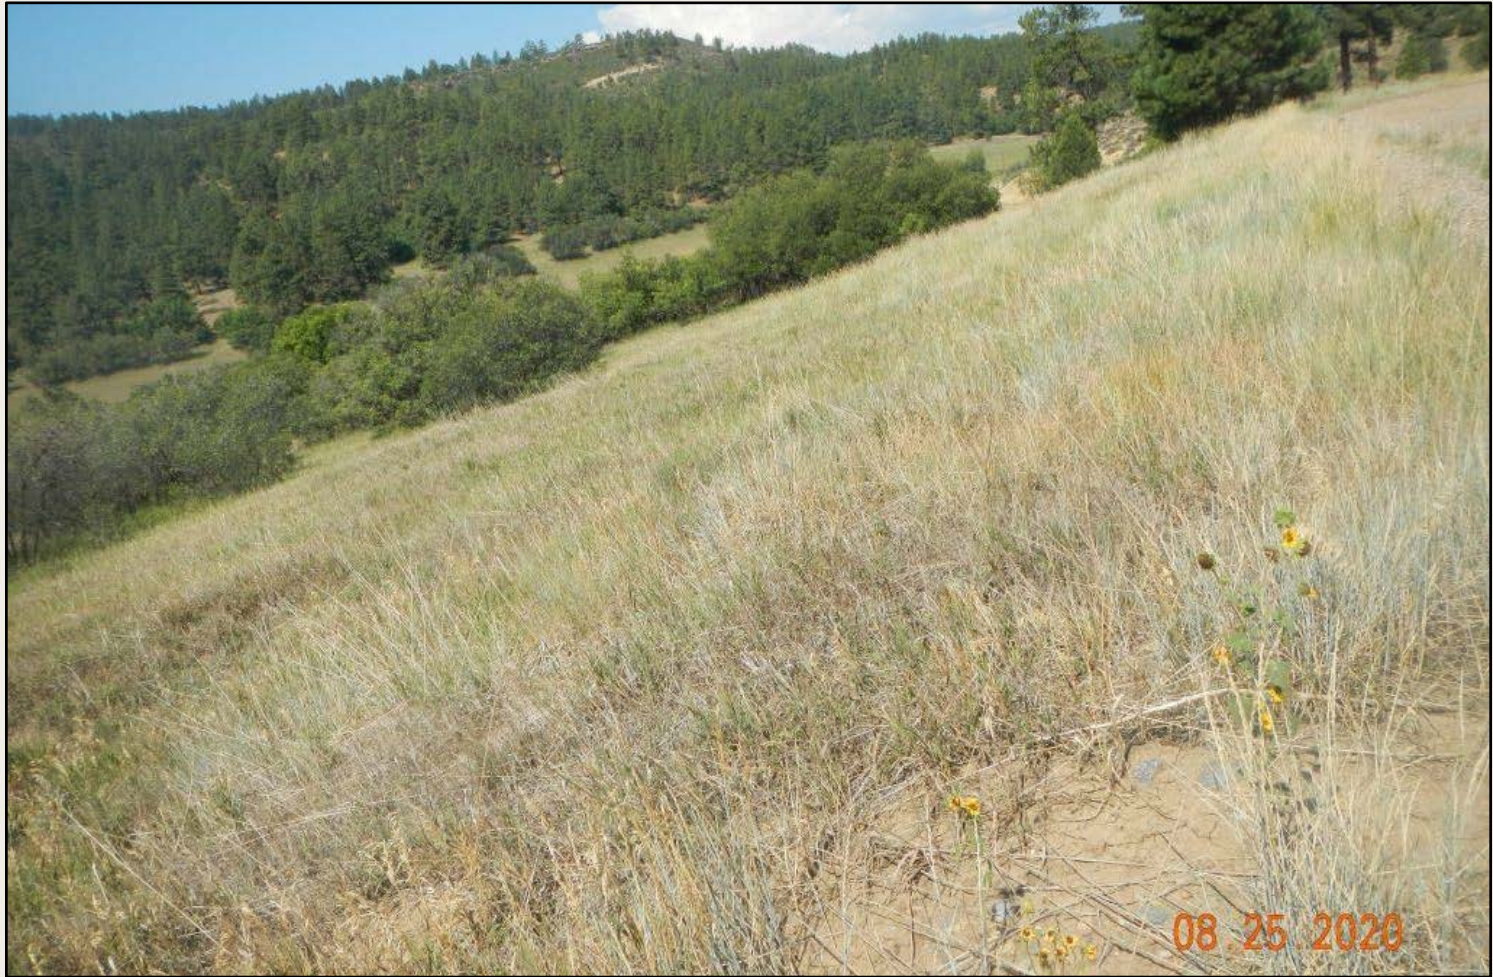
Photo 2. View of the southern fill slope facing westward. Revegetation is progressing with western wheatgrass and smooth brome.

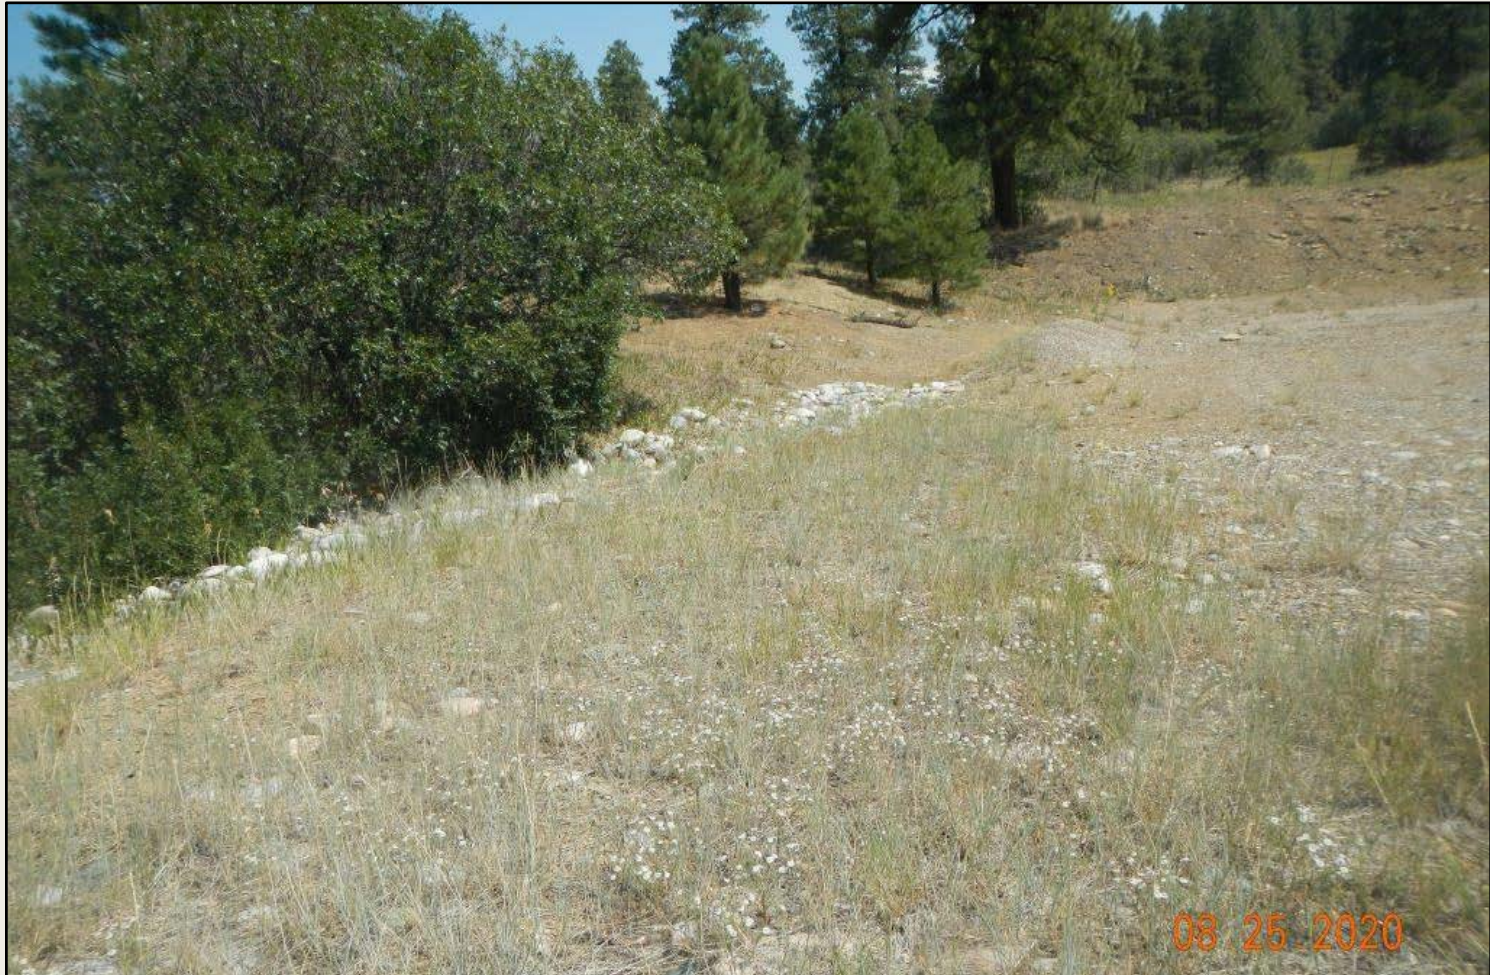
Photo 3. View of the western project area from the southwestern corner facing northward. Stormwater BMPs are installed.

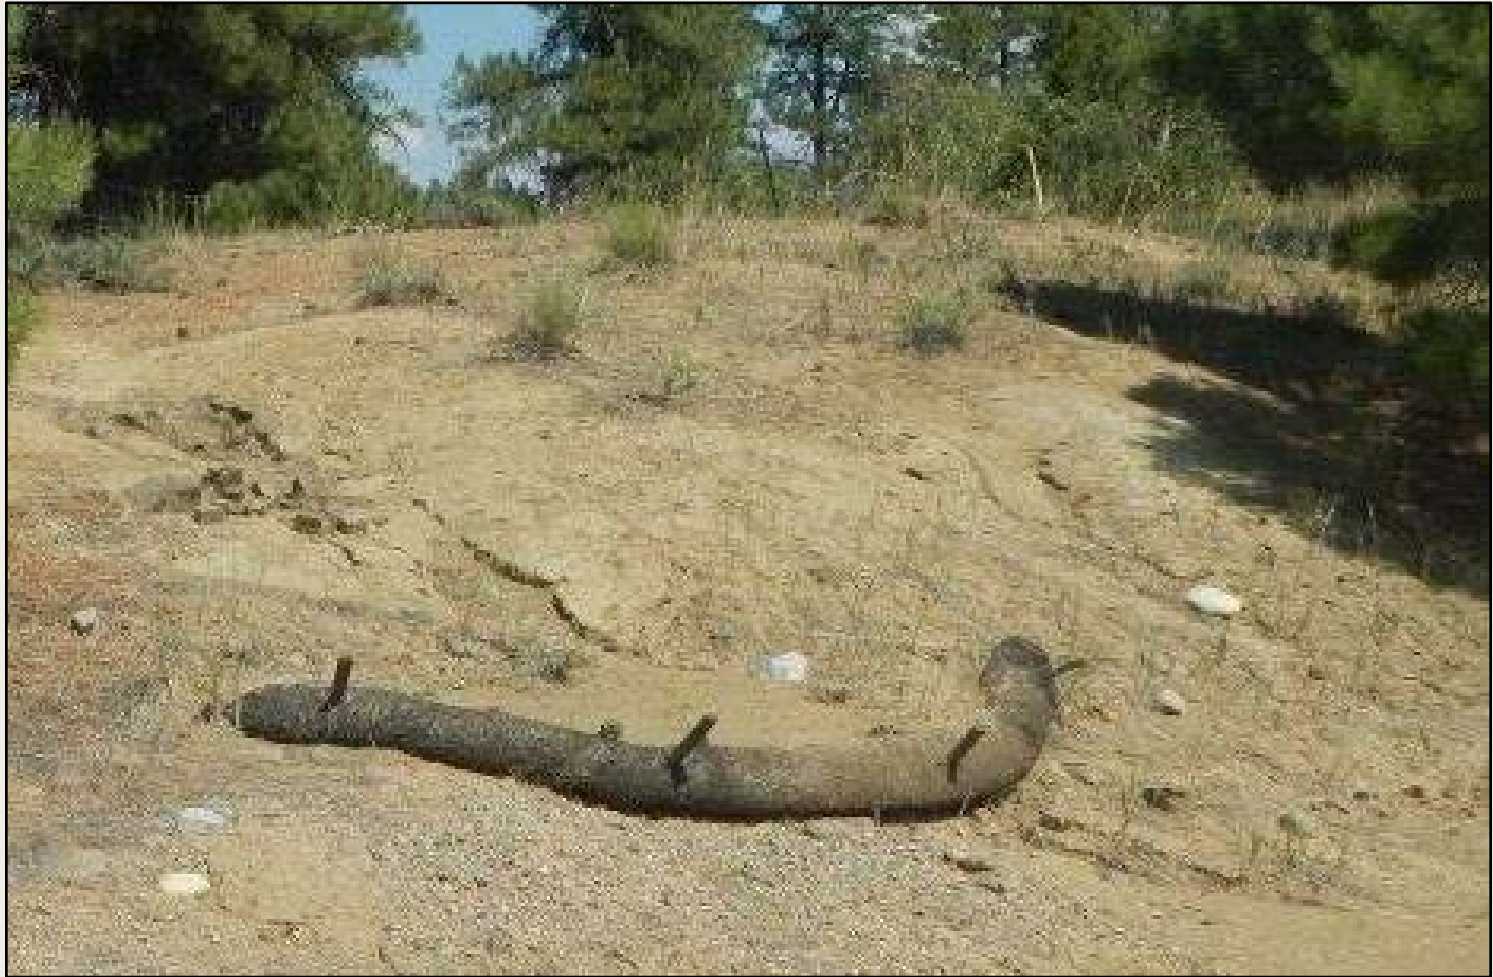
Photo 4. View of wattle on the northwestern cut-slope that is filled with sediment. Wattle does not appear to be an adequate BMP to stabilize this area.

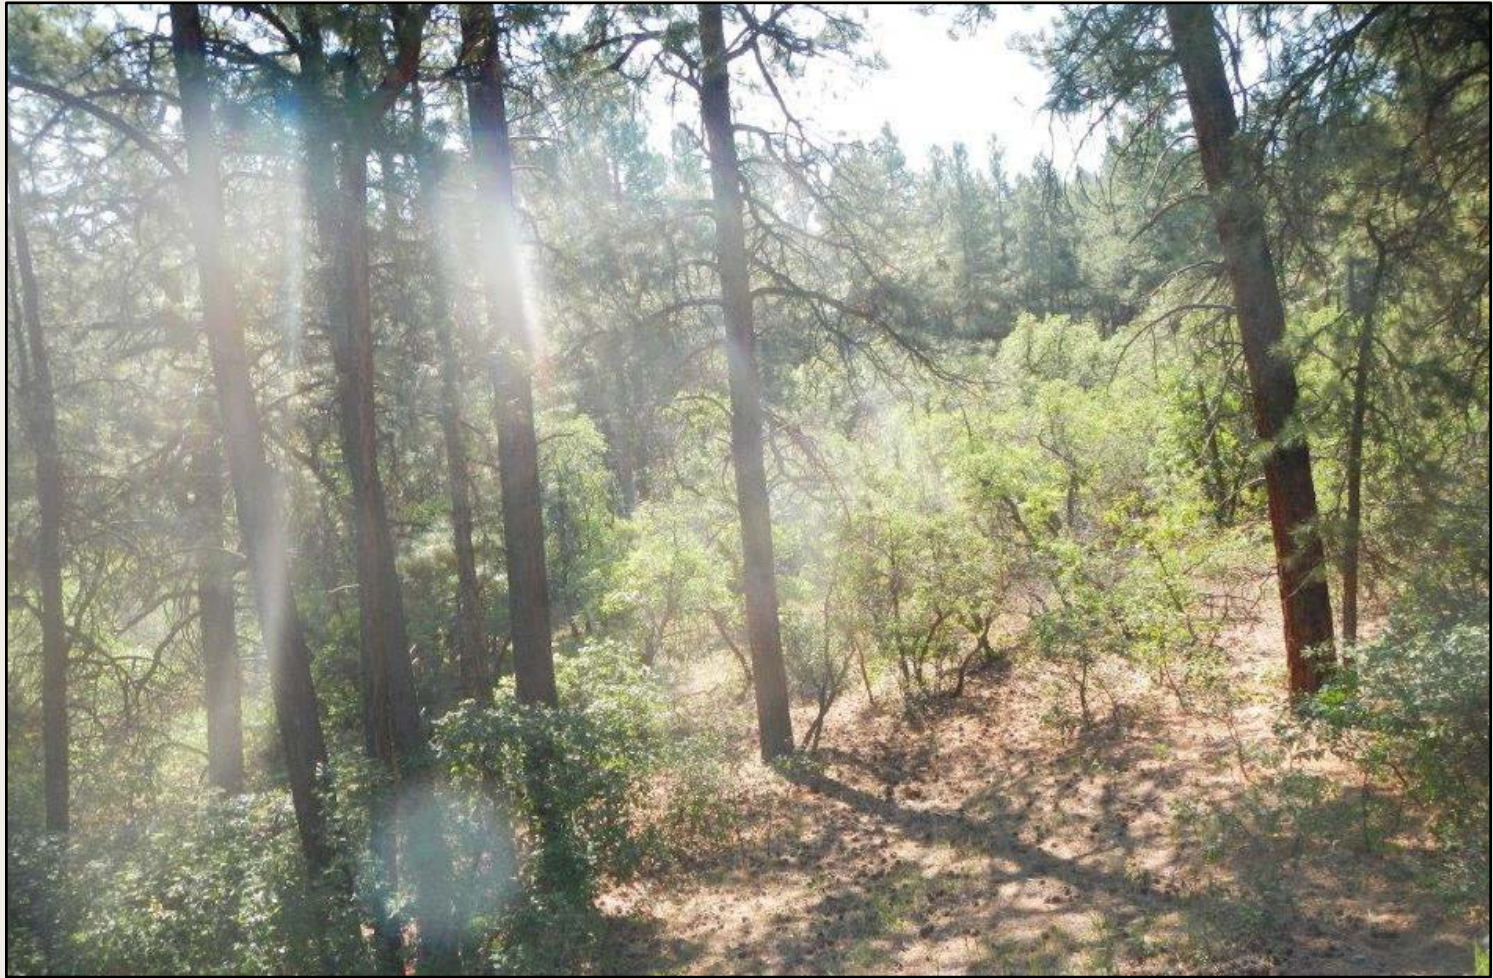
Photo 5. View of reference area comprised of ponderosa pine woodland with understory of gambel oak, Sandberg bluegrass, and forbs such as purple aster.
