Inspection Photos

API: 05-071-07956

Operator: PRESCO INC

Inspection Date: 8/25/2020

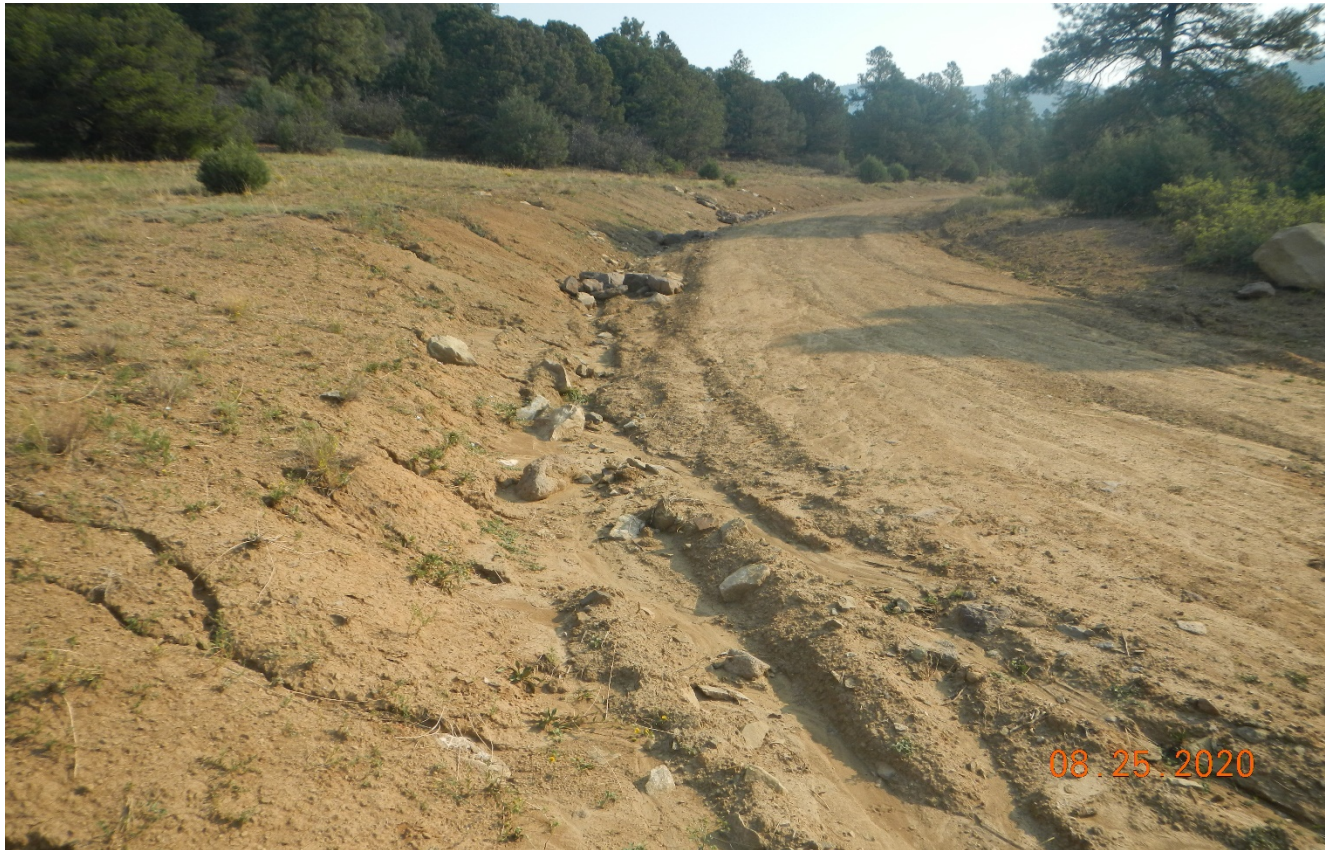
Photo 1. Facing northeast along the access road. The road has been regraded however, BMP's are not adequately installed and there are signs of erosion. The side slopes of the road will need to be seeded and stabilized.

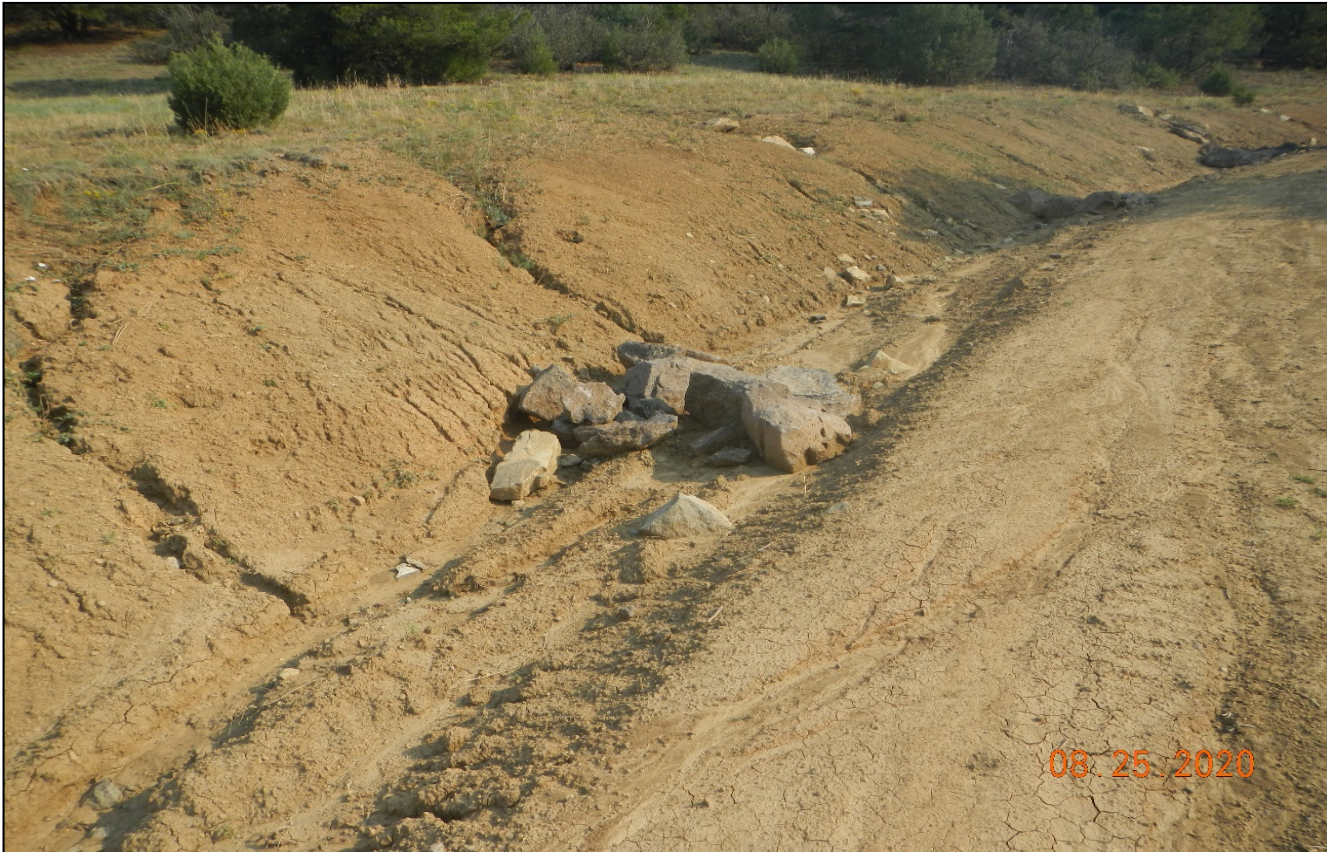
Photo 2. There are rocks piled up for a check dam however, this is not an adequate installation of a check dam. There is erosion along the side slopes of the road which needs to be seeded and stabilized.

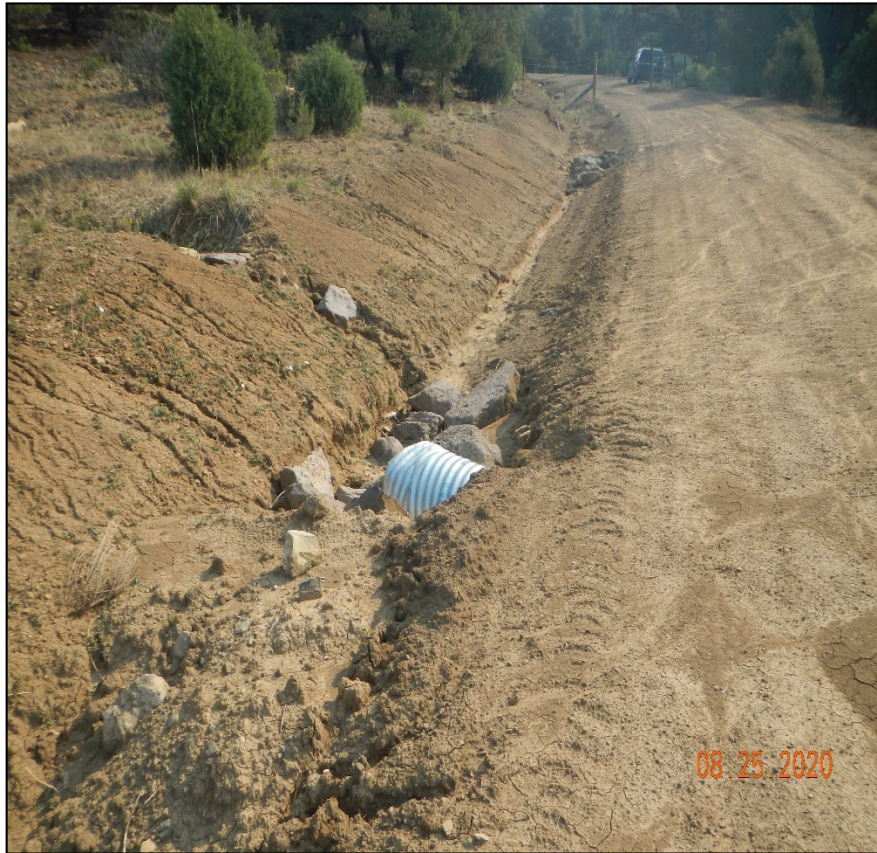
Photo 3. Additional culverts were installed along the road but rock rip/rap is piled in front of the culverts which could block up culvert inlets.

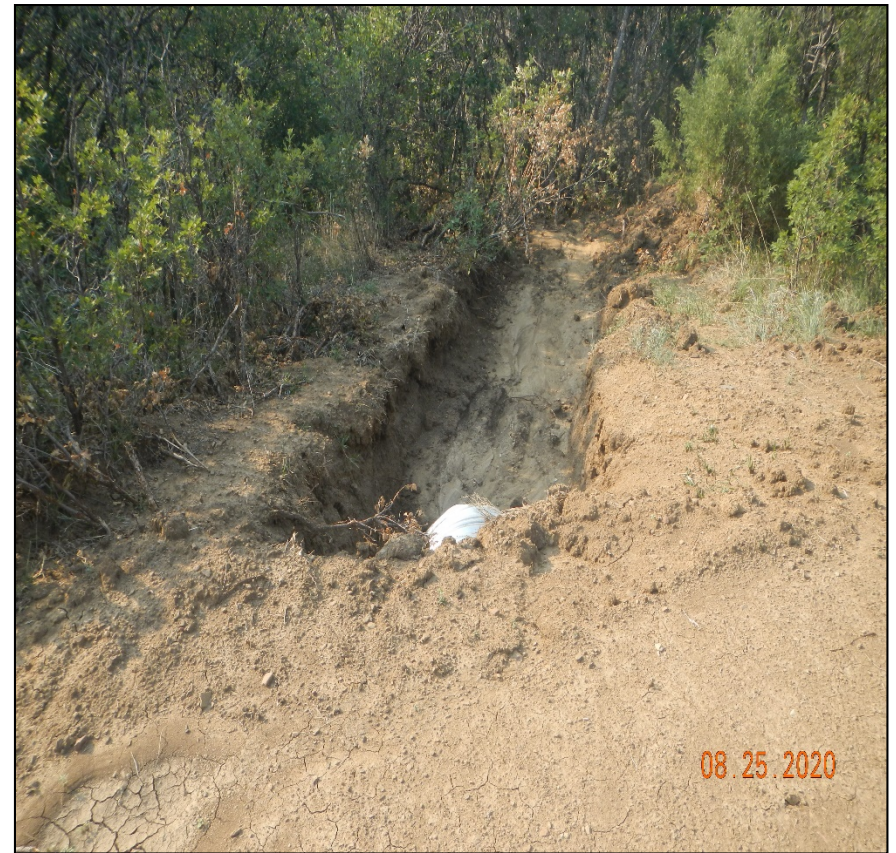
Photo 4. There is no outlet protection installed at the culverts which could cause erosion.

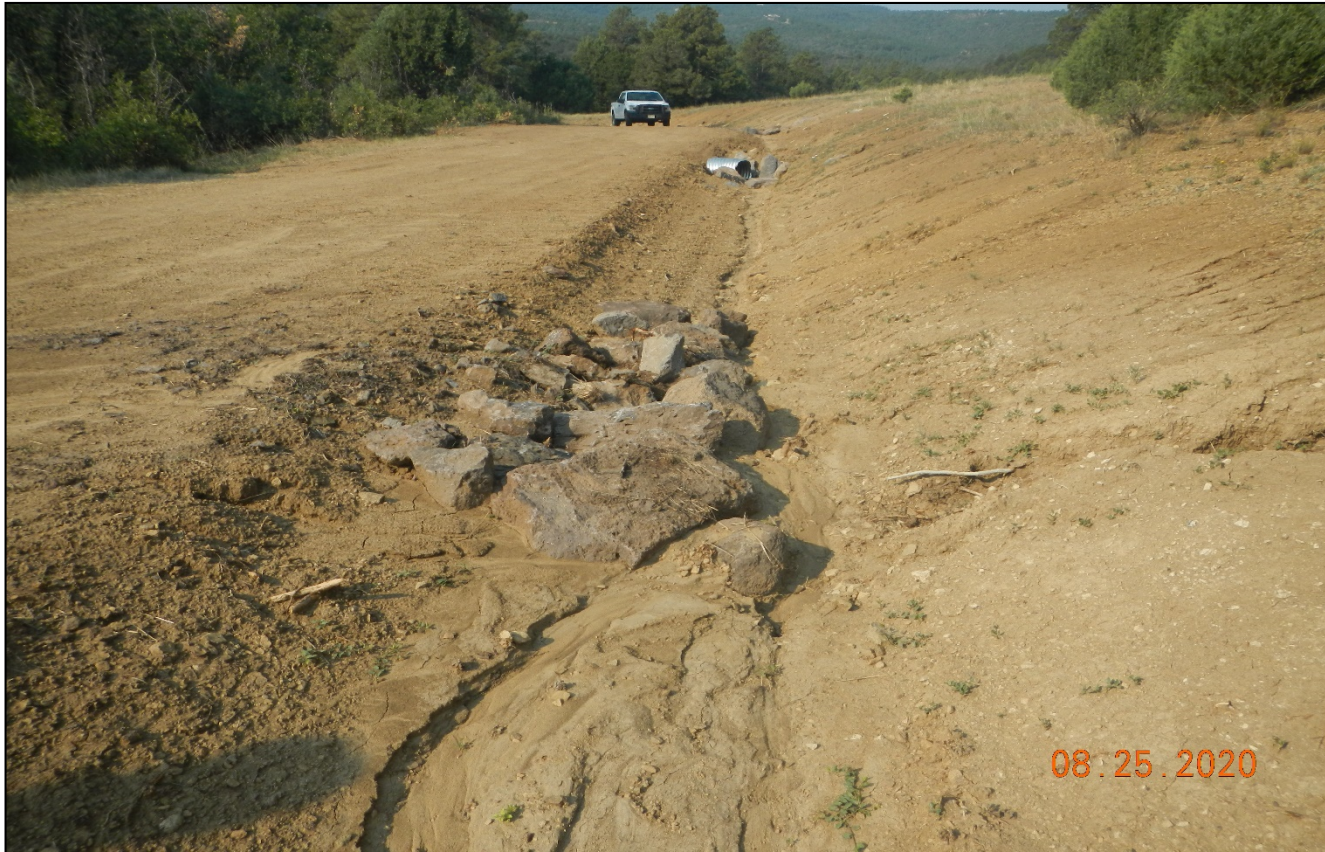
Photo 5. The rock check dam is not properly installed and there is signs that stormwater is flowing around the rip/rap. The check dams need to extend from side to side with the low point at the center of the check dam.

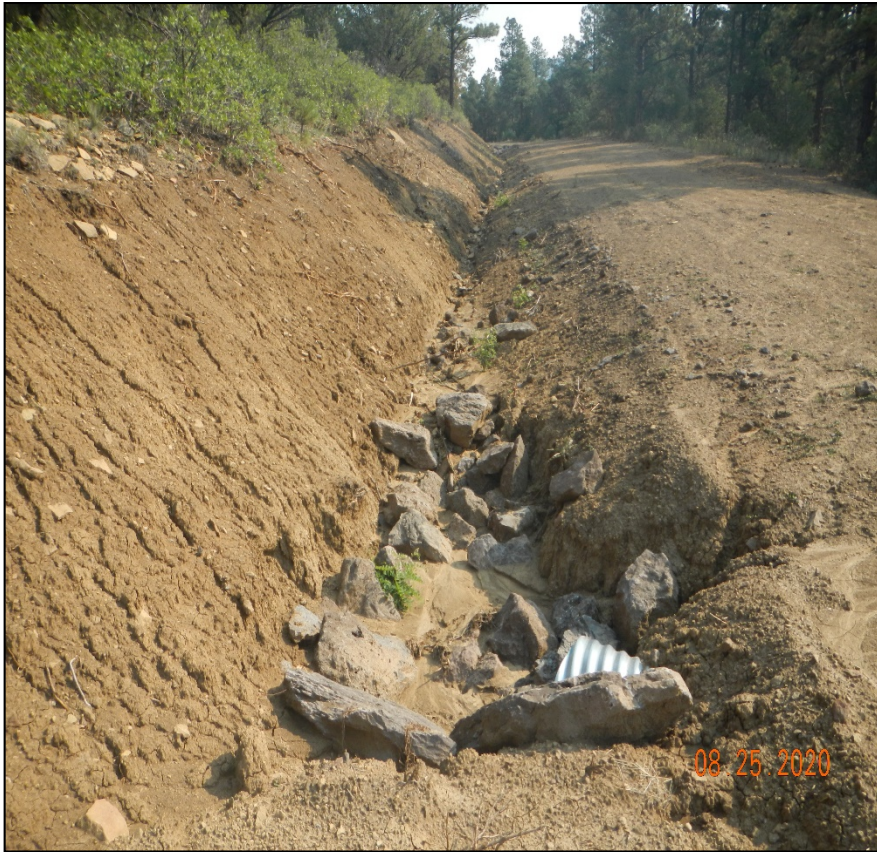
Photo 6. Additional culverts were installed along the road but rock rip/rap is piled in front of the culverts which could block up culvert inlets.

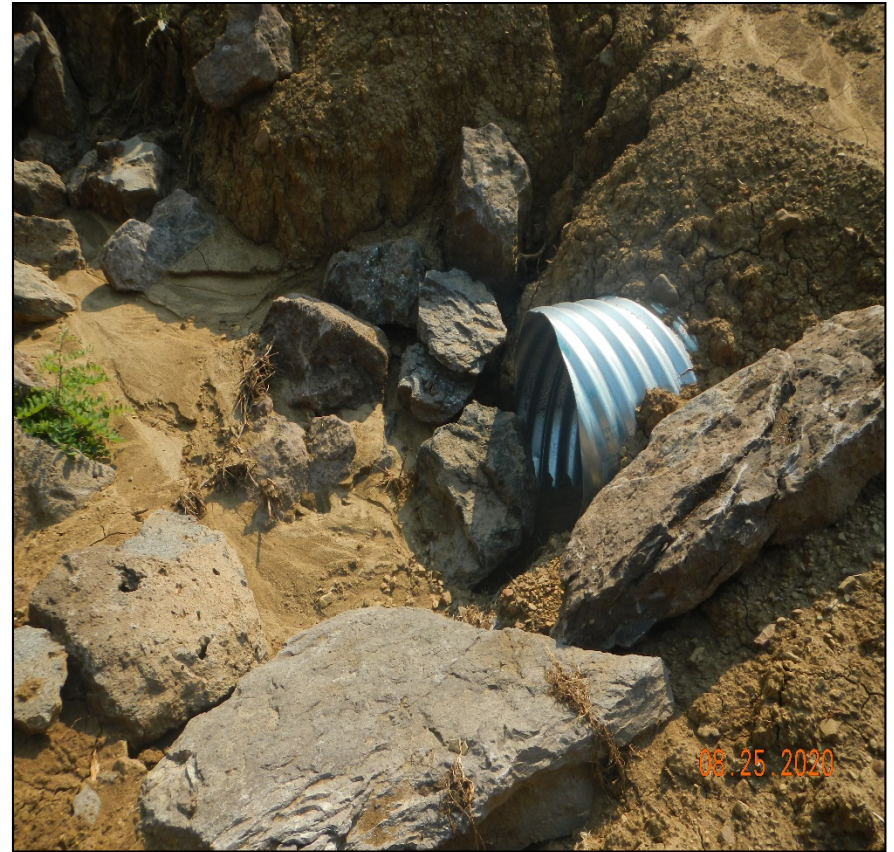
Photo 7. This photo shows the rock obstructing the culvert inlet.

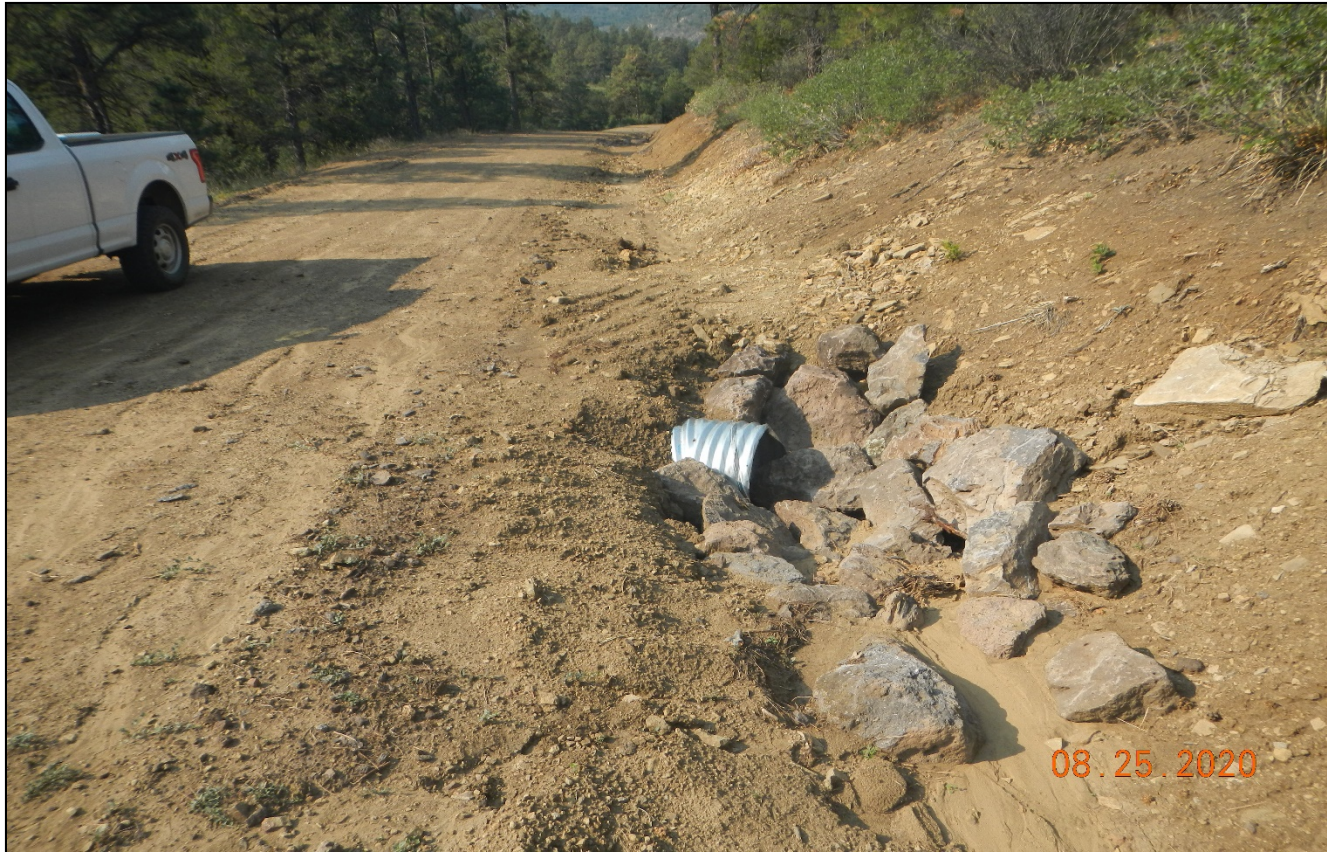
Photo 8. This is a view of another culvert further along the road which the rock is obstructing the culvert inlet.

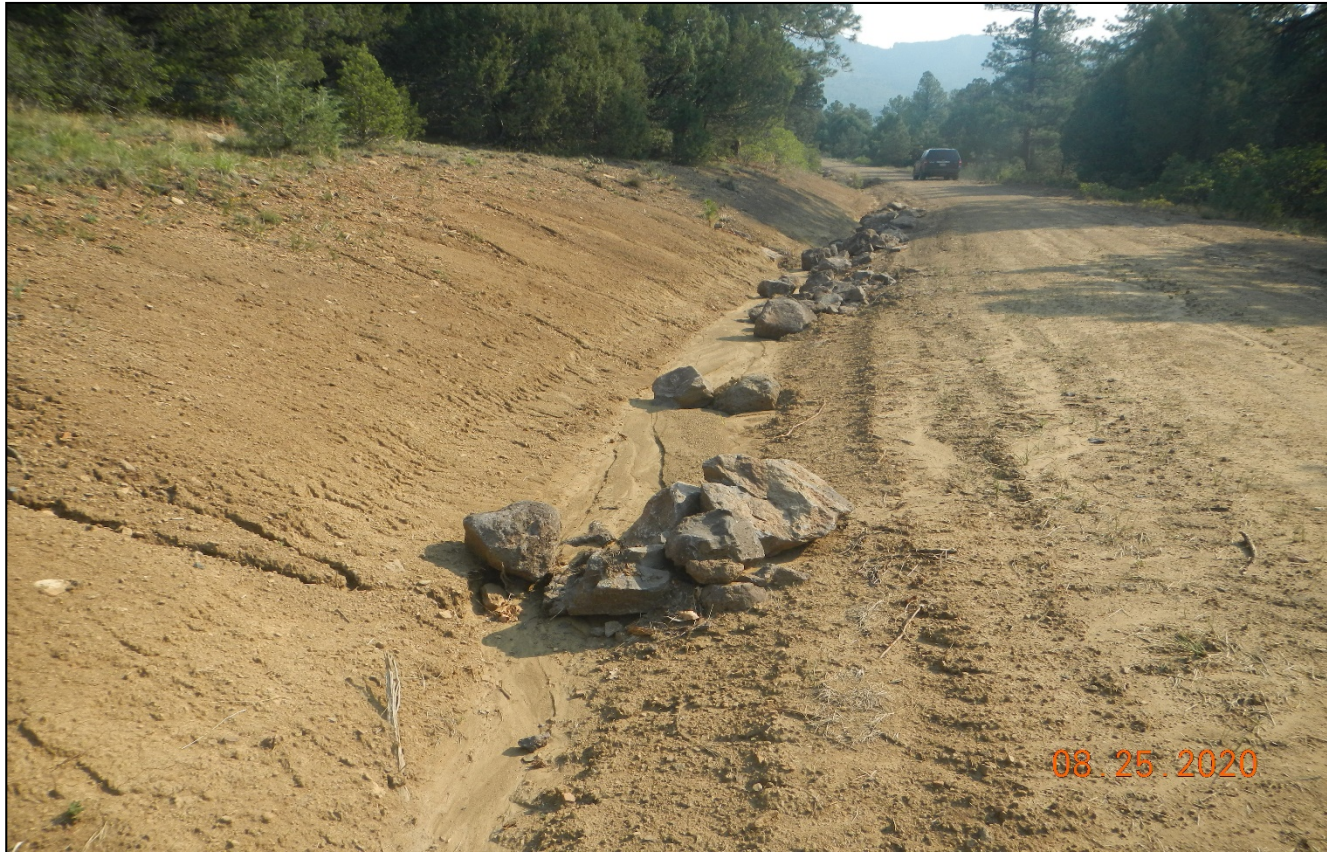
Photo 9. The rock was scattered along the side of the road and not properly installed. The side of the road will need to be seeded and stabilized.

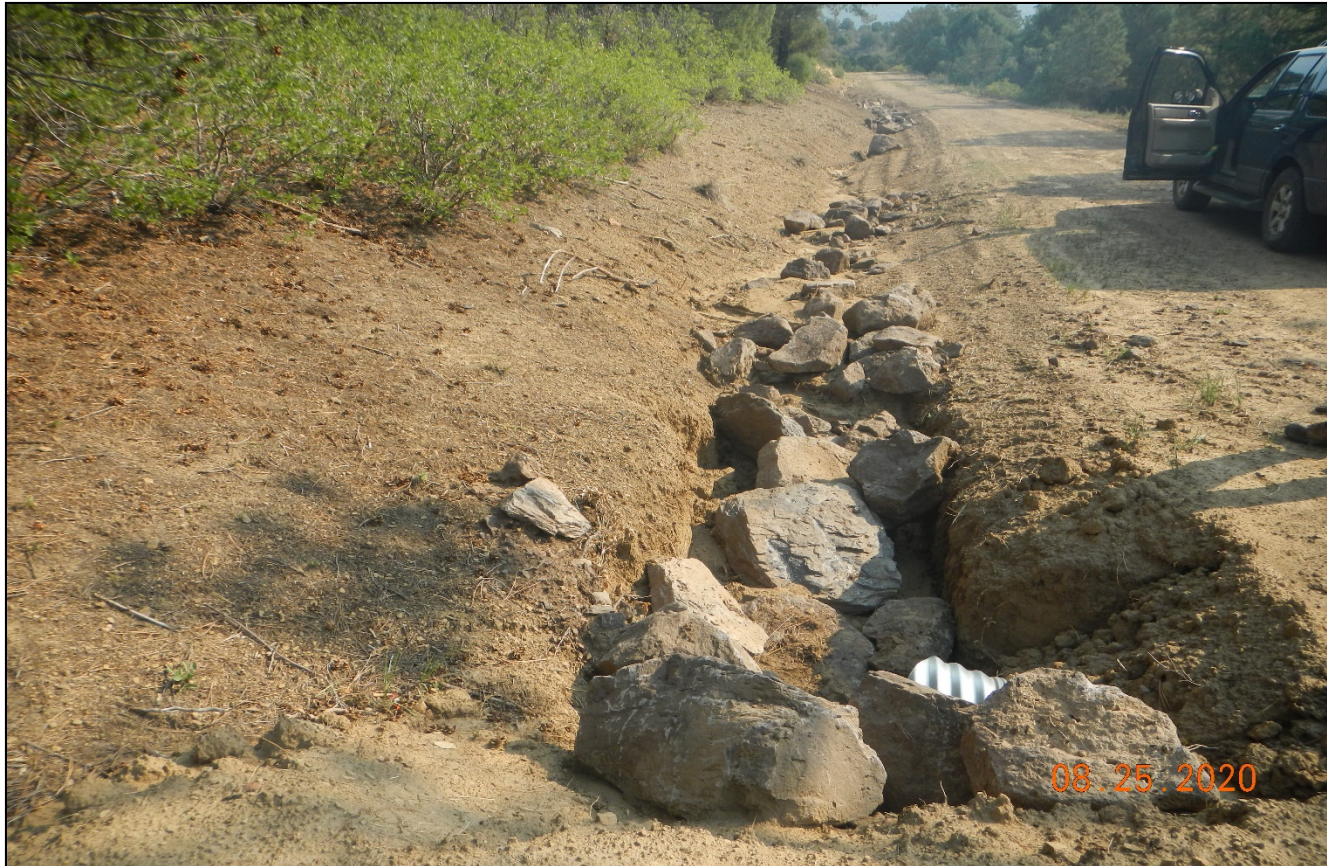
Photo 10. There is large rock rip/rap installed in front of the culverts which may obstruct the culvert inlet.

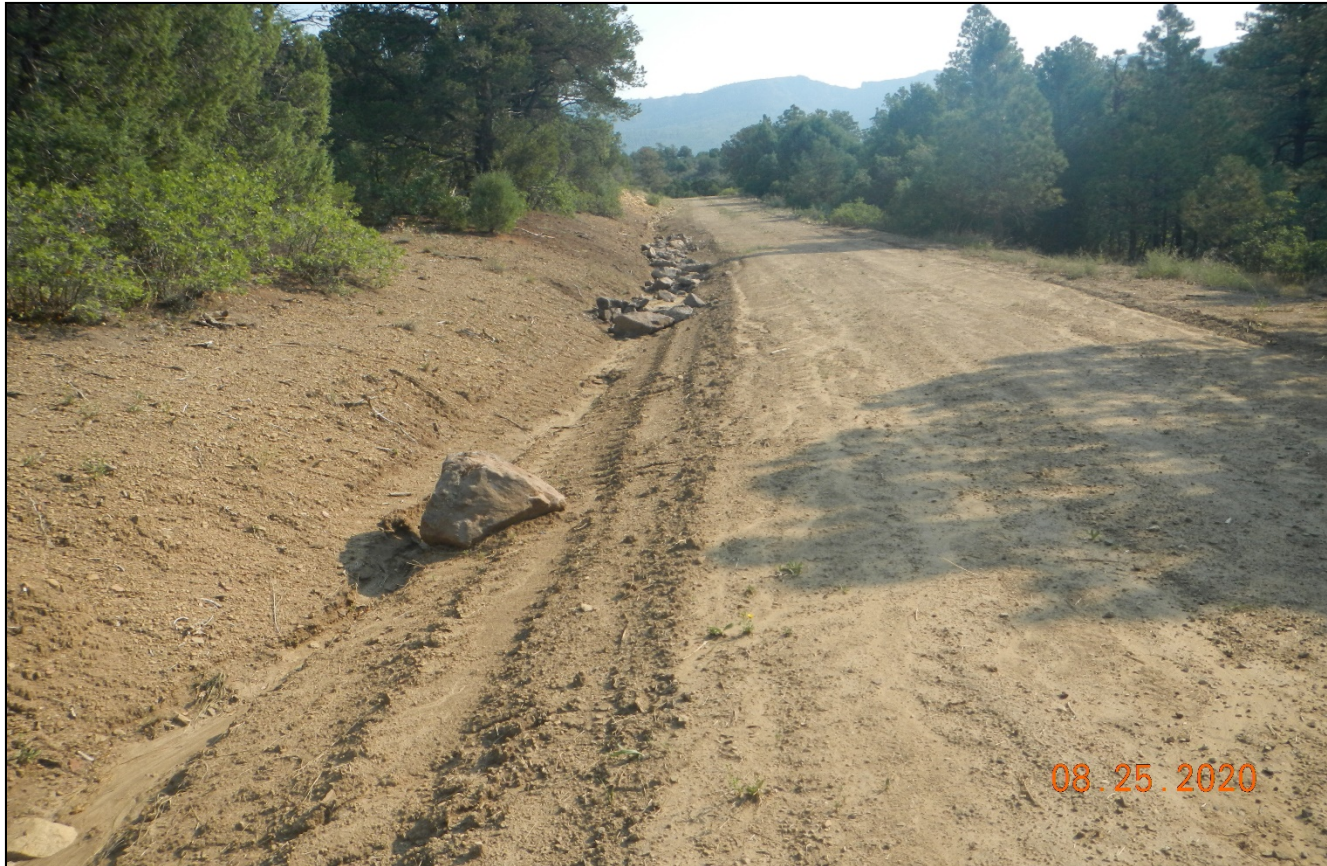
Photo 11. The rock was scattered along the side of the road and not properly installed. The side of the road will need to be seeded and stabilized.

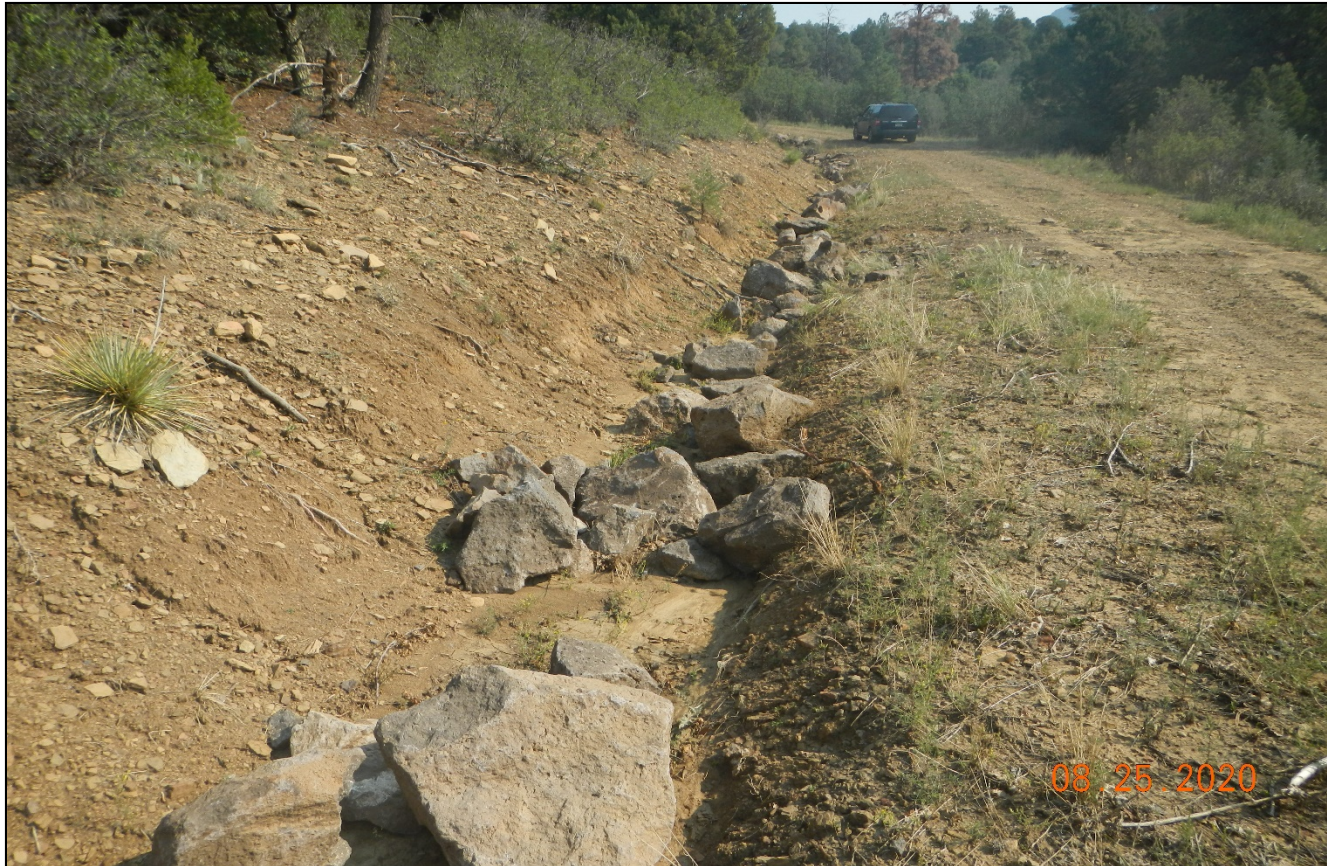
Photo 12. There is large rock piled along the road side.

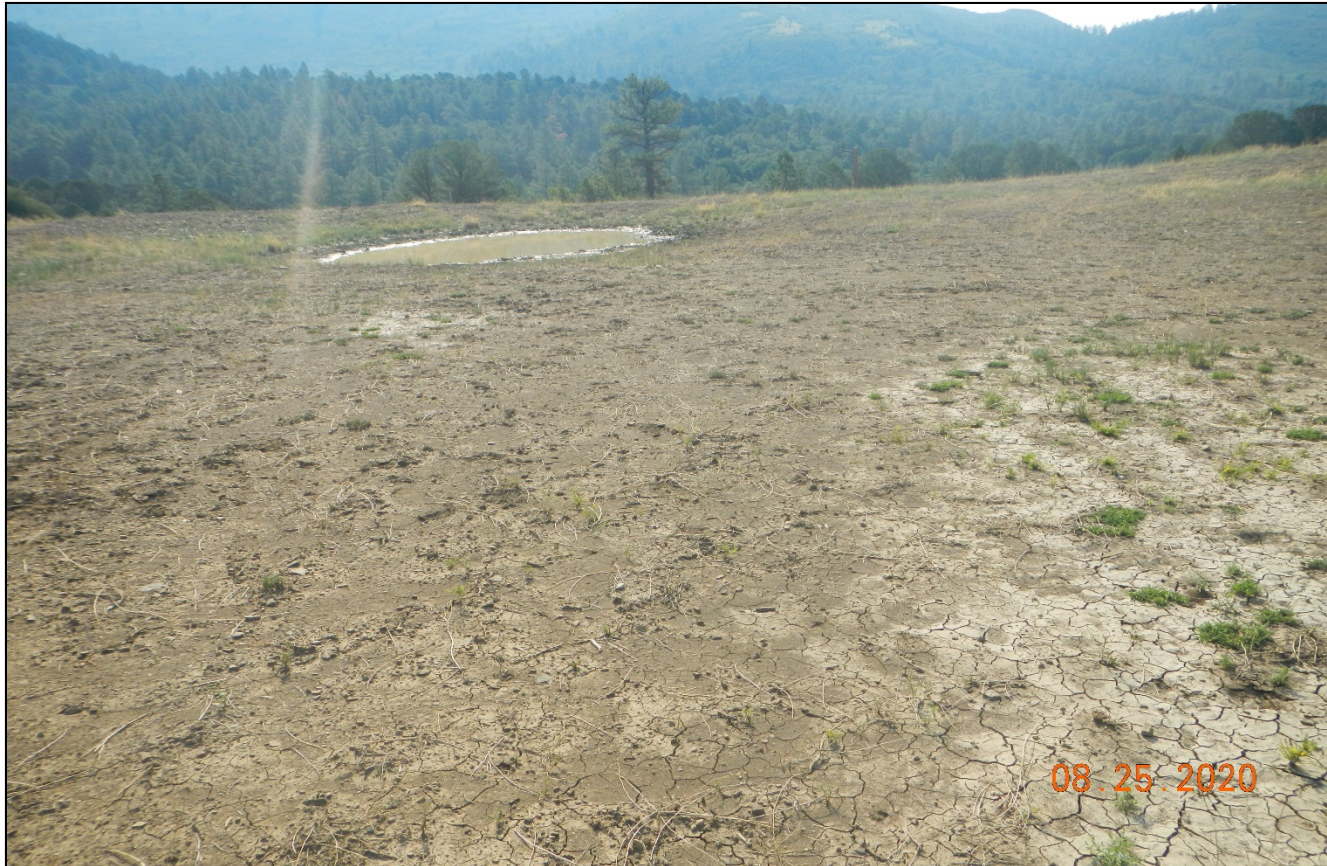
Photo 13. Facing east toward the location. Vegetation has not established at the location and additional seeding is required.

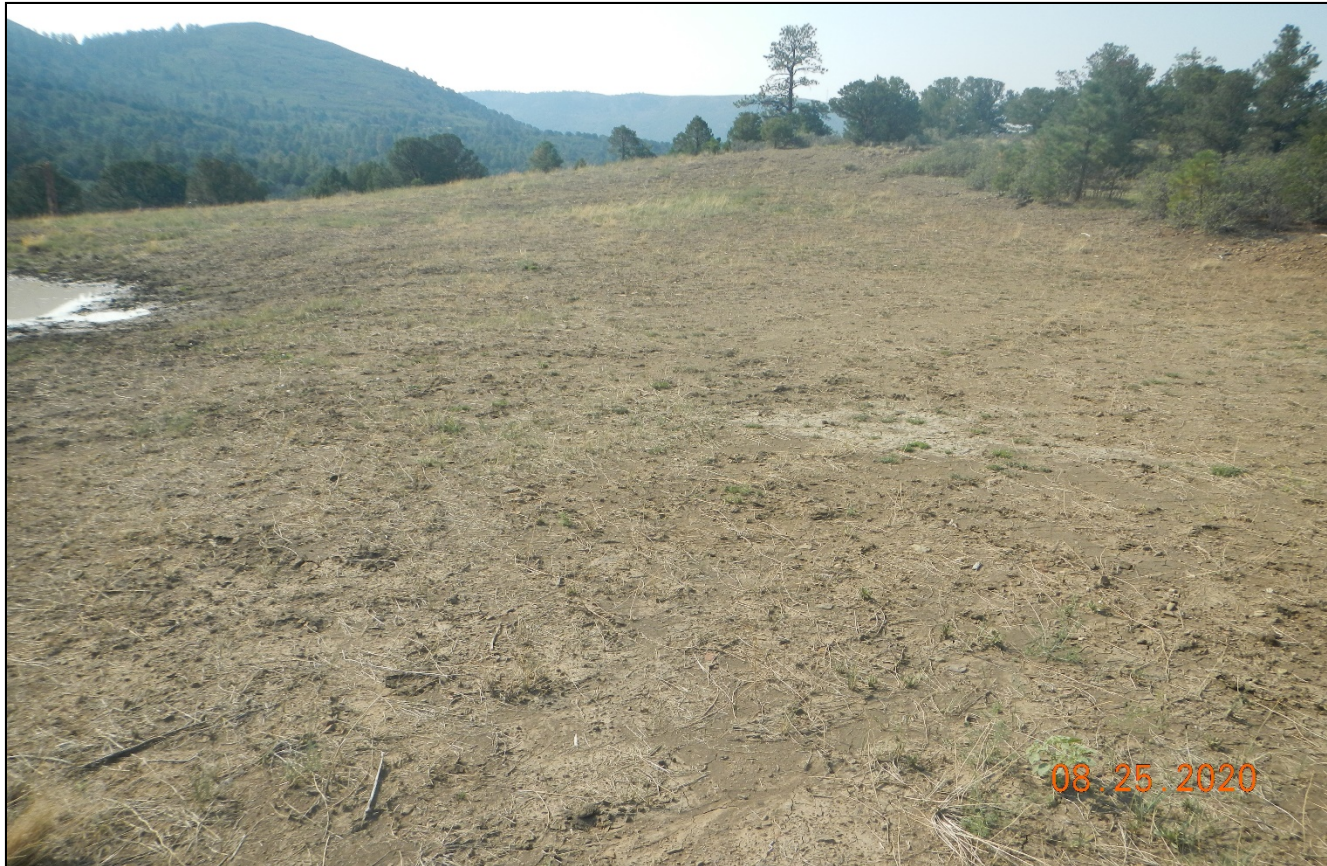
Photo 14. Facing southeast toward the location. Vegetation has not established at the location and additional seeding is required.

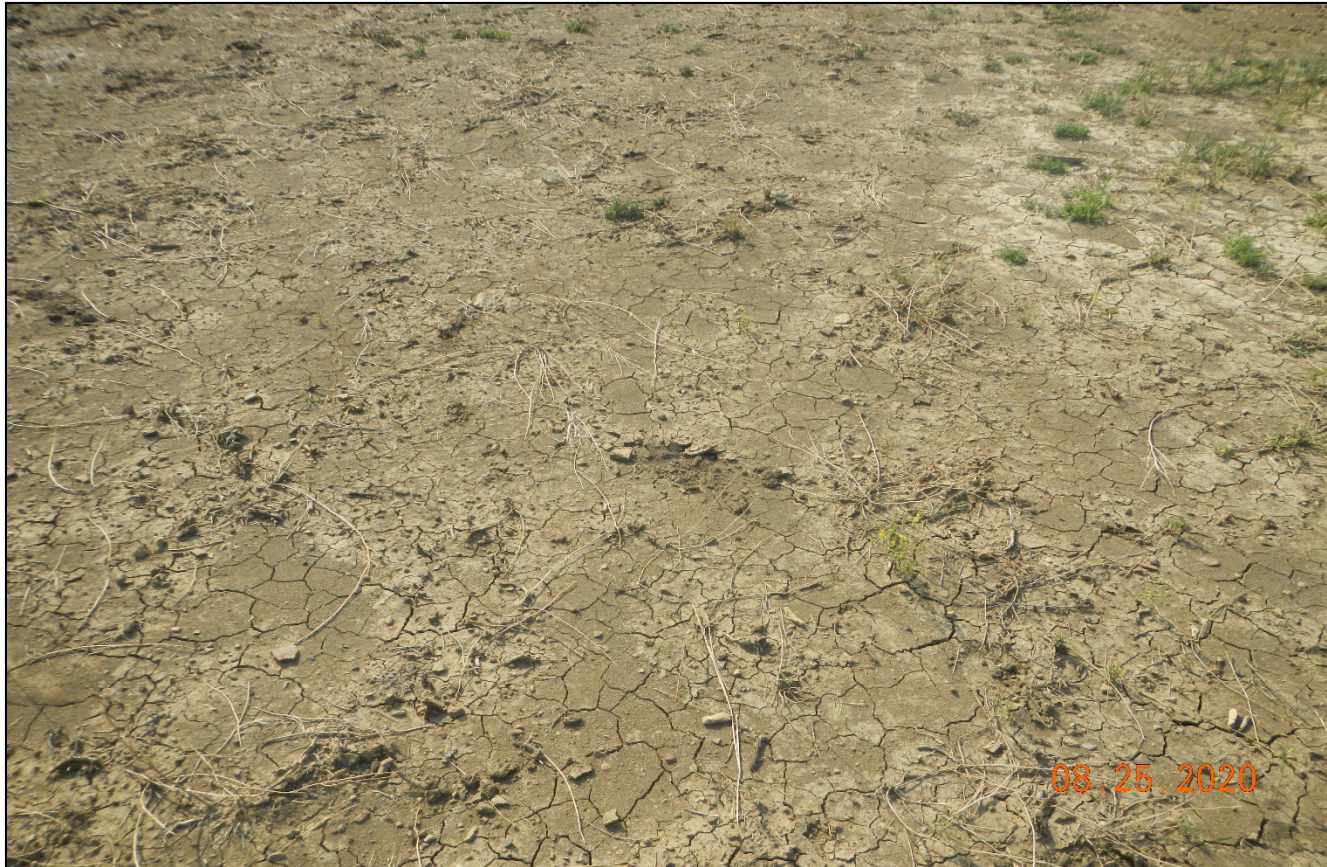
Photo 15. View of ground cover shows bare soil and insufficient vegetation cover.

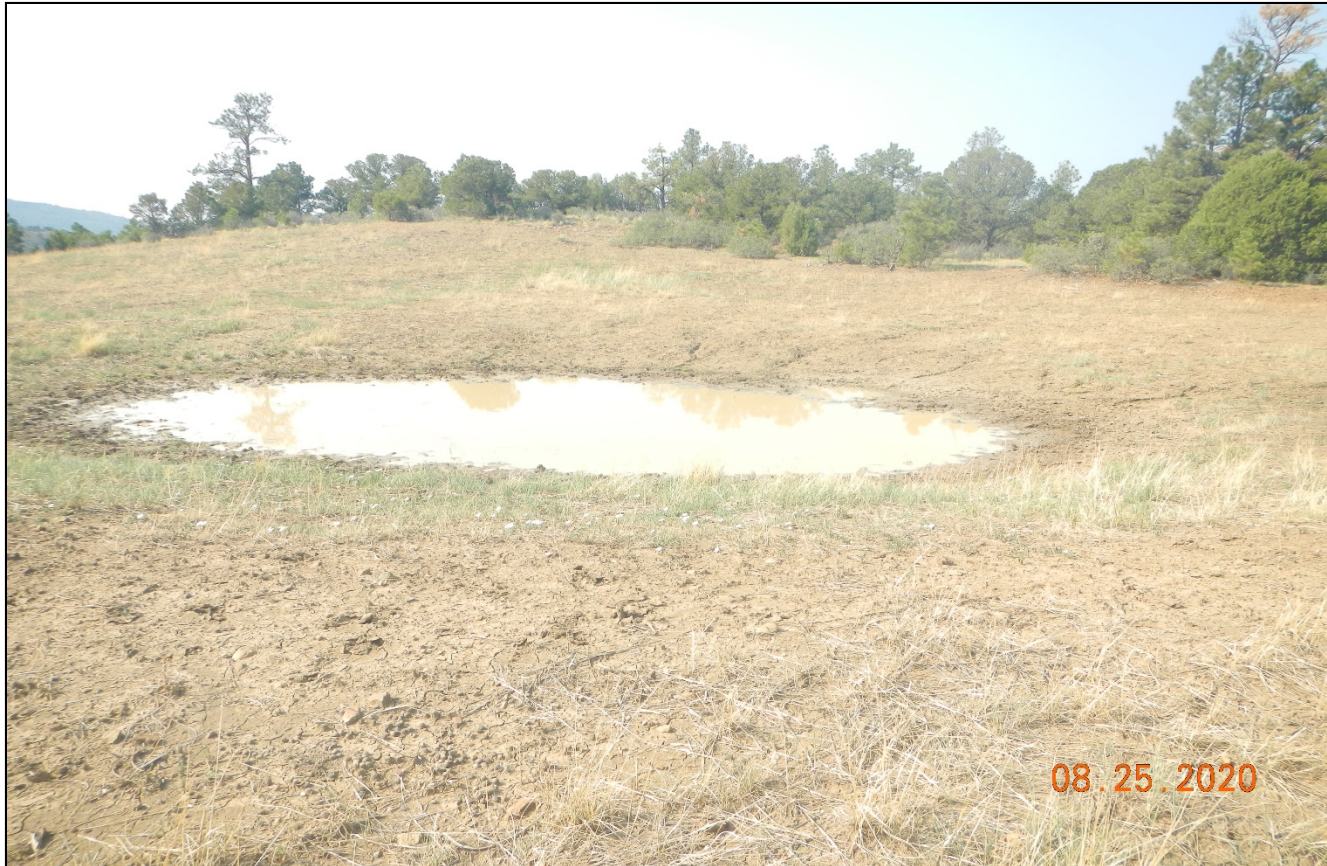
Photo 16. Facing south toward the location. A shallow pit remains per approved variance.

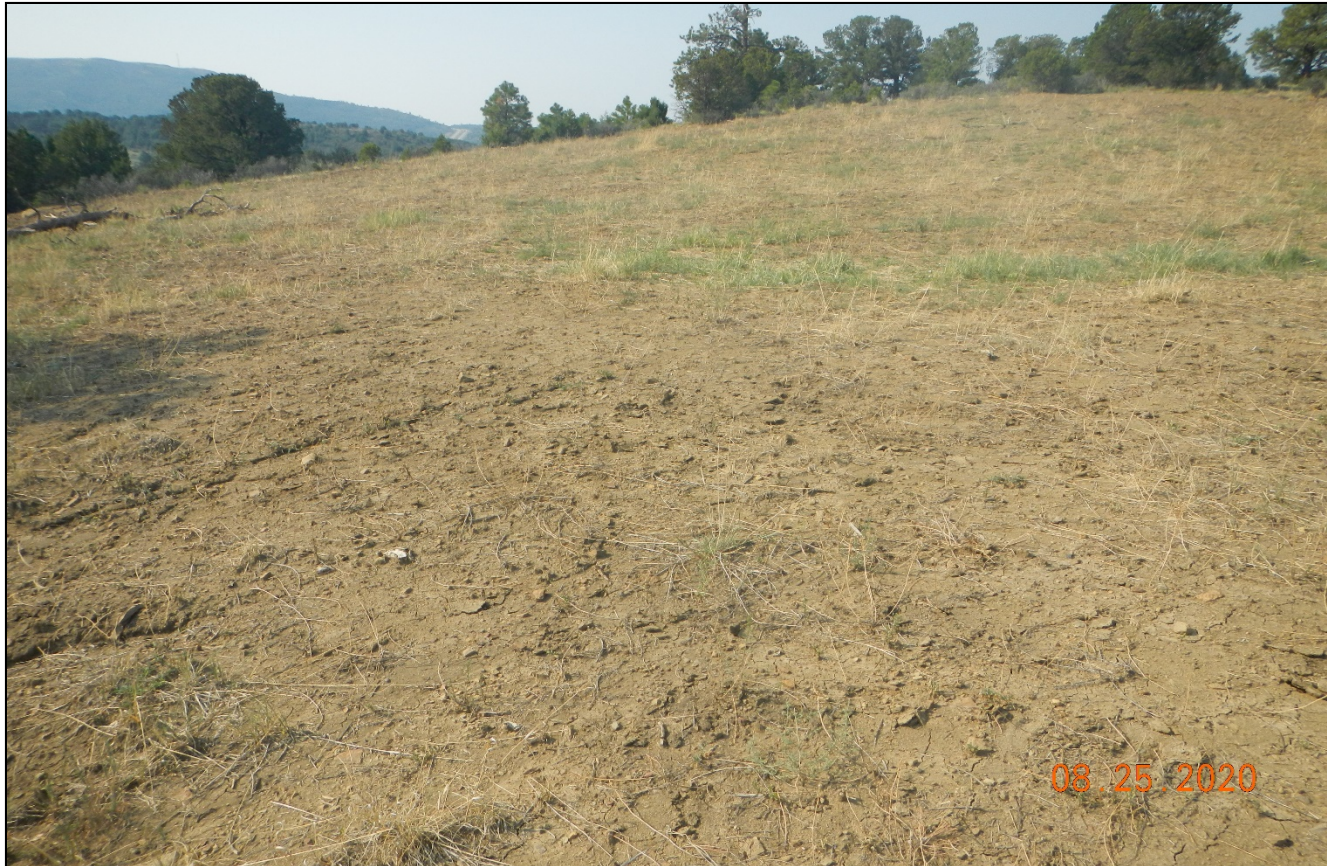
Photo 17. Facing south at the east side of the location. Vegetation has not established at the location and additional seeding is required.

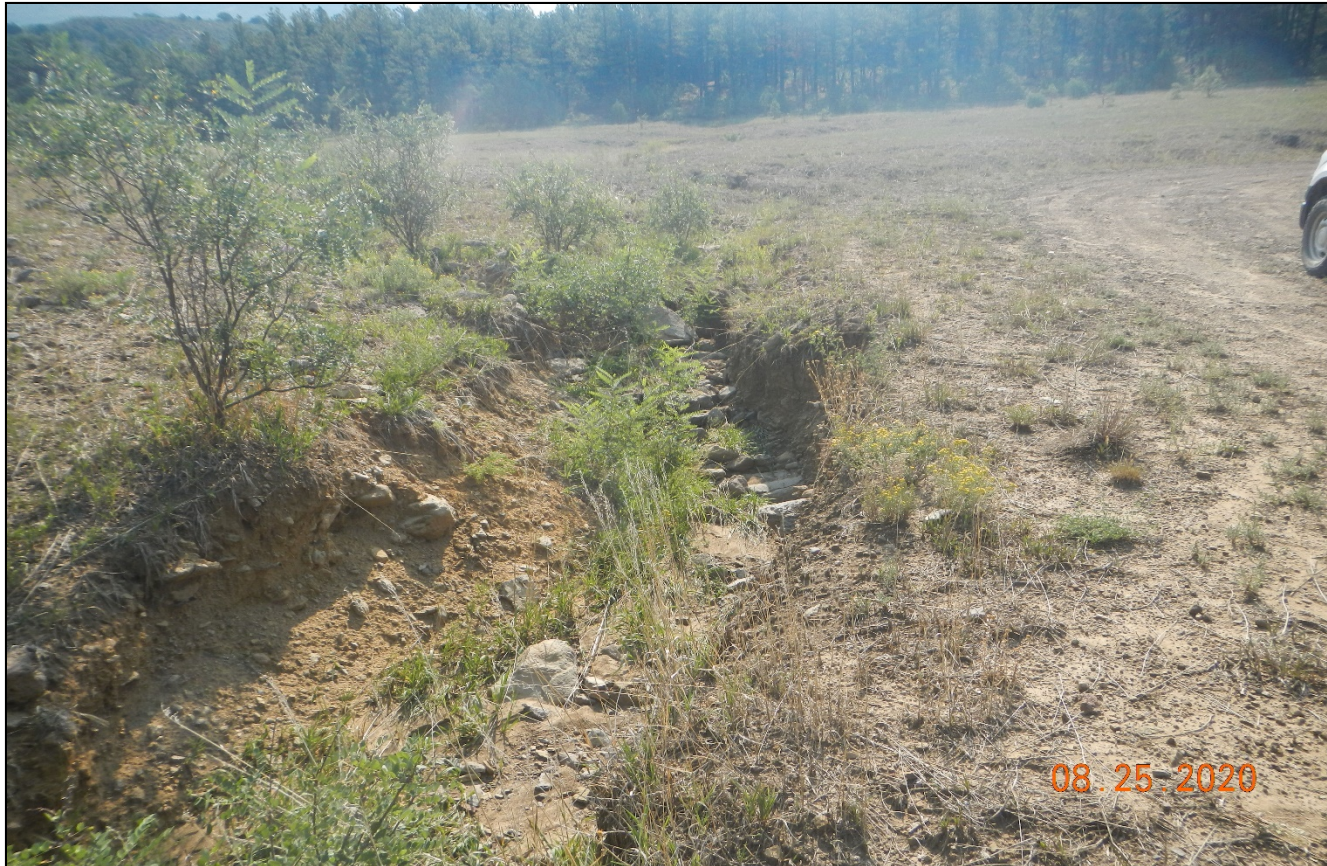
Photo 19. There is an erosional gully along the access road that was not repaired at Lat/Long:37.02219,-104.48216.
