Inspection Photos
Location Name: Champlin 459 Amoco A#2
Location ID: 319997

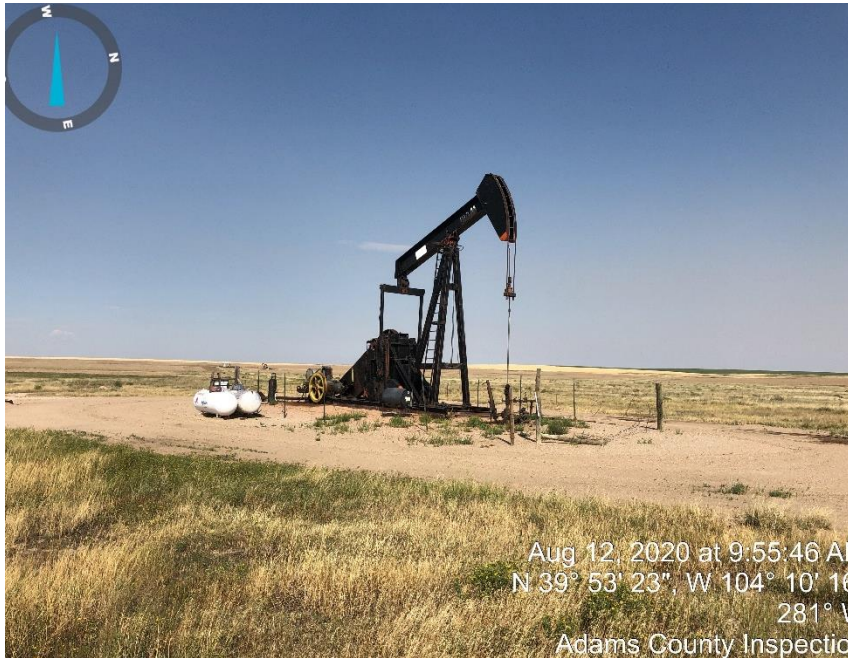
Photo #1 Pump Jack.

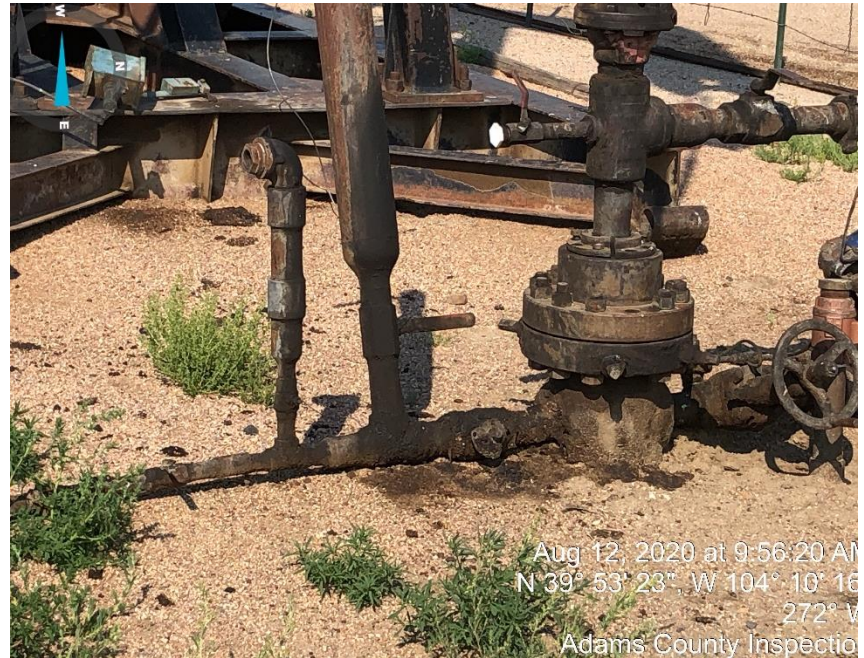
Photo #2 Stained soil.

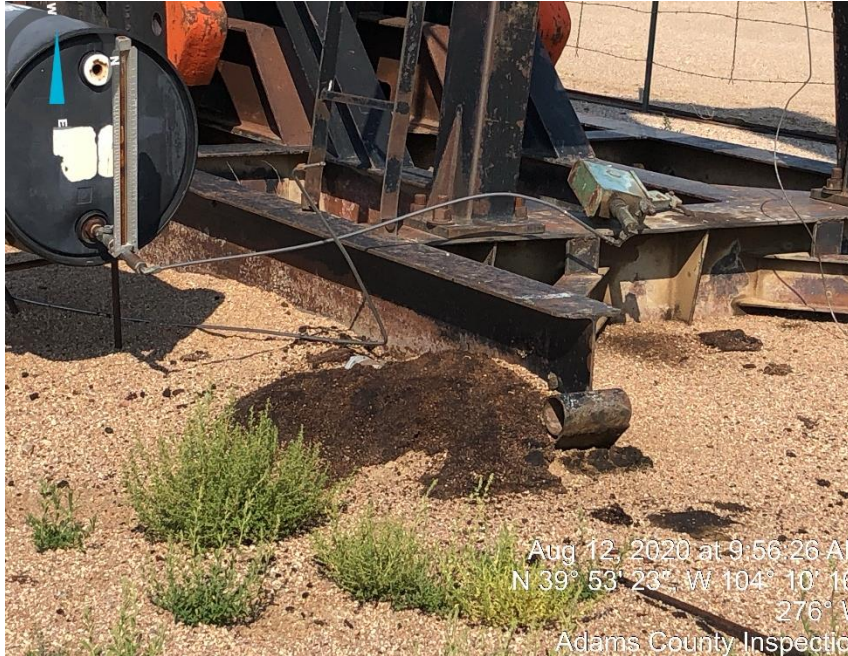
Photo #3 Stained soil.

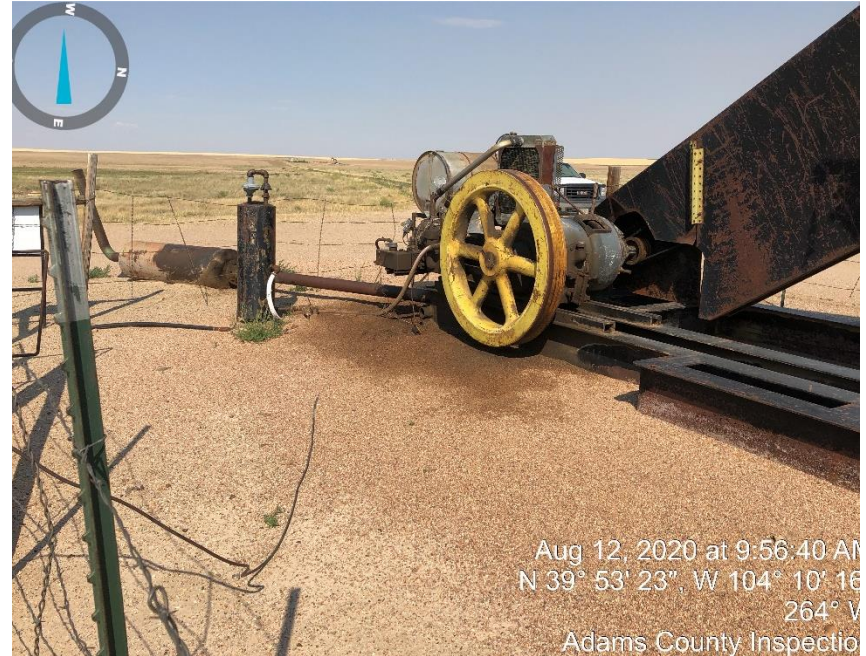
Photo #4 Stained soil.

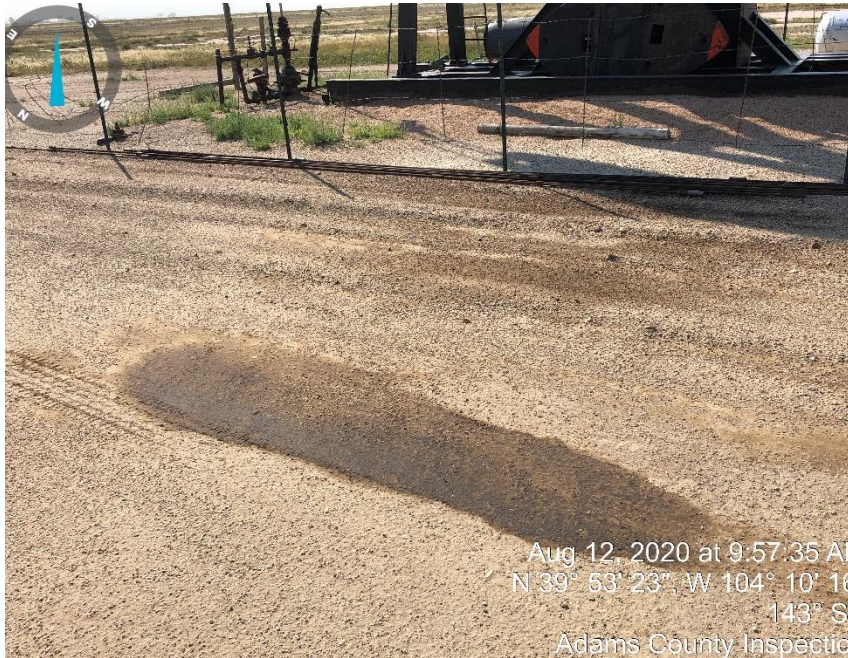
Photo #5 Stained soil.

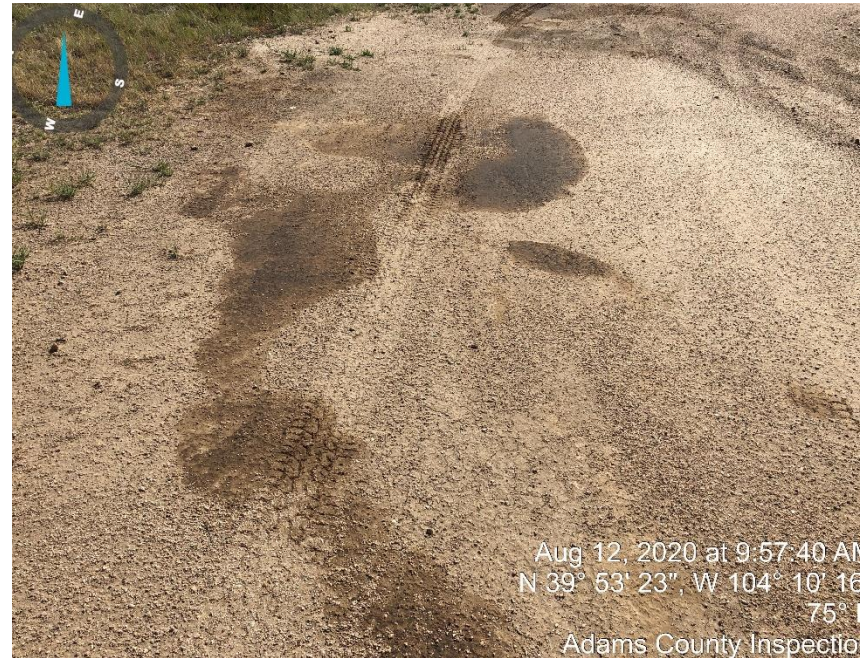
Photo #6 Stained soil.

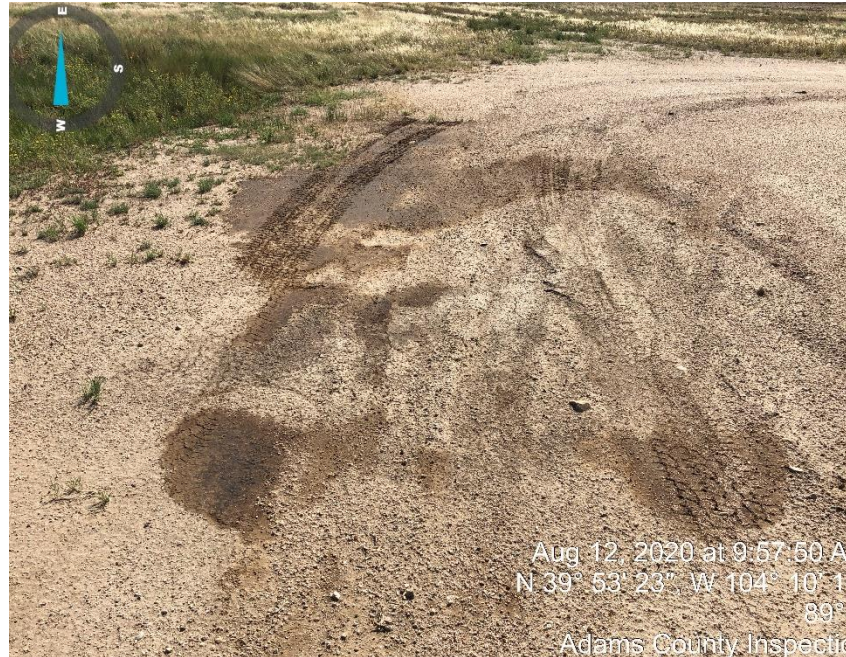
Photo #7 Stained soil.
