Inspection Photos  
Operator: Hilcorp Energy  
API: 067-09816  
Date: 8/27/2020

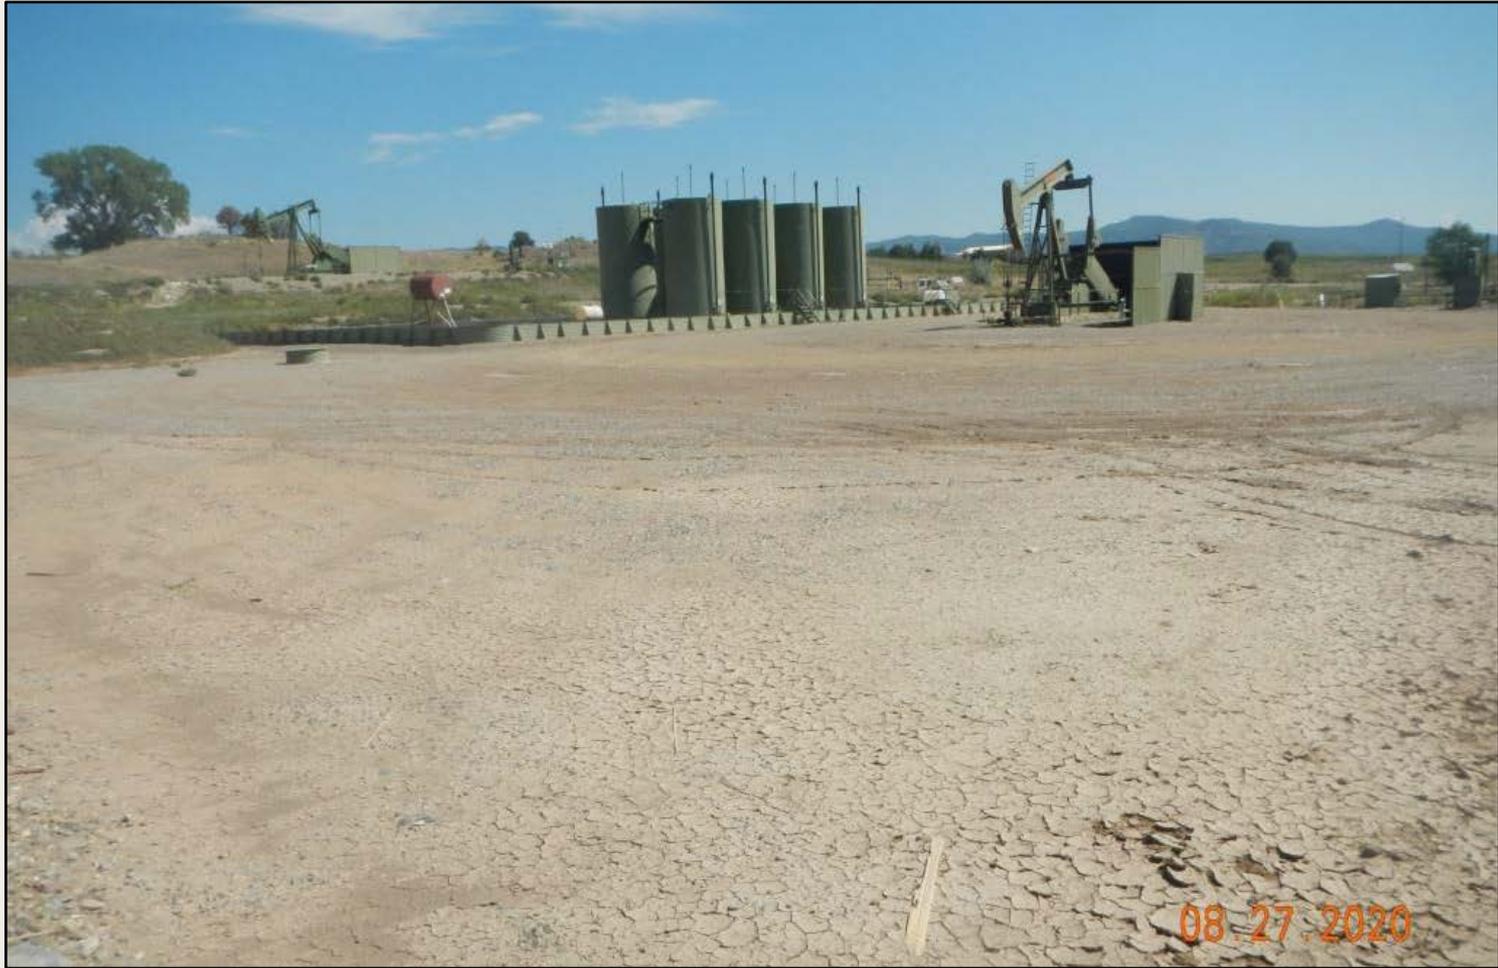
Photo 1. View of the project area from the northwestern edge facing center.

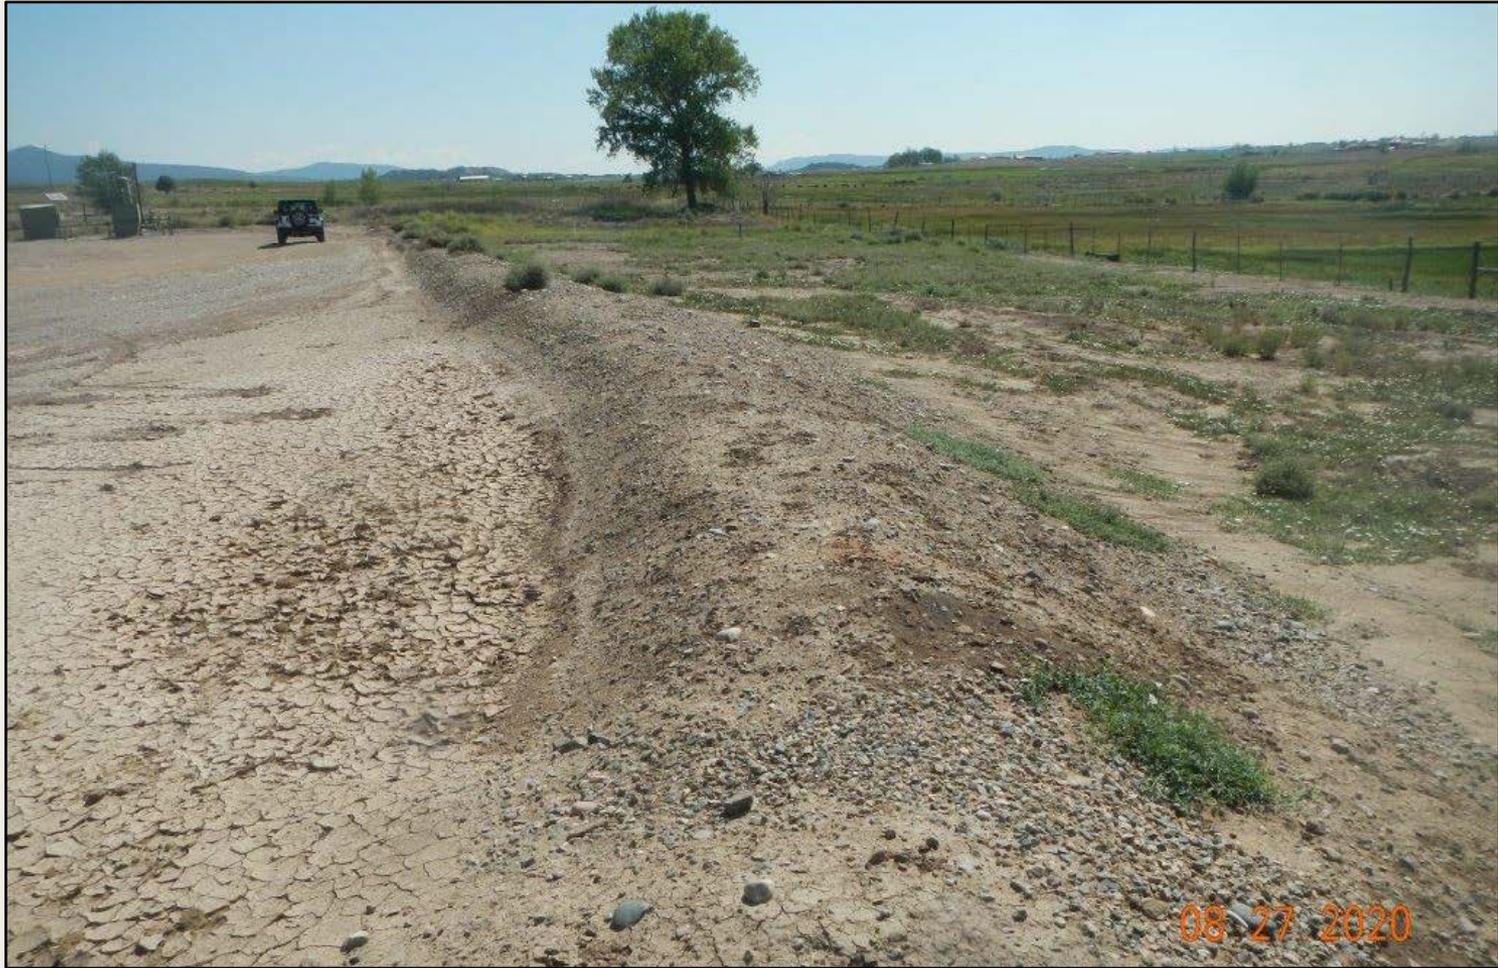
Photo 2. View of the southern fill slope. Berms are installed. Erosion channels are graded and appear to be seeded.

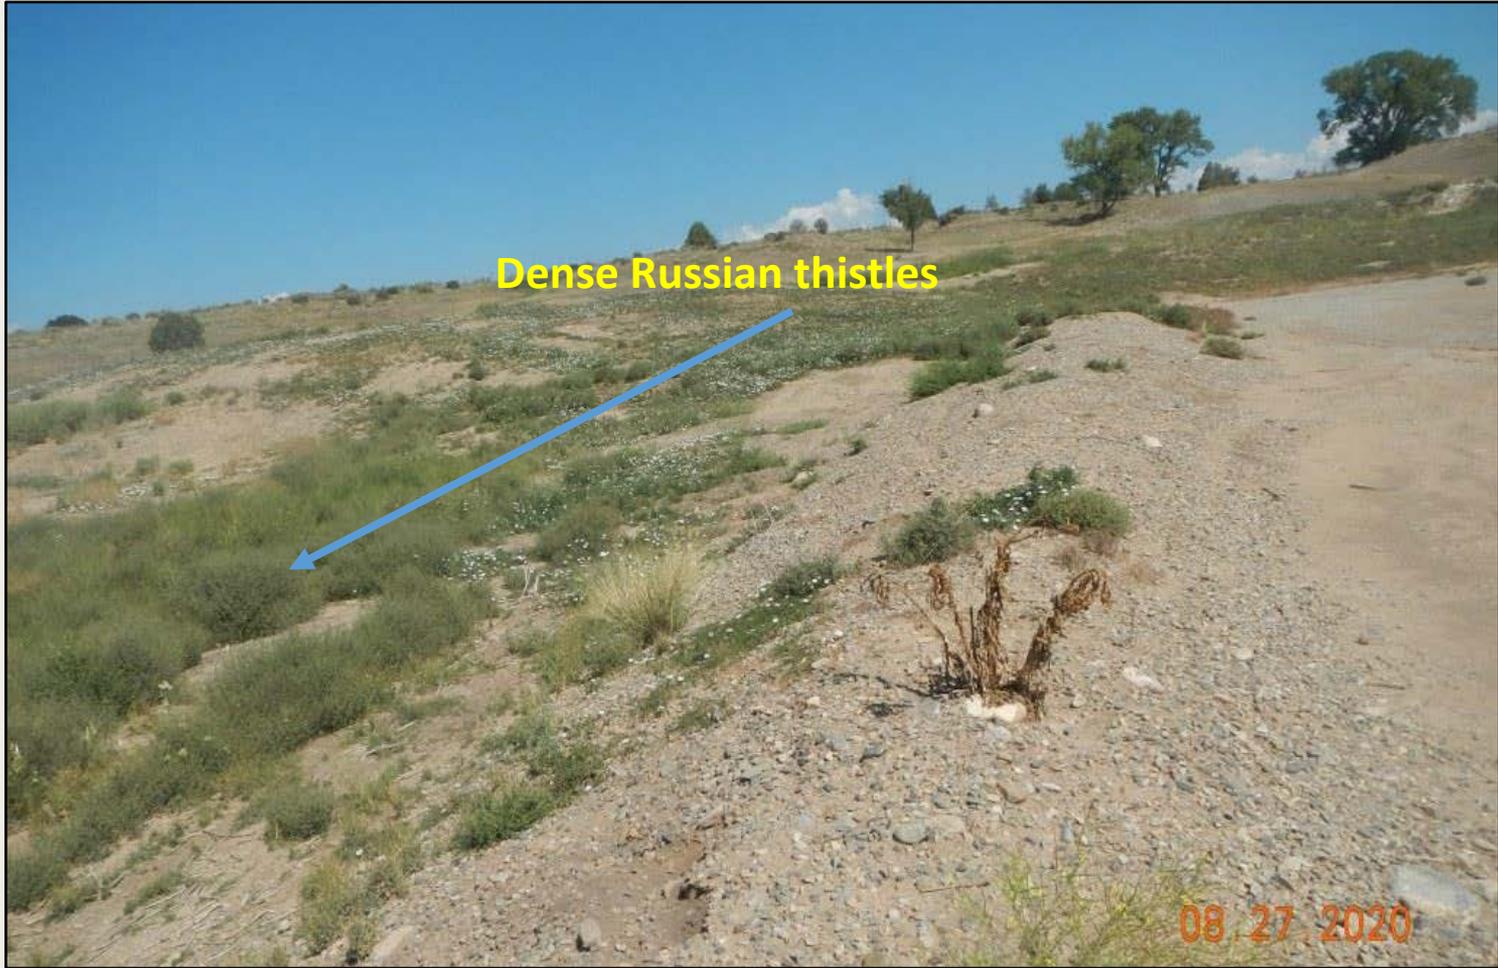
Photo 3. View of the western project area facing northward. Dense Russian thistle debris needs to be removed.

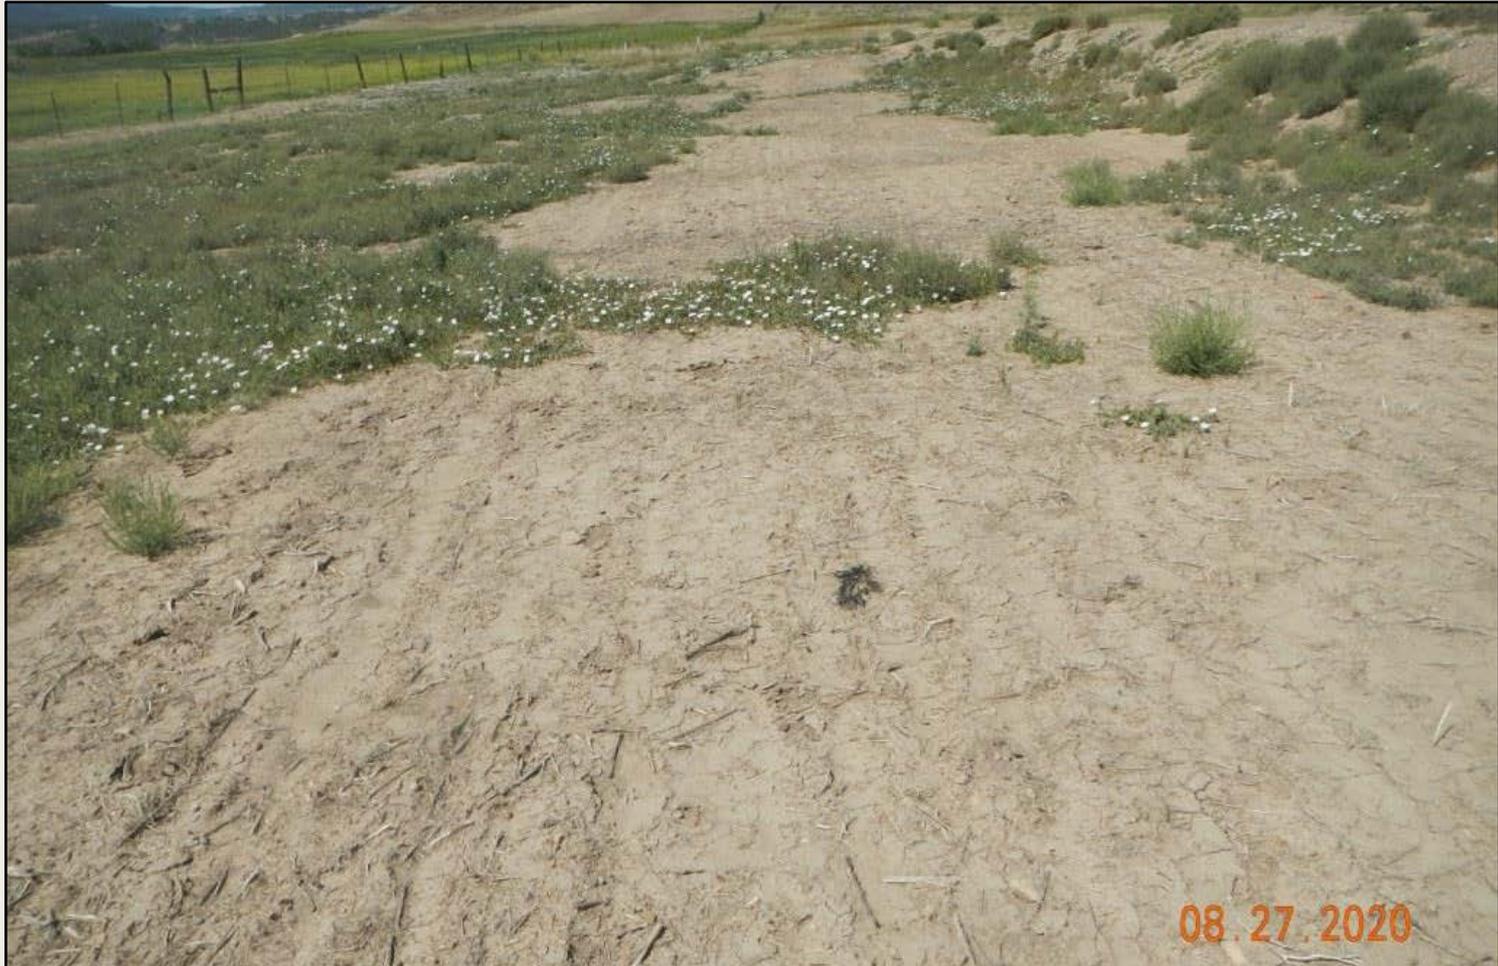
Photo 4. View of area where re-seeding appears to be conducted. Little desirable vegetation observed. It does not appear that the area was mulched, which likely contributed to poor germination.

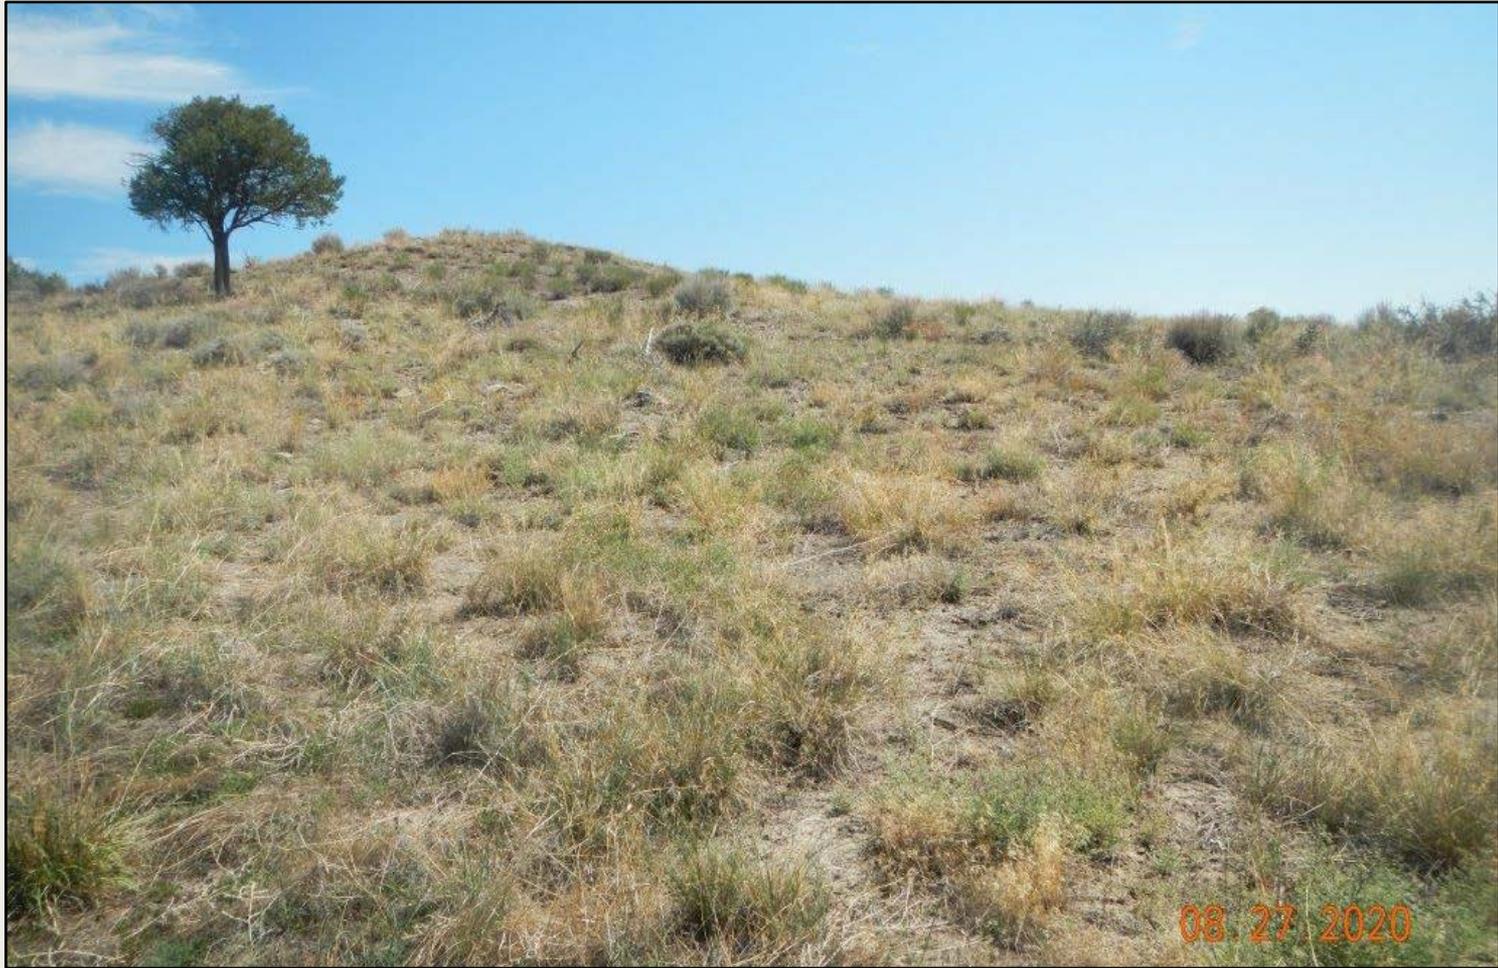
Photo 5. View of reference area vegetation comprised of black sagebrush shrubland with grasses and forbs such as Indian ricegrass, lanceleaf buckwheat, and needleandthread grass.
