Inspection Photos

8/31/2020

Operator: SG INTERESTS I LTD - 77330

Location ID: 418697

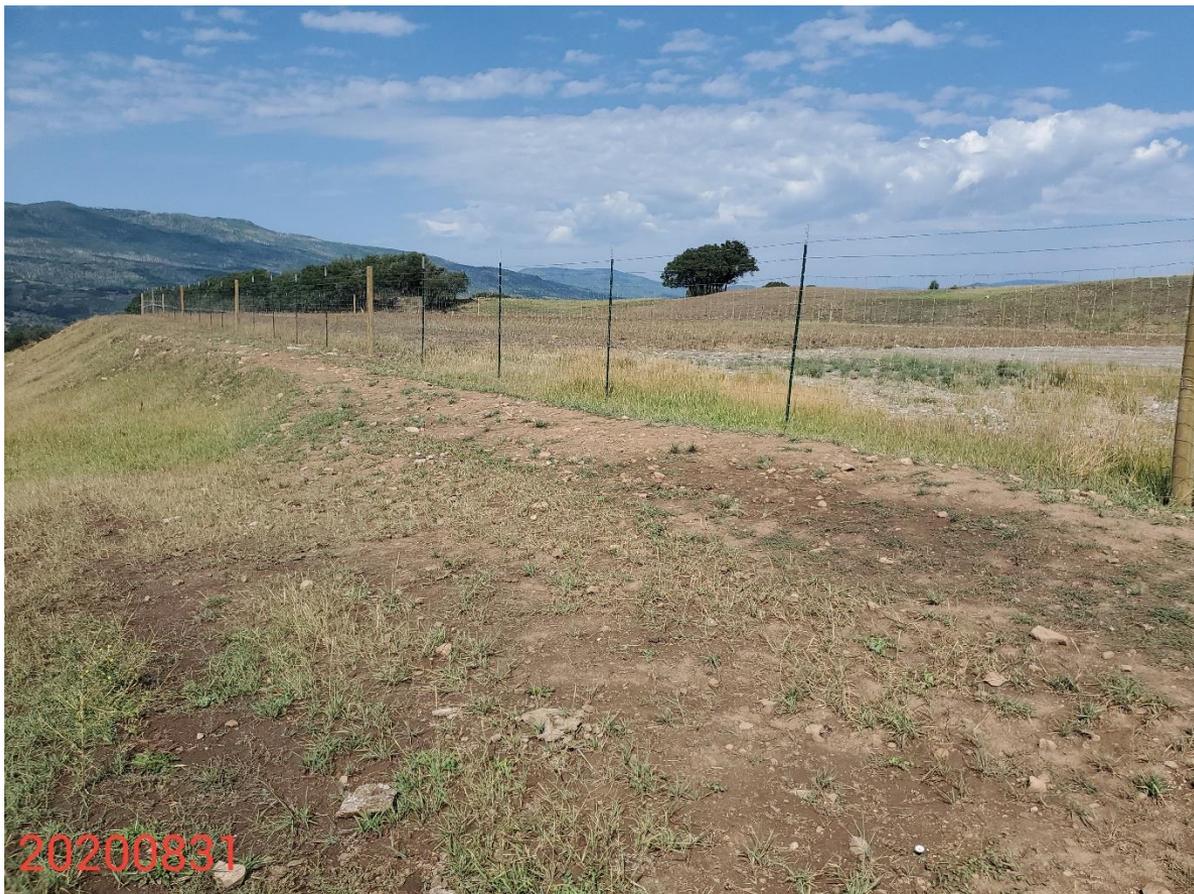
Photo 1: Photo taken from the southeast corner of the Location, facing west. Photo provides an overview of the Location.

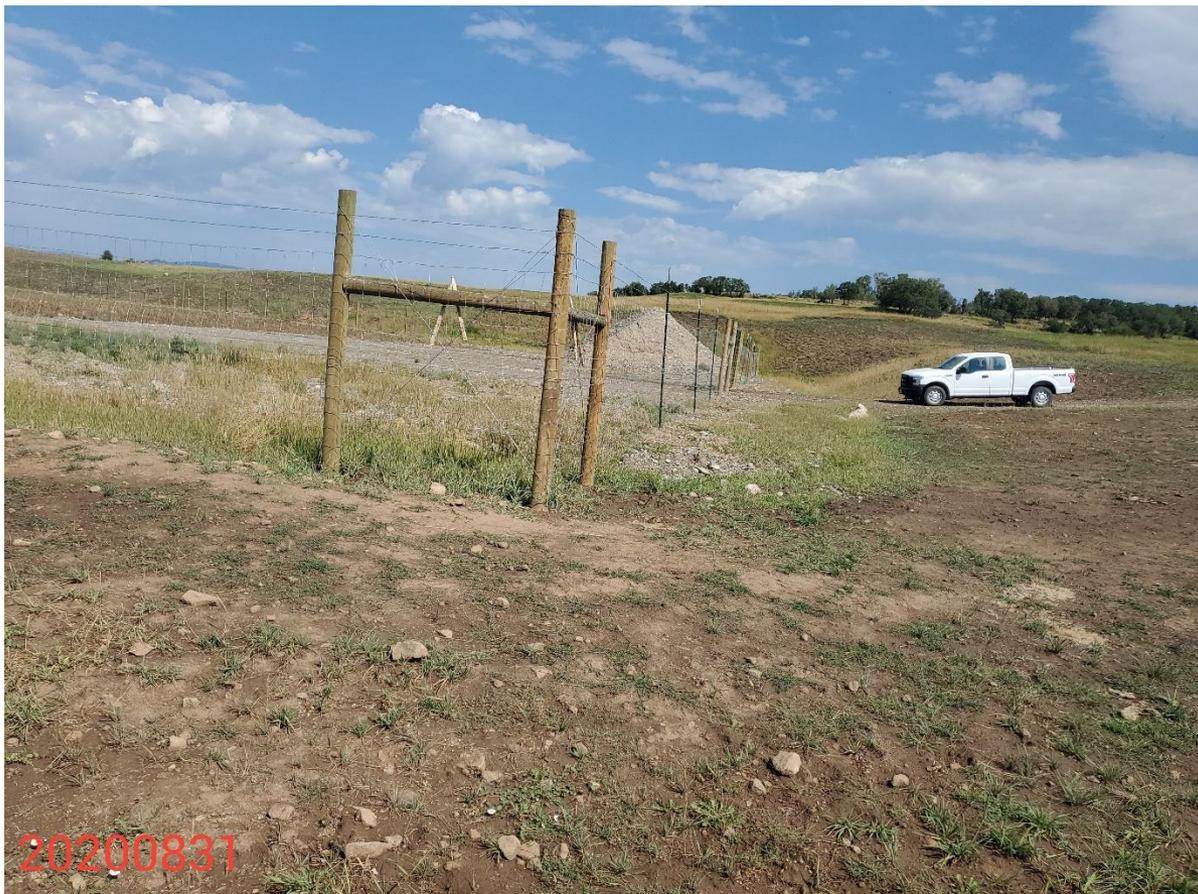
Photo 2: Photo taken from the southeast corner of the Location, facing north. Photo provides an overview of the Location.

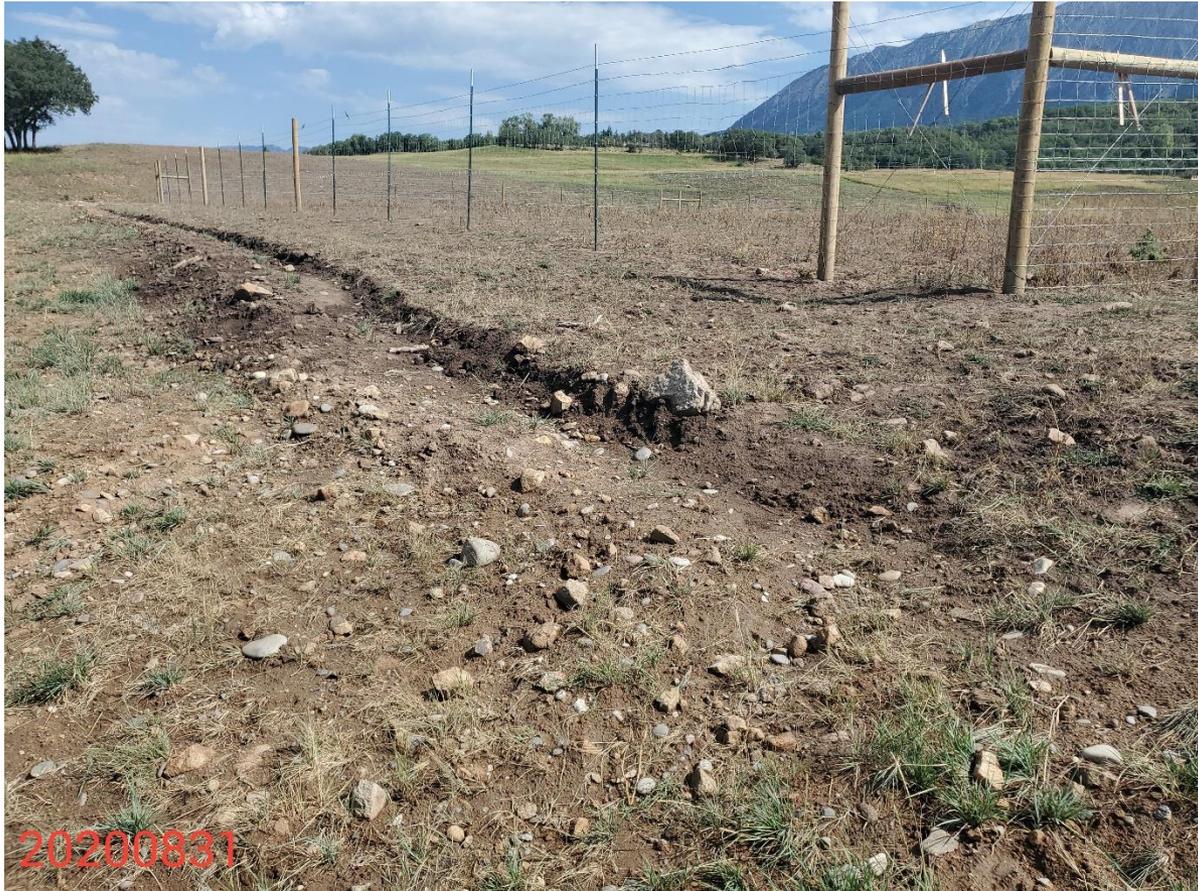
Photo 3: Photo taken from the southwest corner of the Location. Photo shows perimeter stormwater ditch. Ditch BMP has not been constructed in accordance with good engineering practices; BMP ends on the southwest end of the location and does not have a sufficient outlet to allow for sediment laden-free stormwater discharge.

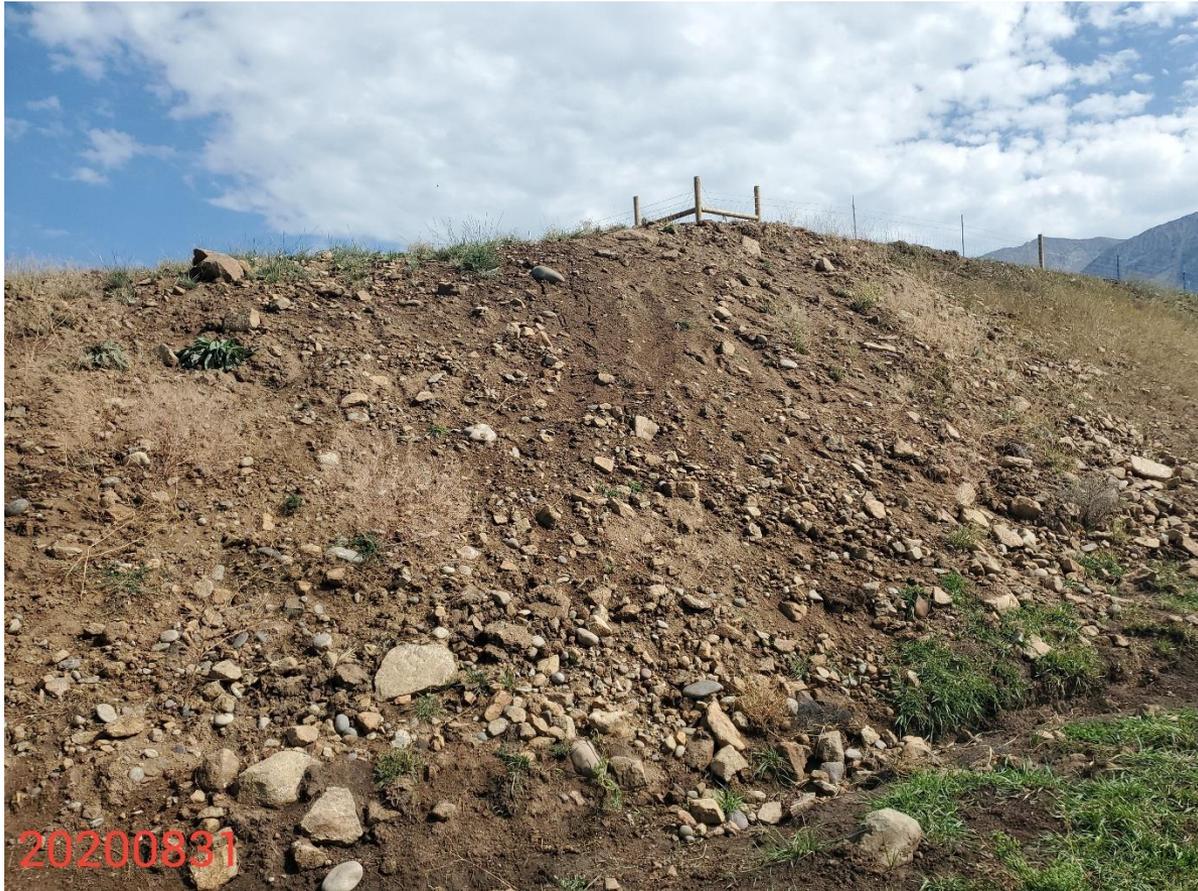
Photo 4: Photo taken from the from the southwest end of the Location, below ditch in photo 3. Photo shows Operator appears to have repaired the erosion degradation documented in the 5/26/2020 inspection. However, BMPs remain insufficient or missing to protect the slopes, and to allow for sediment laden-free stormwater discharge from the ditch

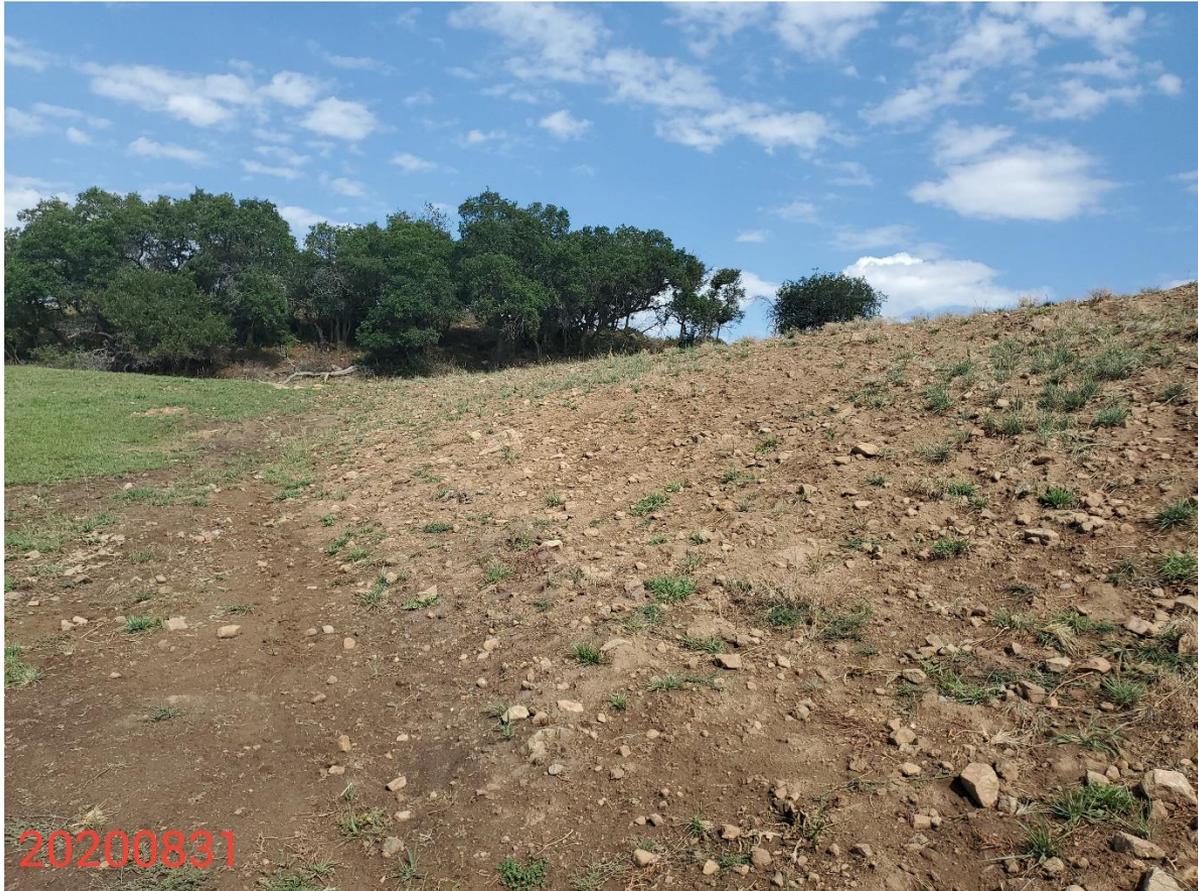
Photo 5: Photo taken from the southwest corner of the Location, facing northwest. Photo show slopes of Location.

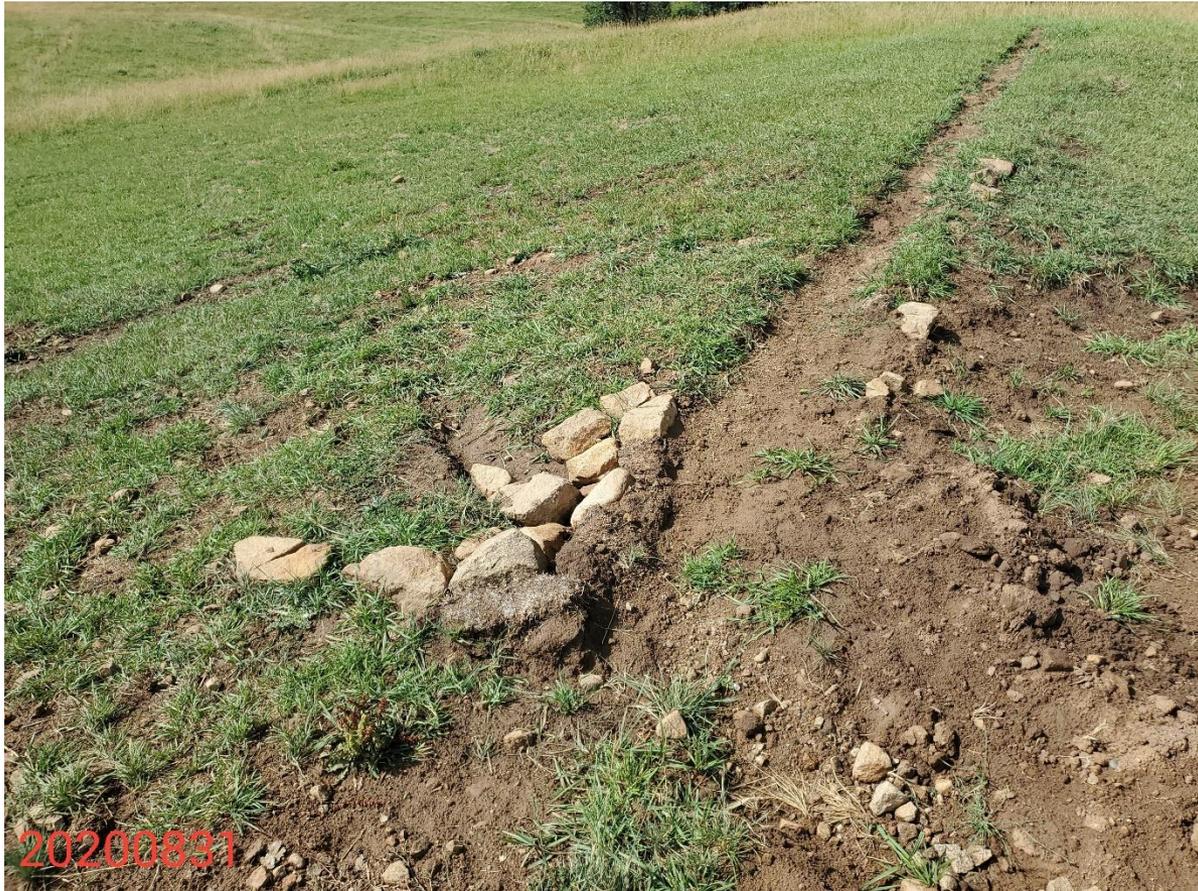
Photo 6: Photo taken from the Ditch BMP on the west end of the Location. Photo shows Operator appears to have installed a velocity check as an outlet; This does not appear to be a sufficient or appropriate long term outlet to allow for sediment laden-free stormwater discharge.

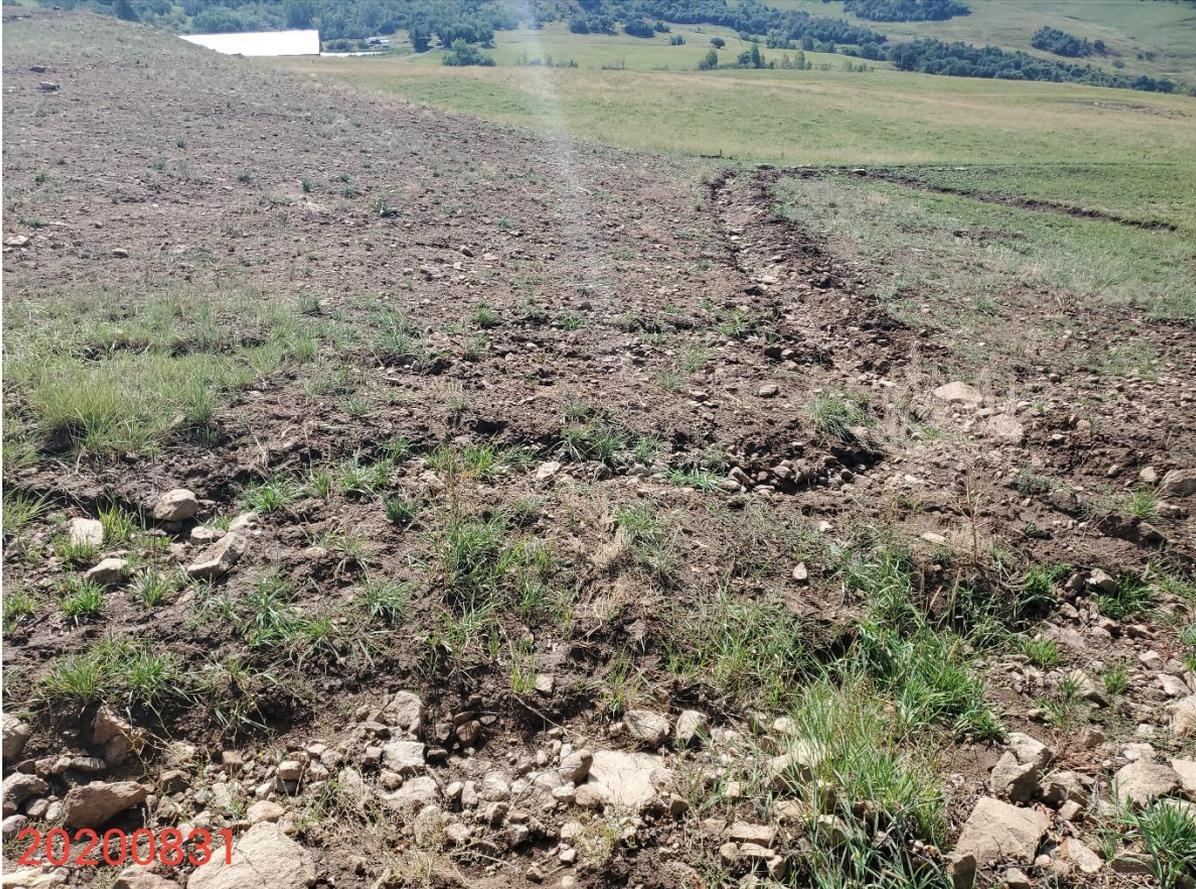
Photo 7: Photo taken from the northwest end of the Location, facing south. Photos shows ditch BMP. BMPs appears insufficient, as stormwater degradation due to runoff is evident below BMPs evident

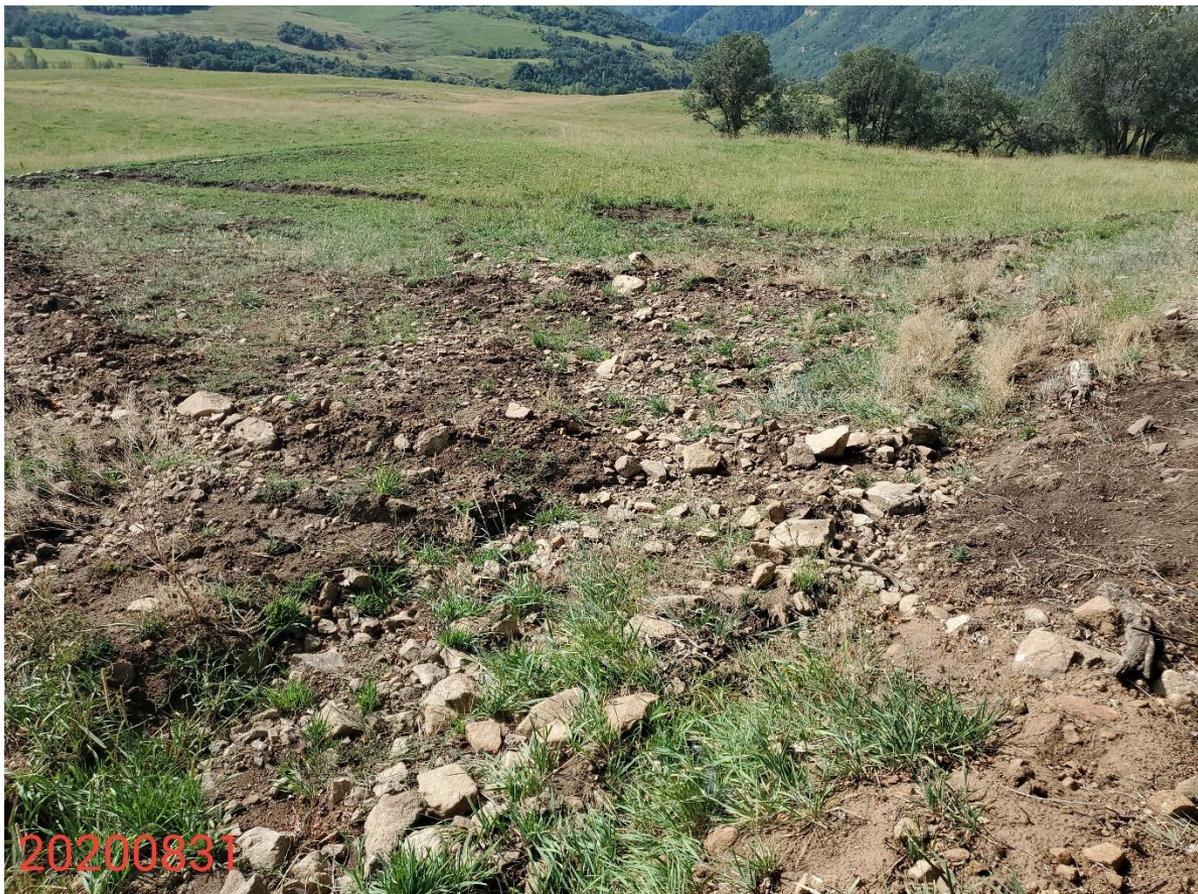
Photo 7.b: Continued from photo 7, facing west. Photo shows stormwater erosion has continued and appears to have removed the soils and finer particulates on areas of the Location and the ditch.

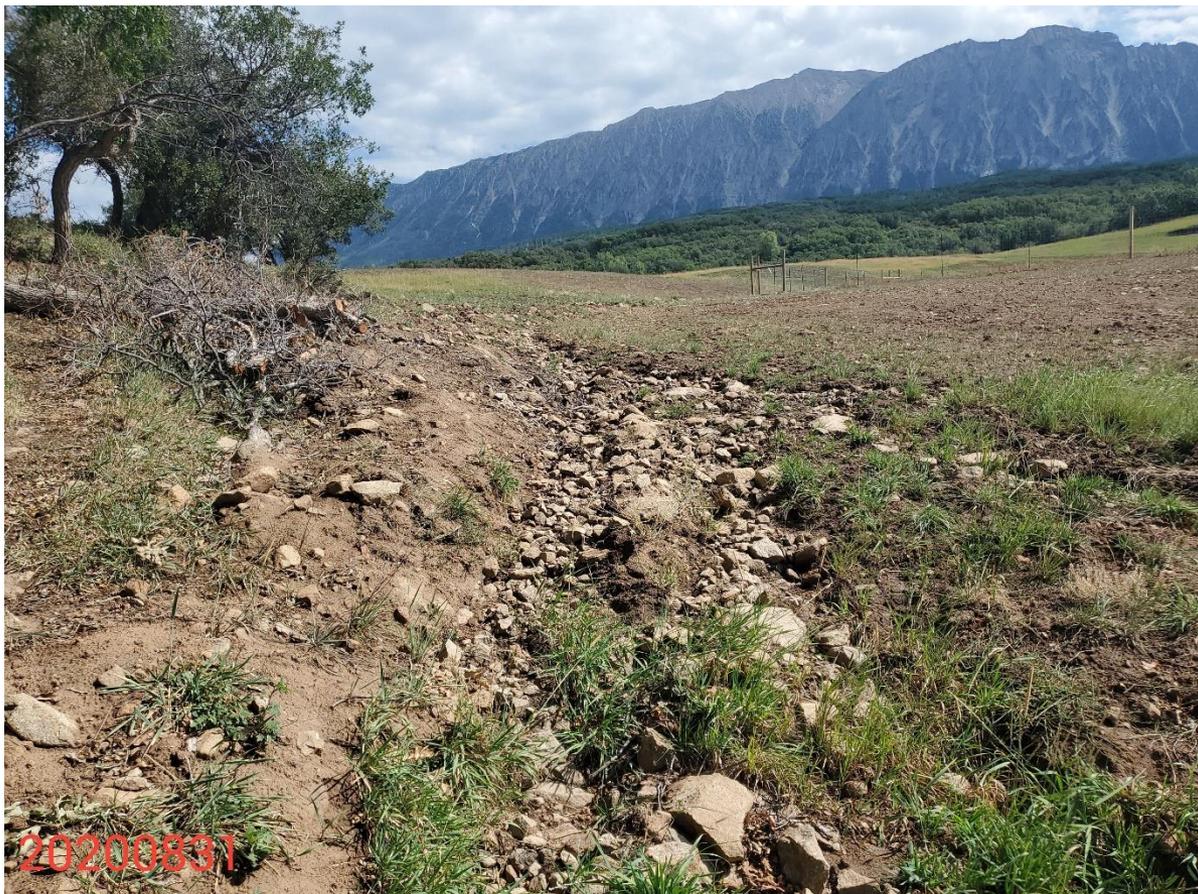
Photo 8: Photo taken from the ditch on the northwest end of the Location, facing east. Photo shows stormwater erosion has continued and appears to have removed the soils and finer particulates on areas of the Location and the ditch.

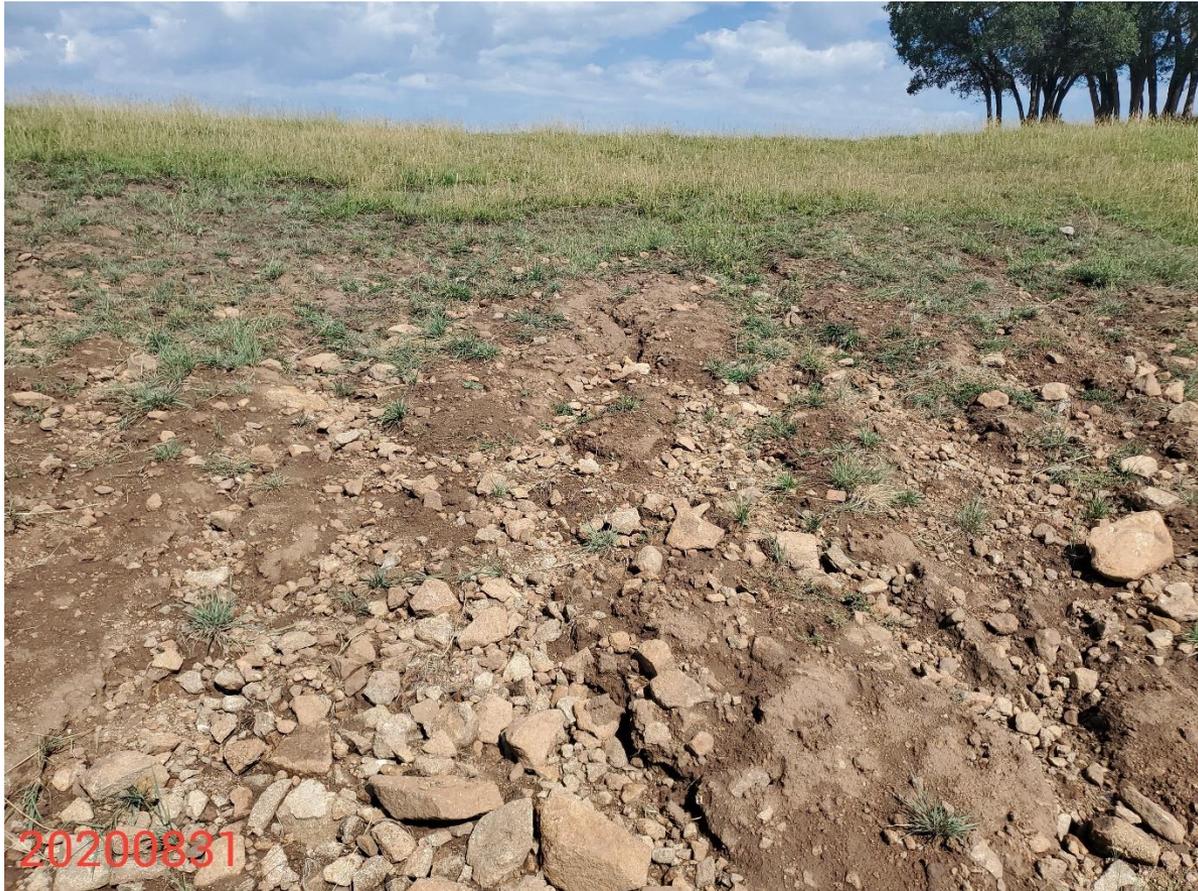
Photo 9: Photo taken from the northwest end of the Location, facing north. Photo shows where topsoil was stored. Photo shows BMPs remain missing, or insufficient to protect slopes, and erosion degradation has continued resulting in loss of soils.

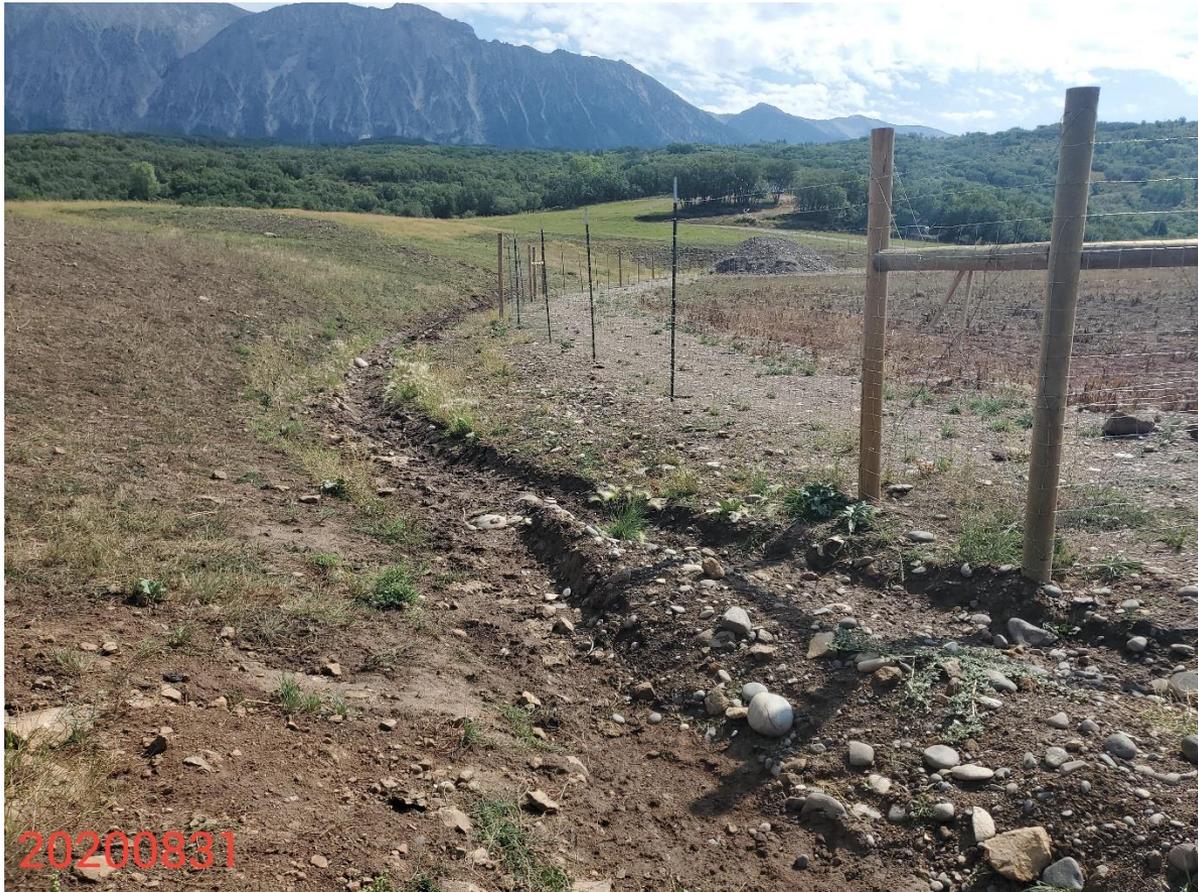
Photo 10: Photo taken from the northwest corner of the Location, facing east. Photo shows perimeter stormwater ditch.

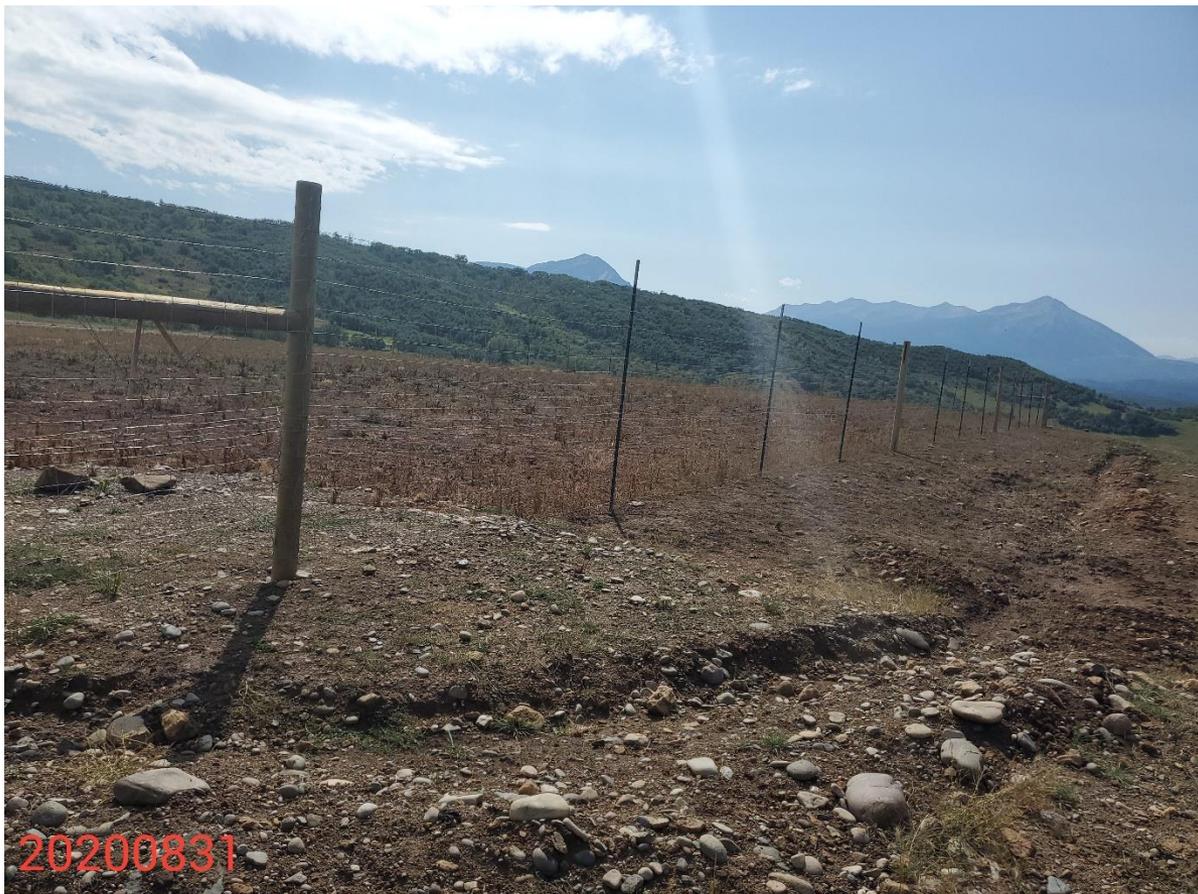
Photo 11: Photo taken from the northwest corner of the Location, facing south. Photo shows perimeter stormwater ditch. .

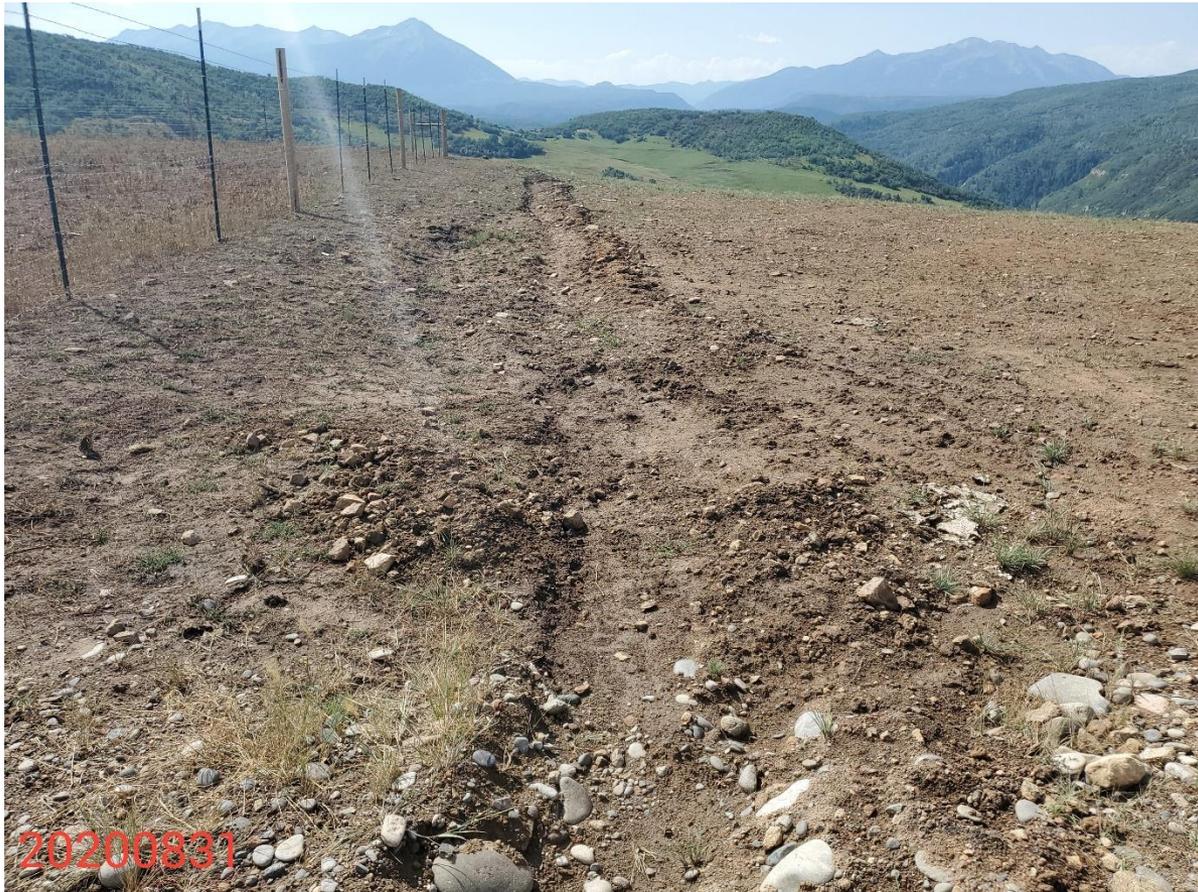
Photo 12: Photo taken from the northwest corner of the pad, facing south. Photo shows stormwater ditch is filling with sediment.

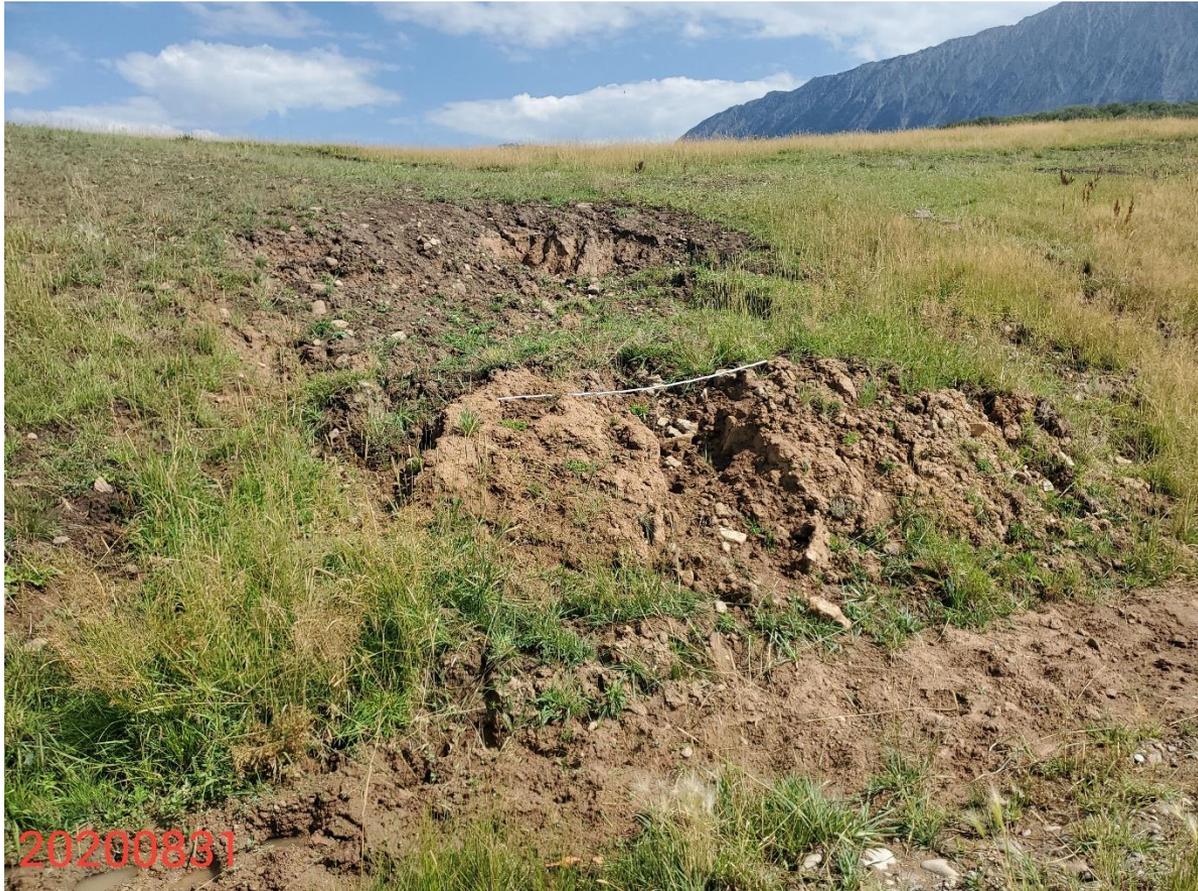
Photo 13: Photo taken from the cut slopes on the north end of the Location. Photo shows Operator has failed to implement BMPs to protect and stabilize slopes; erosion degradation has continued. 6 foot measuring stick for reference.

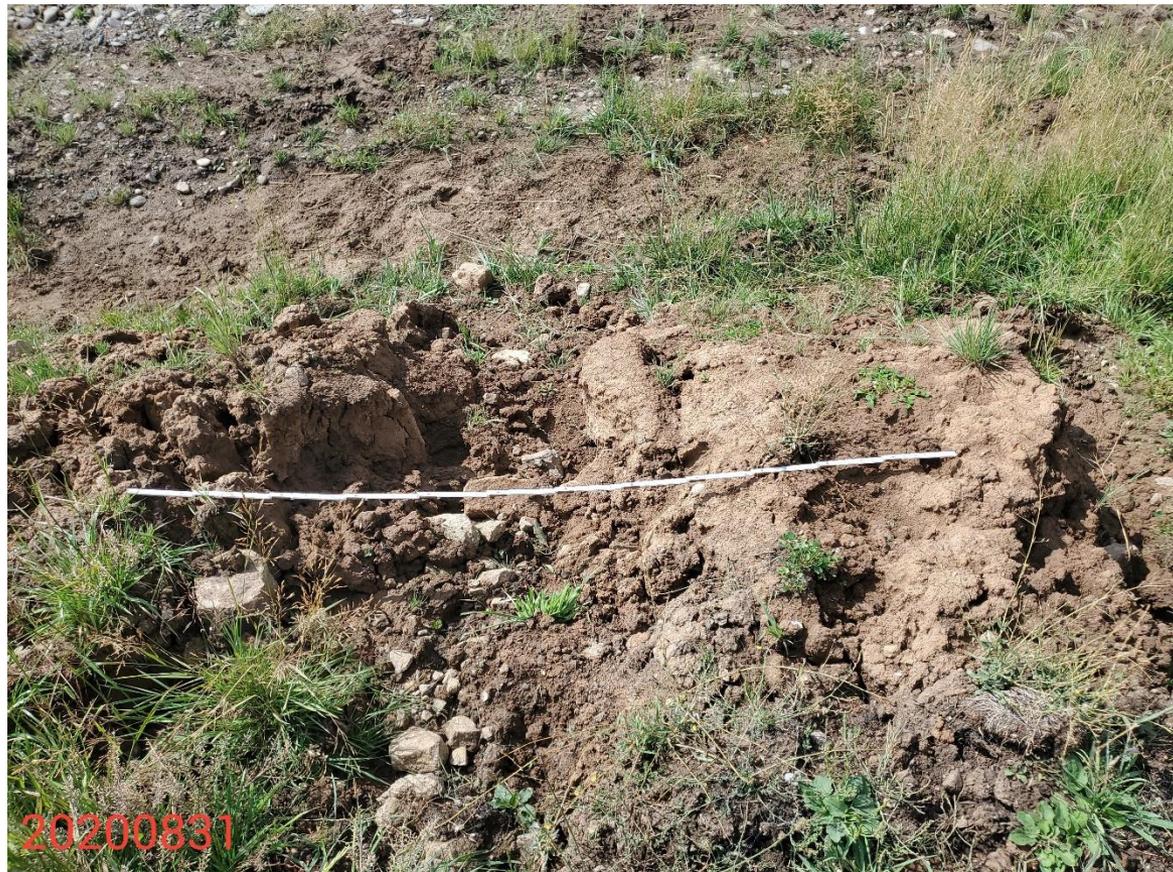
Photo 14: See comments under photo 13. 6 foot measuring stick for reference. .

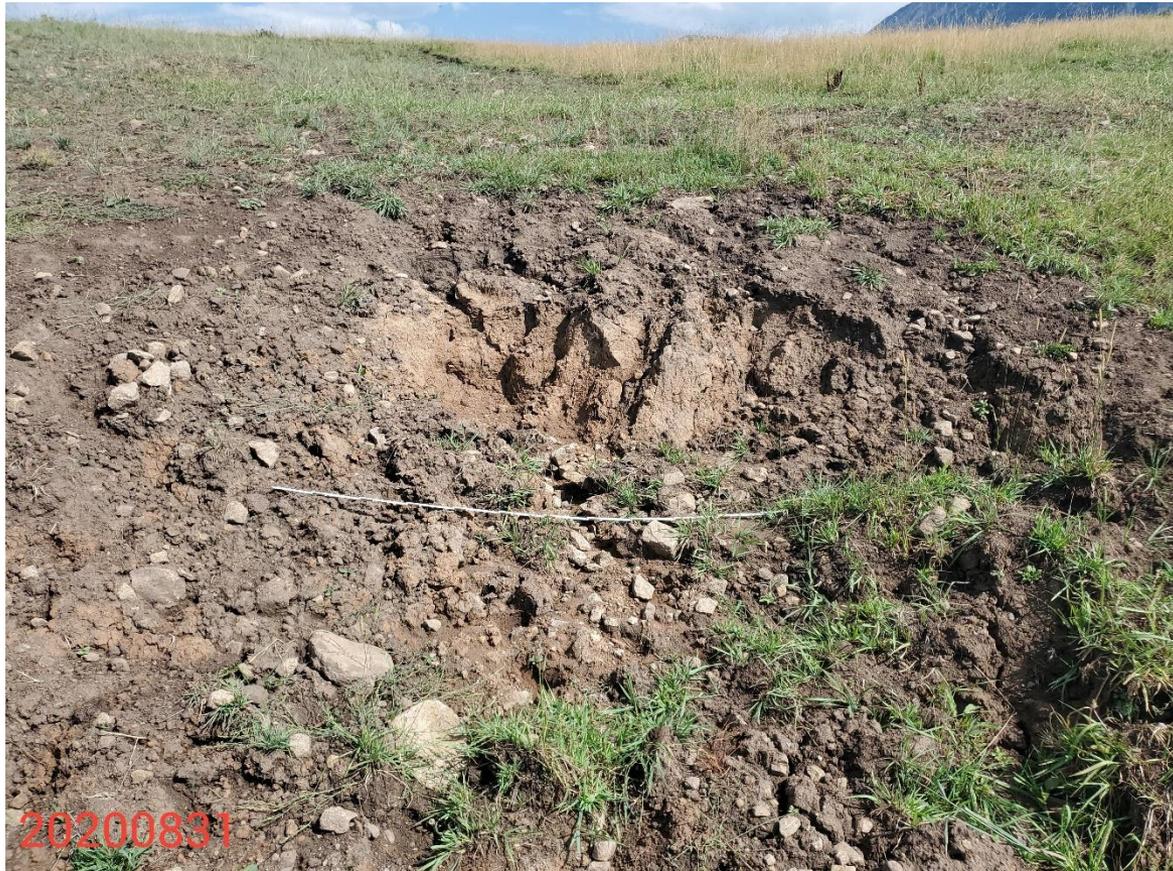
Photo 15: See comments under photo 13. 6 foot measuring stick for reference.

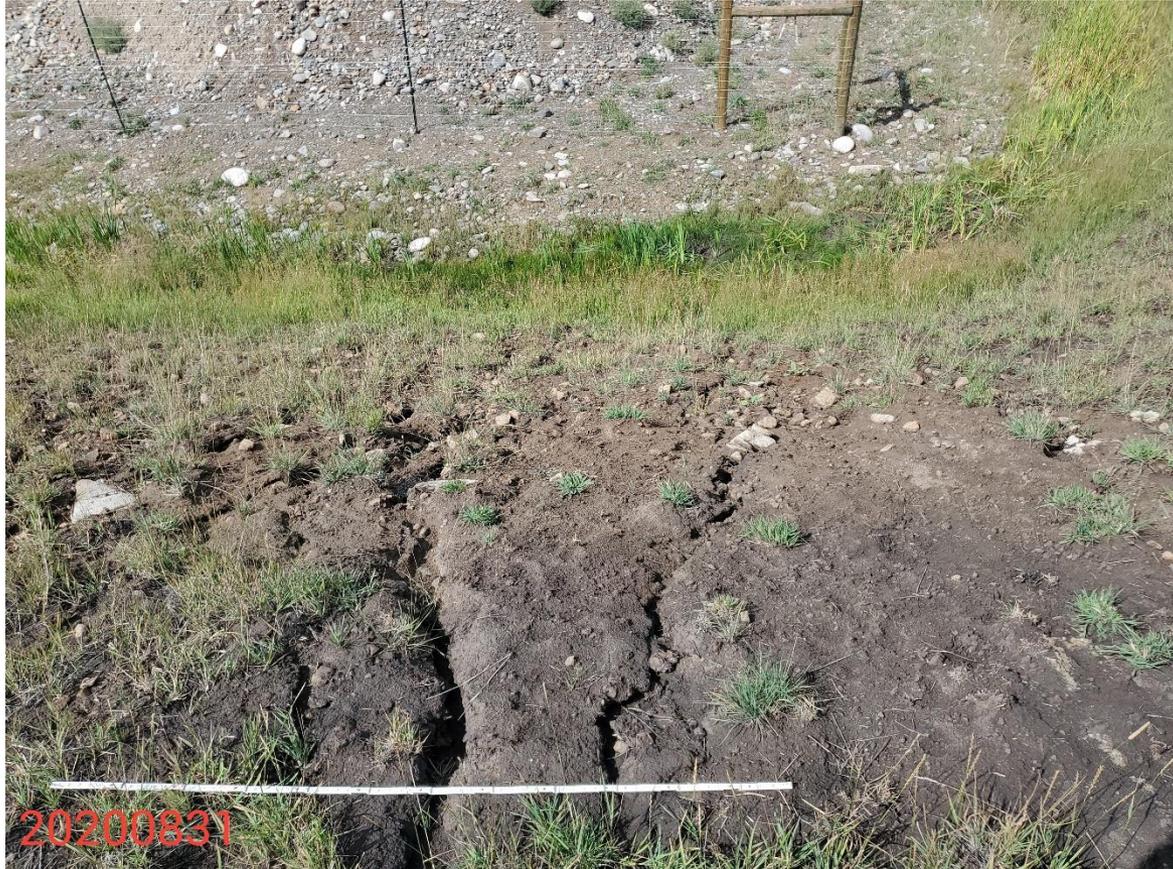
Photo 16: Photo taken from the cut slopes on the northeast corner of the Location. Photo shows BMPs remain missing or insufficient to stabilize and protect slopes. 6 foot measuring stick for reference.
