Inspection Photos
Operator: Hilcorp Energy
API: 067-08082
Date: 8/27/2020

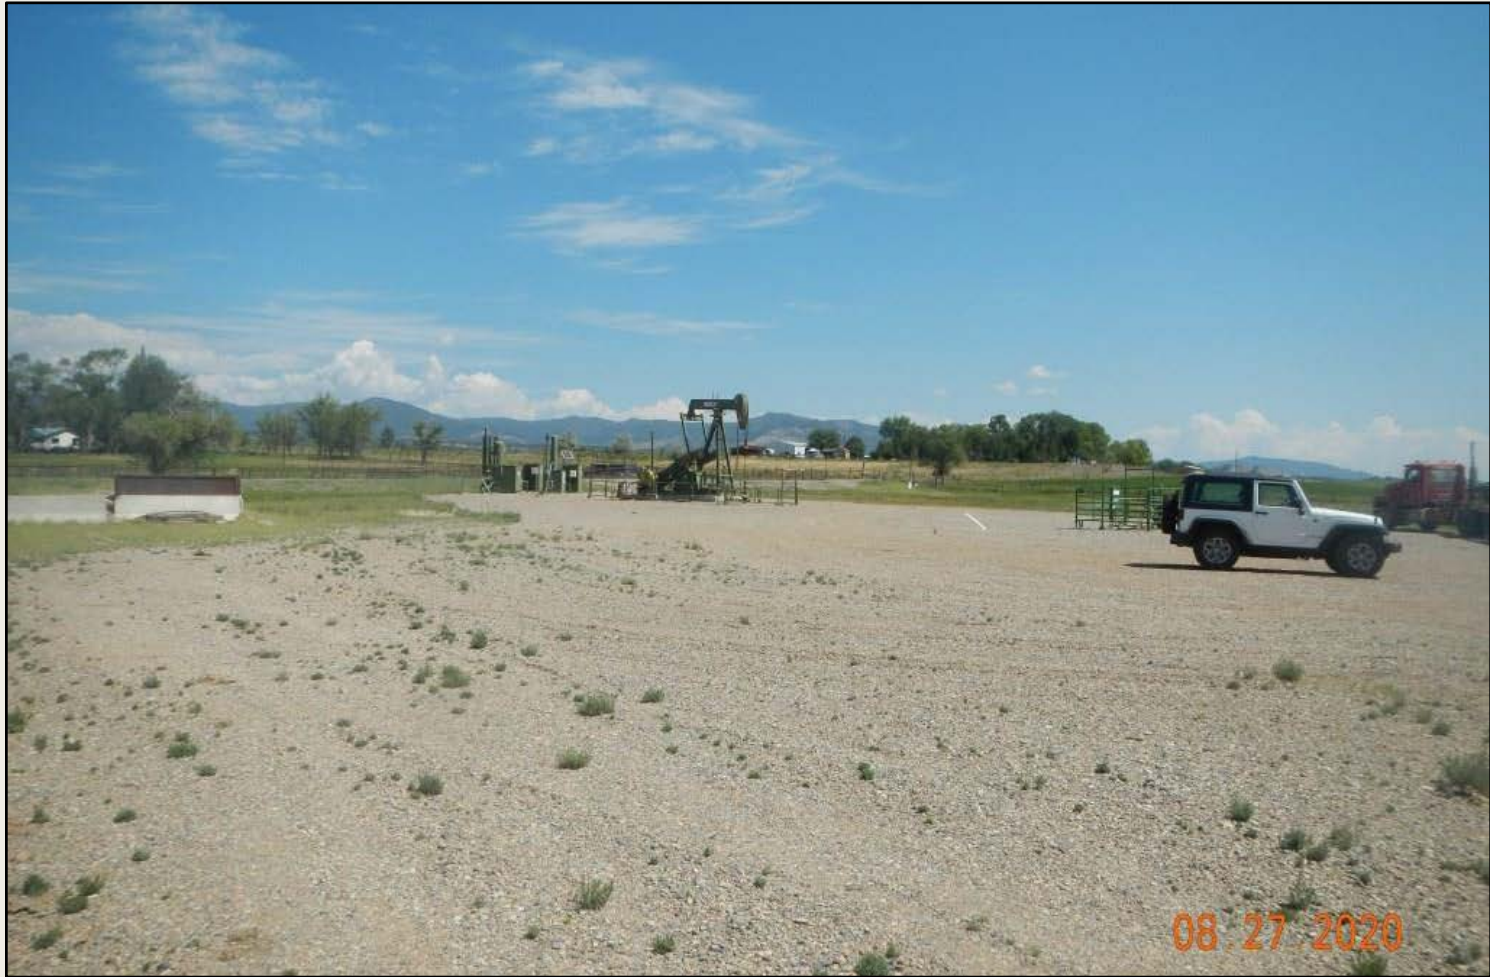
Photo 1. View of the project area from the southwestern corner facing center.

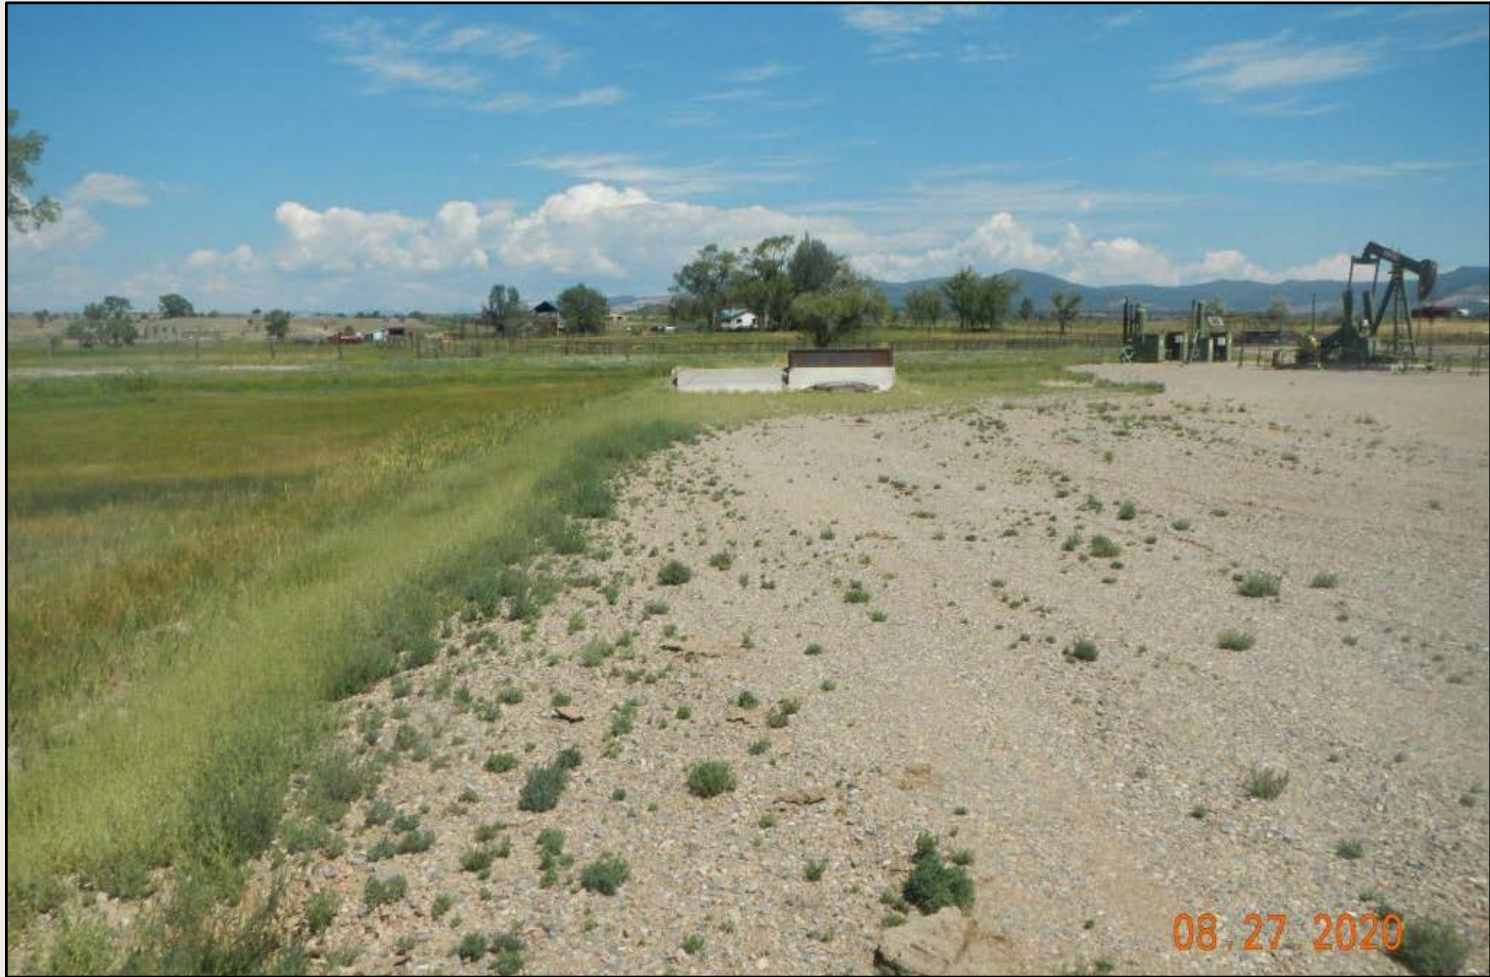
Photo 2. View of the western project area reclamation is not conducted here.

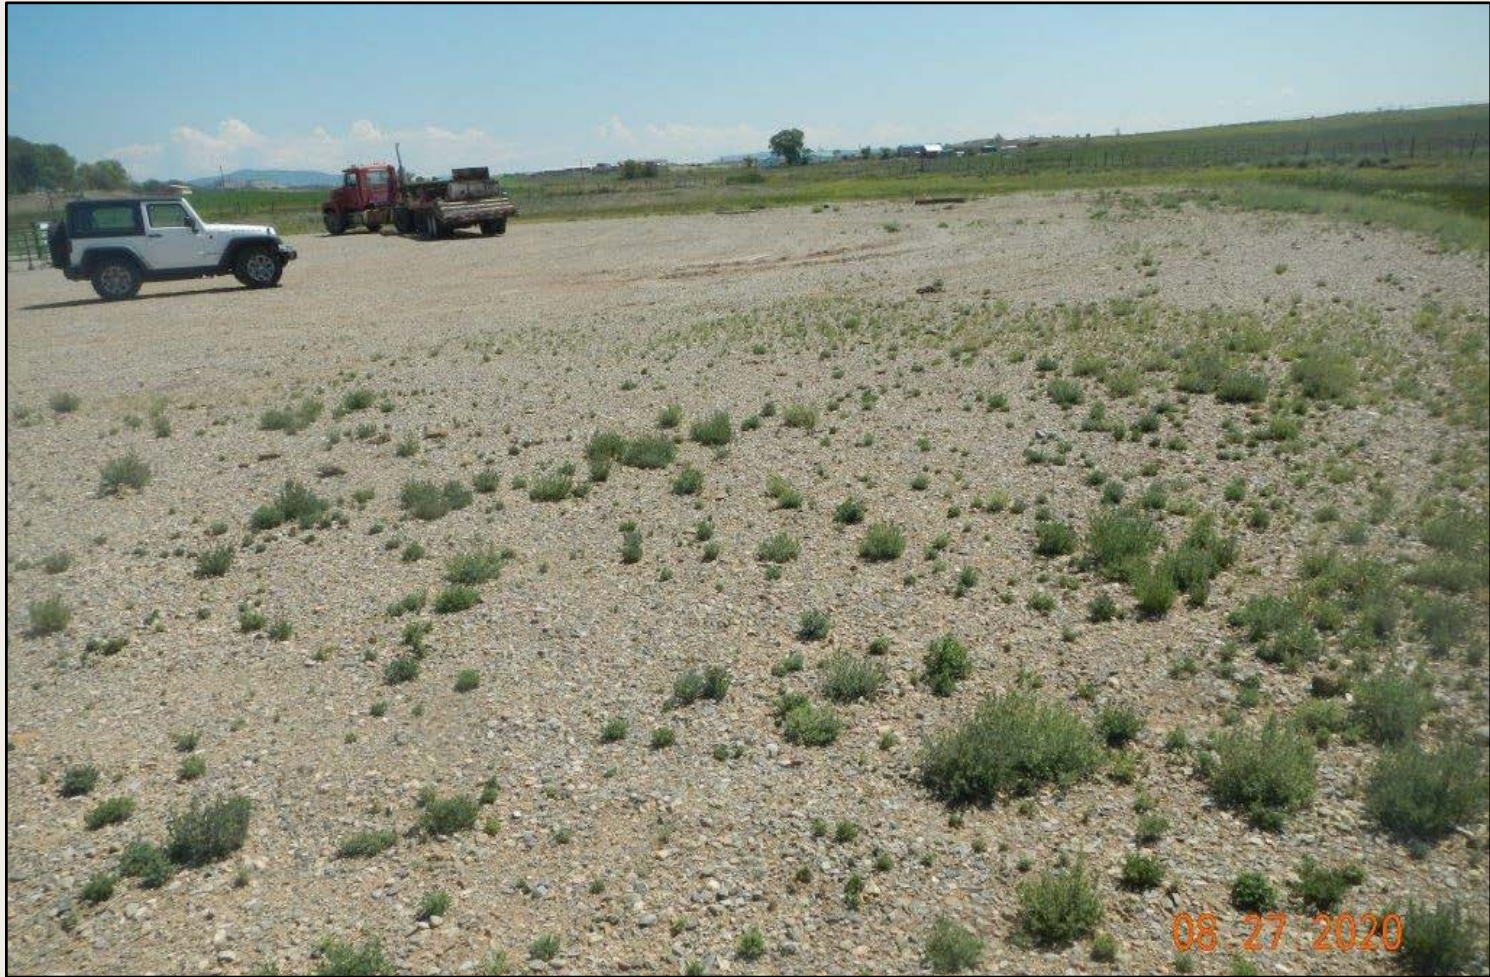
Photo 3. View of the southern project area from the southwestern corner facing eastward. Area is not used for production and needs reclamation.

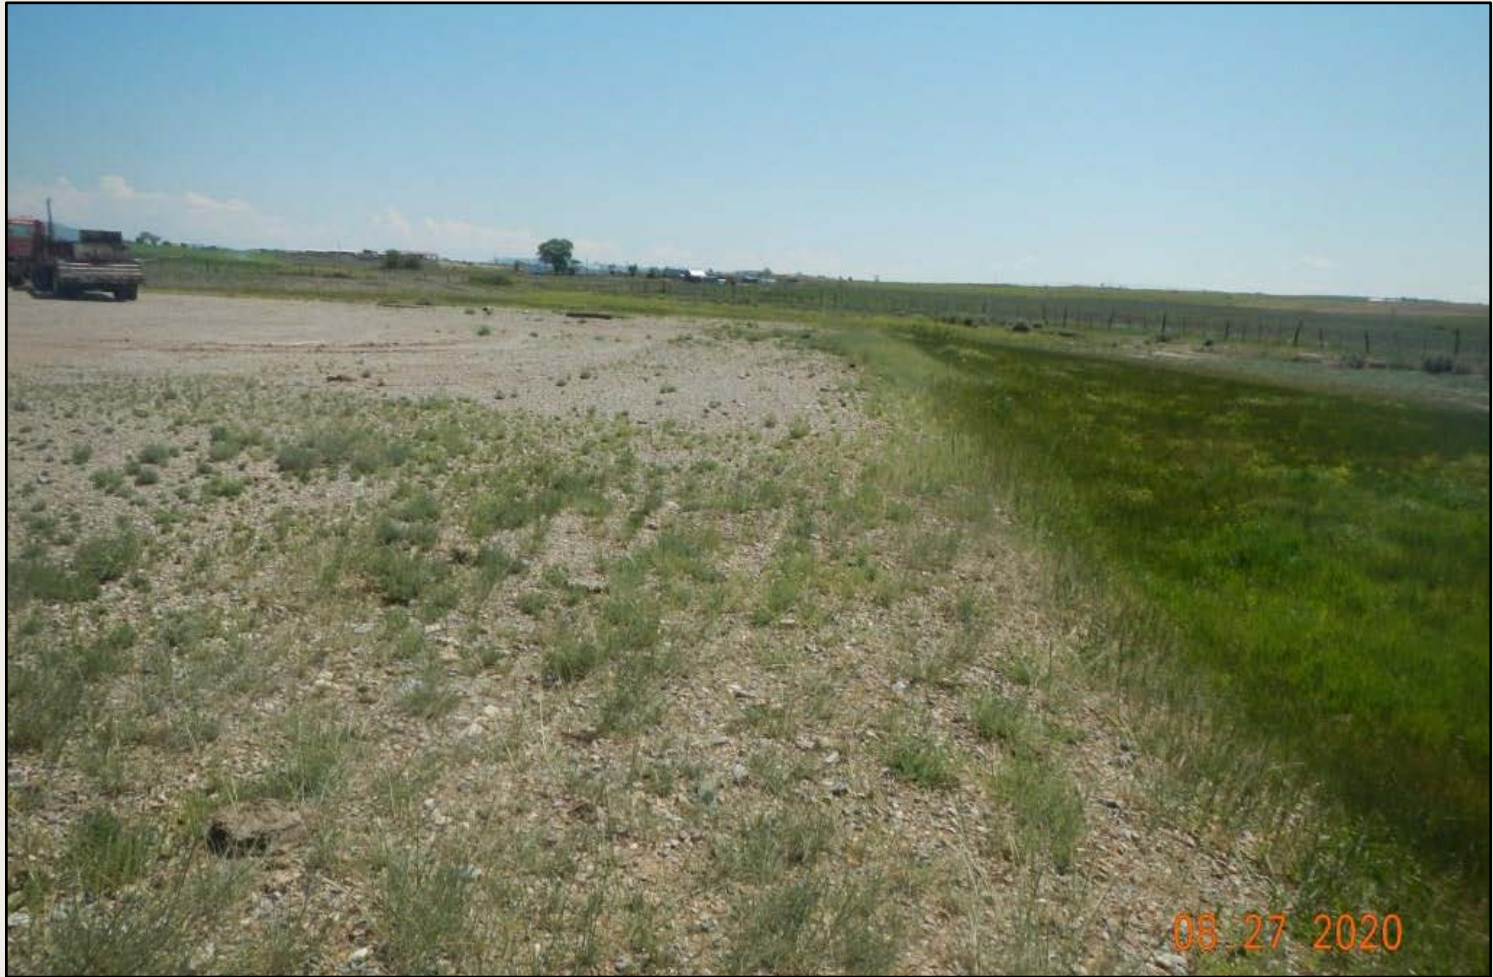
Photo 4. View of the southern edge of the project area facing eastward.

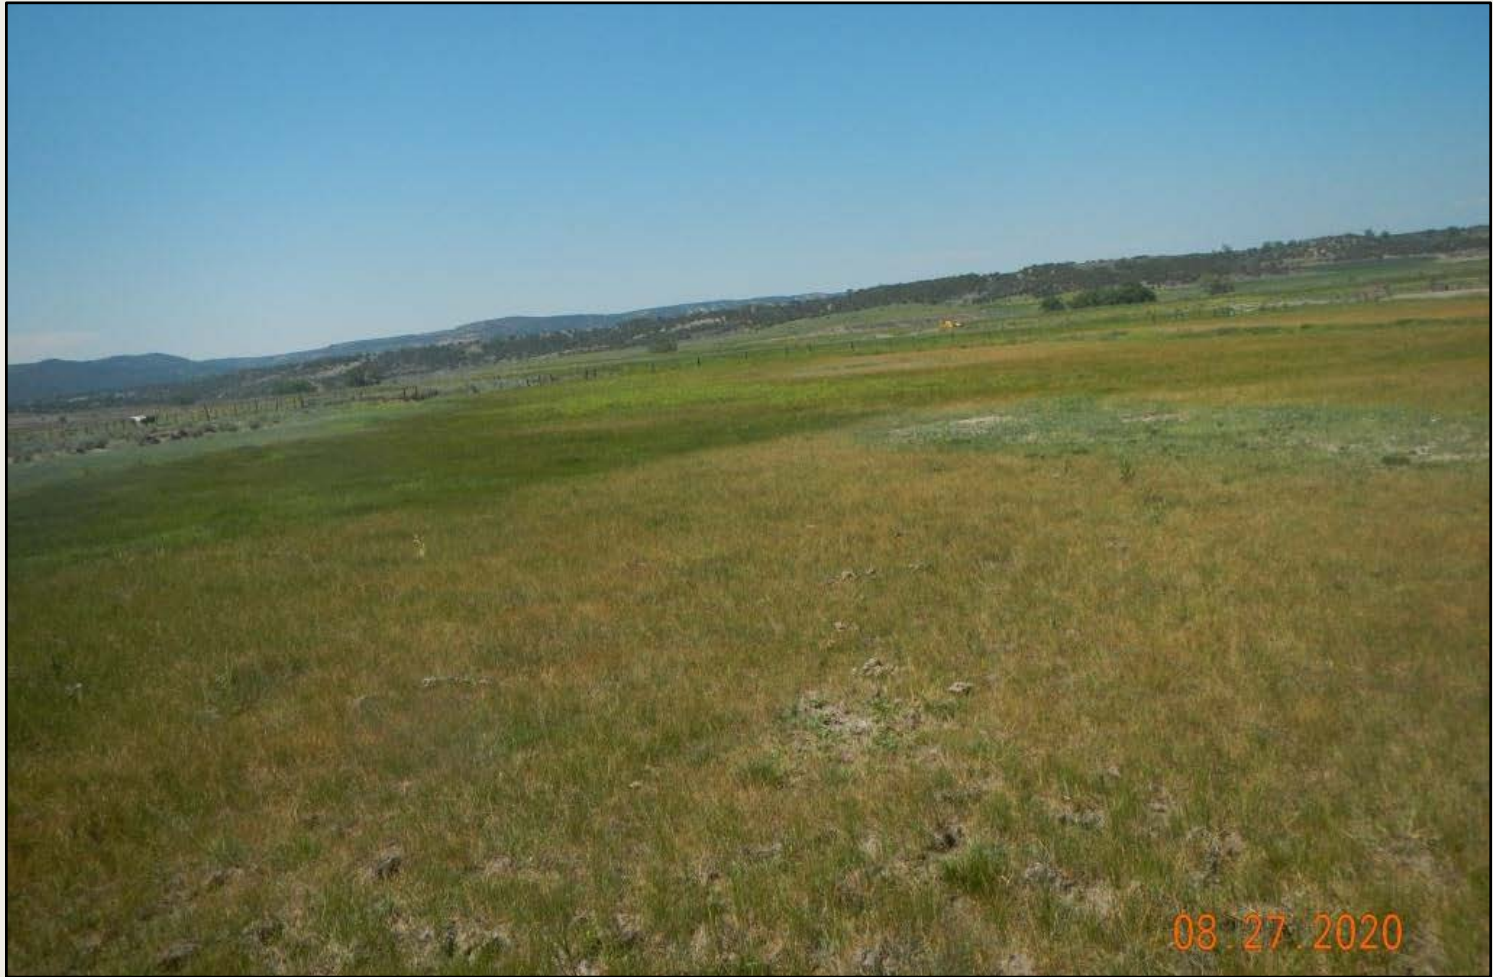
Photo 5. View of reference area vegetation comprised of irrigated grass field with grasses such as orchard grass as well as sedges and rushes such as Baltic rush.
