Inspection Photos
Operator: BP America
API: 067-07161
Date: 9/2/2020

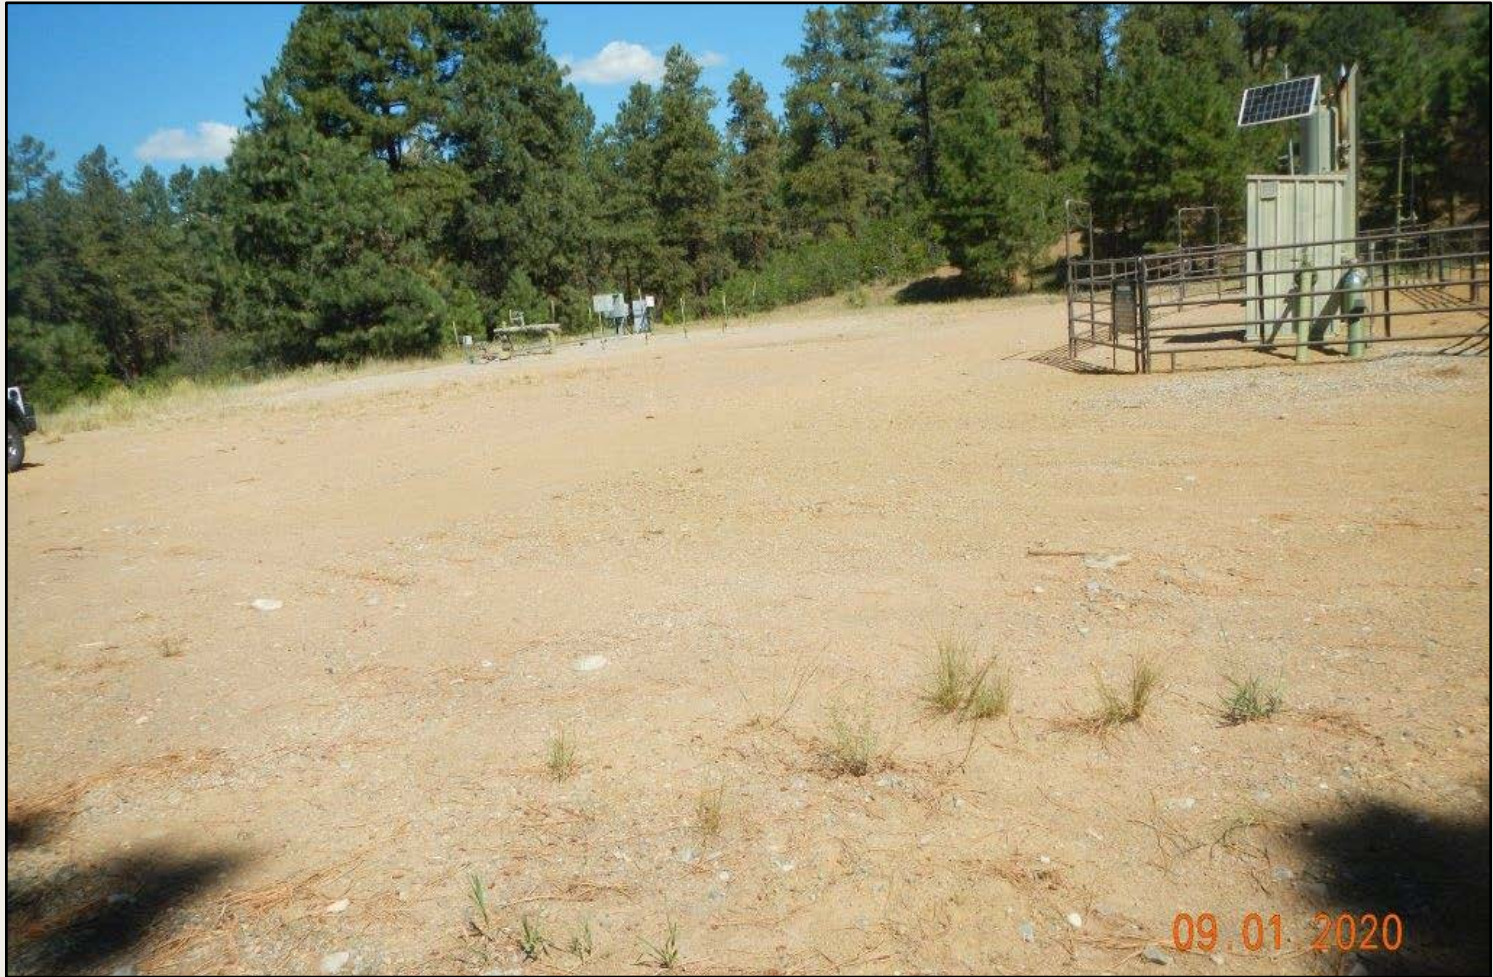
Photo 1. View of the project area from the southeastern corner facing center.

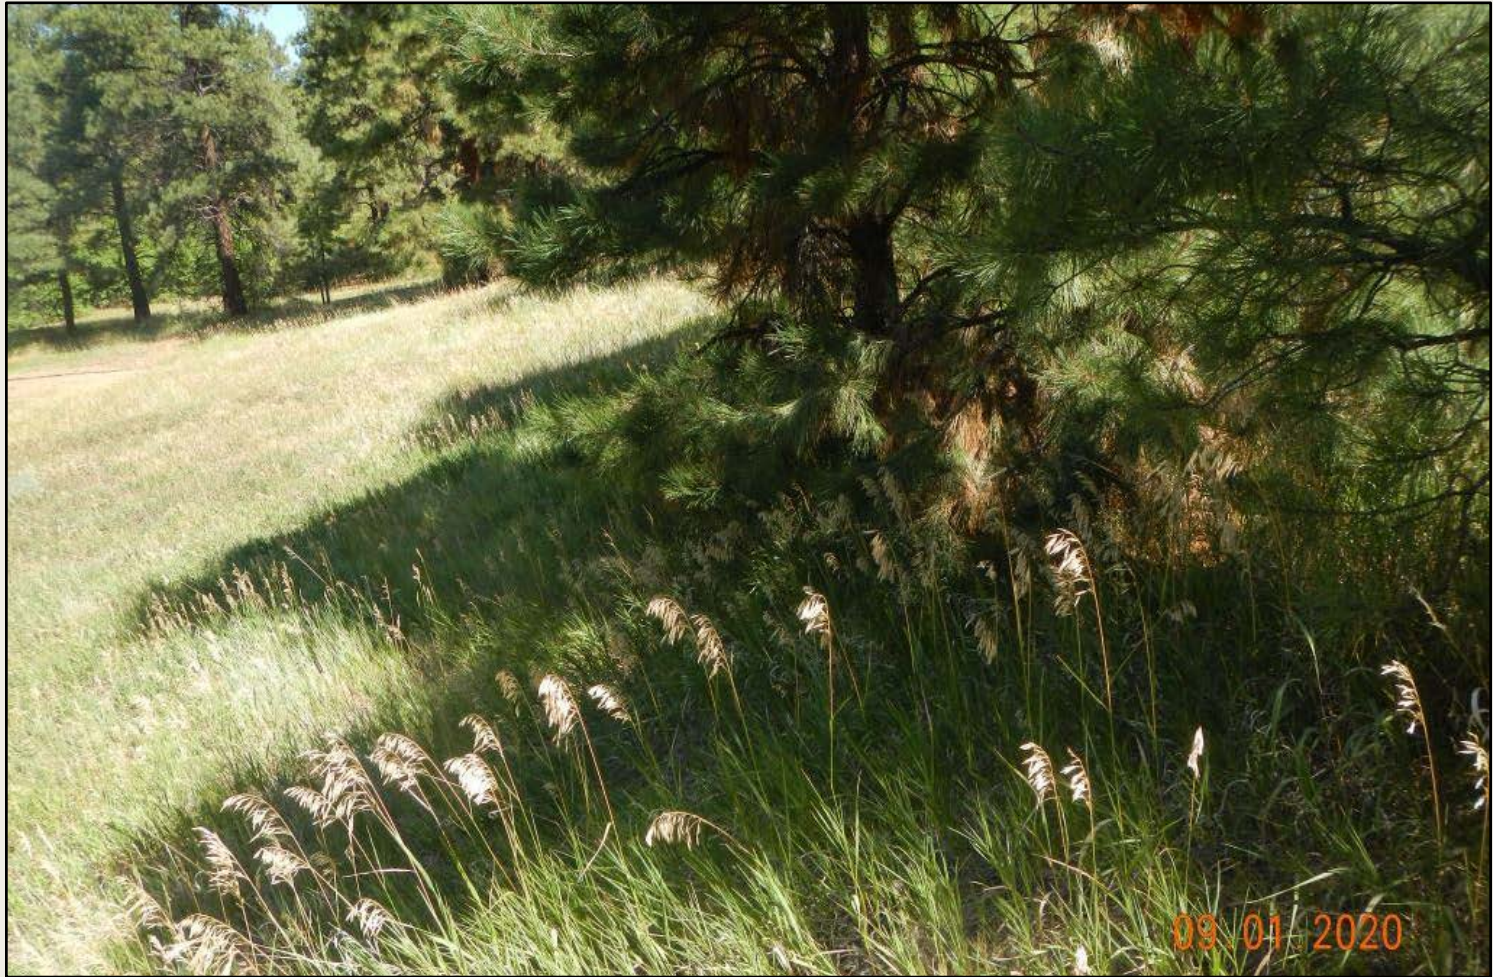
Photo 2. View of the western fill slope from the southwestern corner facing northward. Revegetation is progressing with smooth brome and ponderosa pine trees.

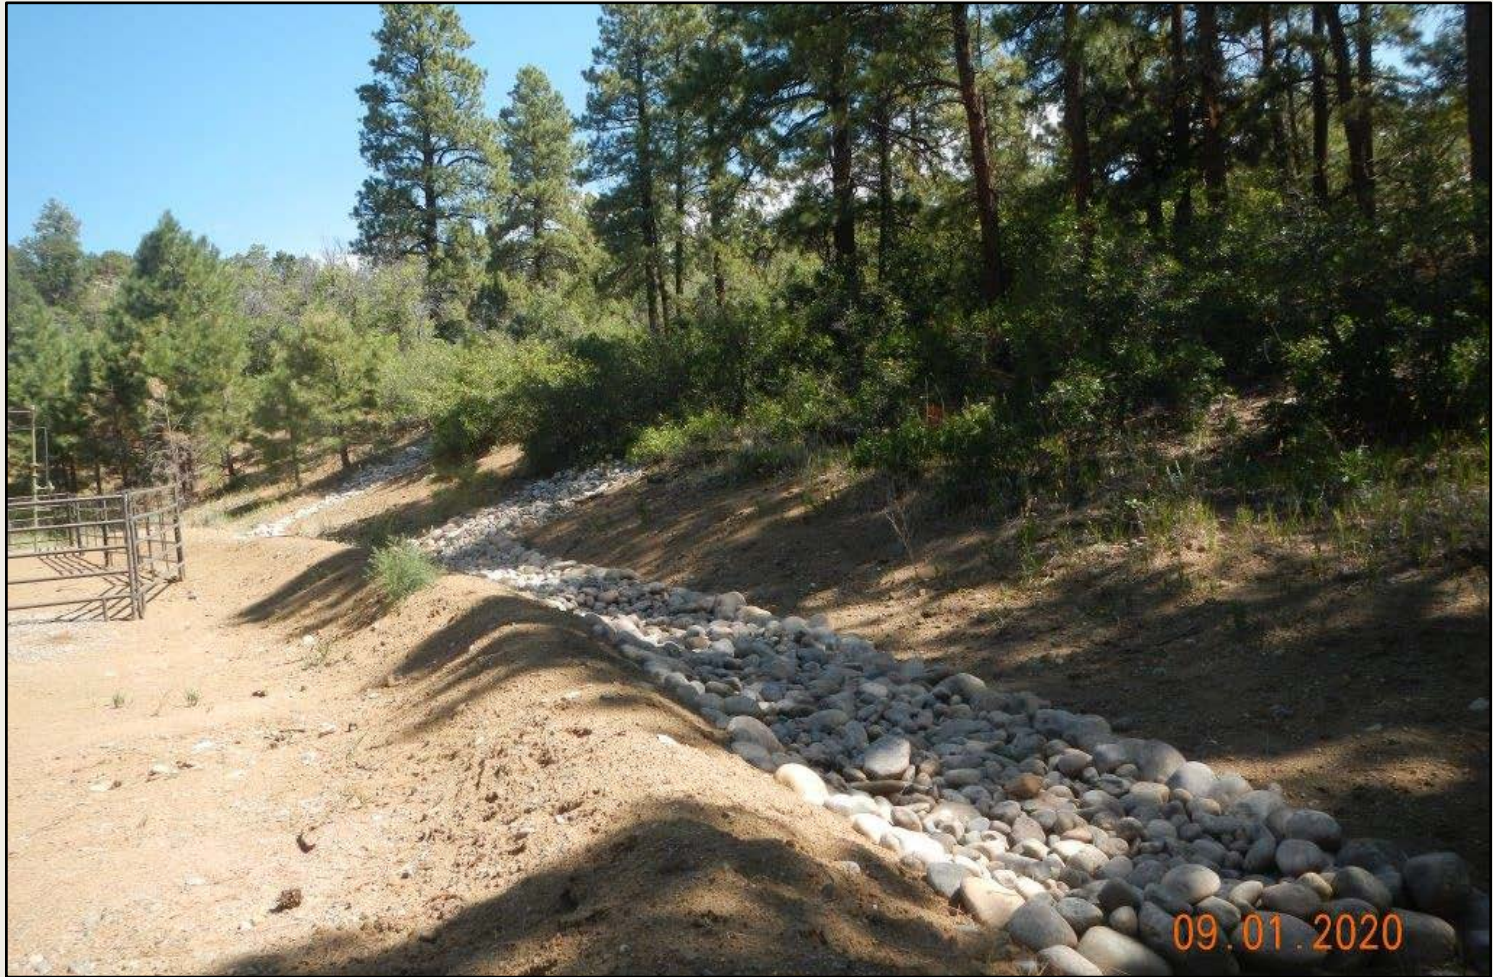
Photo 3. View of the eastern project area facing northward. Stormwater controls including cobble run-down, are installed.

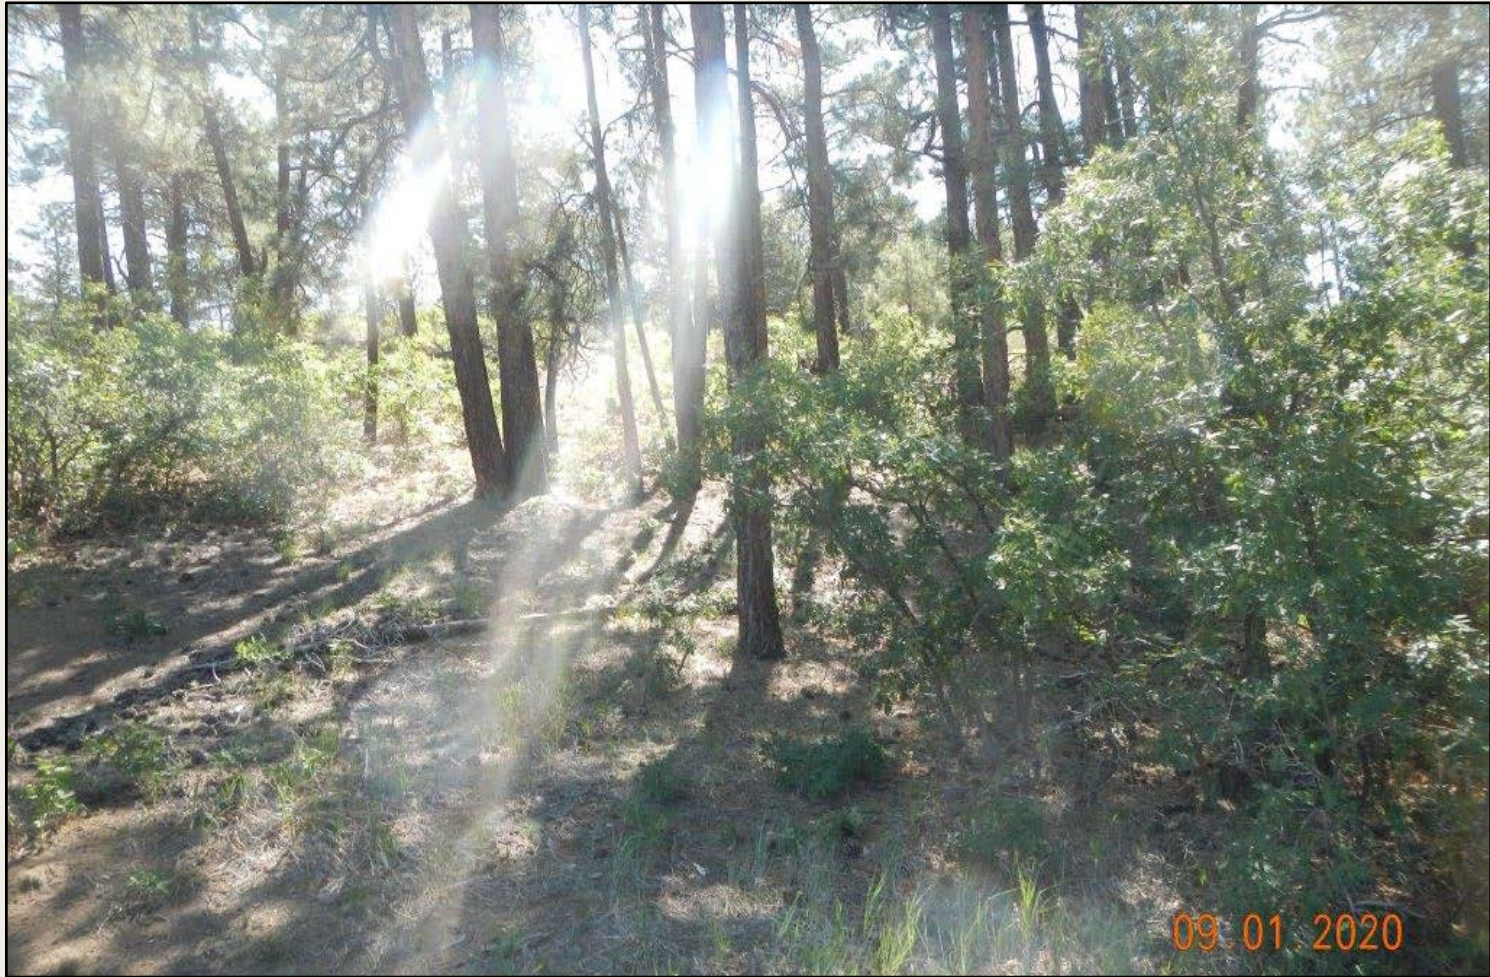
Photo 4. View of reference area vegetation comprised of ponderosa pine forest with an understory of gambel oaks, Oregon grape, Junegrass, Sandberg bluegrass.
