Inspection Photos

Location Name: MARALEX RESOURCES INC FEDERAL-68S98W /25SESW

Location ID: 312507

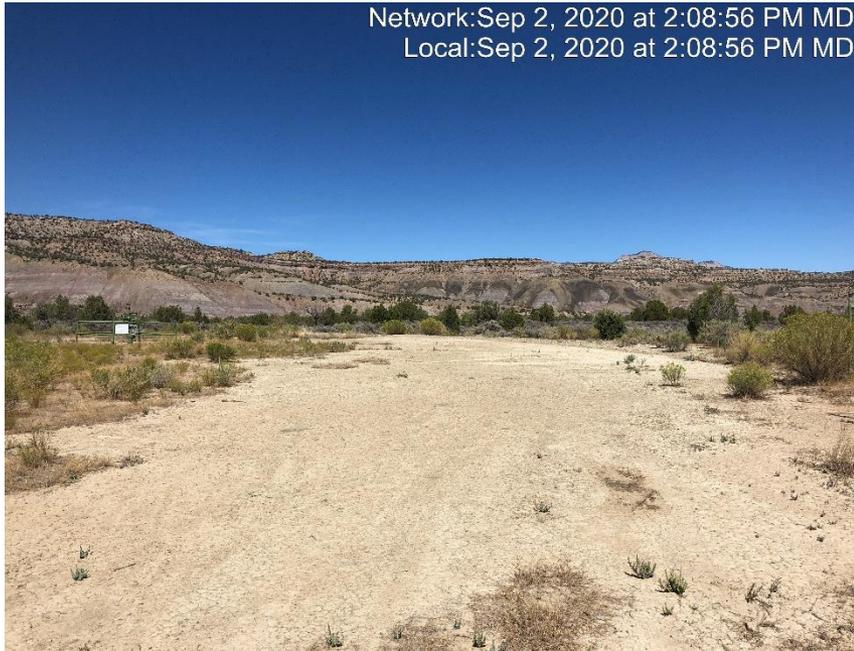
Photo #1838 from entrance to location

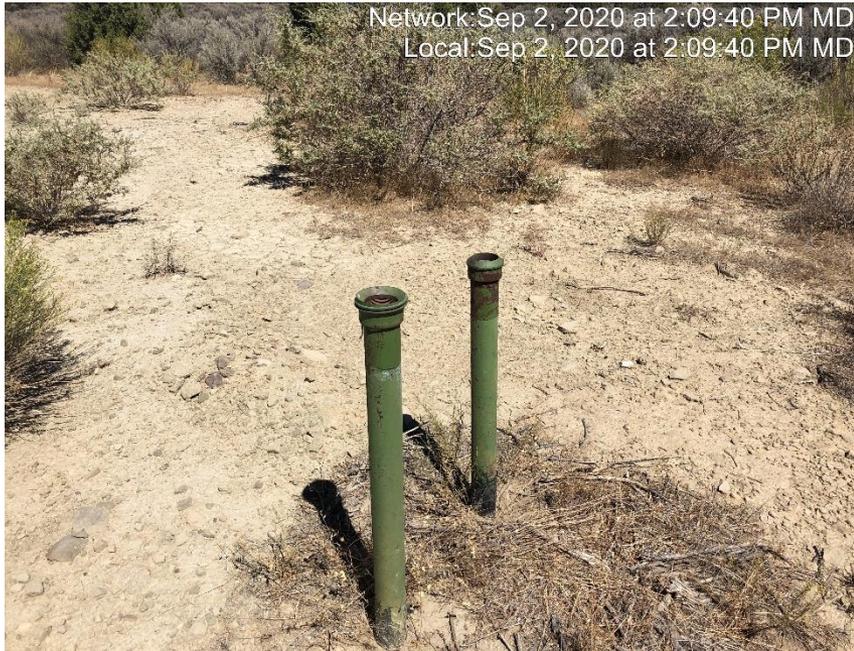
Photo #1839 flow line risers not LO/TO.
