Inspection Photos

Operator: BP America
API: 067-07114
Date: 9/1/2020

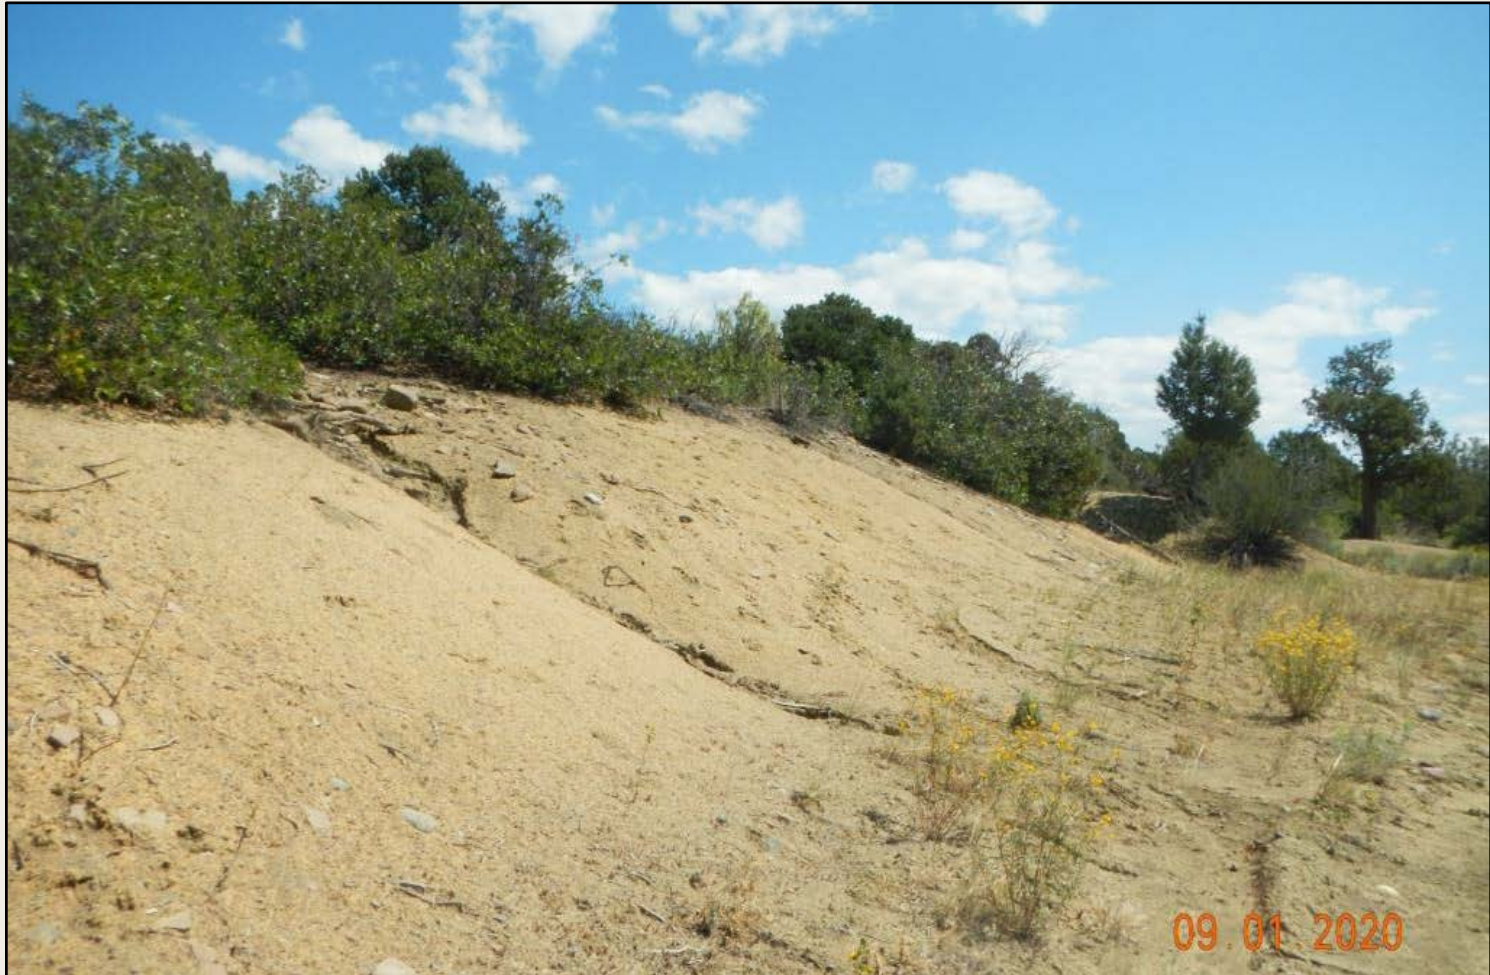
Photo 1. View of the northern cut-slope facing northeastward. Area is hydromulched, erosion and revegetation need to be monitored here.

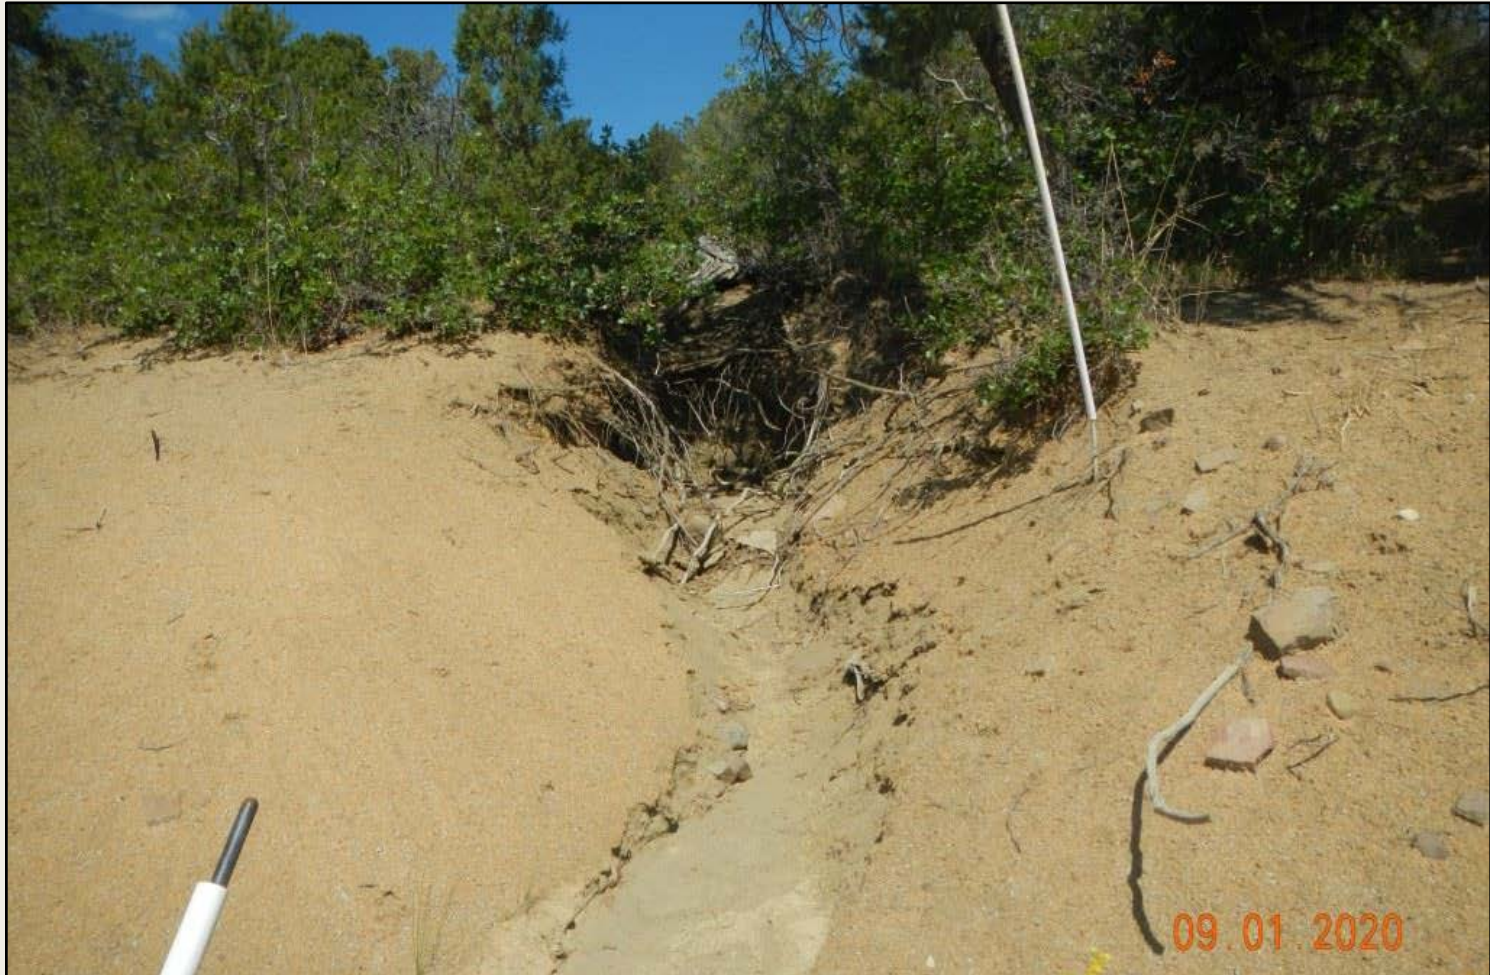
Photo 2. View of erosional channel approximately 3-5 feet wide and deep, within the northern cut-slope. Stabilization measures are needed here as significant erosion is observed.

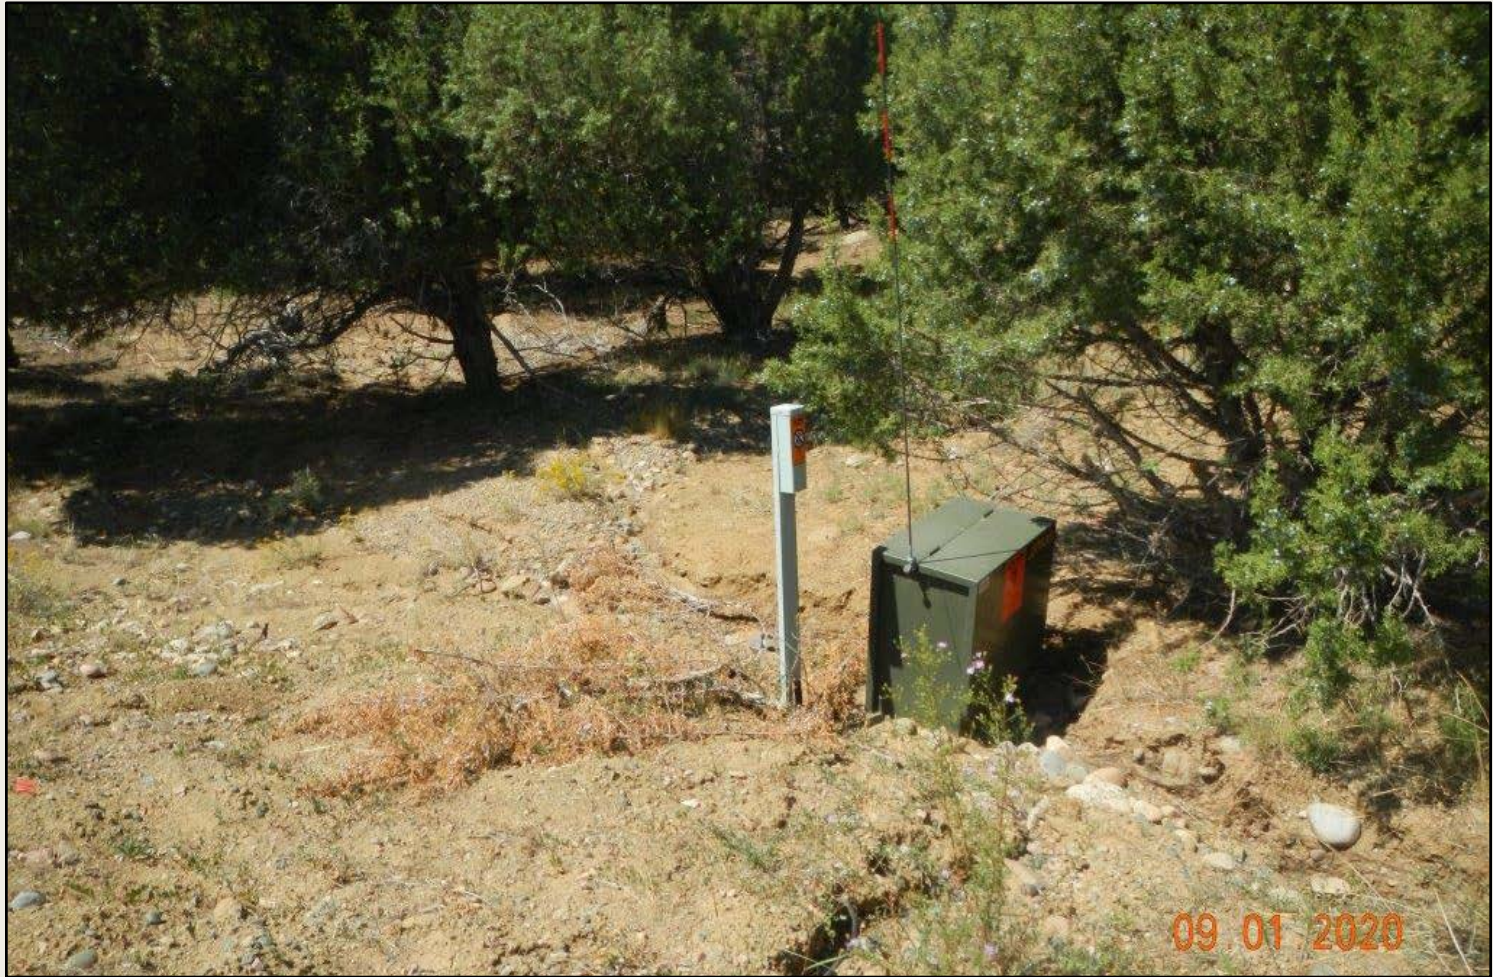
Photo 4. View of erosional channeling near the well pad entrance, approximately 1.5-2 feet wide and deep.

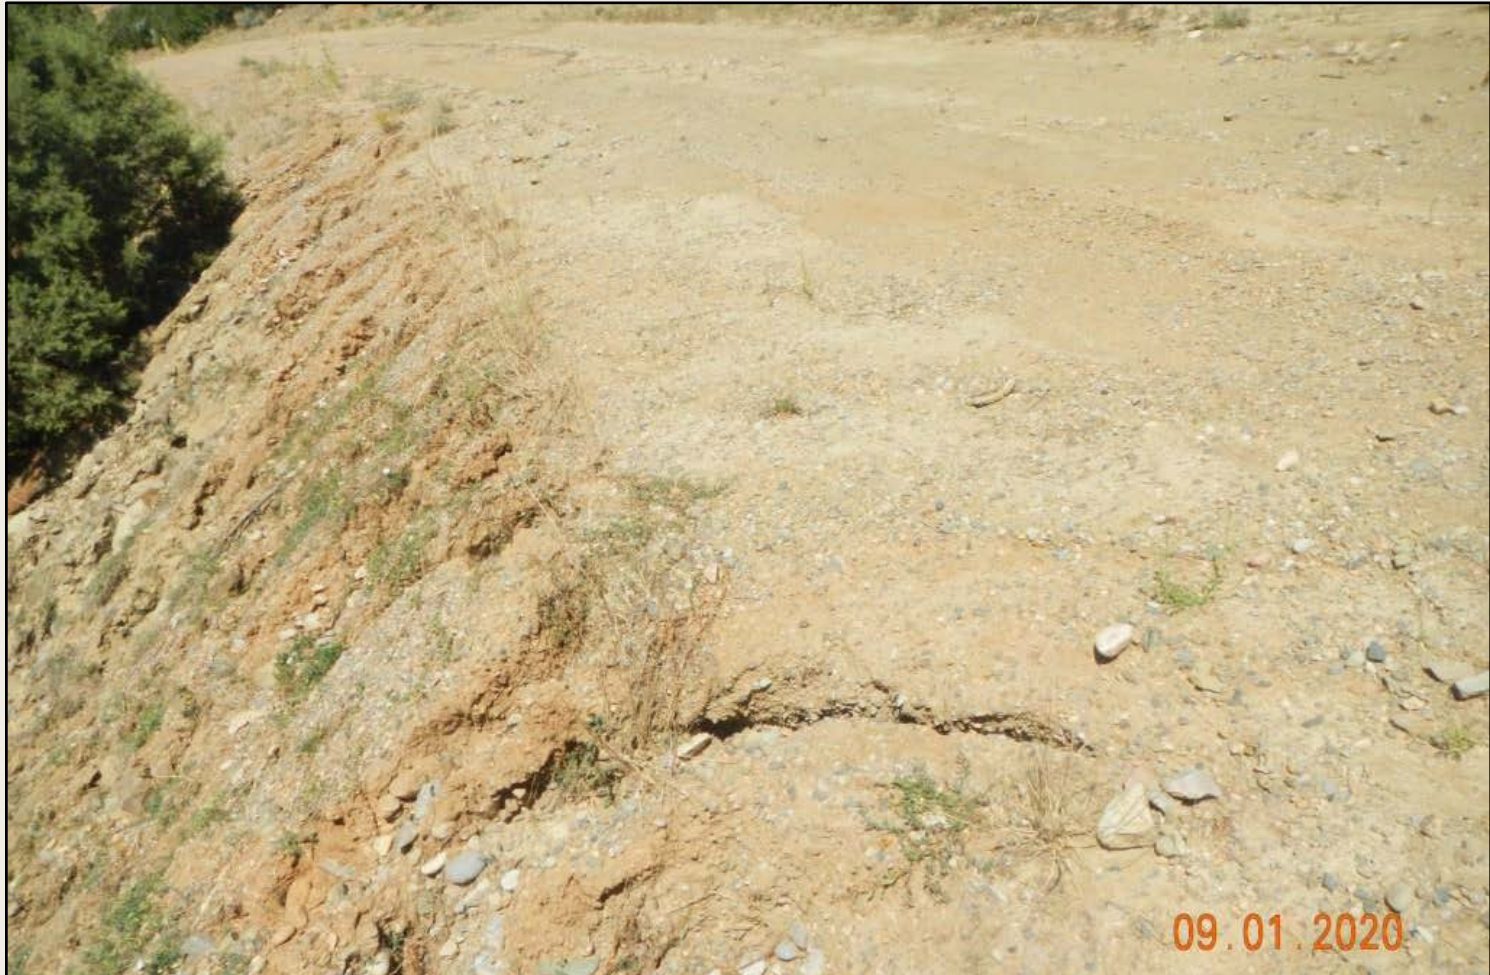
Photo 5. View of deep (~1 ft) rilling and scouring occurring along the access road where it appears that a recent storm event has recently caused significant erosion. BMPs along the access road need maintenance and repair,
