Inspection Photos
Operator: BP America
API: 067-08150
Date: 9/1/2020

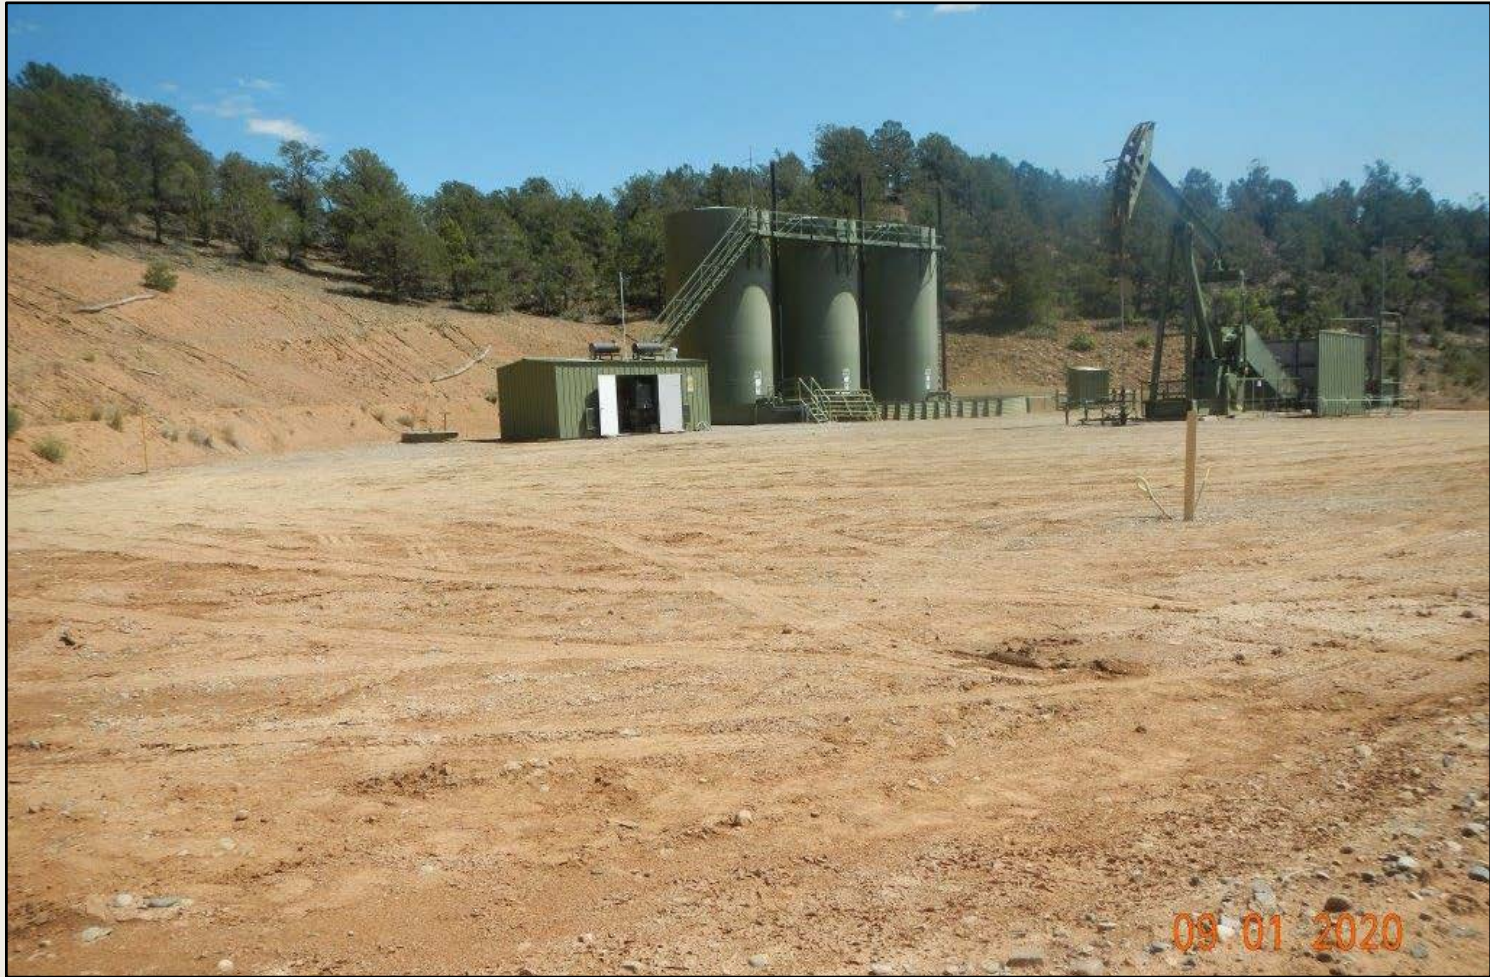
Photo 1. View of the project area from the northwestern corner facing center.

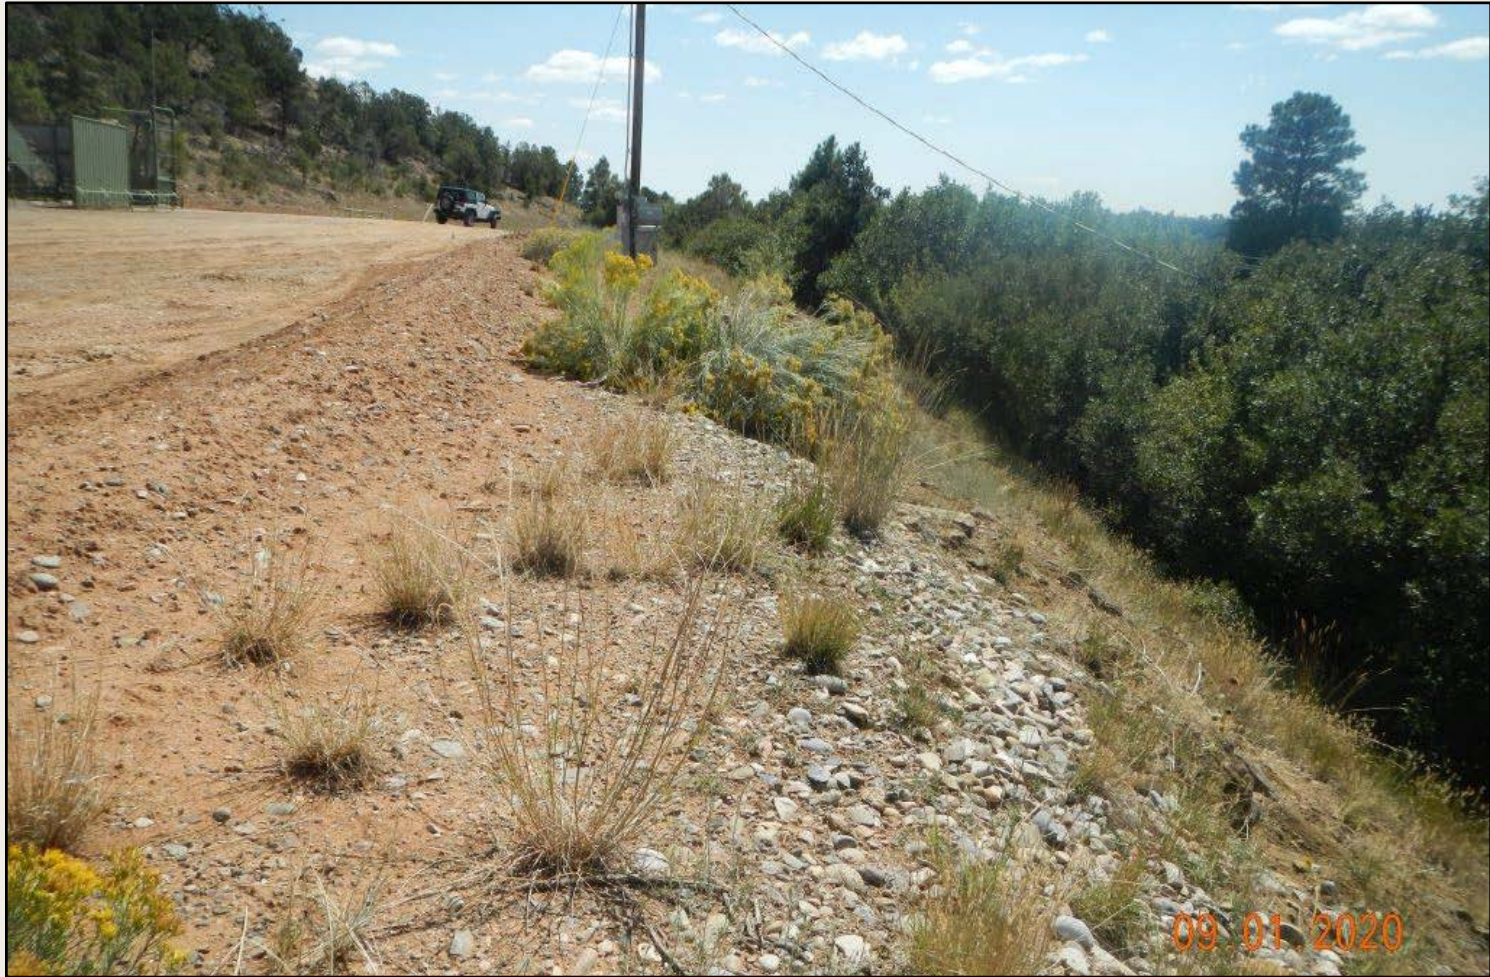
Photo 2. View of the western fill slope from the northeastern corner facing southward. Revegetation is progressing with grasses such as crested wheatgrass and sand dropseed.

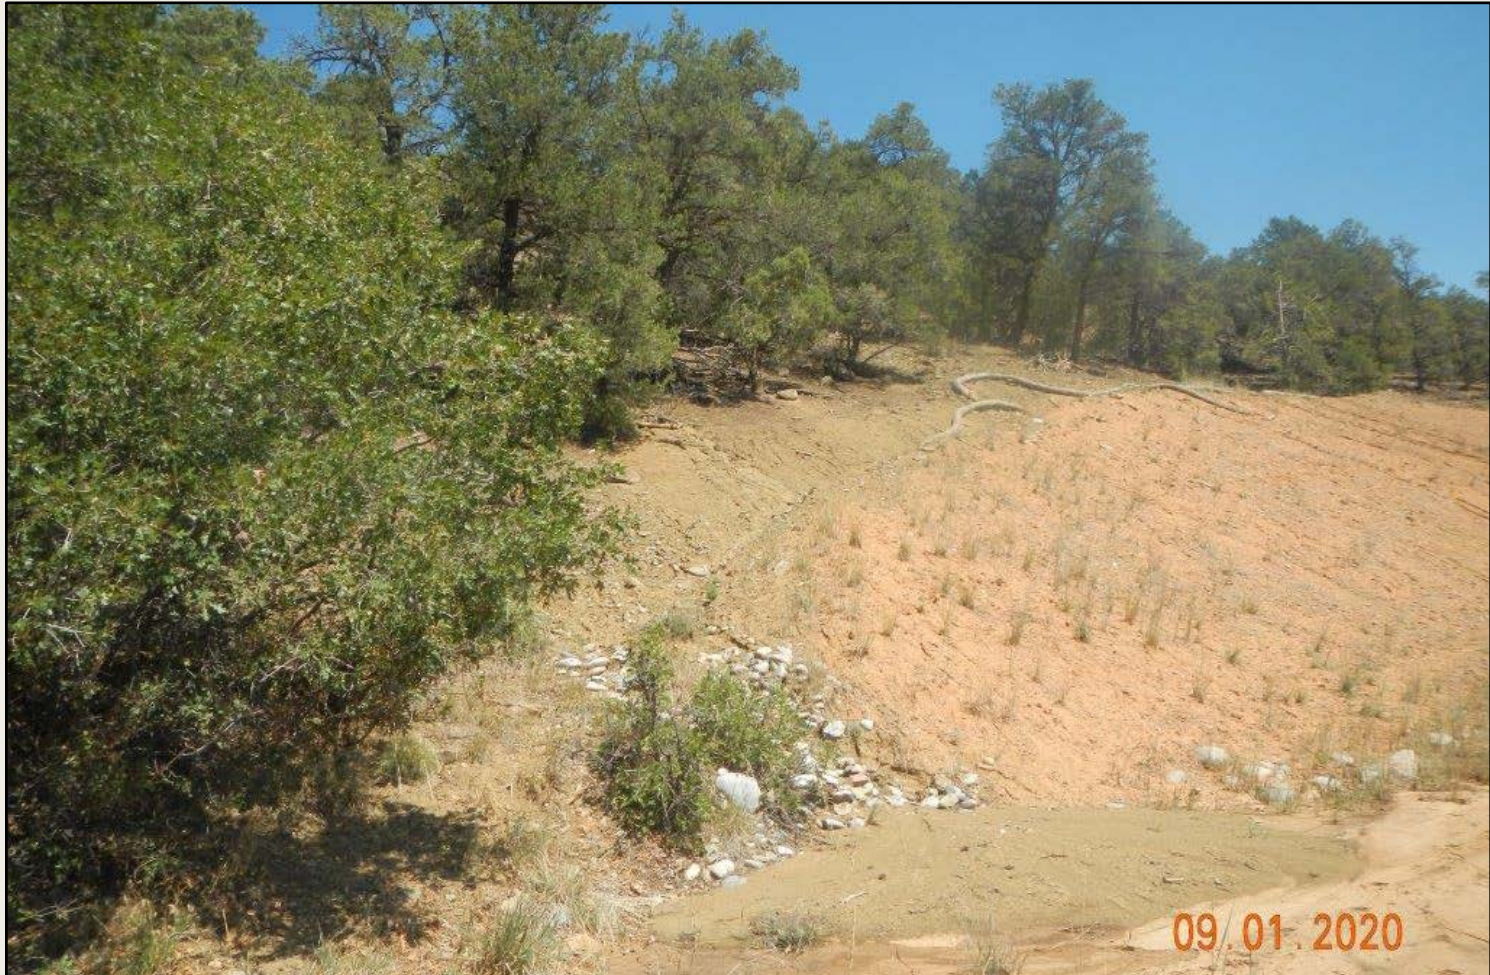
Photo 3. View of sediment plume from the well pad cut-slope settled in the northeastern project area.

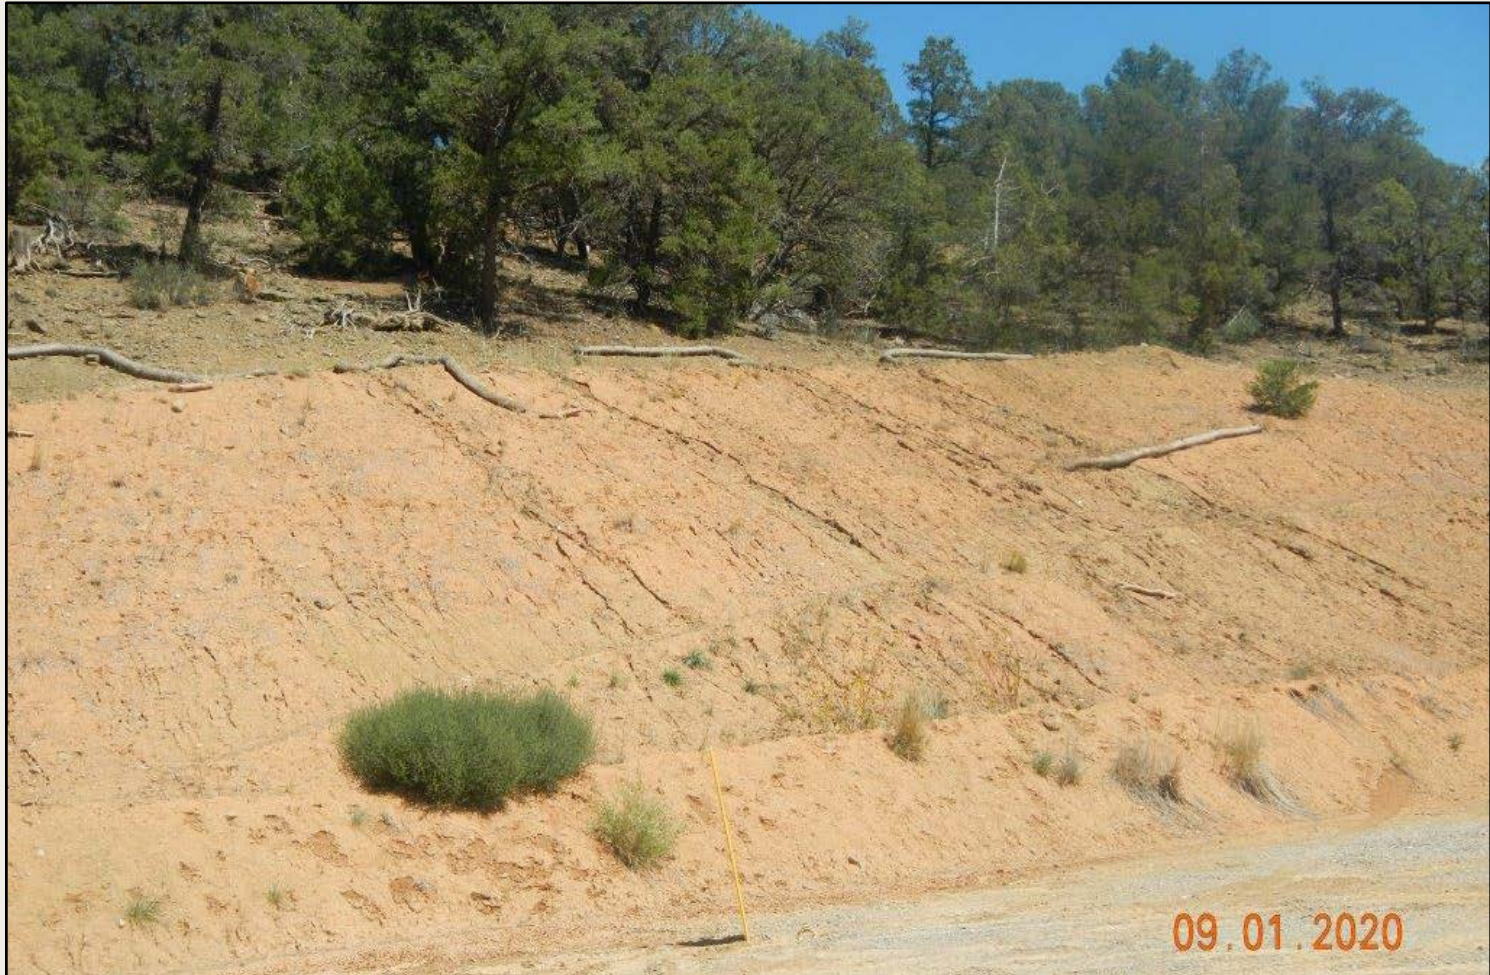
Photo 3. View of well pad cut-slope showing wattles needing maintenance. Area appears to be hydroseeded.

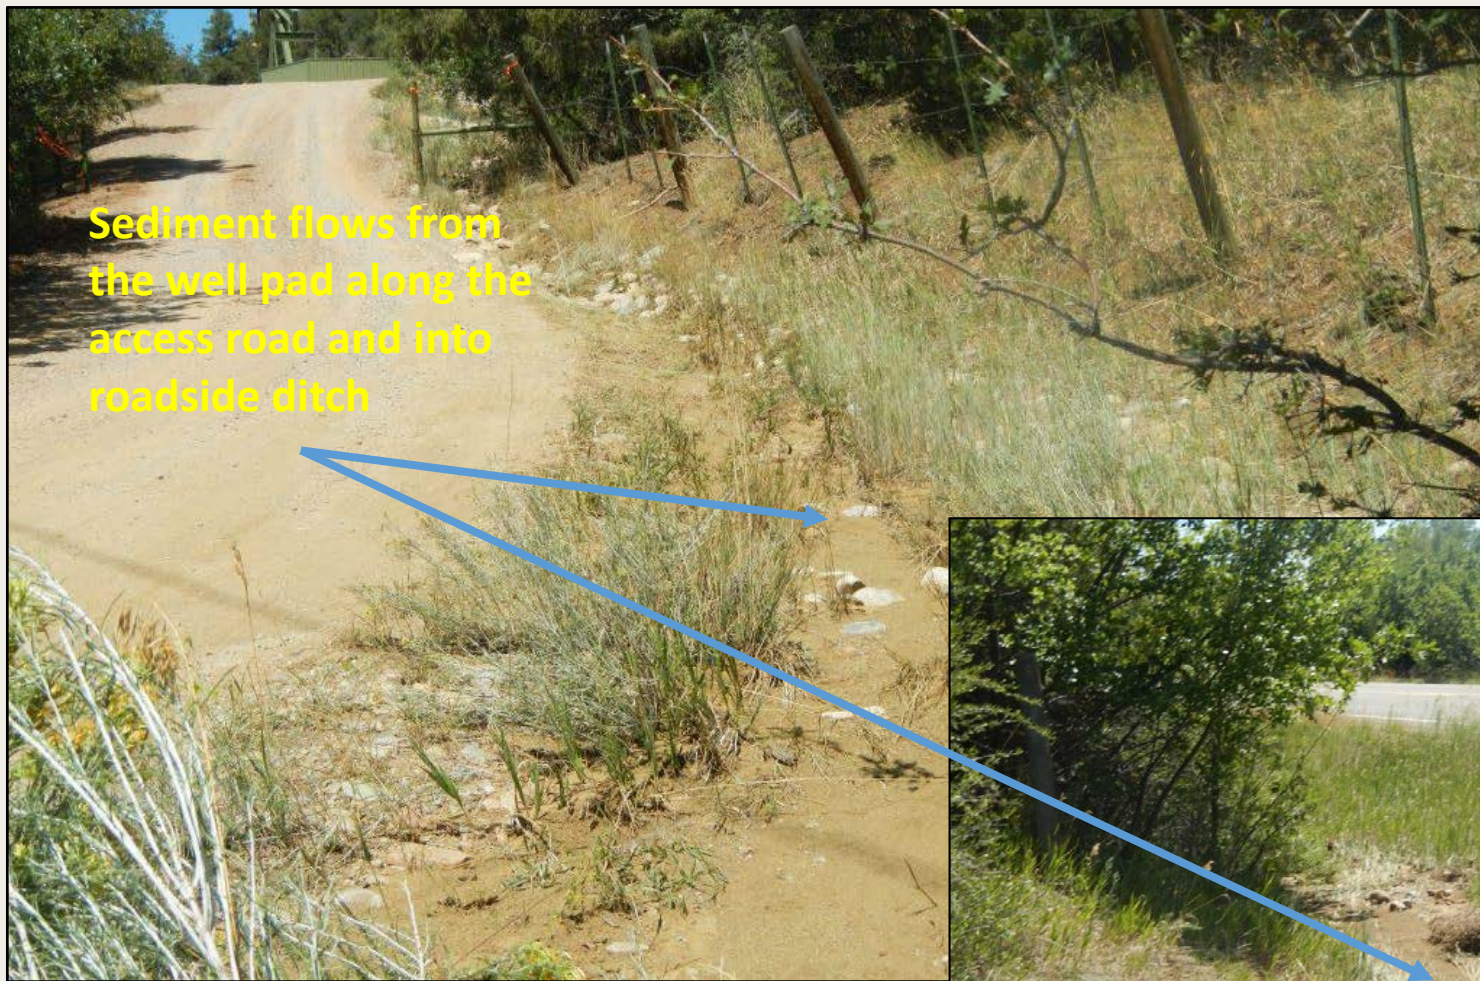
5.

Sediment flows from
the well pad along the
access road and into
roadside ditch

Photos 5/6. View of sediment flow downstream from the well pad, along the access road (5), and into roadside ditch (6).

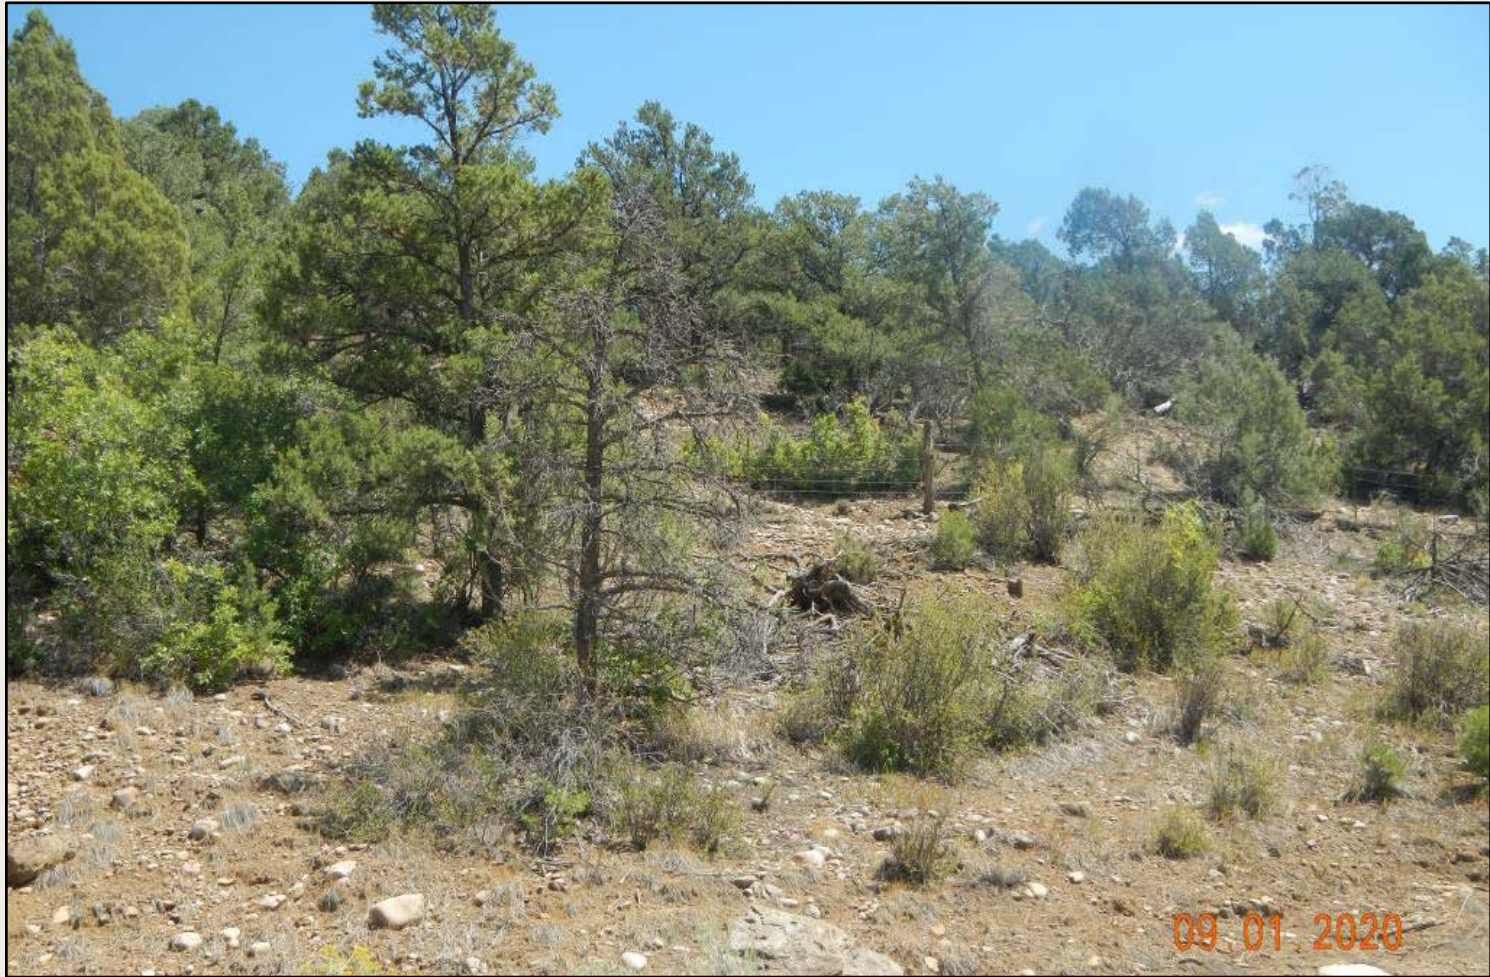
Photo 7. View of reference area vegetation comprised of mixed gambel oak and ponderosa pine woodland, with pinyon and juniper trees, shrubs such as mountain mahogany and antelope bitterbrush, as well as grasses and forbs such as Indian ricegrass, James galleta, and bricklebrush.
