Inspection Photos
Location Name: Grant Tank Battery
Location ID: 446484
Remediation Project No. 12158

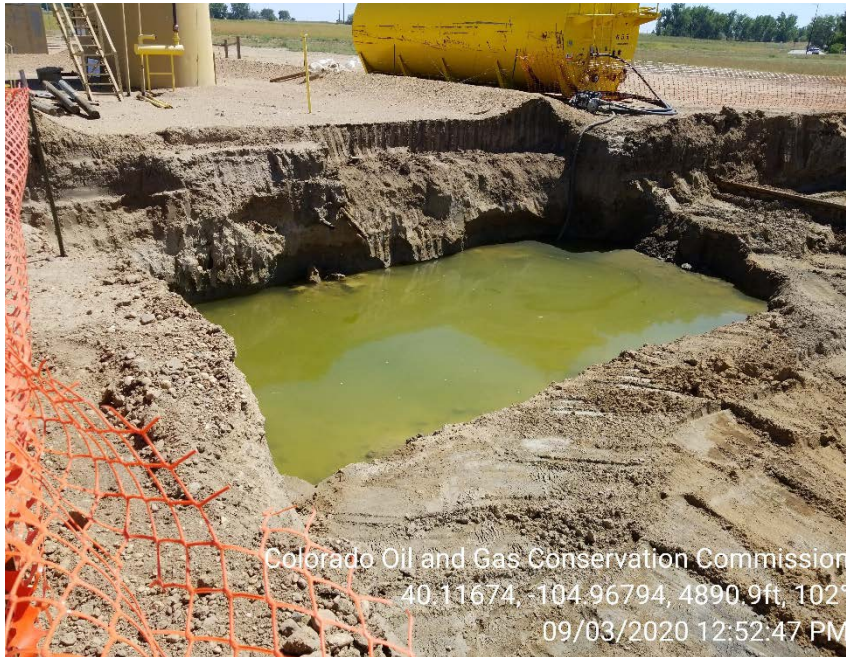
Photo 1 – Groundwater in northeast portion of the eastern excavation. Sheen observed on the water.

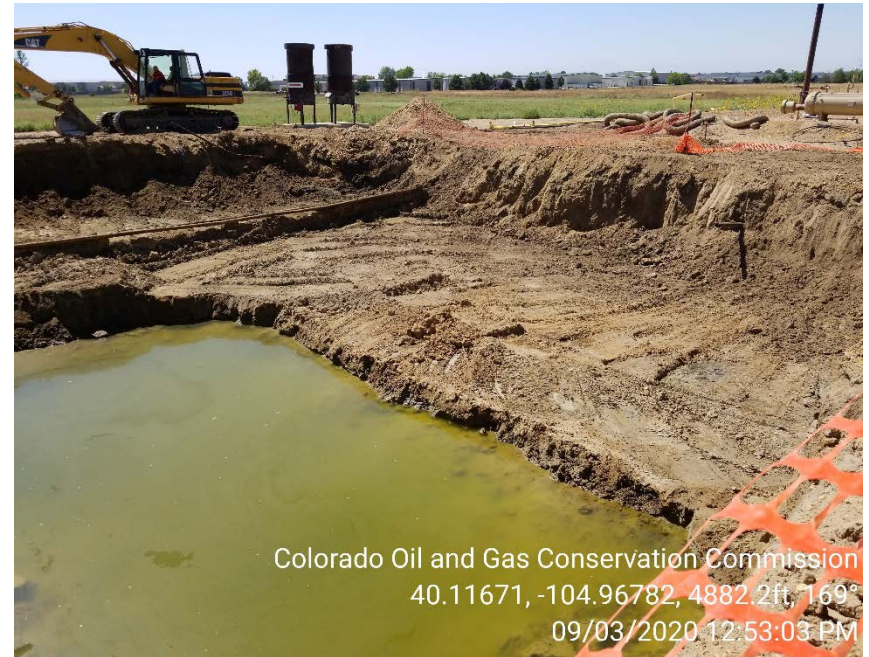
Photo 2 – South and west sidewall of eastern excavation. Flowlines exposed in portions of the excavation.

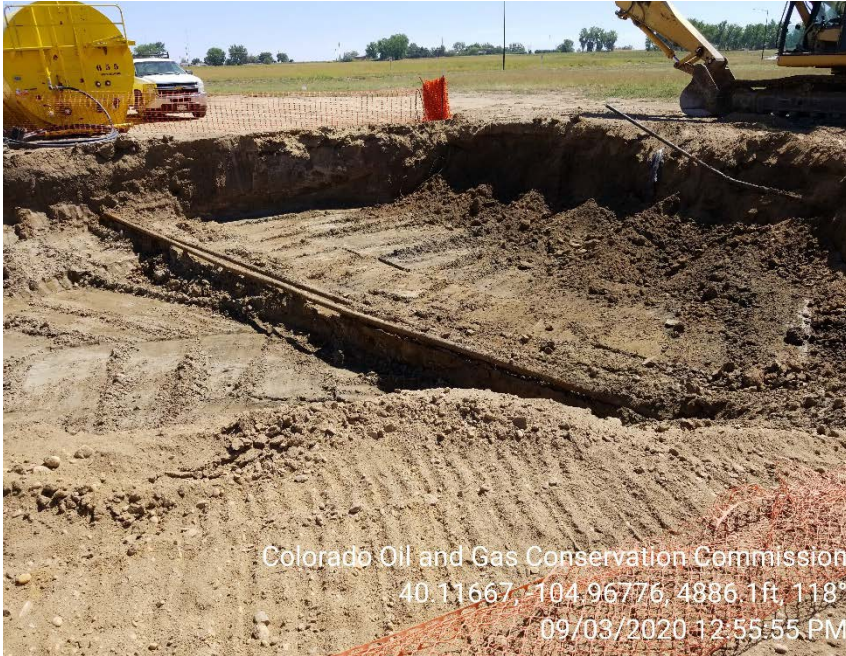
Photo 3 – Flowlines exposed in eastern excavation

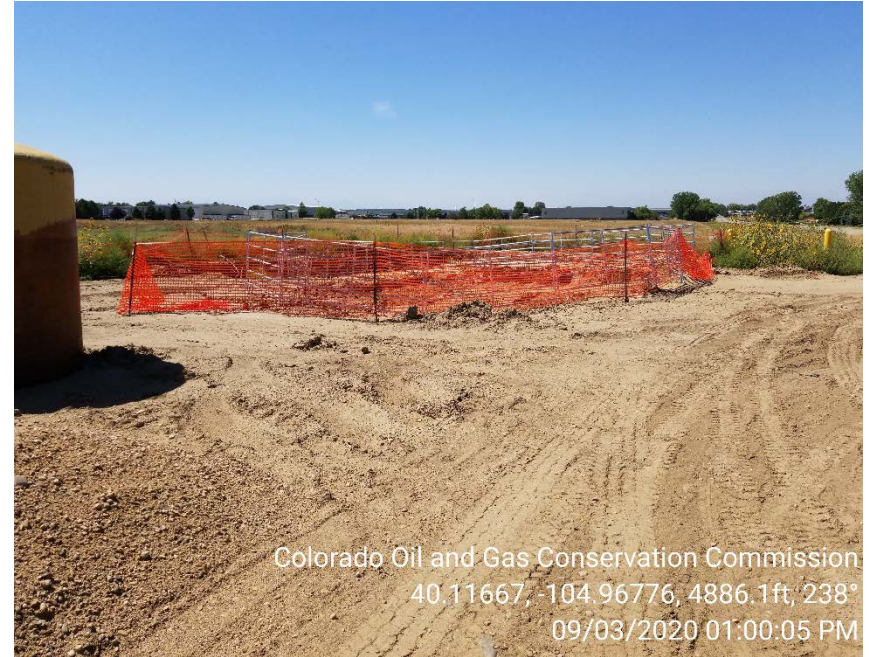
Photo 4 – Fencing in place surrounding western excavation.

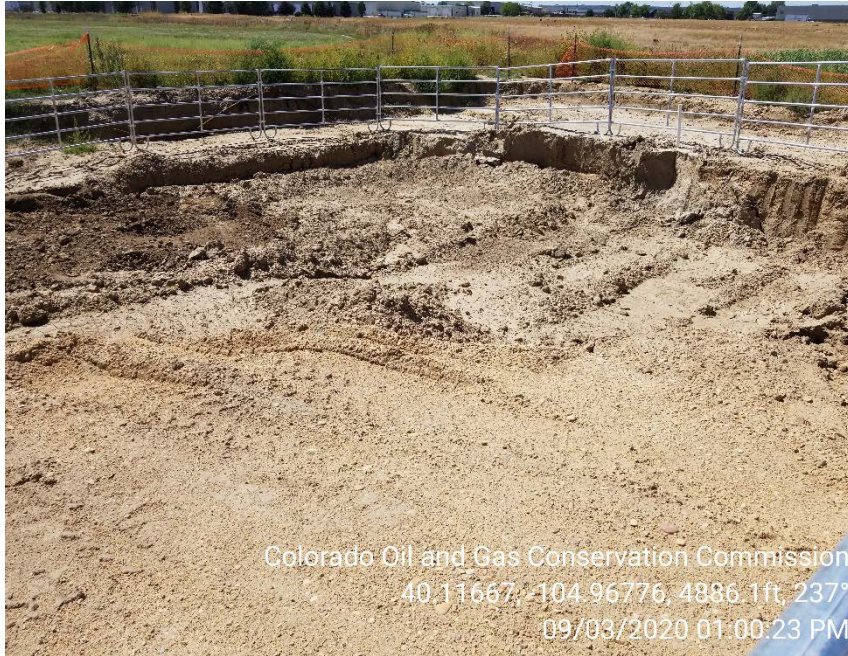
Photo 5 – Western excavation has been partially backfilled.
