API: 05-007-06136

Inspection Photos
Location Name: Chavez #2
API: 05-007-06136

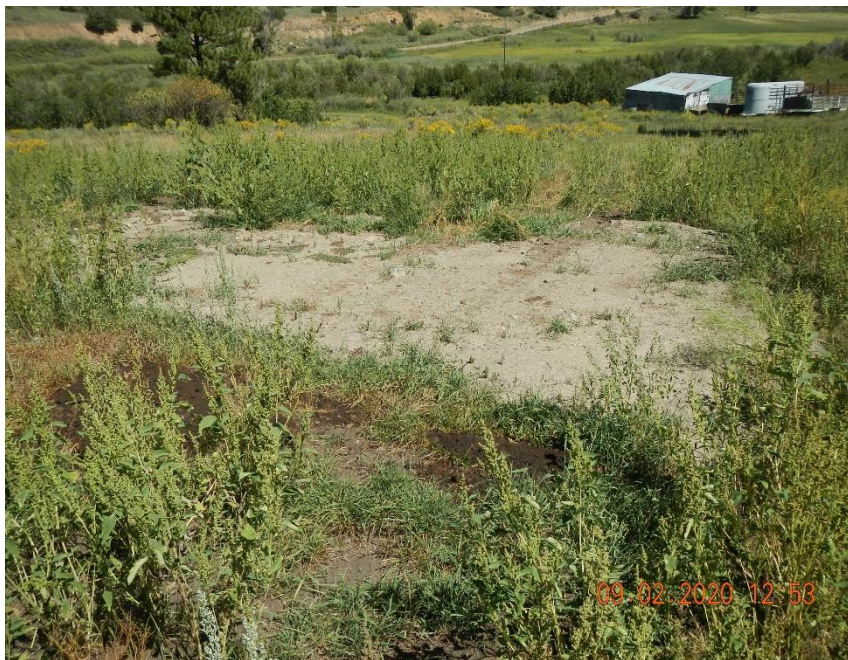
Impacted material allegedly from the Albert Martinez #1 tank battery.

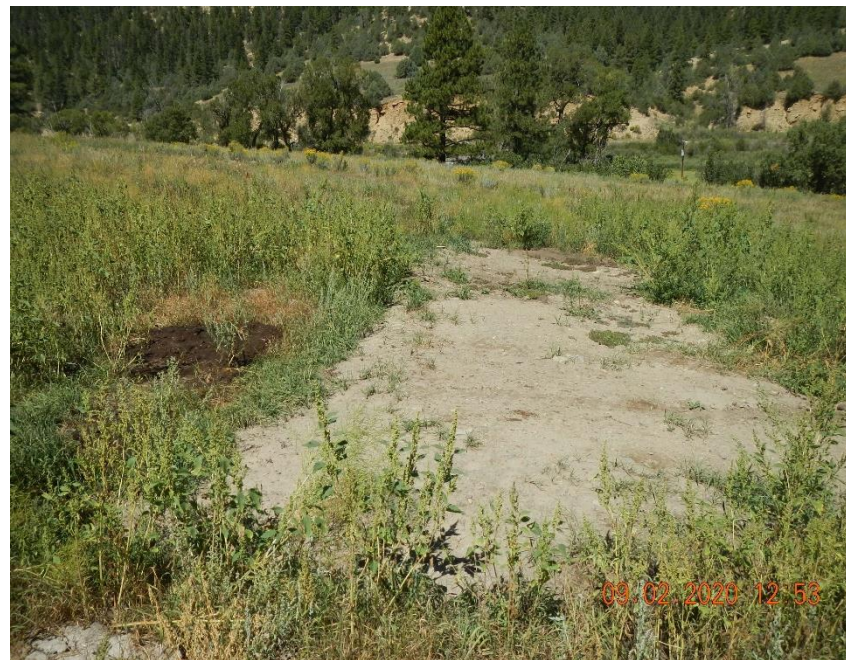
Stock piled oily soil from the Albert Martinez #1 tank battery.

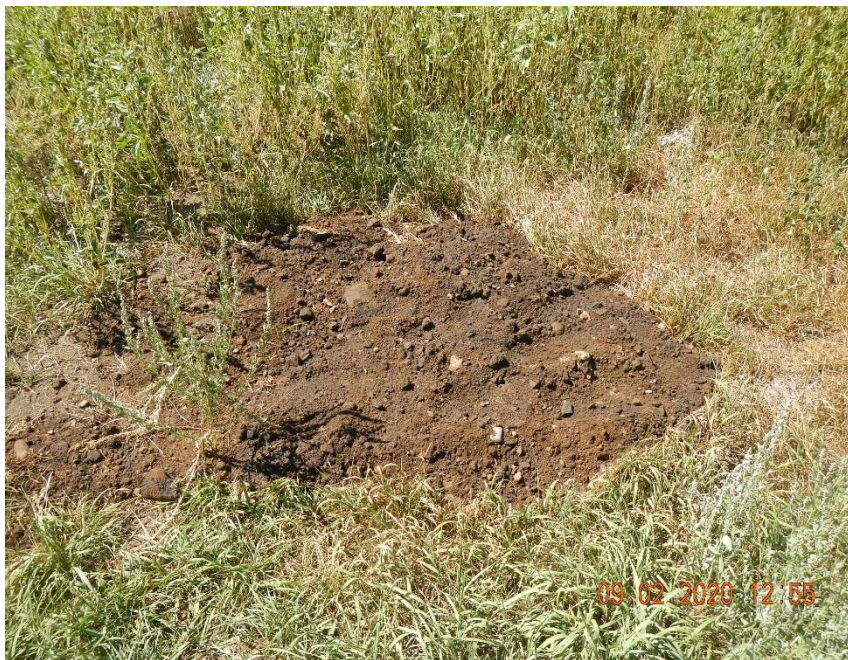
Impacted material stock piled near Chavez #2.

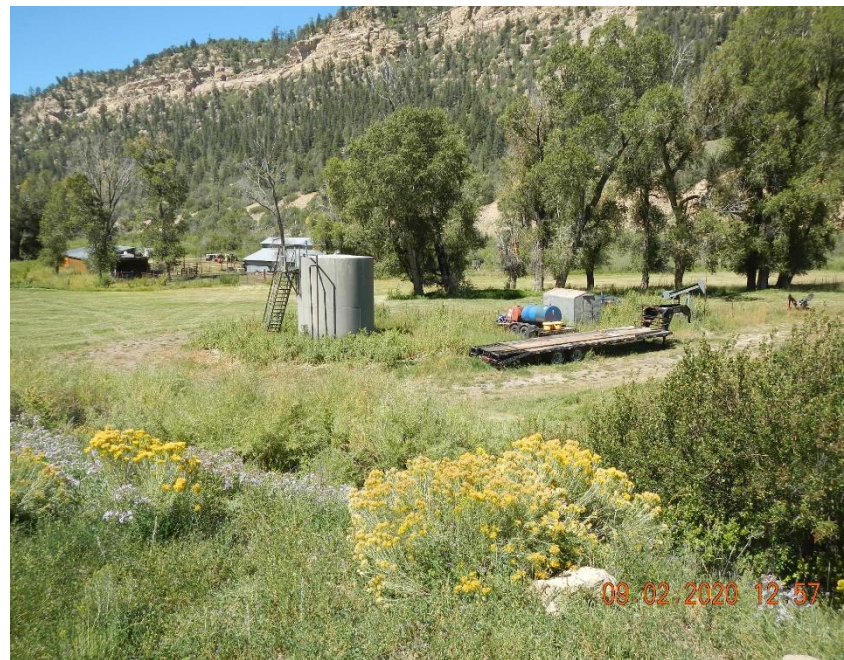
AST for Chavez #1 and #2 on Chavez #1 location.
