Inspection Photos
Location Name: Albert Martinez #1
API: 05-007-06253

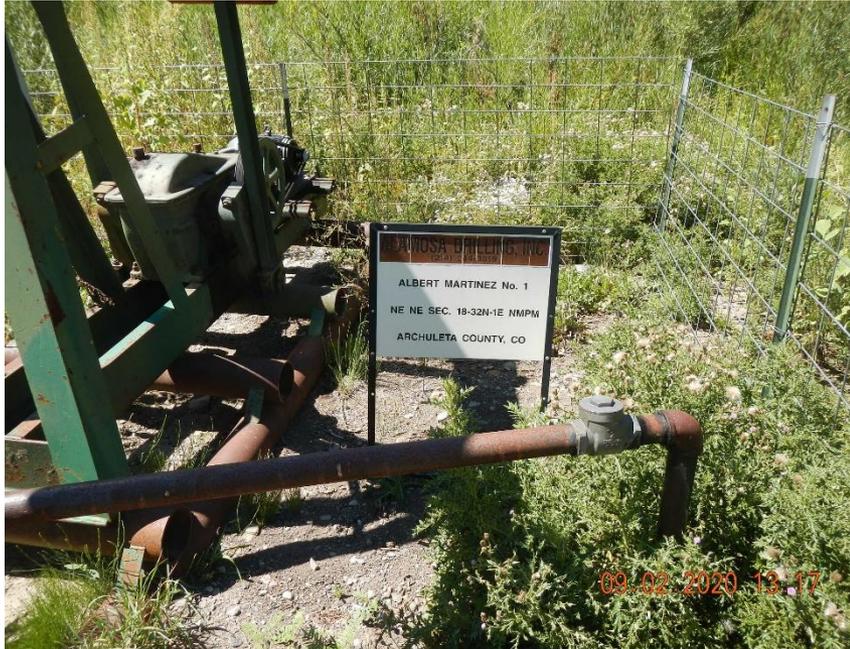
Albert Martinez #1 pump jack and location sign.

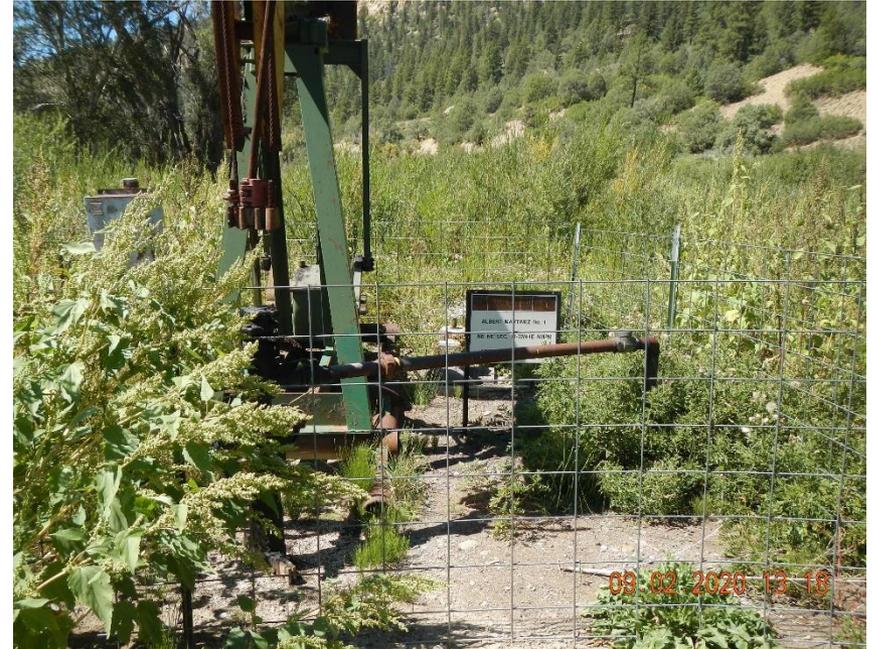
Weeds present near well head and pump jack.

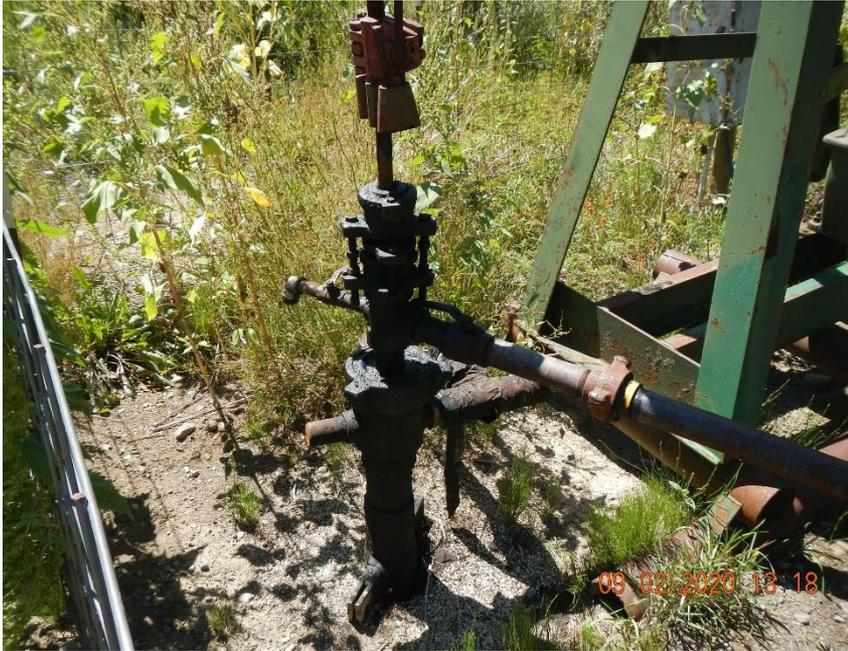
Well head is wet and stained.

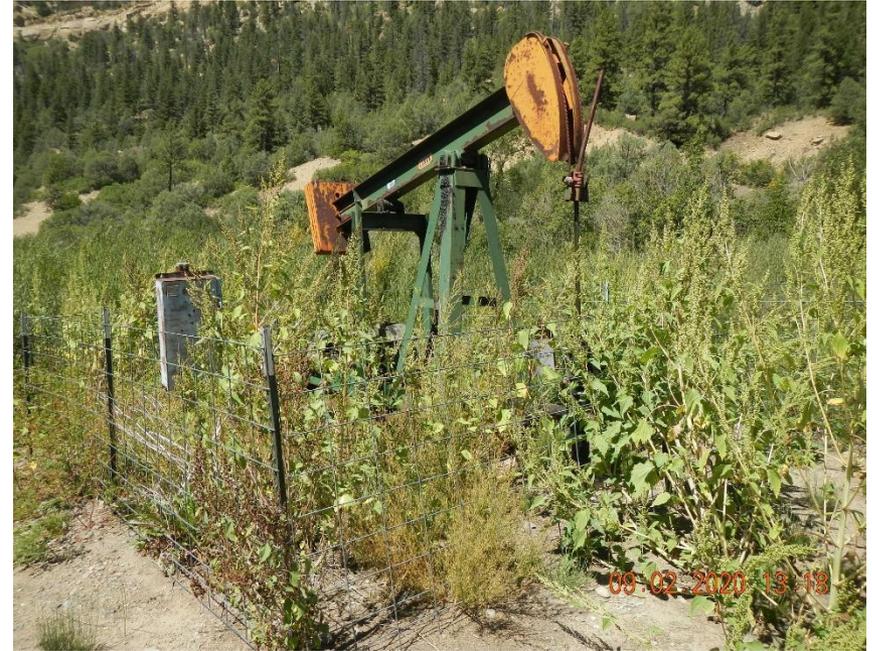
Weeds present on location.

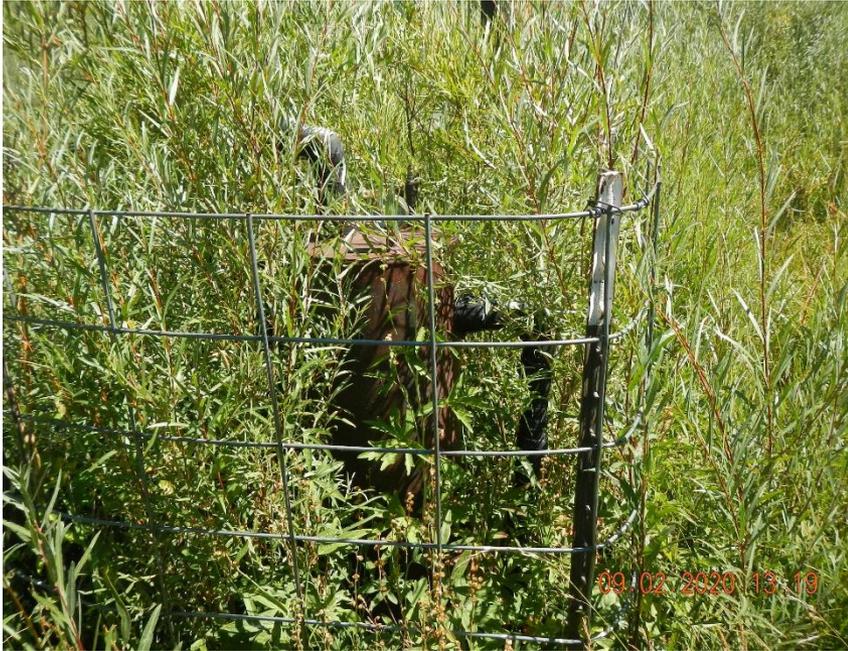
Domestic gas tap.

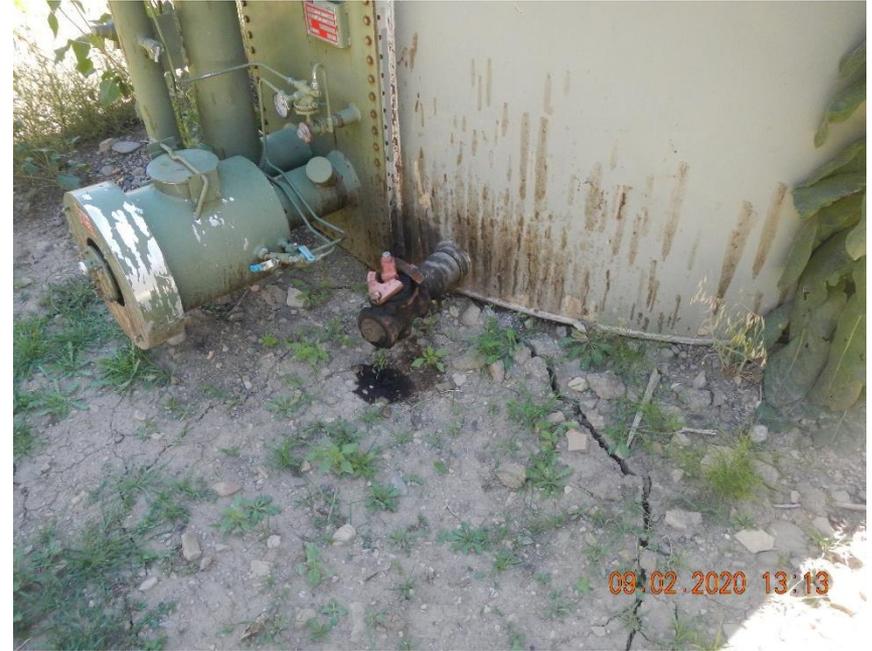
Stained soil beneath load out valve on eastern AST.
