**Inspection Photos**  
**Location Name: Black Resources State 36-11**  
**API #: 083-06519**

**COLORADO**  
Oil & Gas Conservation  
Commission  
Department of Natural Resources

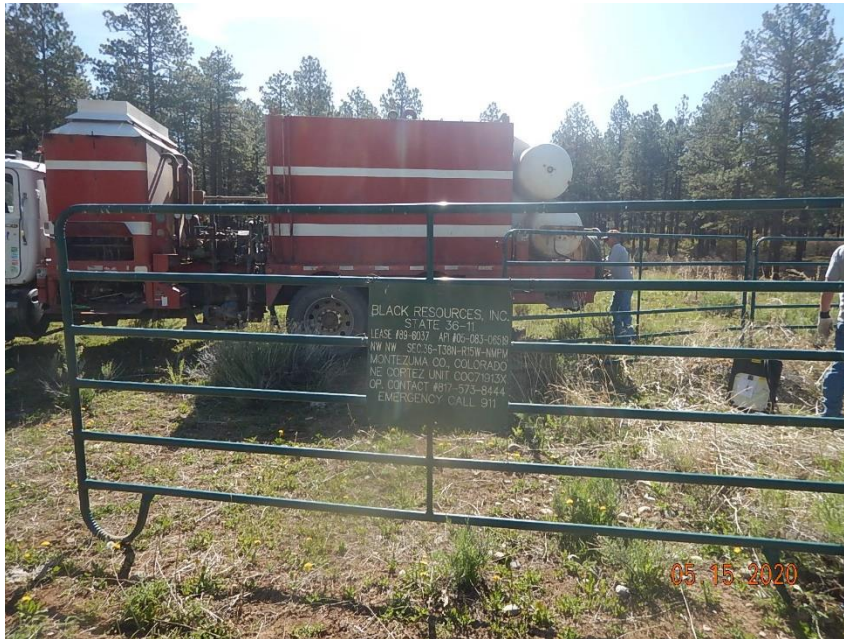
**Weed debris and wellhead from 5/15/20 inspection**

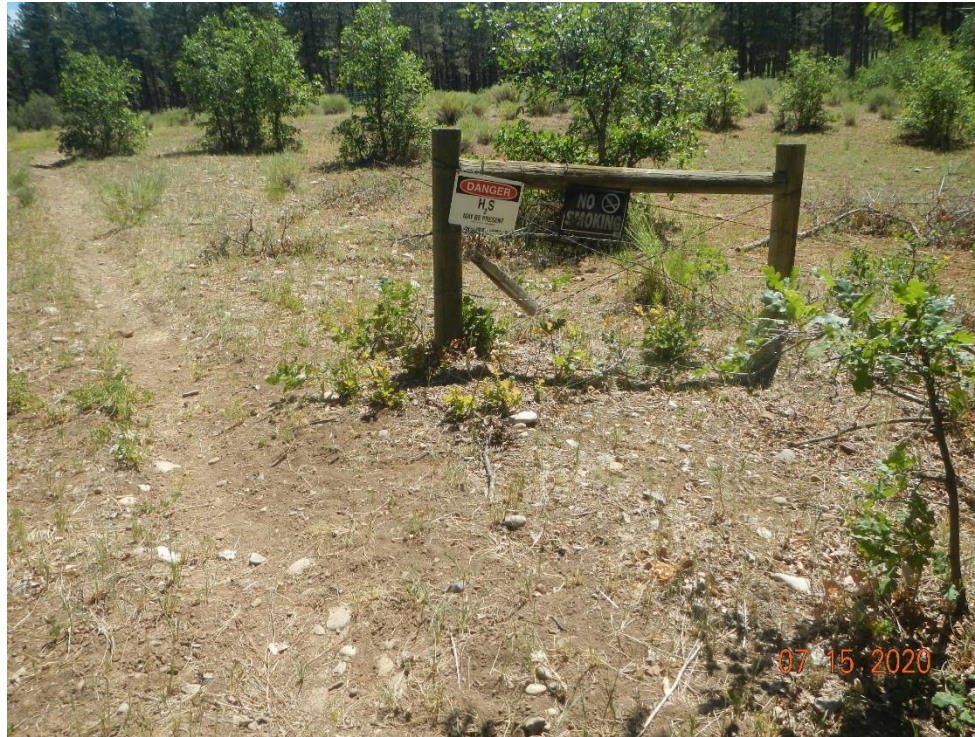
**H2S sign on fence post of location fence at entrance to location. On-shore Order No. 6 requires signage on access 200' before entrance to location.**

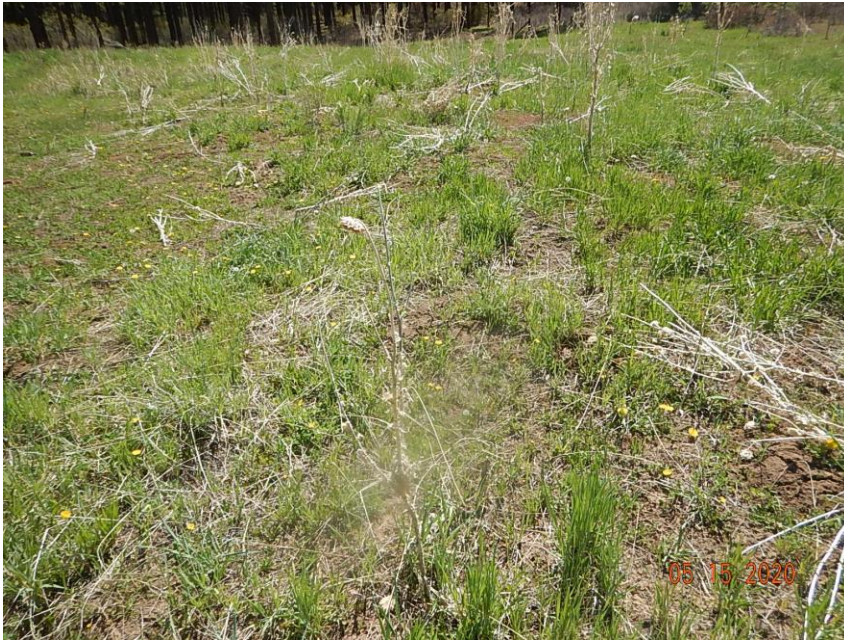
**Thistle debris cited in previous inspection**

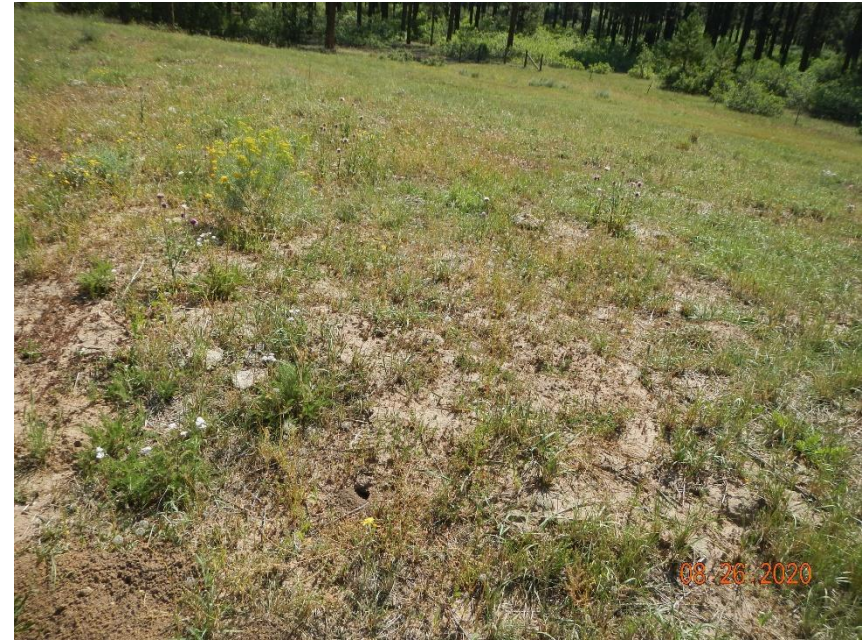
**Debris removed and new thistle growth**

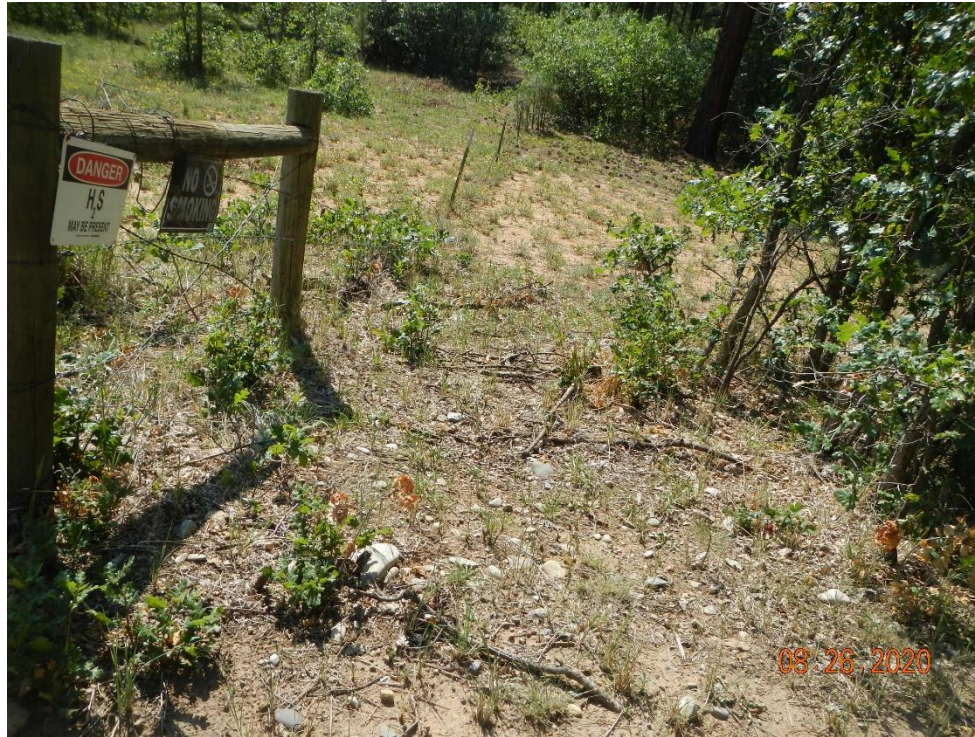
H2S sign on fence post of location fence at entrance to location. On-shore Order No. 6 requires signage on access 200' before entrance to location.

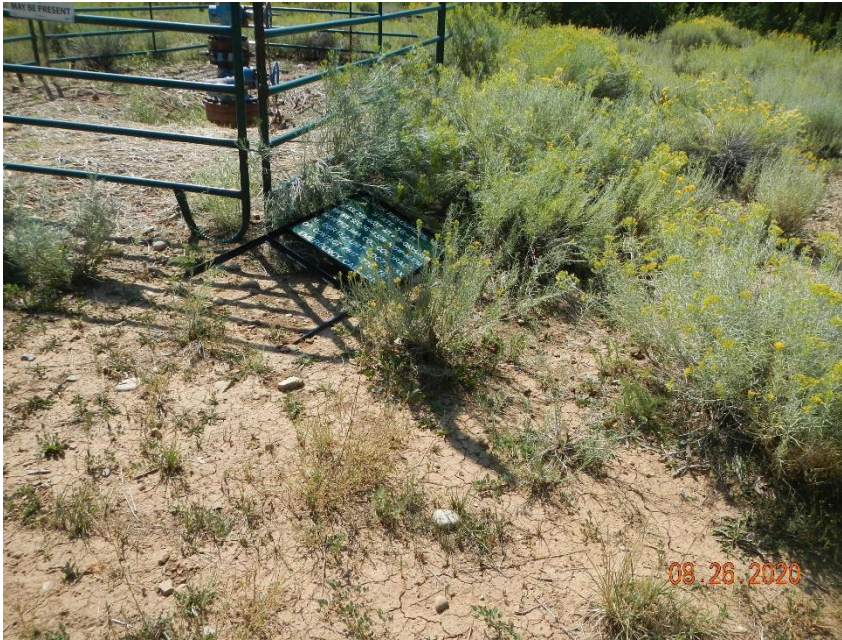
**Well sign with different contact number (unused equipment?)**

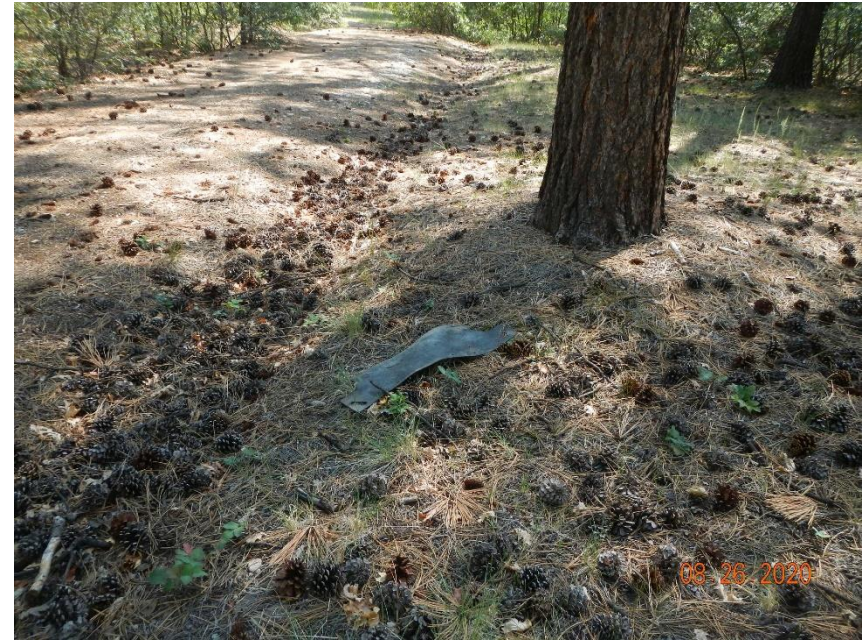
**Trash/debris on side of access road**
