Inspection Photos
Operator: BP America
API: 067-06481
Date: 9/11/2020

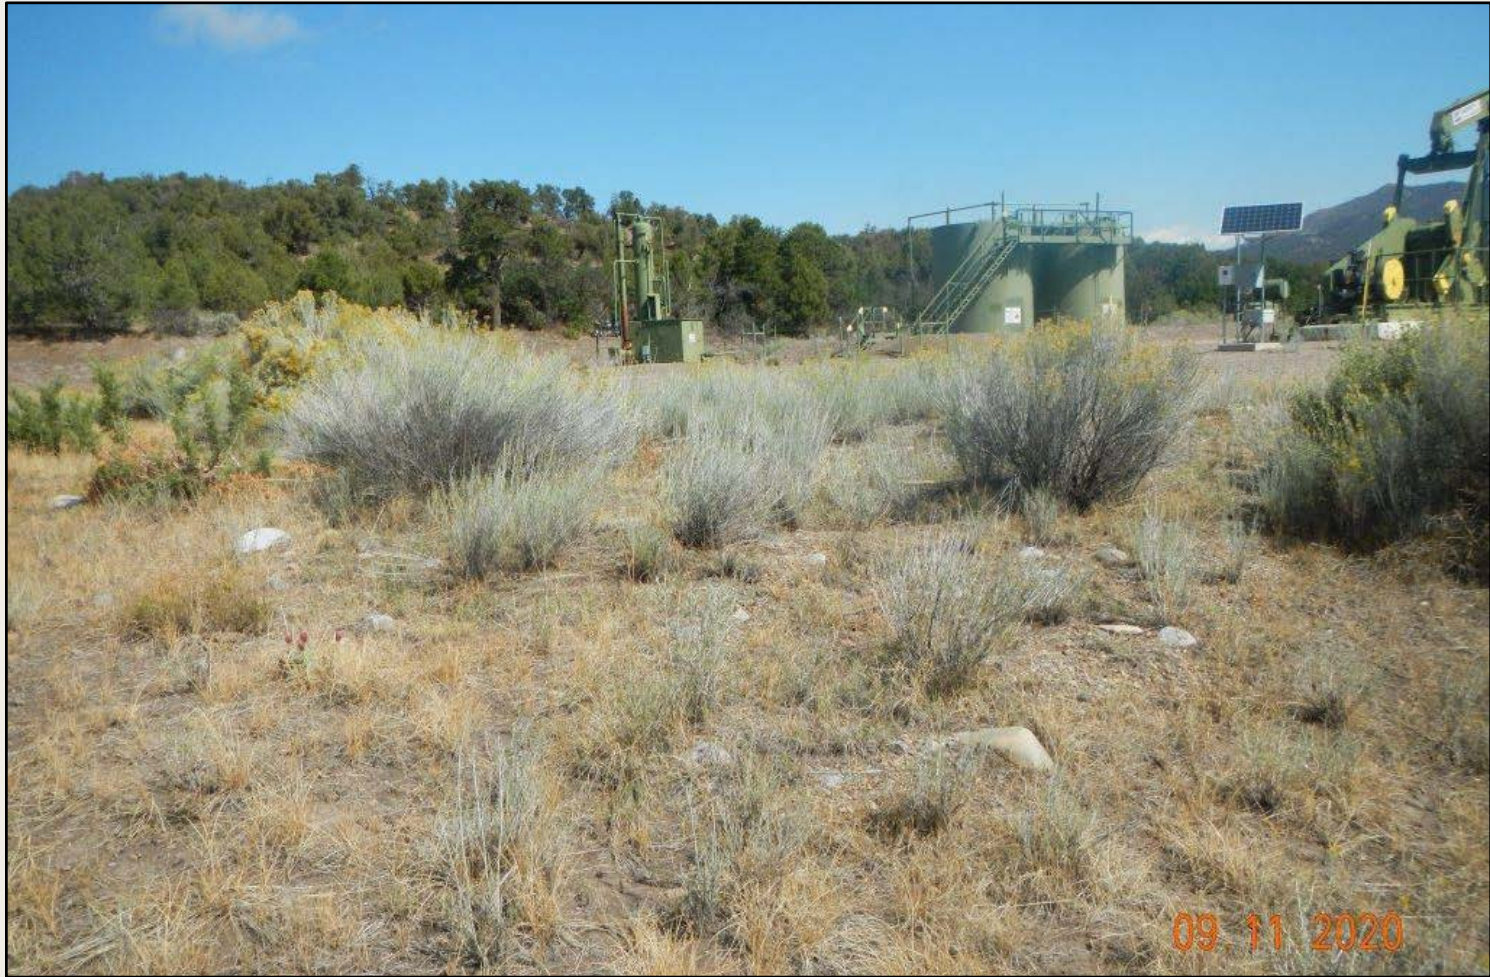
Photo 1. View of the project area from the southwestern corner facing center.

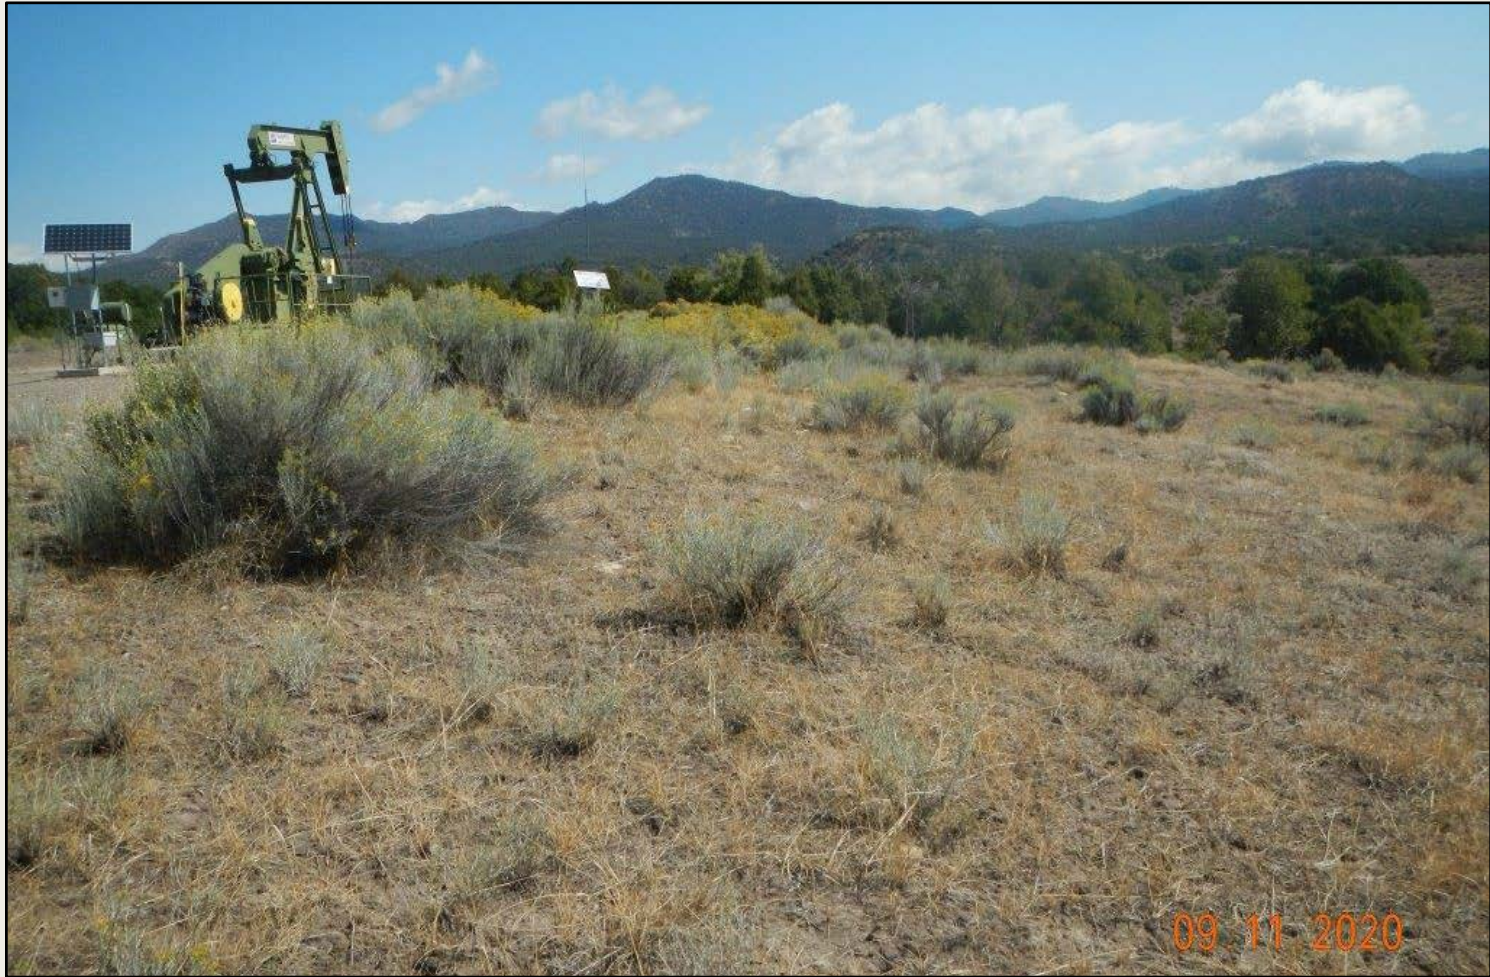
Photo 2. View of the southern fill slope from the southwestern corner facing eastward. Revegetation is progressing with grasses and shrubs such as western wheatgrass and rubber rabbitbrush.

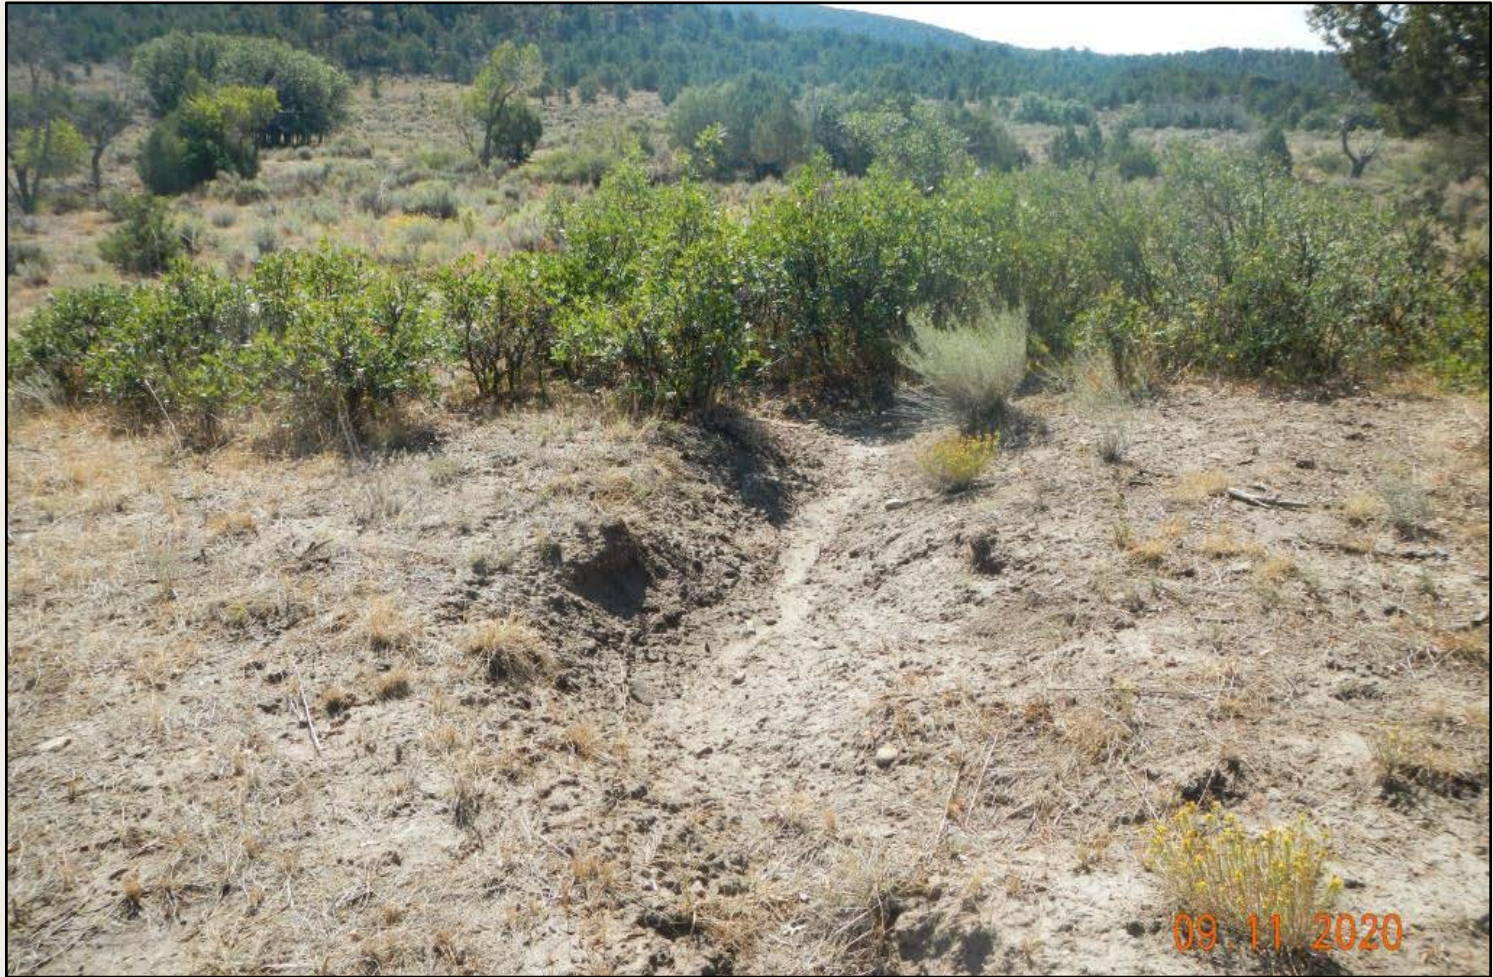
Photo 3. View of erosional channel, approximately two feet wide and deep, forming from a shallow headcut in the southwestern corner of the project area.

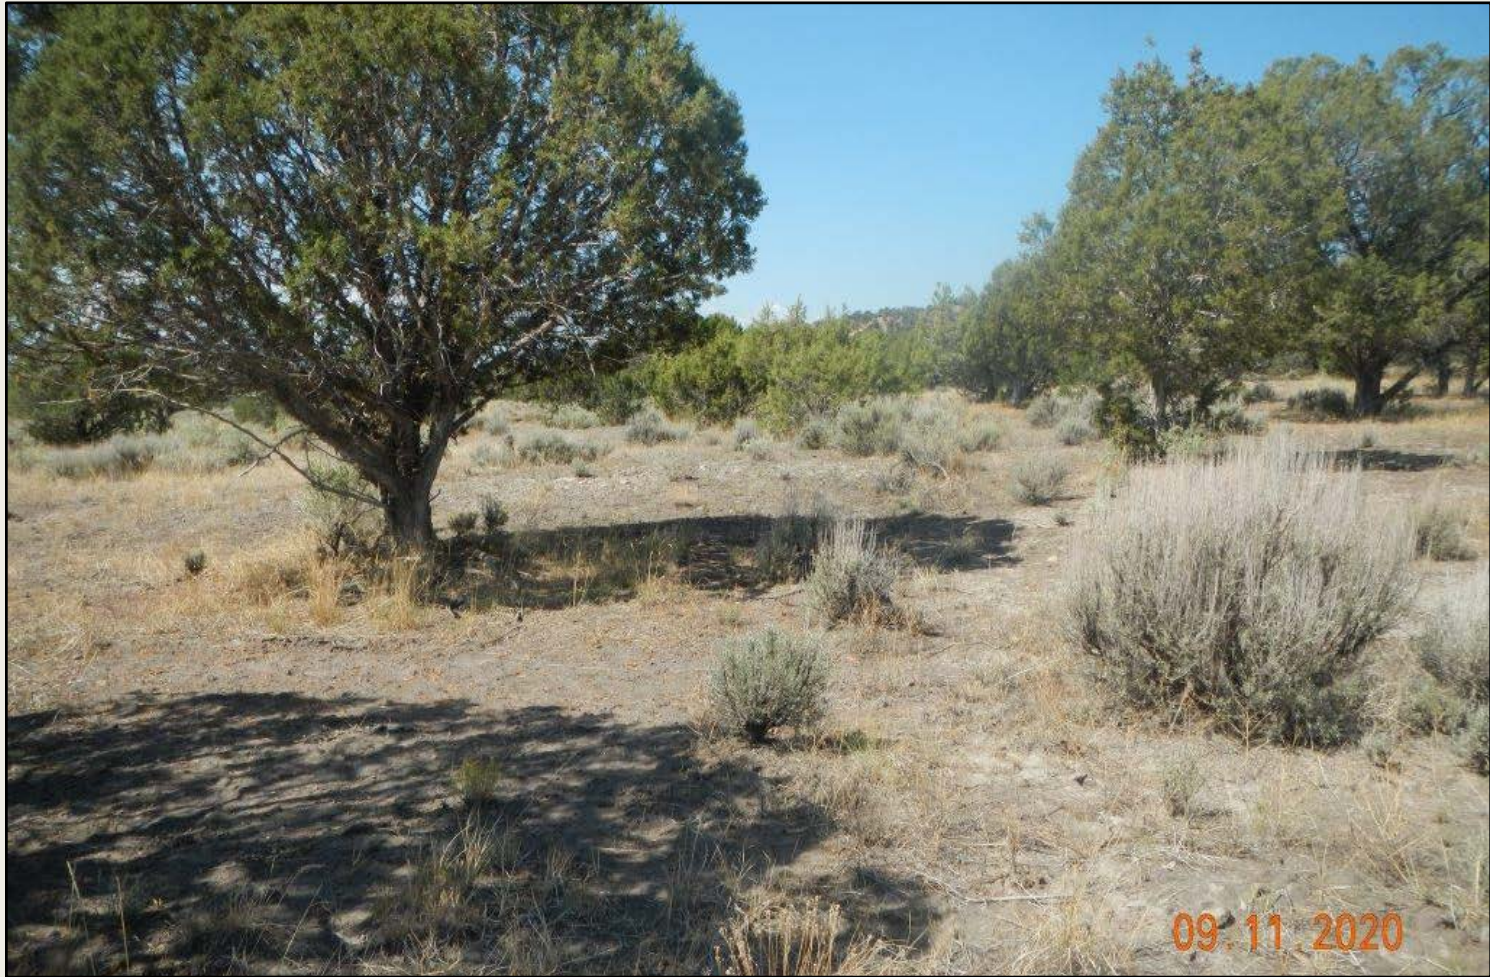
Photo 4. View of reference area vegetation comprised of open pinyon and juniper woodland, with understory of sagebrush, western wheatgrass, squirreltail, and Indian ricegrass.
