Inspection Photos
Operator: Hilcorp Energy
API: 067-07031
Date: 8/11/2020

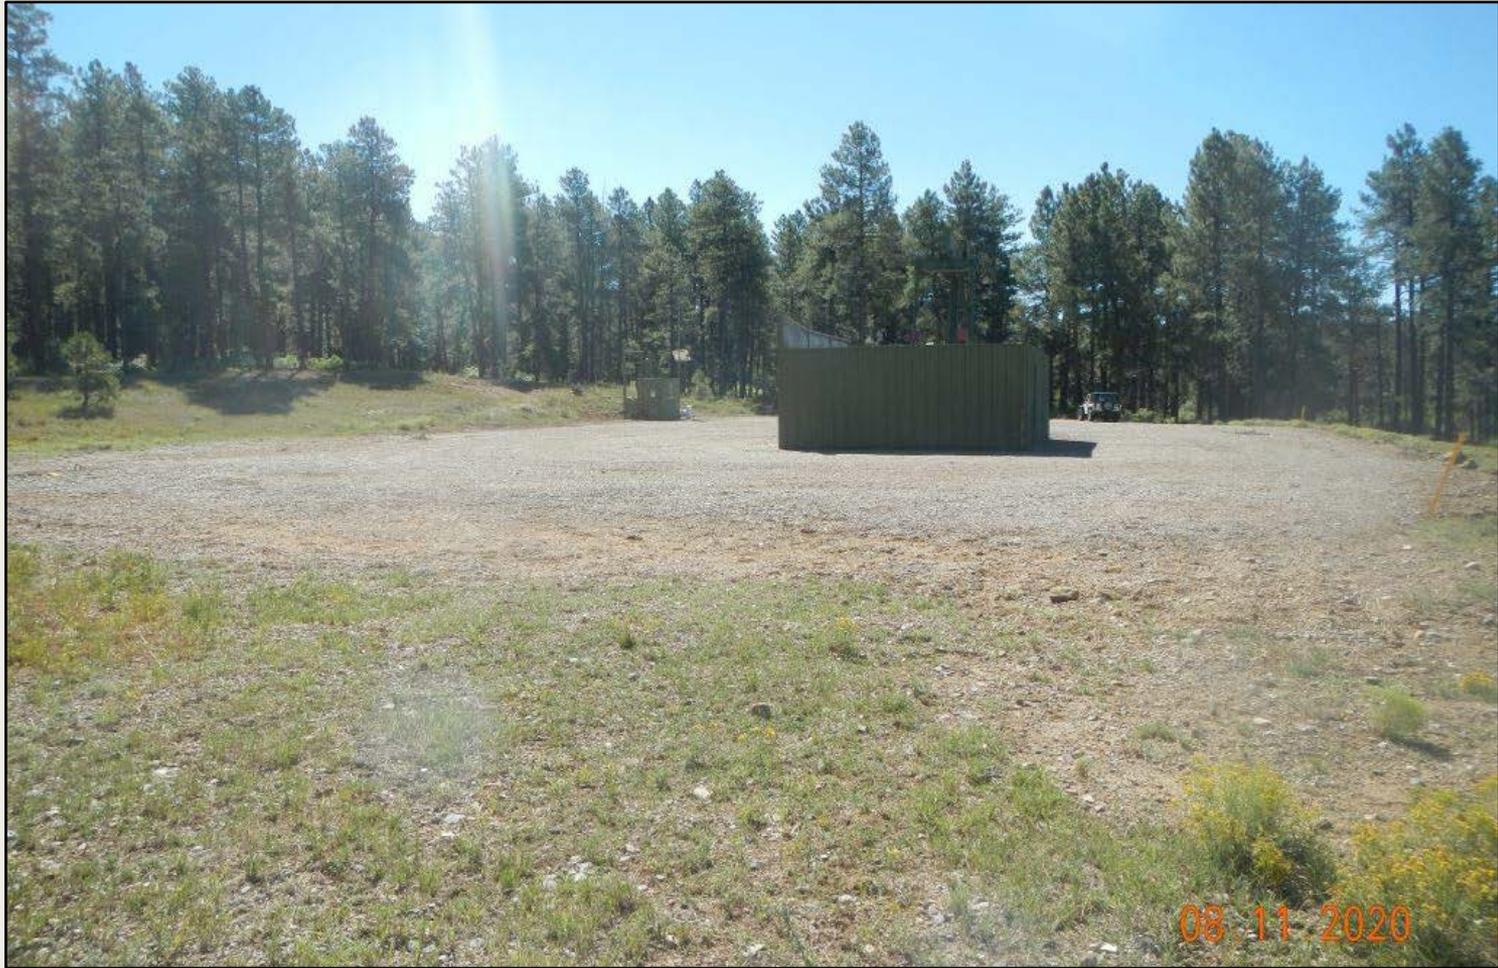
Photo 1. View of the project area from the northwestern corner facing center.

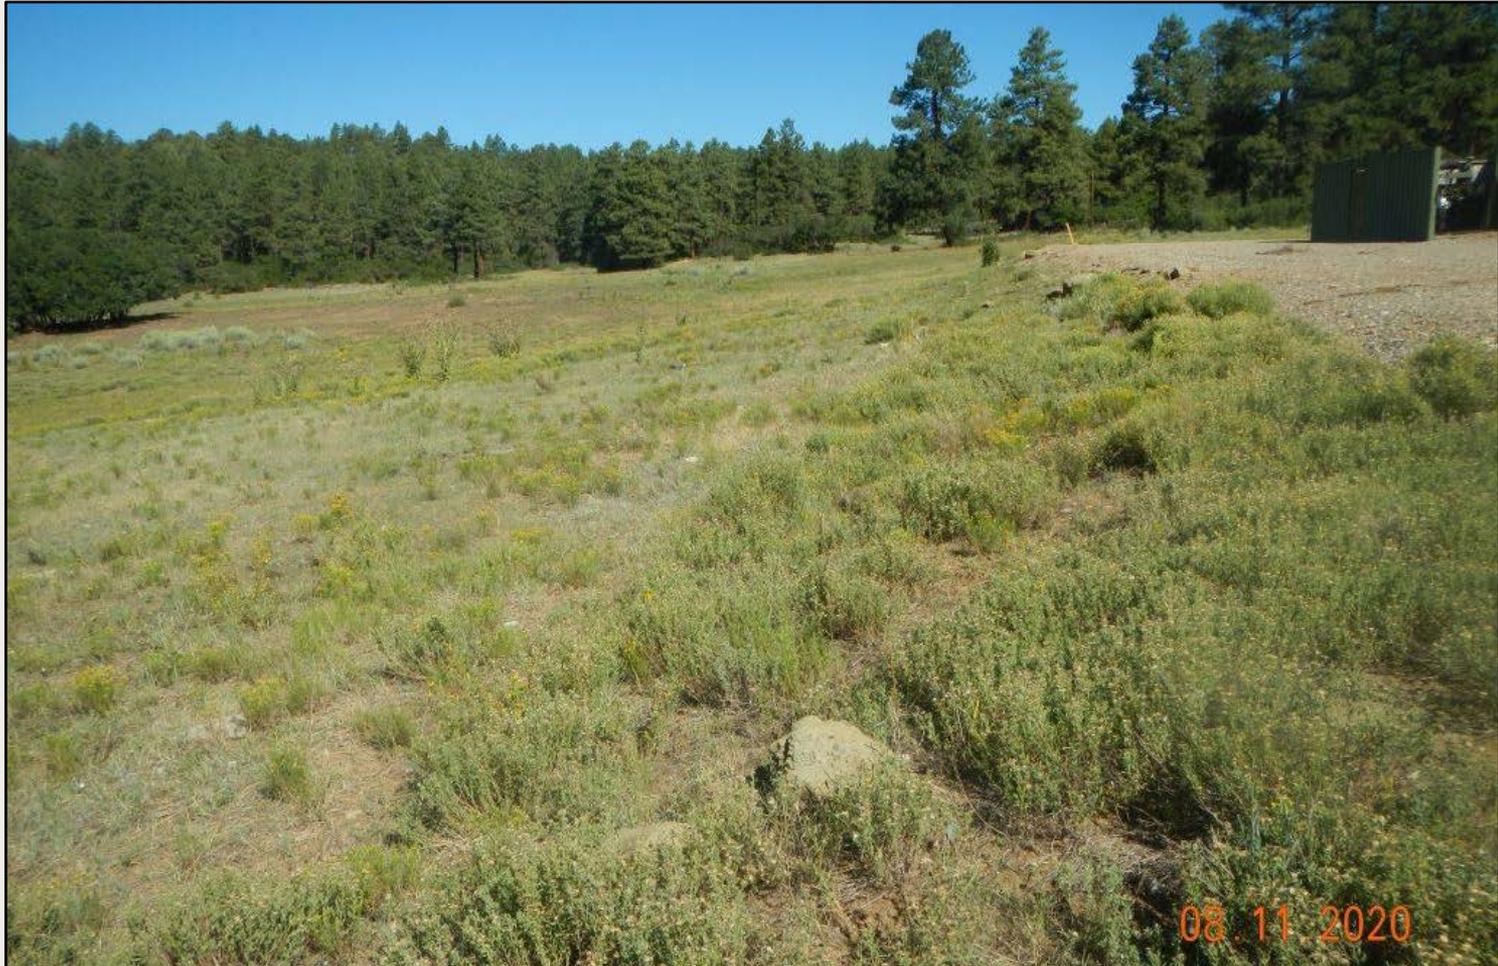
Photo 2. View of the western portion of the project area from the southwestern corner facing northward. Revegetation is progressing with western wheatgrass, *Heterotheca villosa*, and snakeweed.

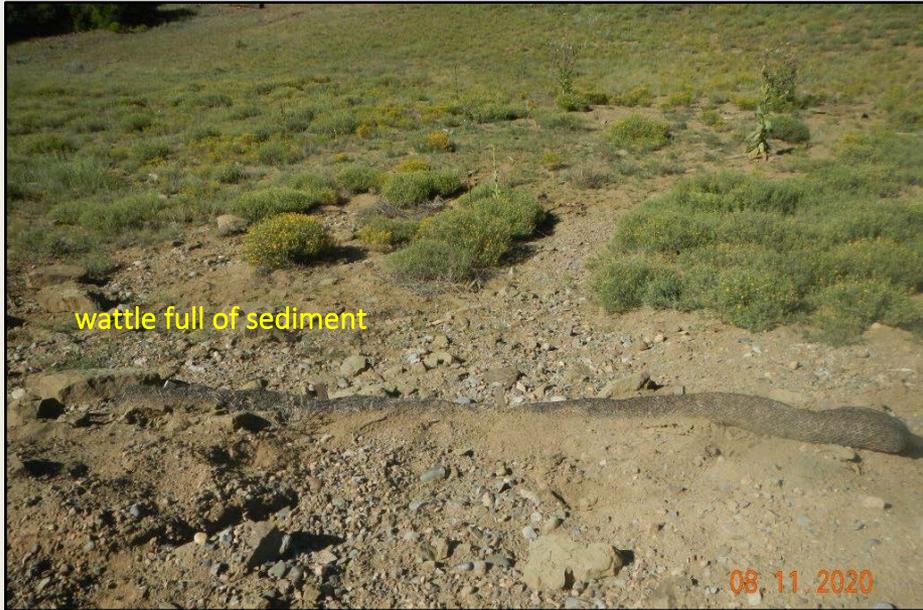
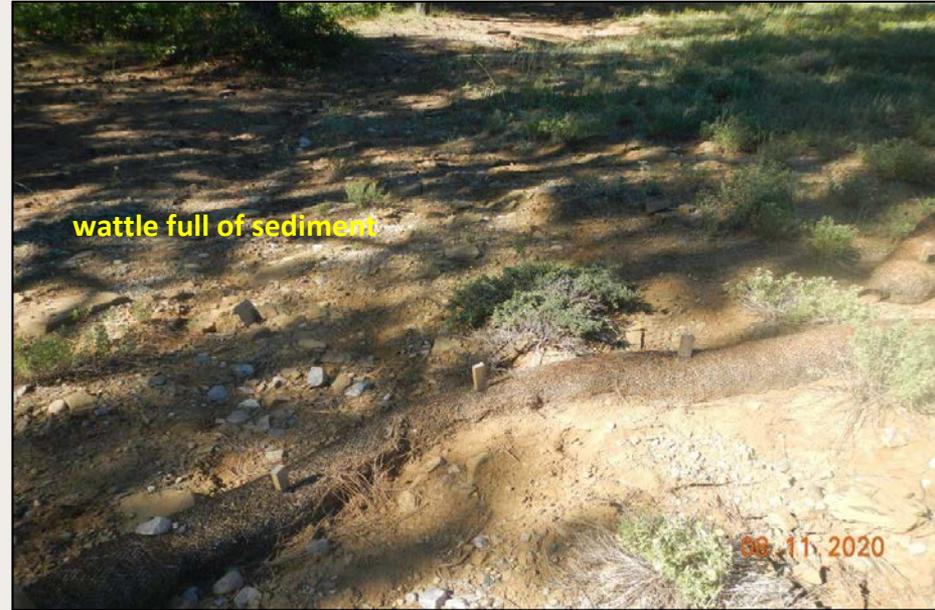
Photos 3/4. View of wattles in the western and southwestern project area that are full of sediment, displaced, and no longer functioning. Wattles are not adequate BMPs in these areas.

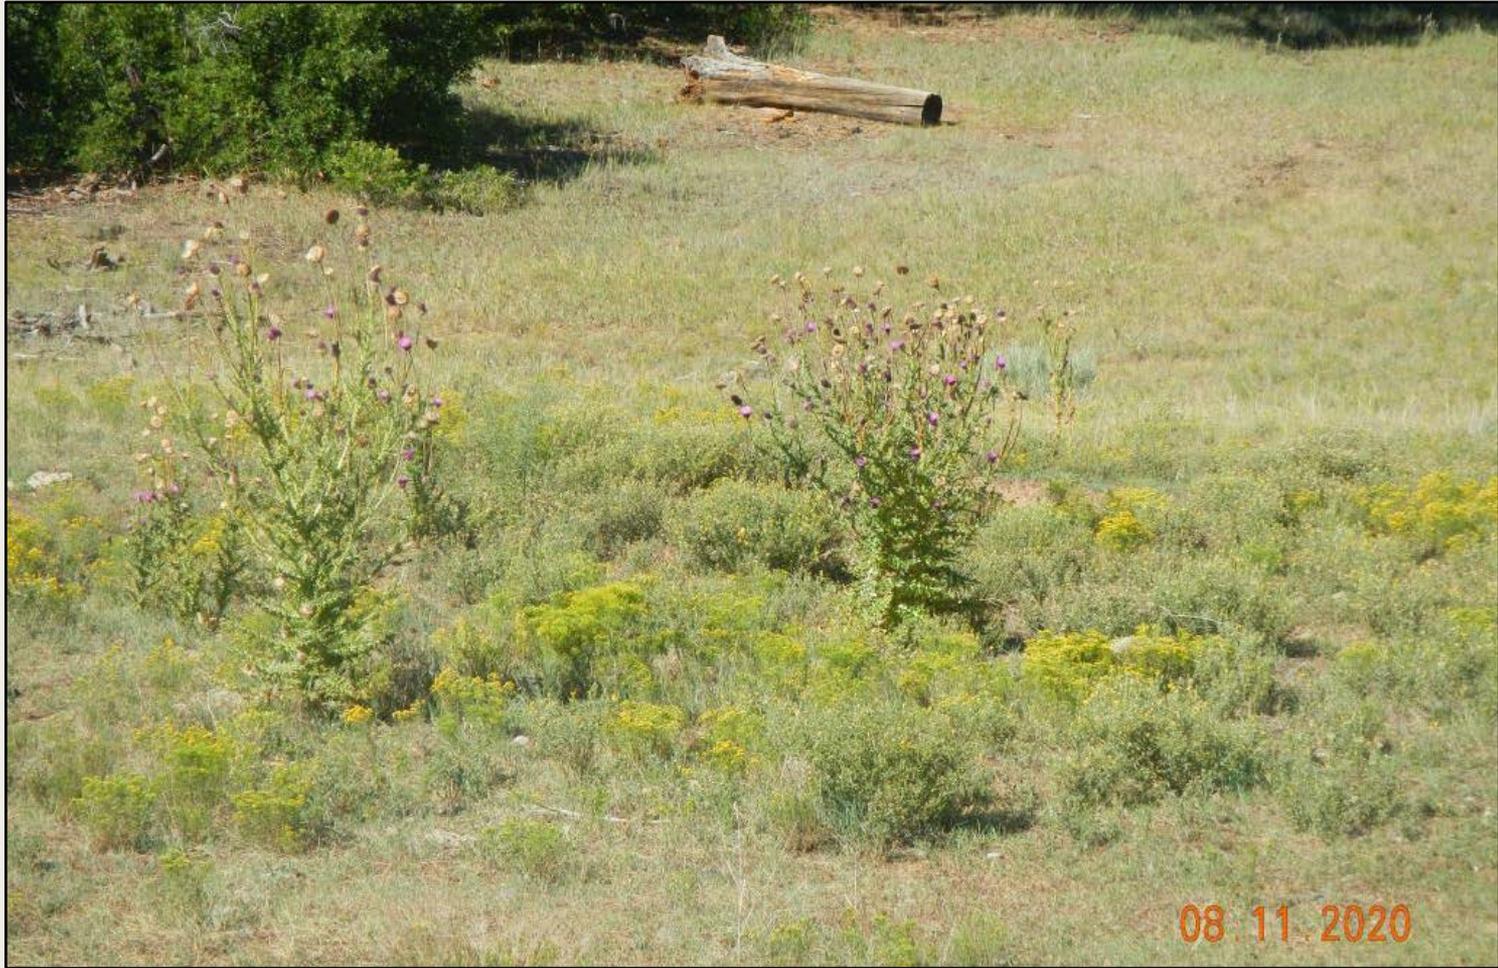
Photo 5. View of musk thistles within the western project area that are in flowering condition and dispersing seed. Approximately 25 individuals observed.

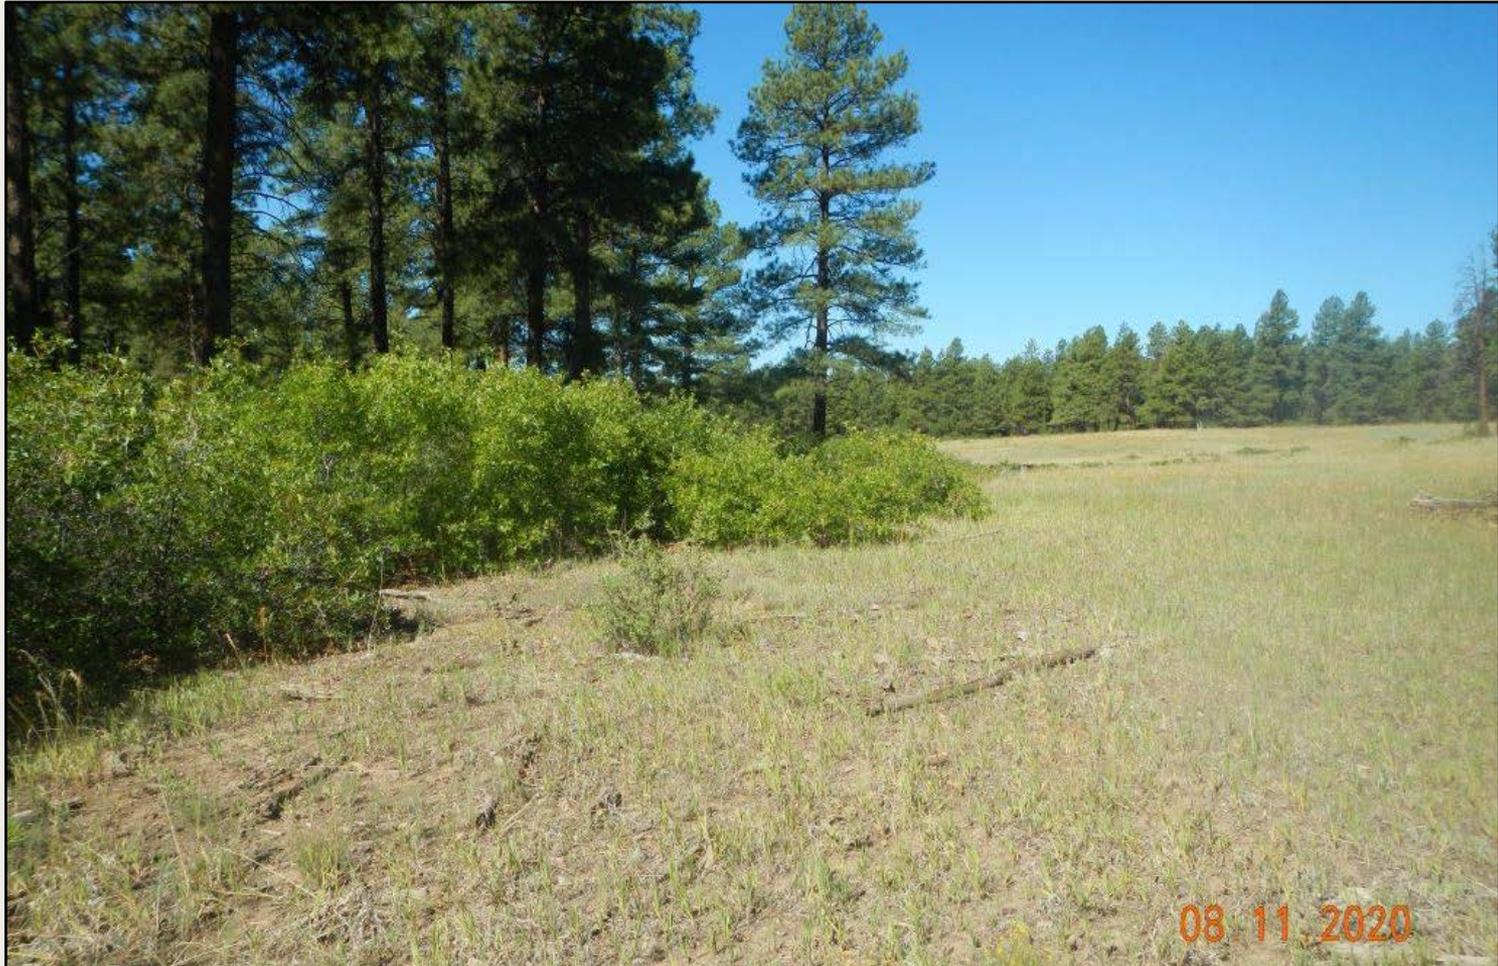
Photo 6. View of reference area comprised of ponderosa pine woodland with gambel oak understory, with a mosaic of open grassland largely comprised of smooth brome and western wheatgrass.
