Inspection Photos  
Operator: BP America  
API: 067-08880  
Date: 9/18/2020

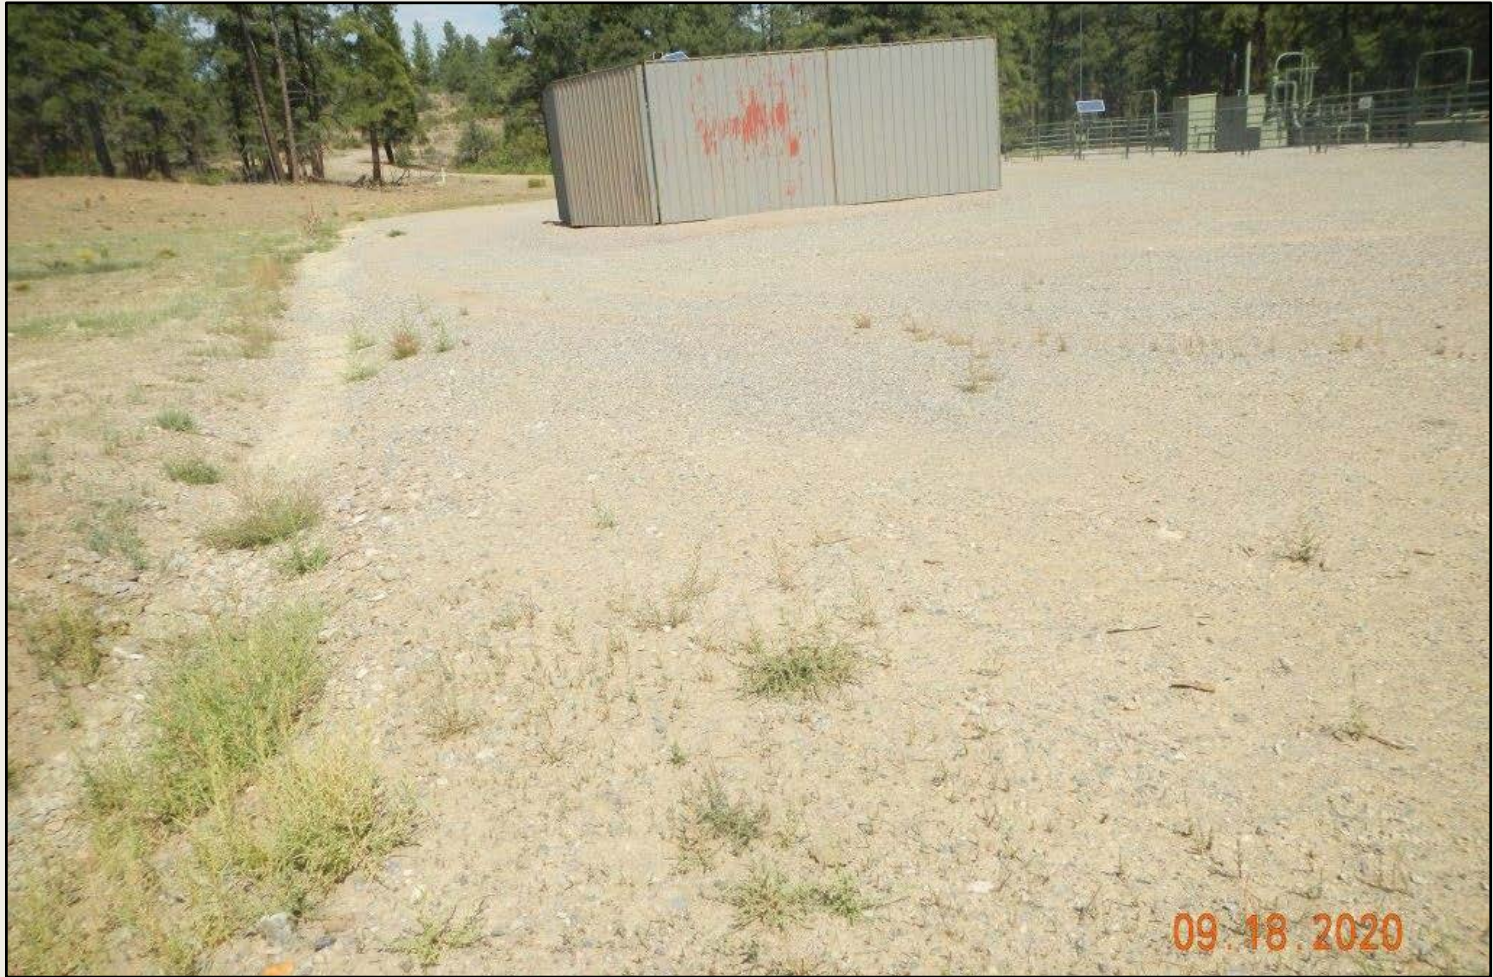
Photo 1. View of the project area from the southwestern corner facing center.

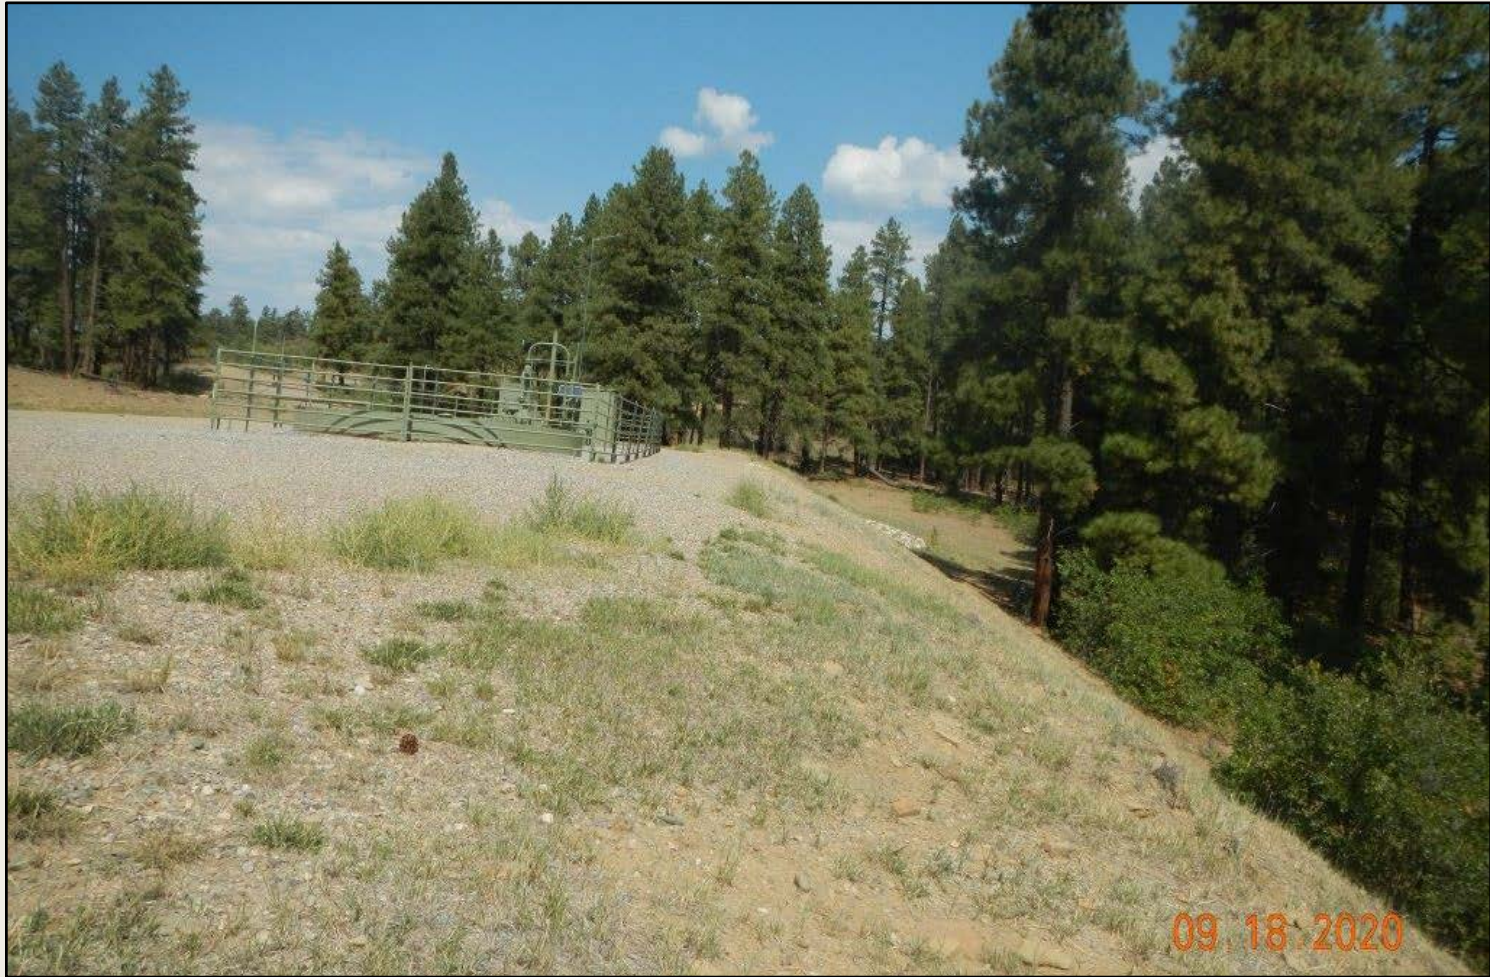
Photo 2. View of the eastern fill slope from the southeastern corner facing northward. Revegetation is progressing with grasses such as western wheatgrass and sand dropseed, largely in a grazed condition.

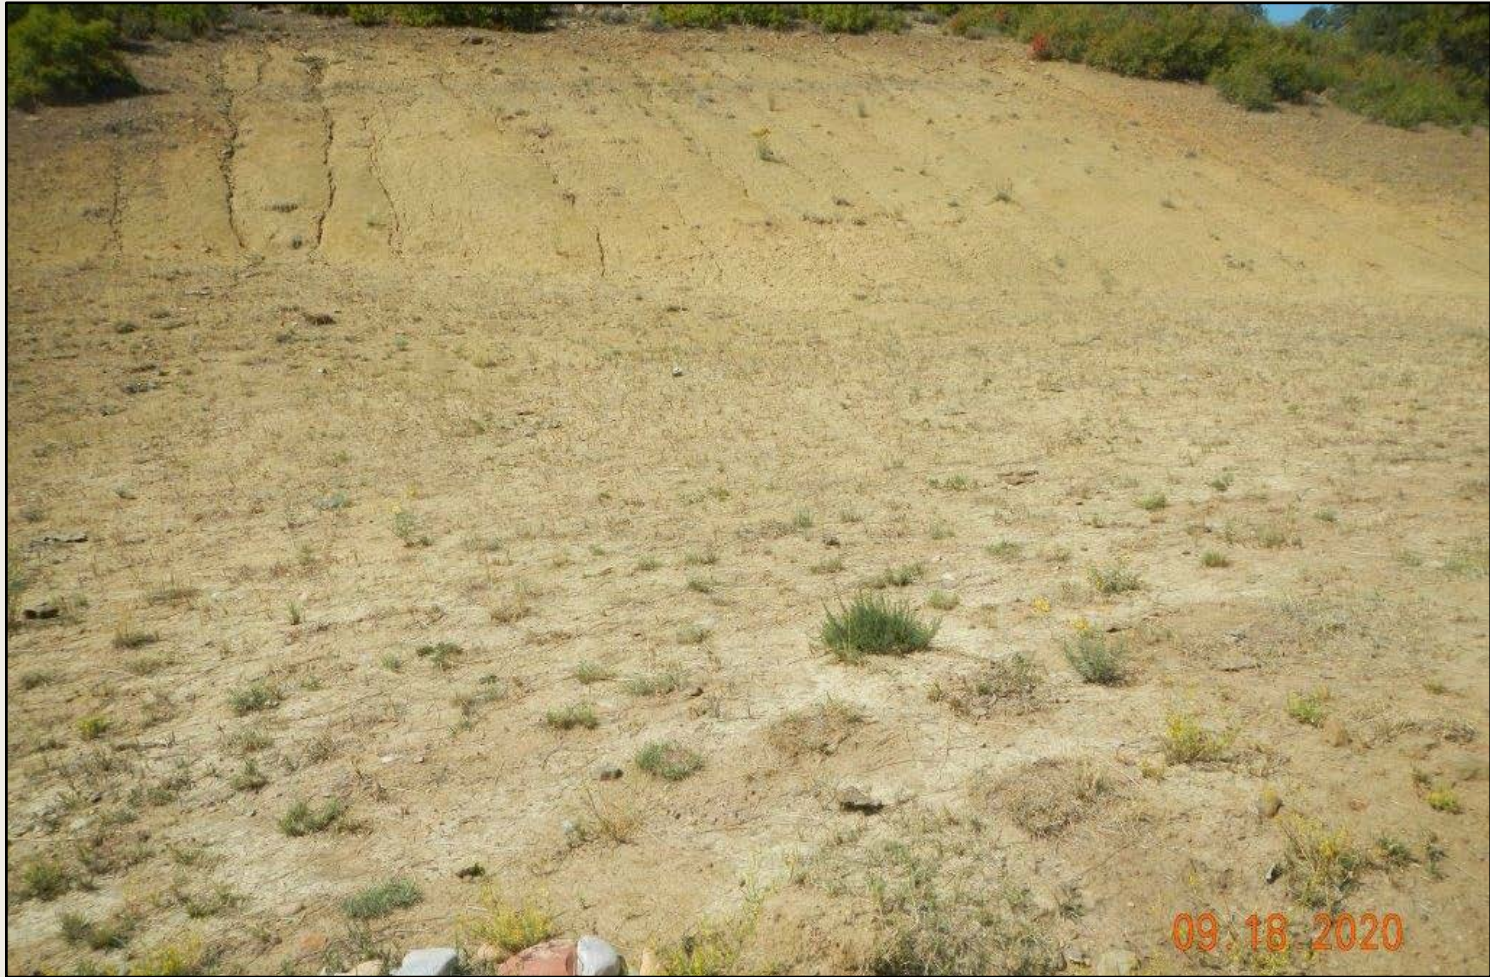
Photo 3. View of the western cut-slope showing areas that remain sparse and where additional stabilization is needed. Erosion controls need to be installed to stabilize erosion on bare soils until stabilized with desirable perennial vegetation.
