Inspection Photos

Operator: Catamount Energy
API: 007-06095
Date: 9/11/2020

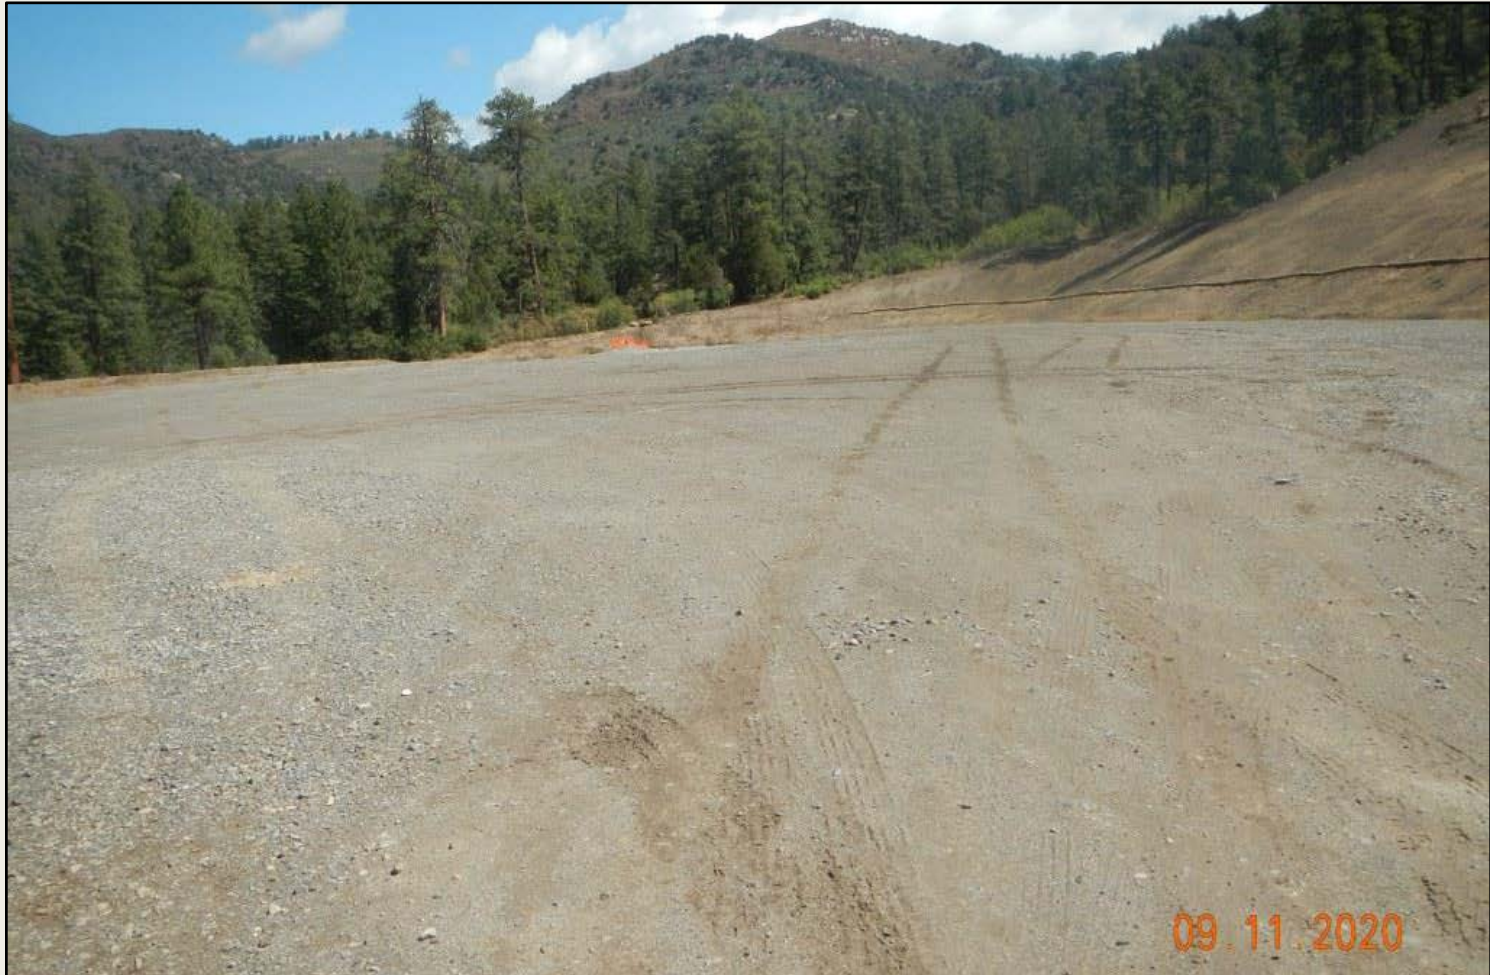
Photo 1. View of the project area from the northwestern corner facing toward the well.

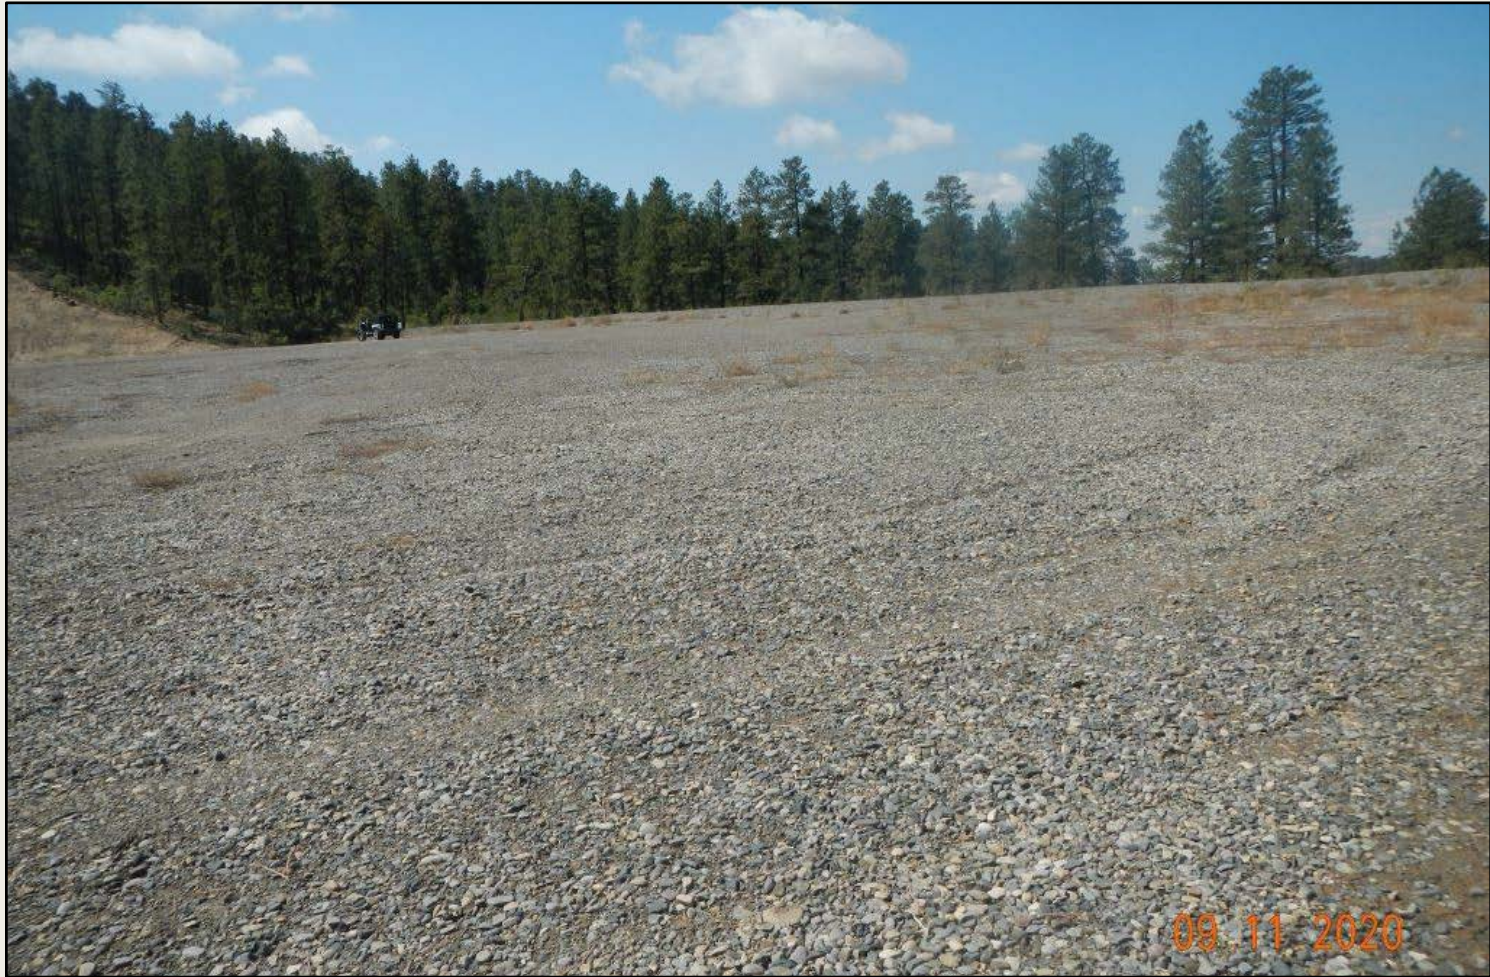
Photo 2. View of the northern project area from the eastern edge facing southwestward. Interim reclamation is not conducted.

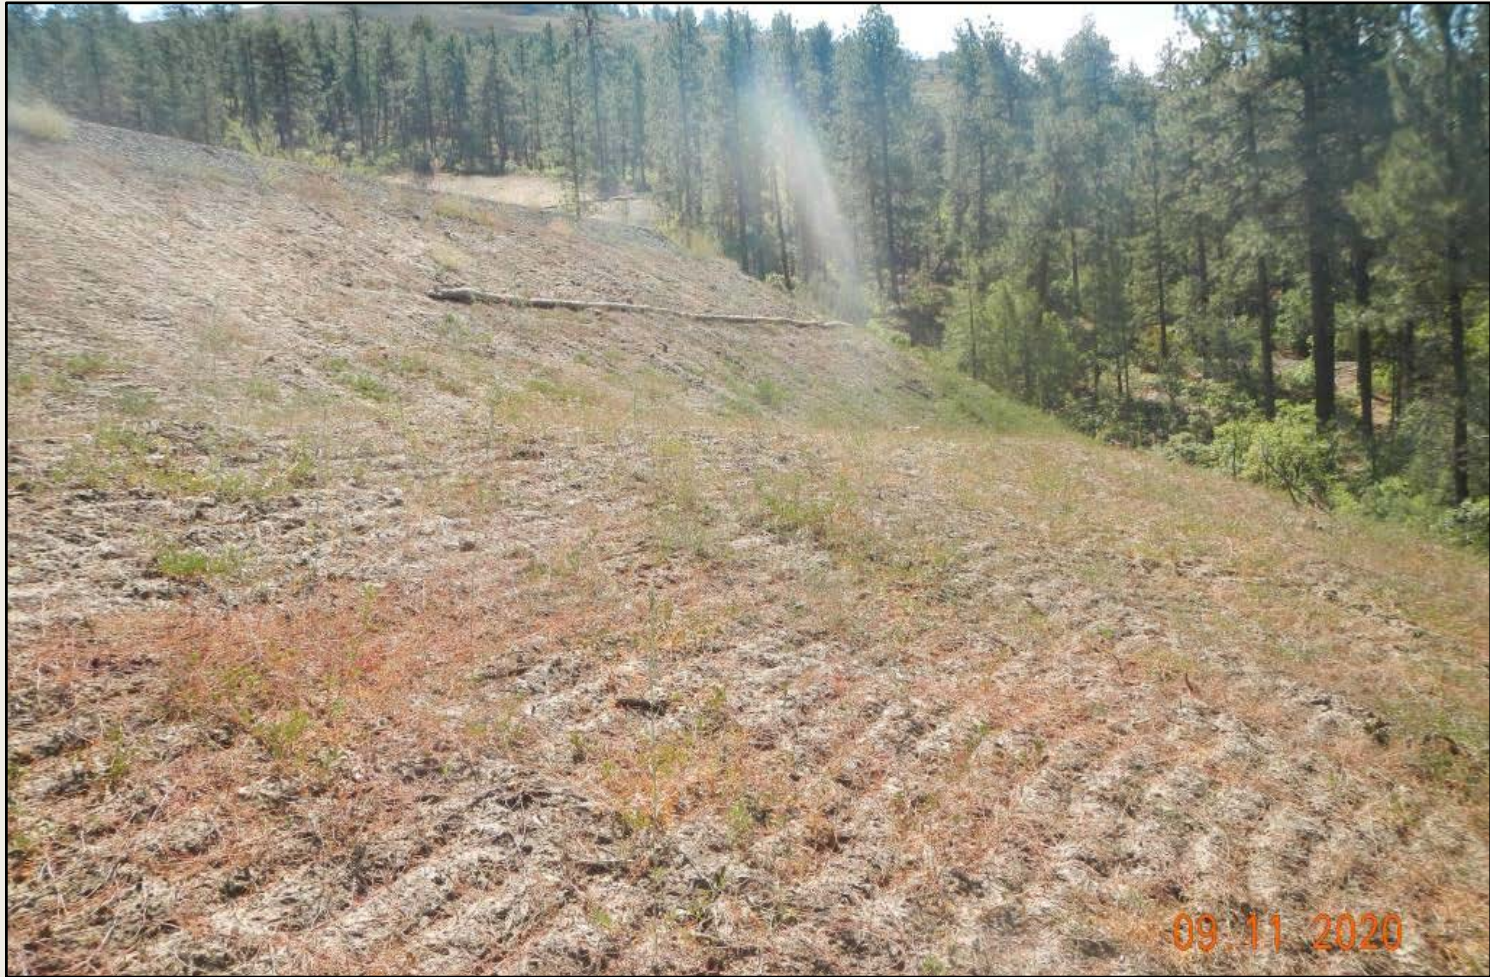
Photo 3. View of the western fill slope from the northwestern corner facing southward. Little desirable vegetation observed. Plants on the slope are largely comprised of weedy and annual species such as knotweed, Russian thistle, yellow sweetclover, and goosefoot.

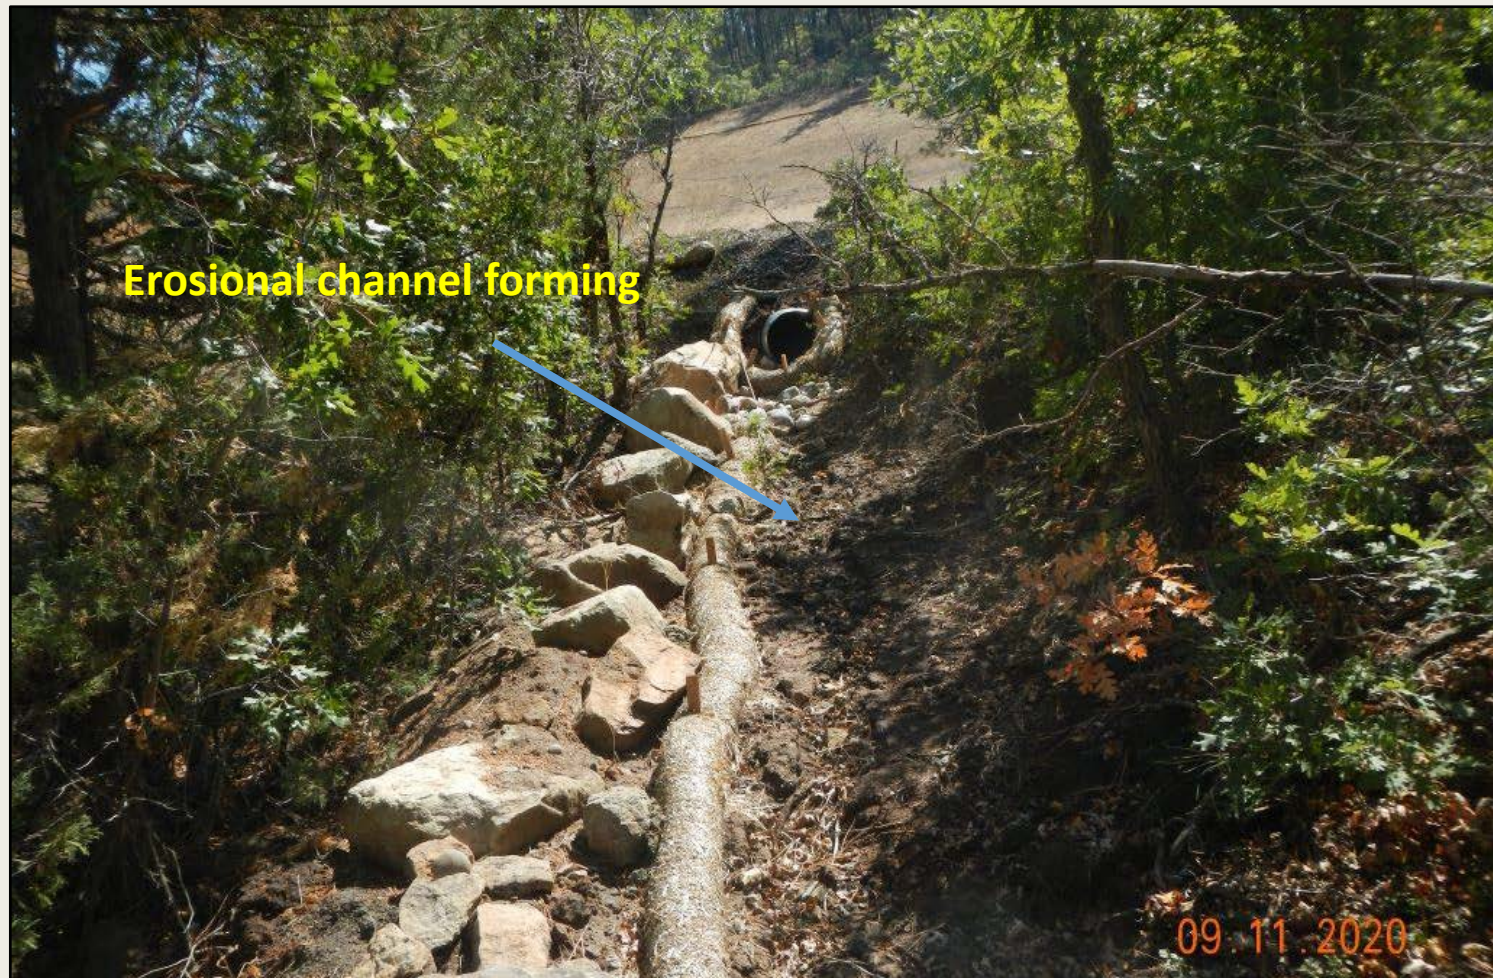
Photo 4. View of erosional downcutting occurring downstream from culvert outlet, near the well pad entrance. Wattle is placed along the slope.

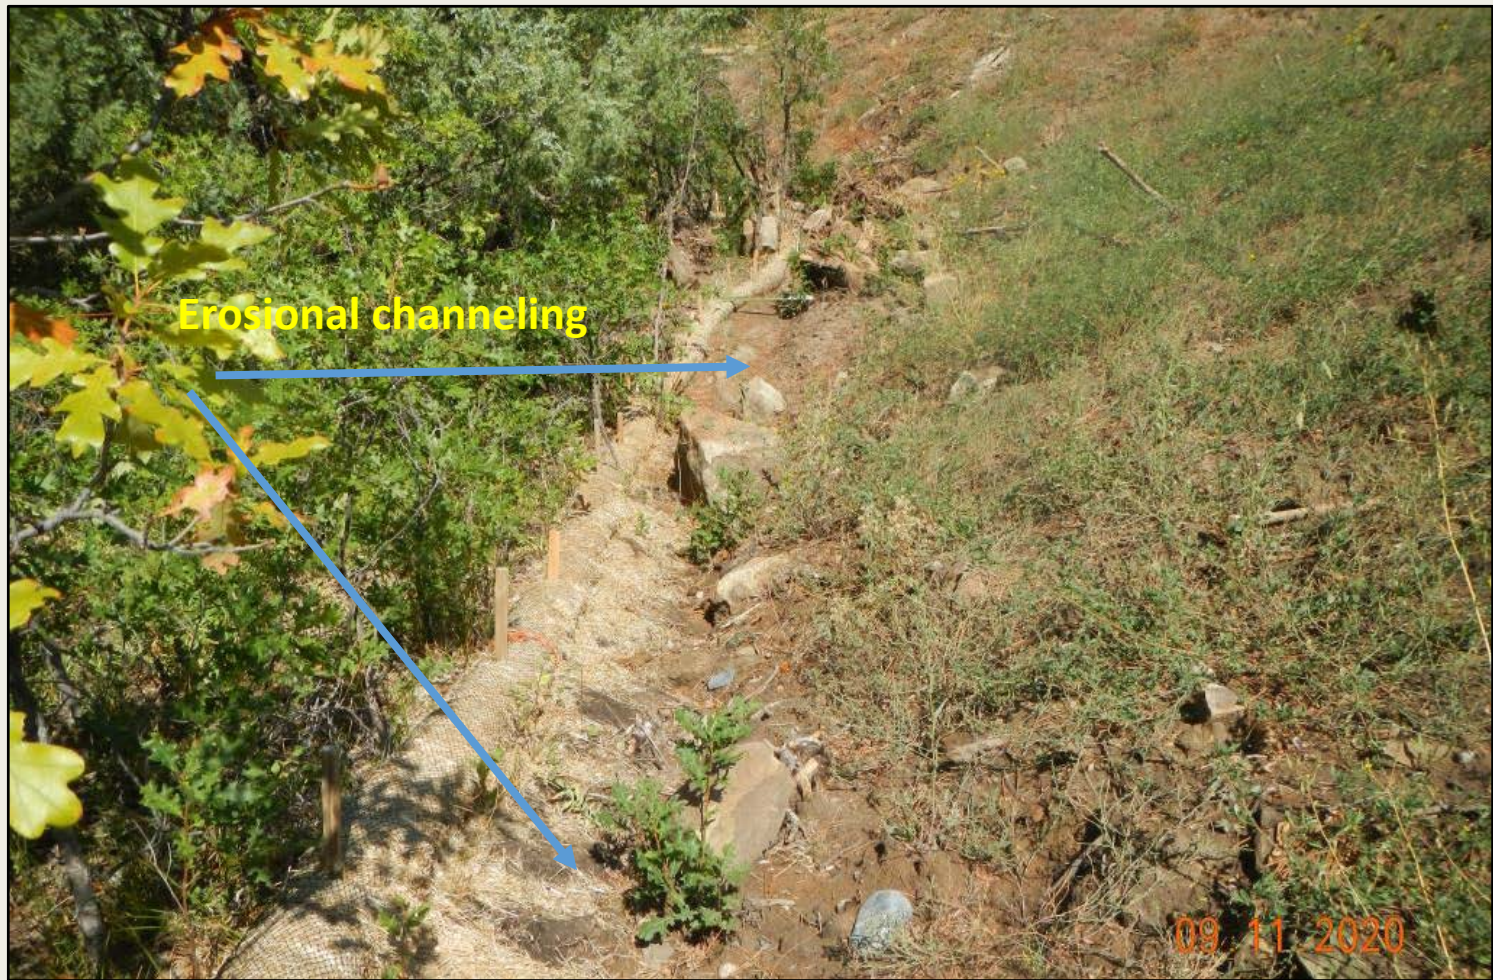
Photo 5. View of erosional channel in photo 4, continuing along the wattle and into the drainage on the western edge of the project area.

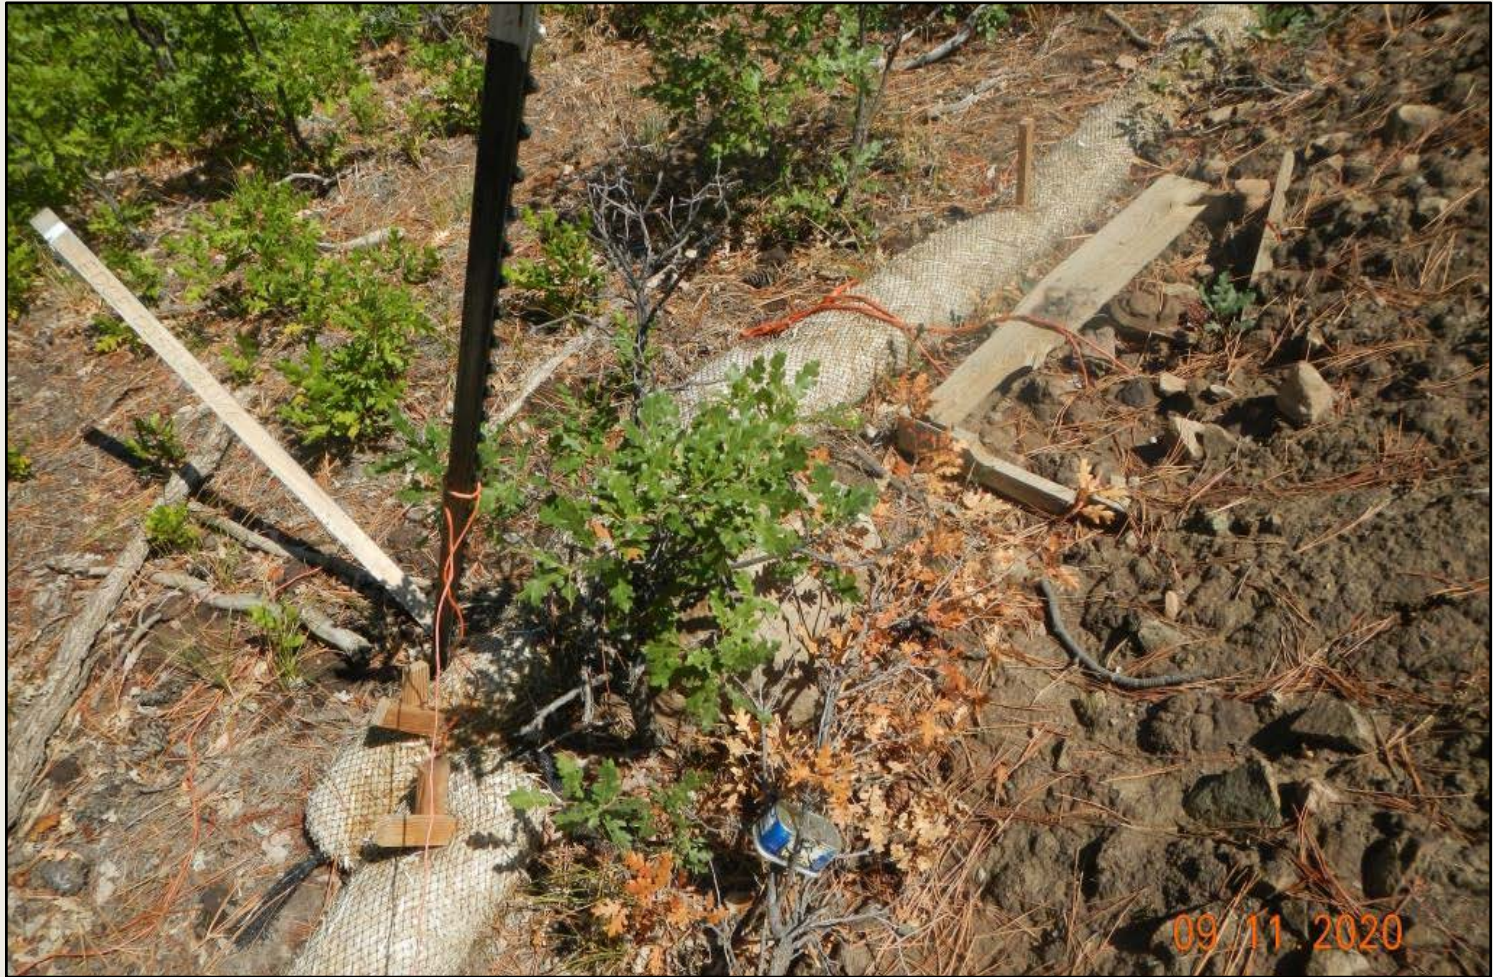
Photo 6. View of fencing and twine debris along the outer perimeter of the project area.

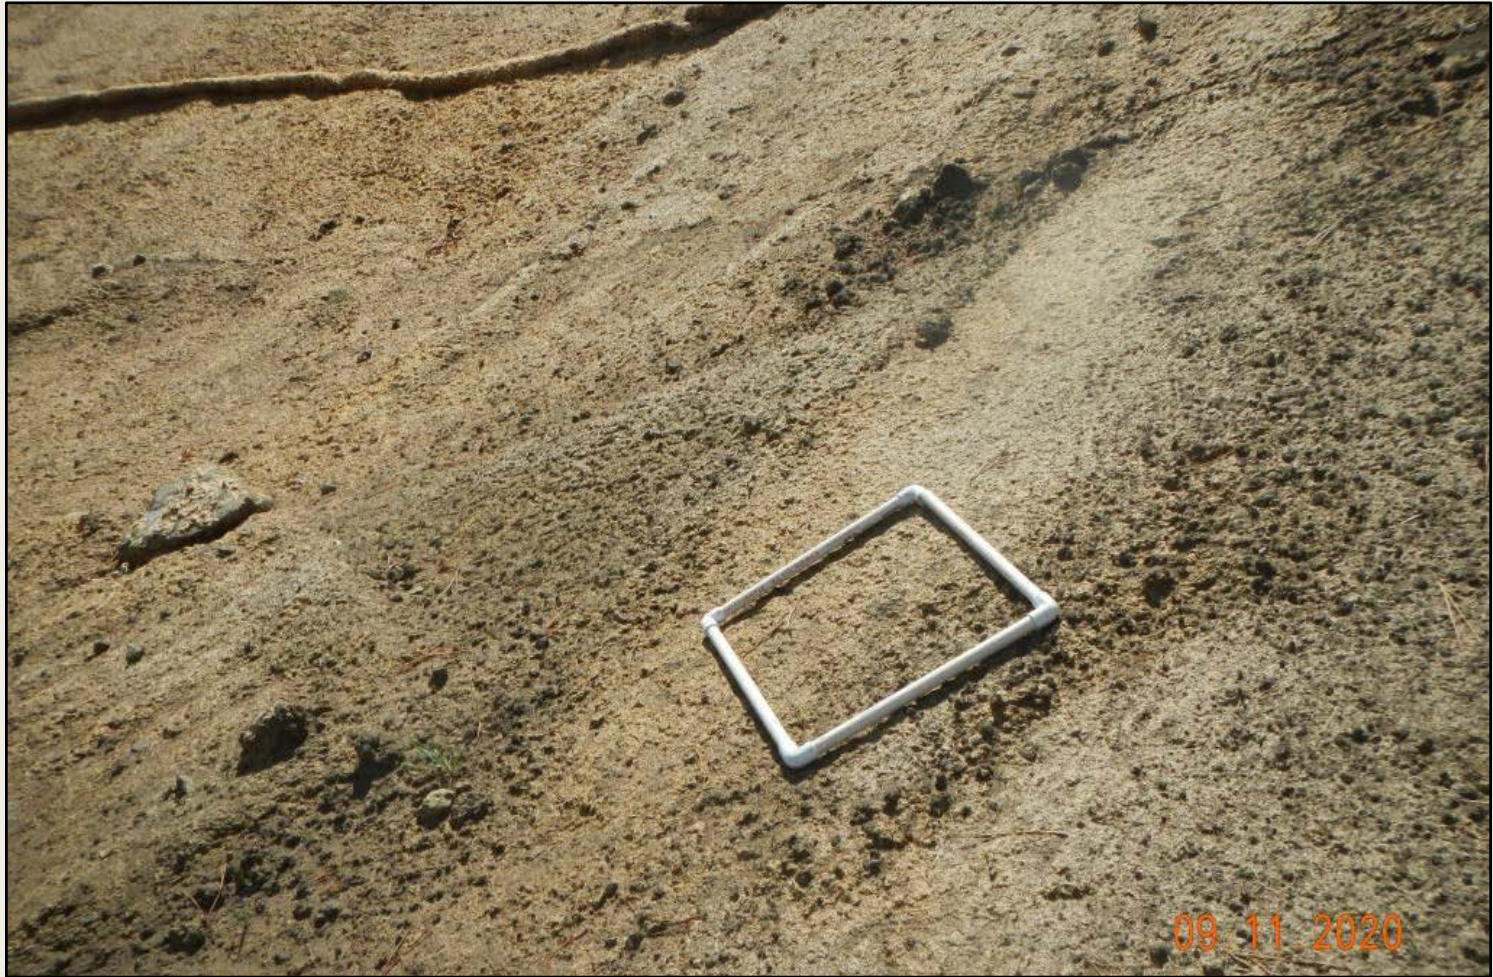
Photo 7. View of quadrat 1, on germination “Transect 1”. No desirable vegetation was observed within any of the 20 quadrat samples taken along the Transect.

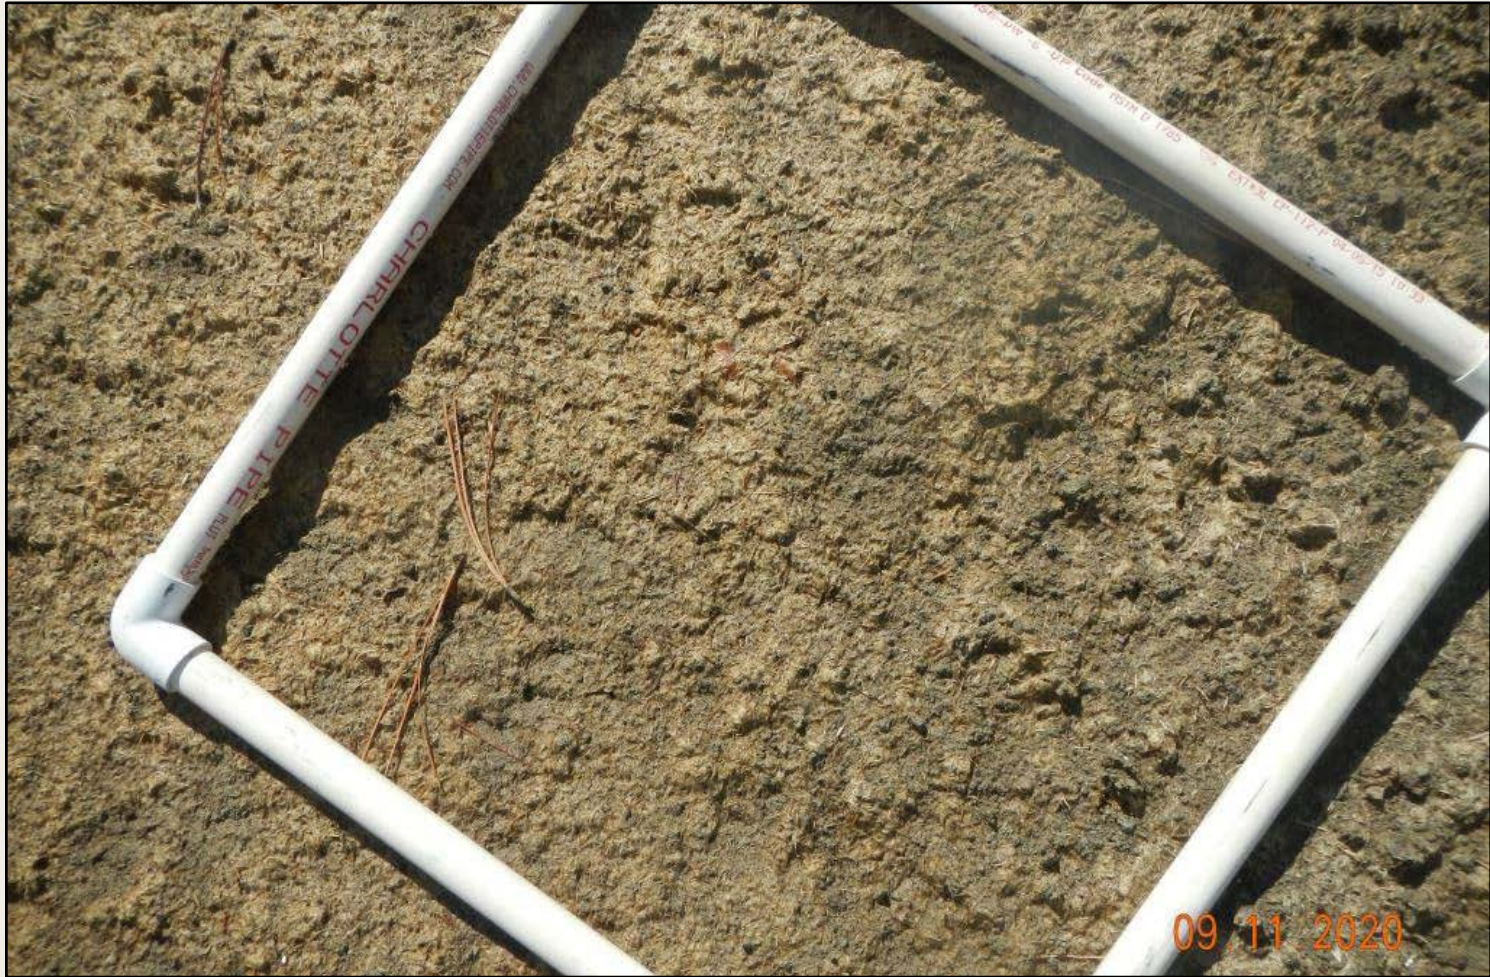
Photo 8. Closeup view of quadrat sample, showing no desirable vegetation germinating within the quadrat.

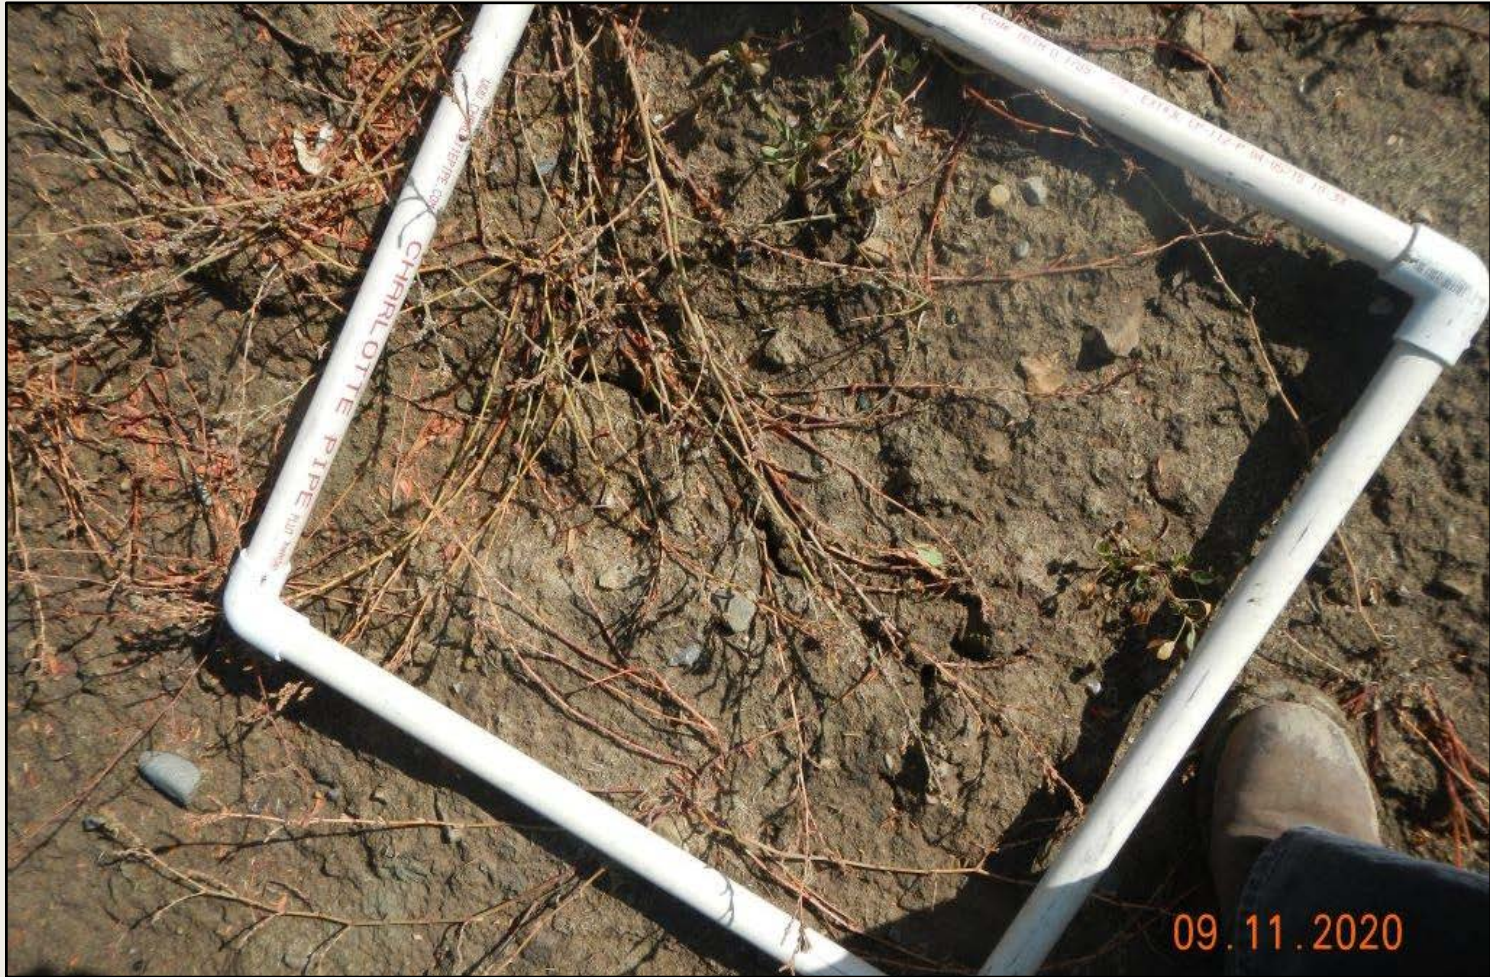
Photo 9. View of typical quadrat along germination Transect 2, within the western fill slope. Observable vegetation is comprised of weedy, prostrate knotweed.

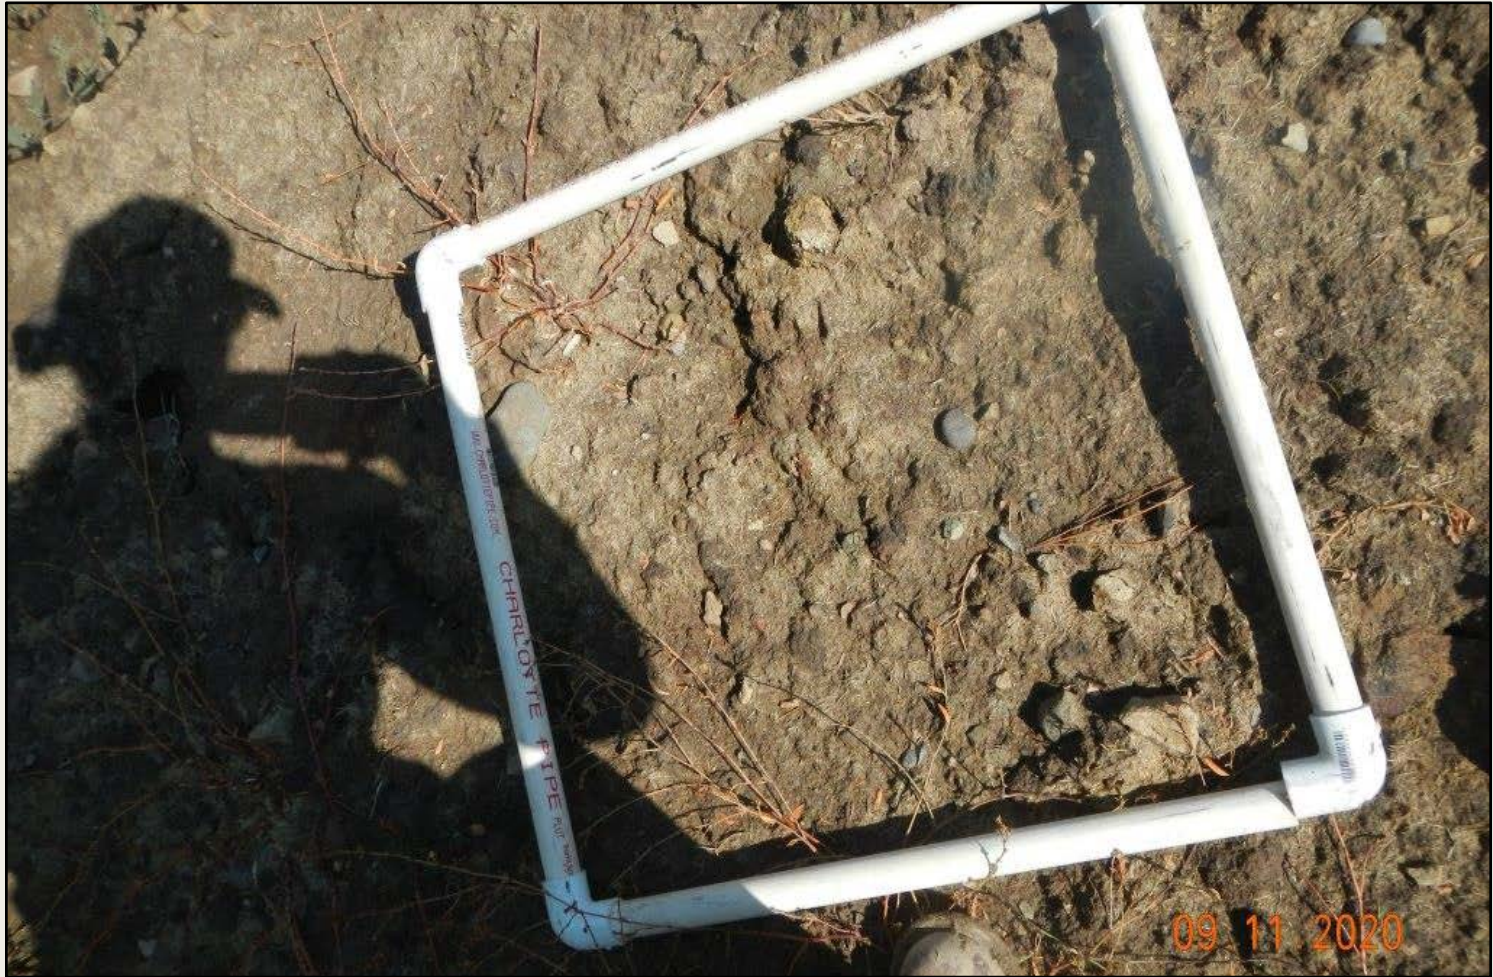
Photo 10. Another birdseye view of germination quadrat along “Transect 2”.

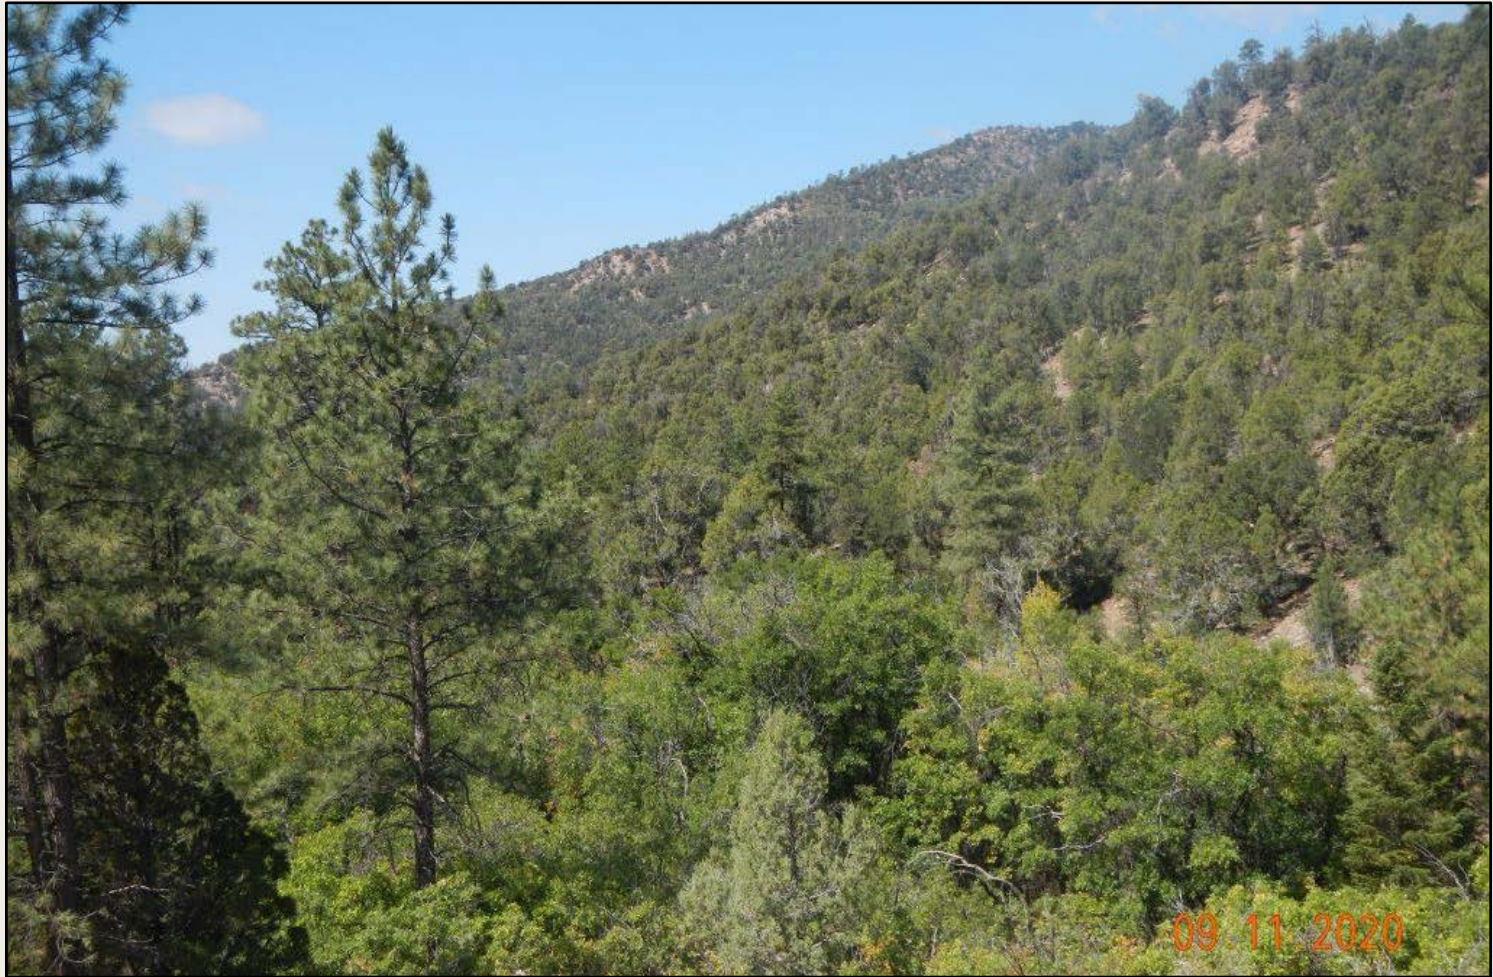
Photo 11. View of reference area vegetation comprised of ponderosa pine forest with gambel oak, snow berry, Oregon grape, and junegrass in the understory.
