Inspection Photos
Location Name: Zabka 12-15
Location ID: 332144

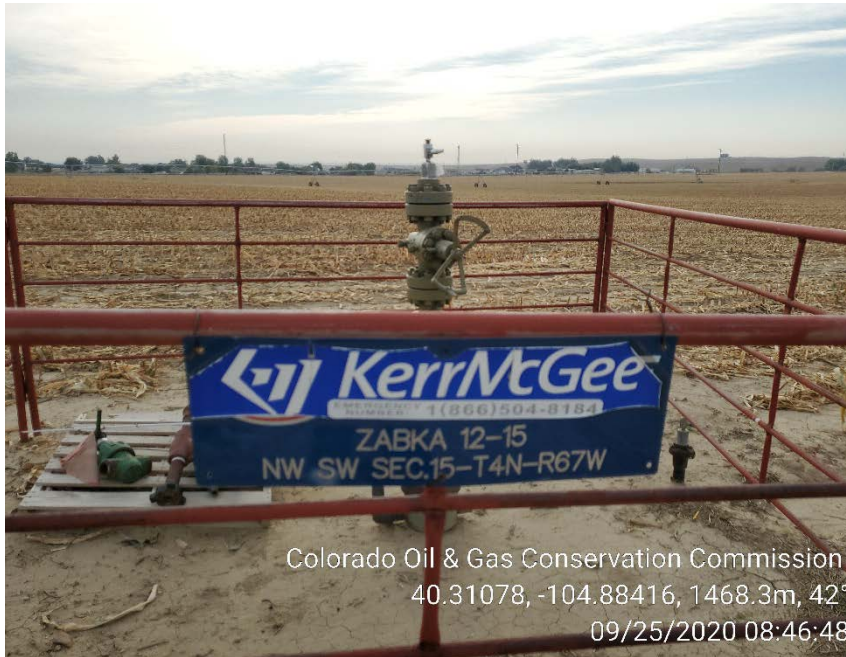
Wellhead

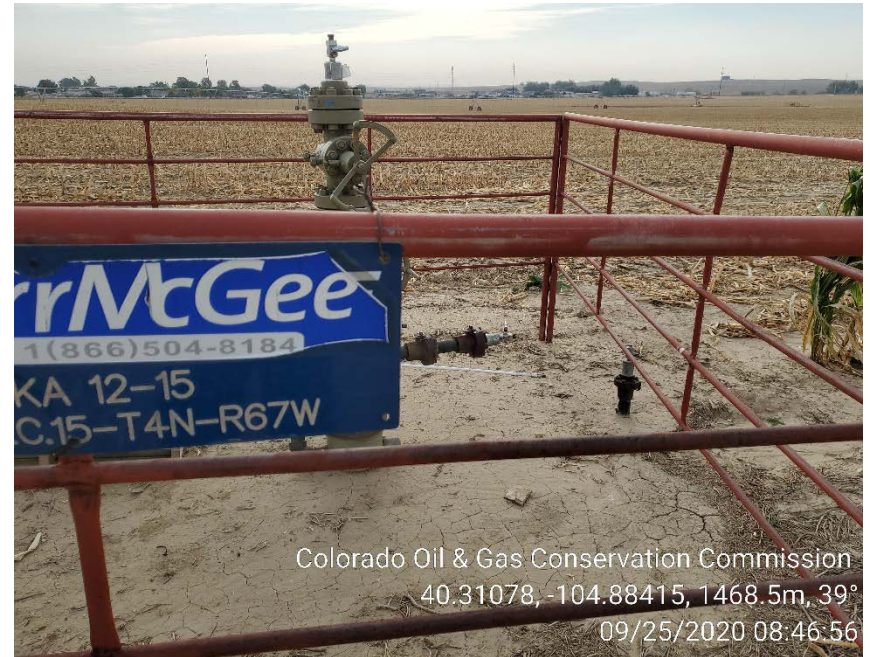
Disconnected flowline
