Inspection Photos
Location Name: Zabka 11-15
Location ID: 332146

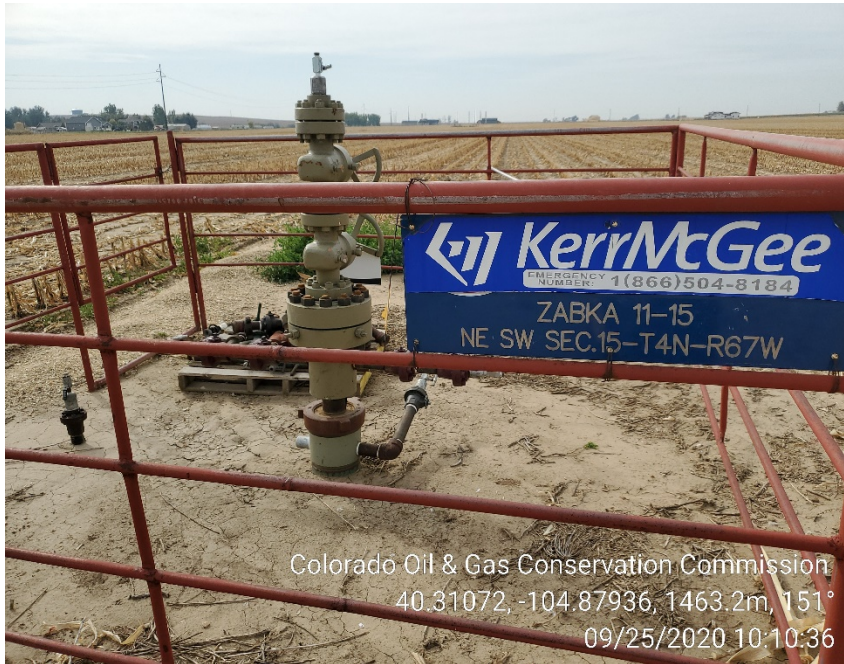
Wellhead

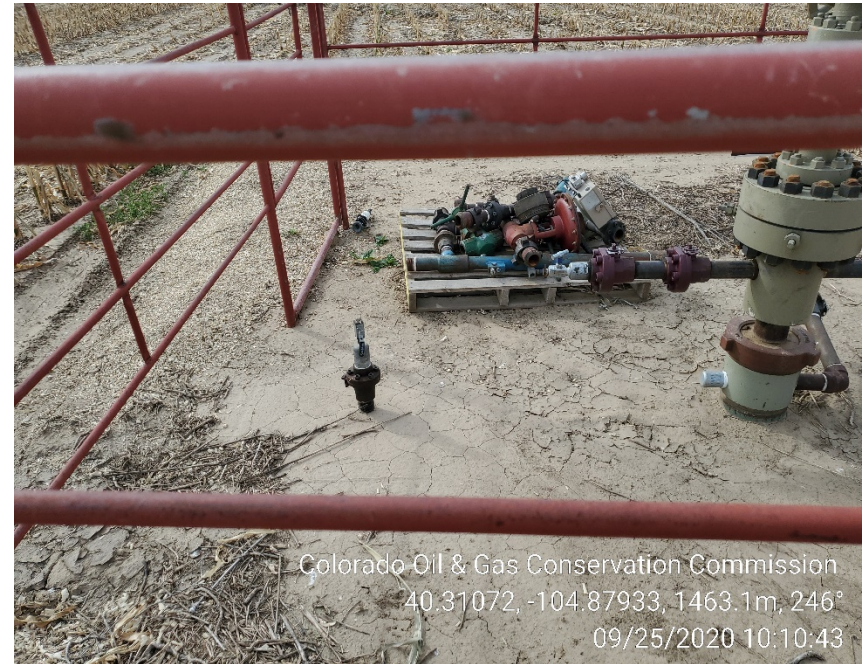
Disconnected flowline
