Location Name: Vallejo 44-5 lease road Location ID/API #: Spill 478196

COLORADO
Oil & Gas Conservation
Commission
Department of Natural Resources

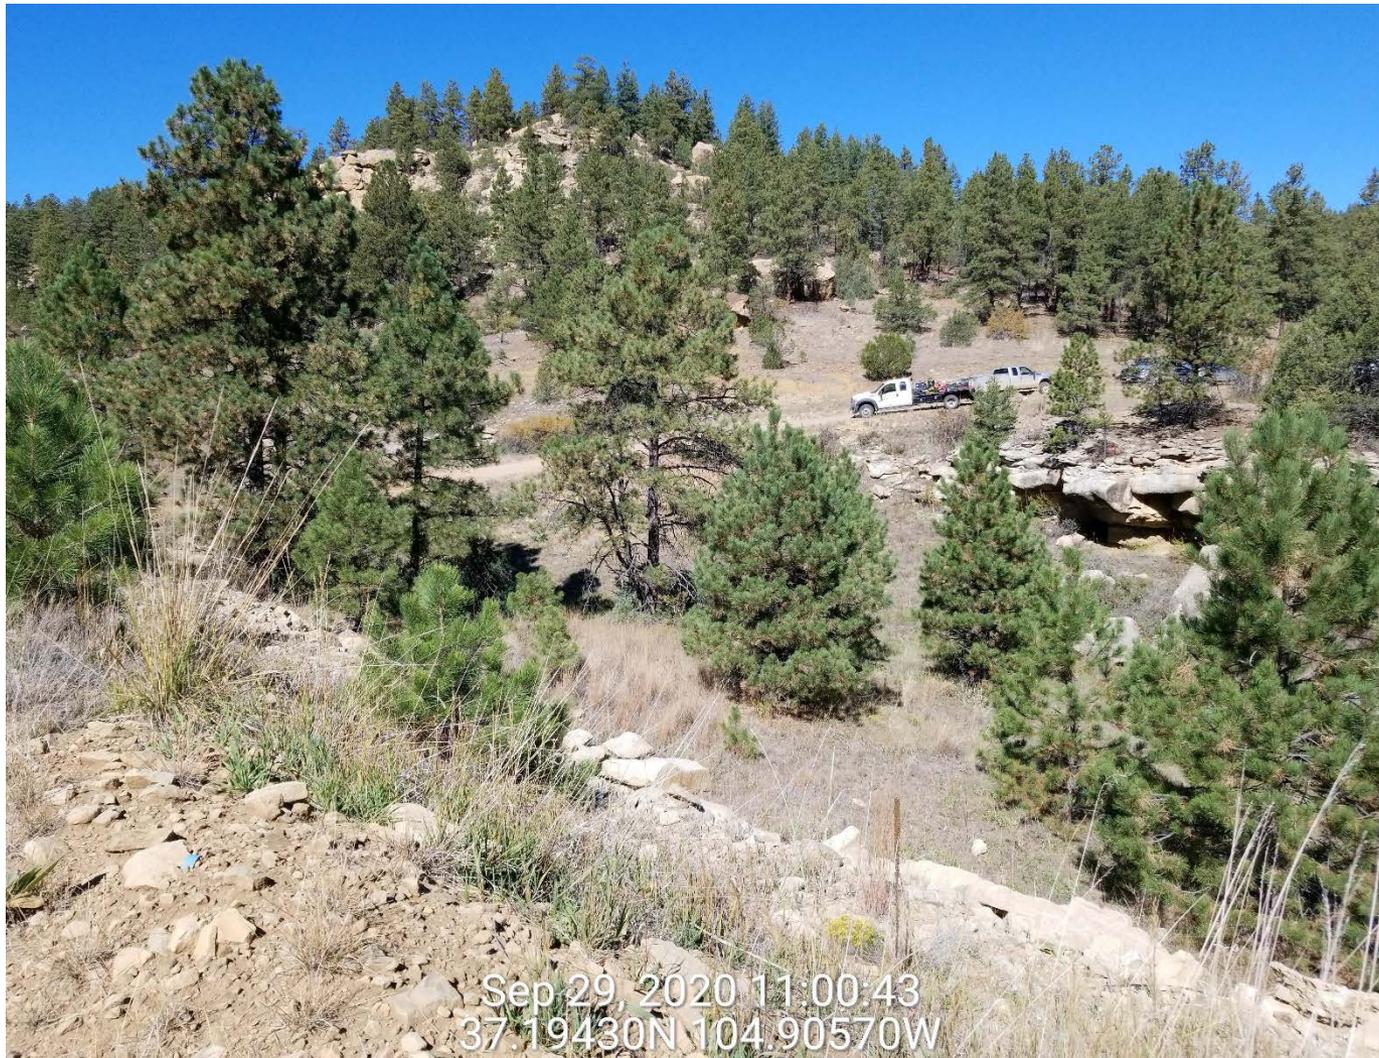
Spill flowed from left to right in the drainage pictured.

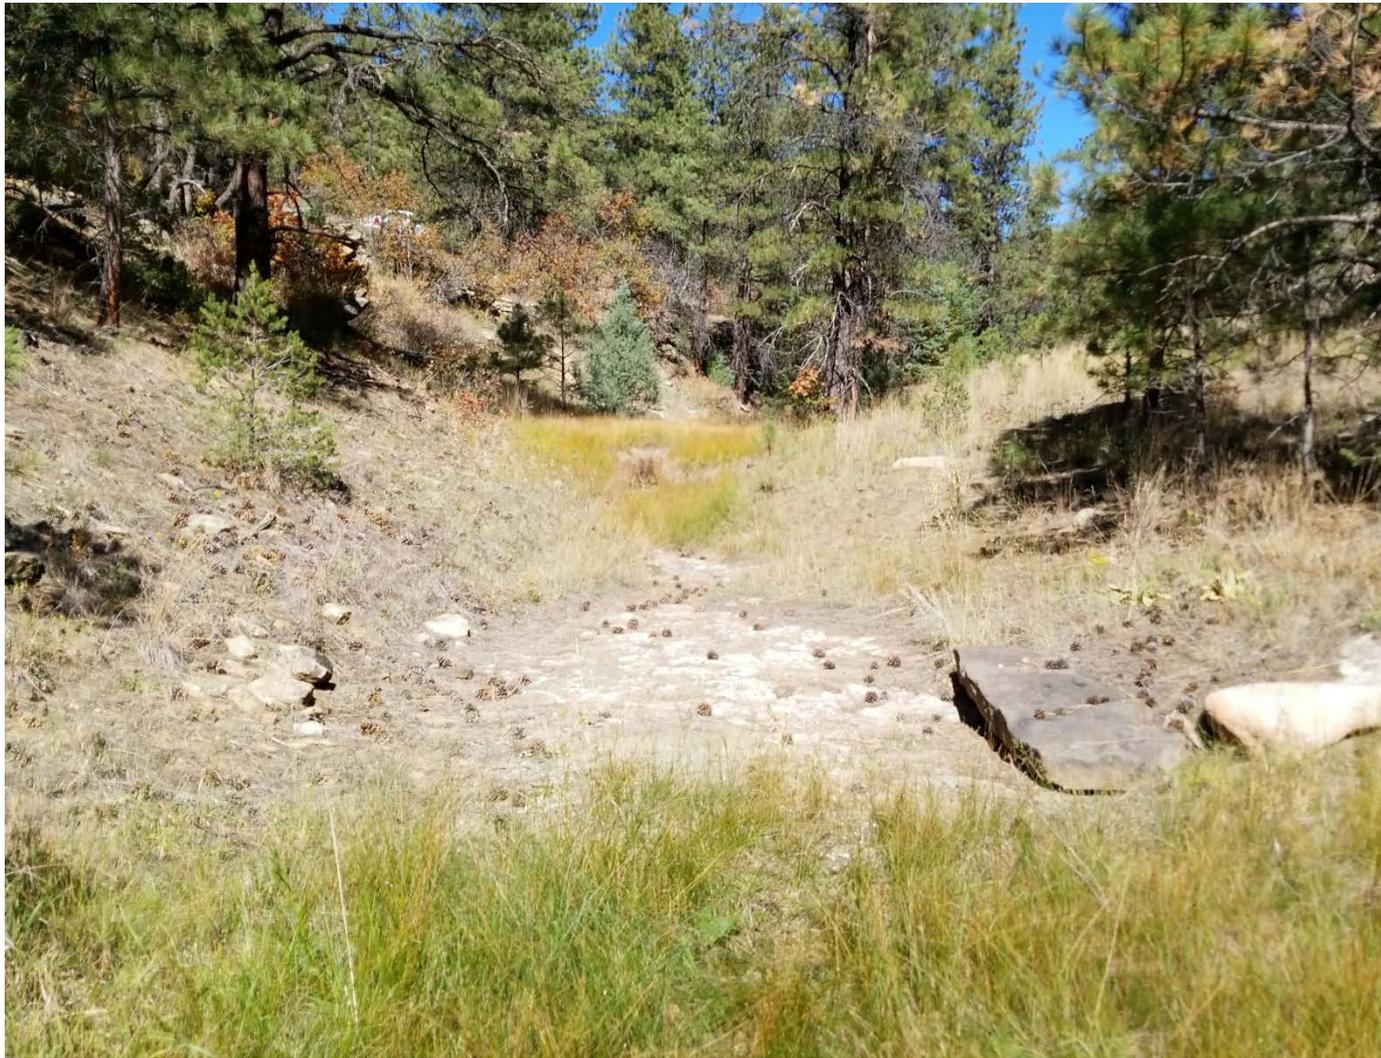
**Downstream from produced water pool shown in next photo.
Operator was instructed to obtain water sample downstream
from this area to show background.**

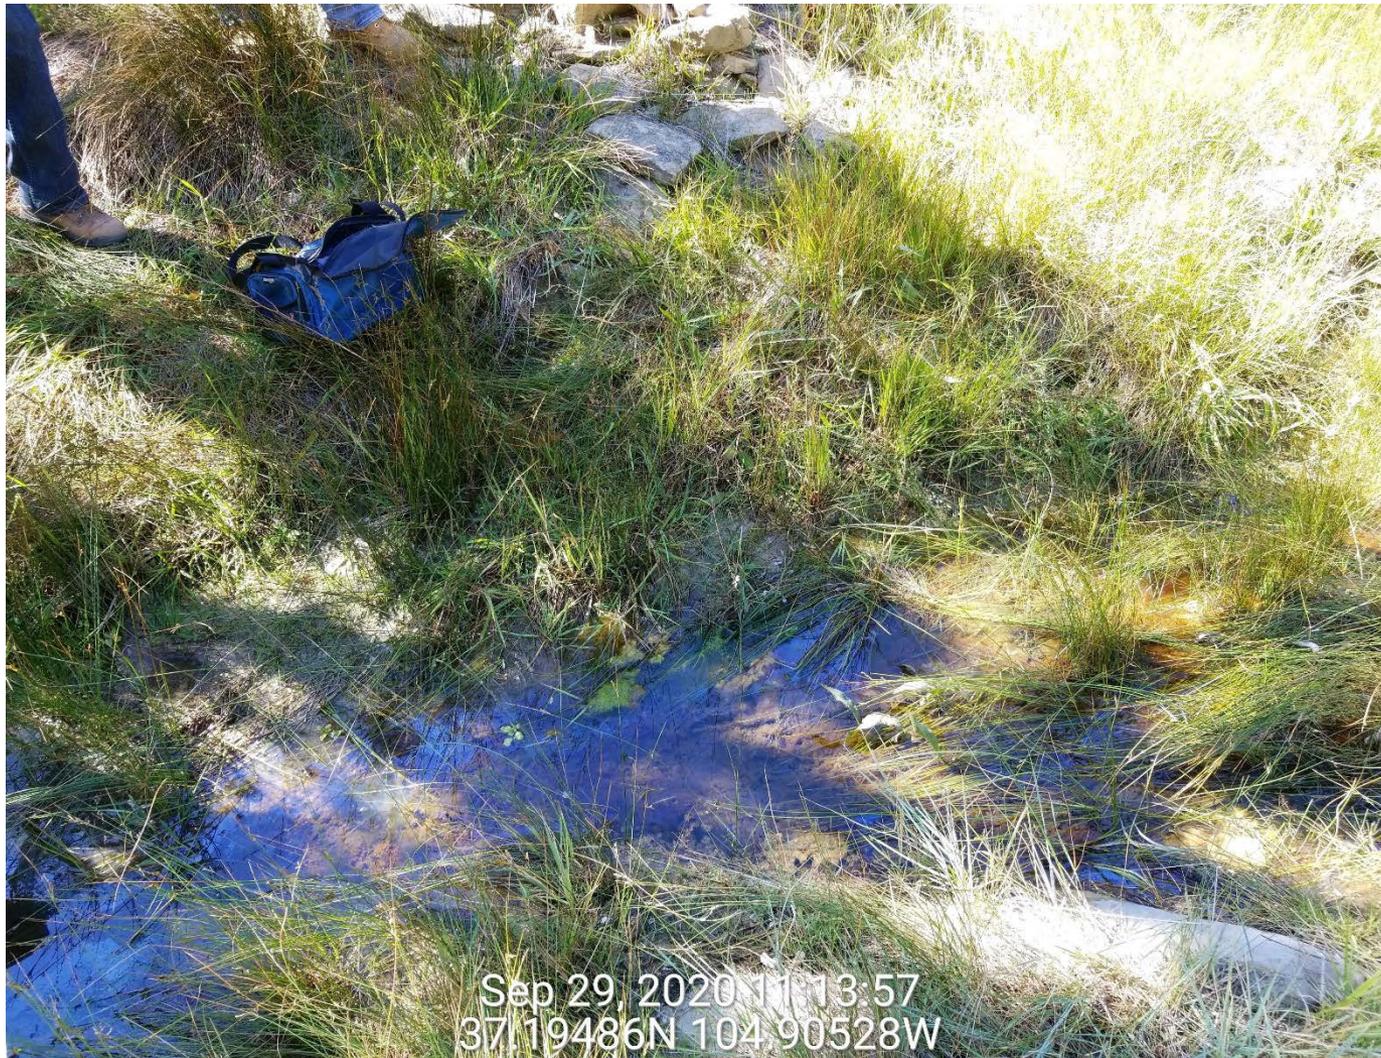
Sep 29, 2020 11:13:57
37.19486N 104.90528W

Pool of suspected produced water in drainage

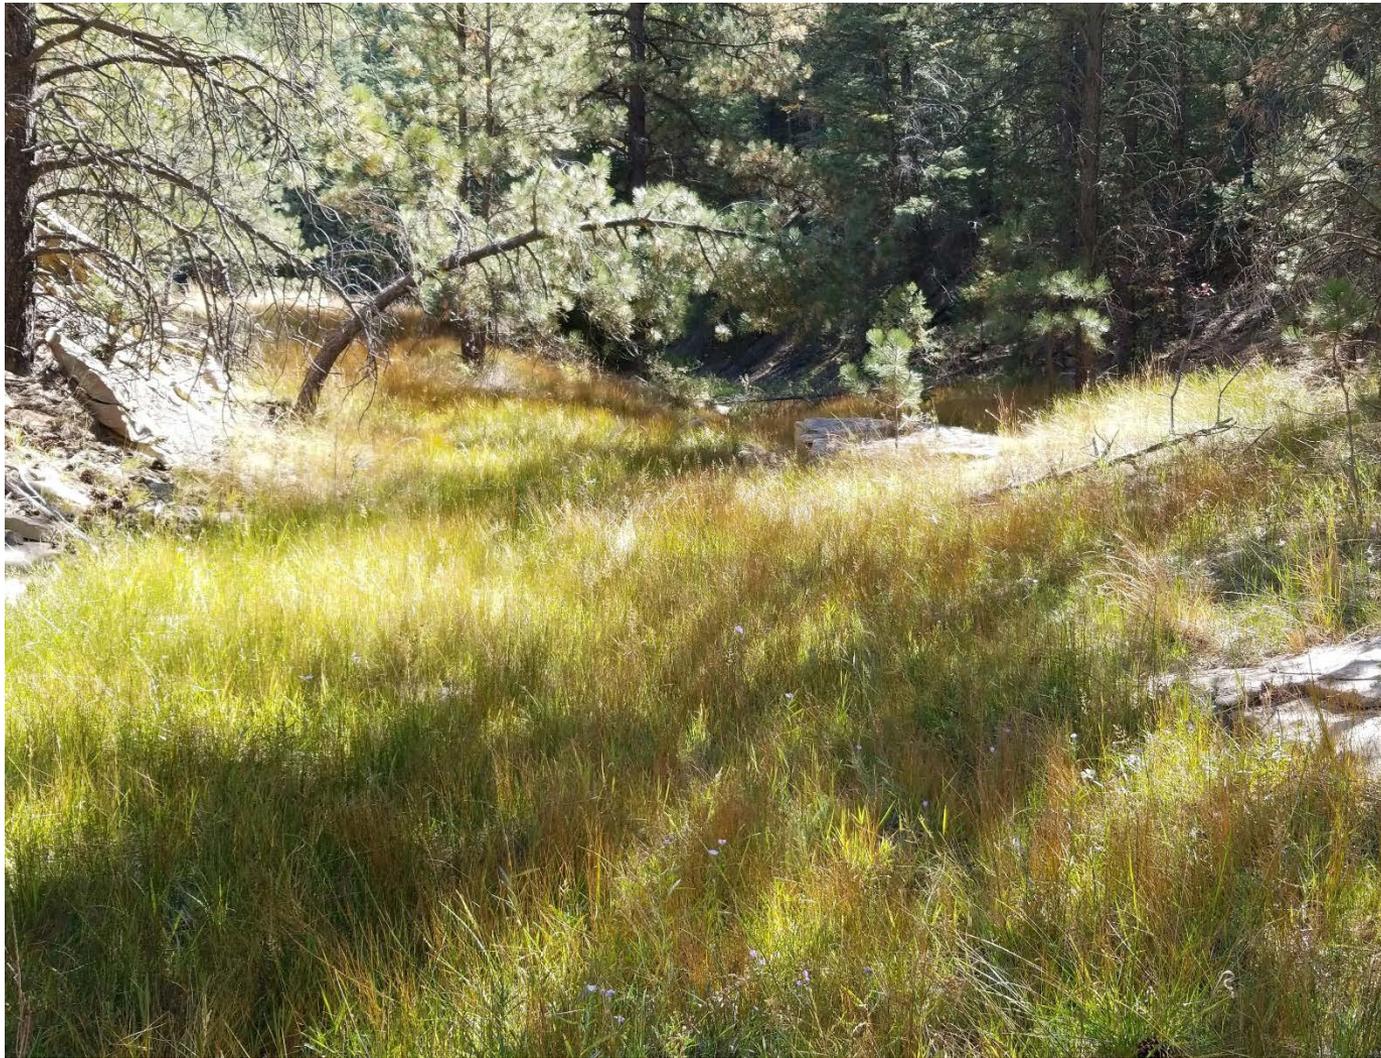
Drainage contained marshy grass

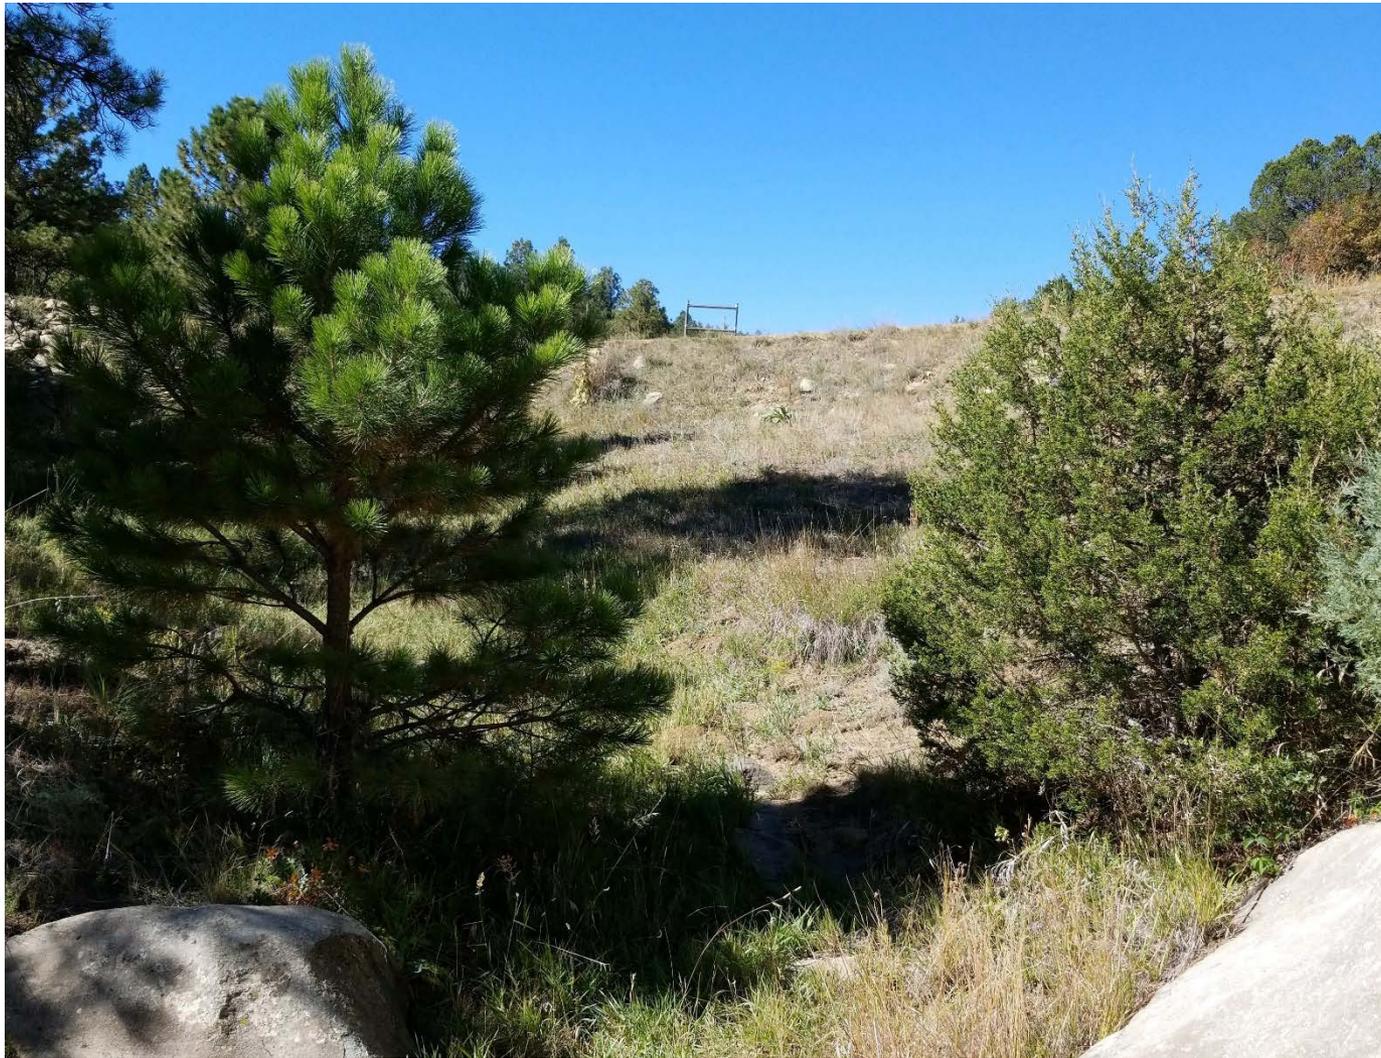
Looking from drainage where spill flowed up toward source of spill

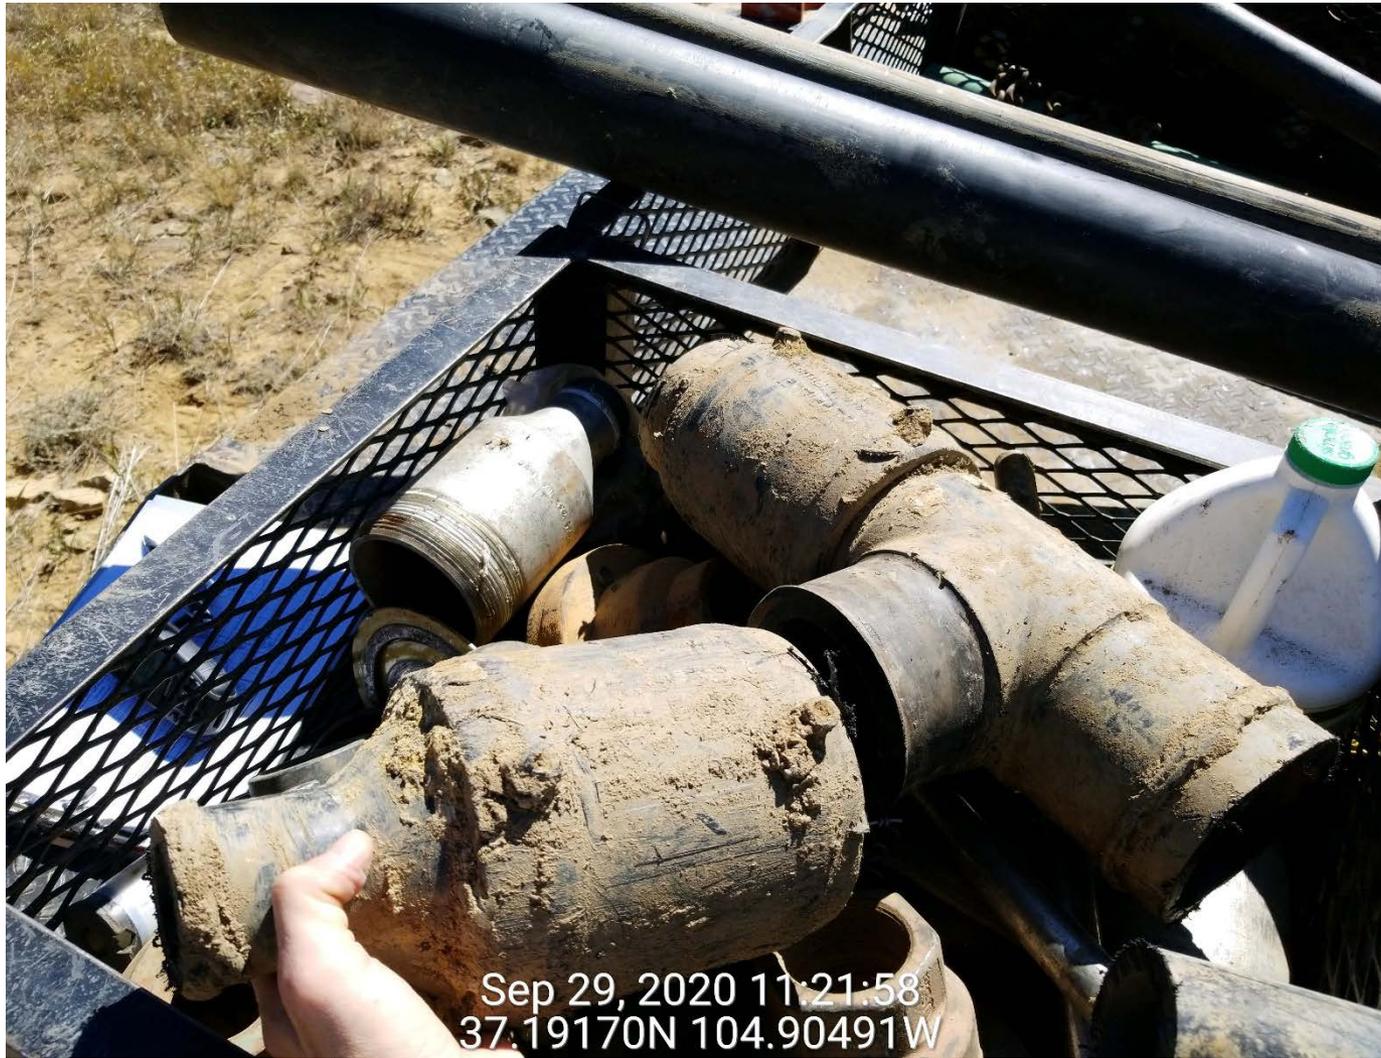
Sep 29, 2020 11:21:58
37.19170N 104.90491W

Source of leak was failure at this nipple.
