# Reclamation Inspection

September 18, 2020 (field inspection)

Operator: KERR MCGEE OIL & GAS ONSHORE LP #47120

Complaint #: 200449186

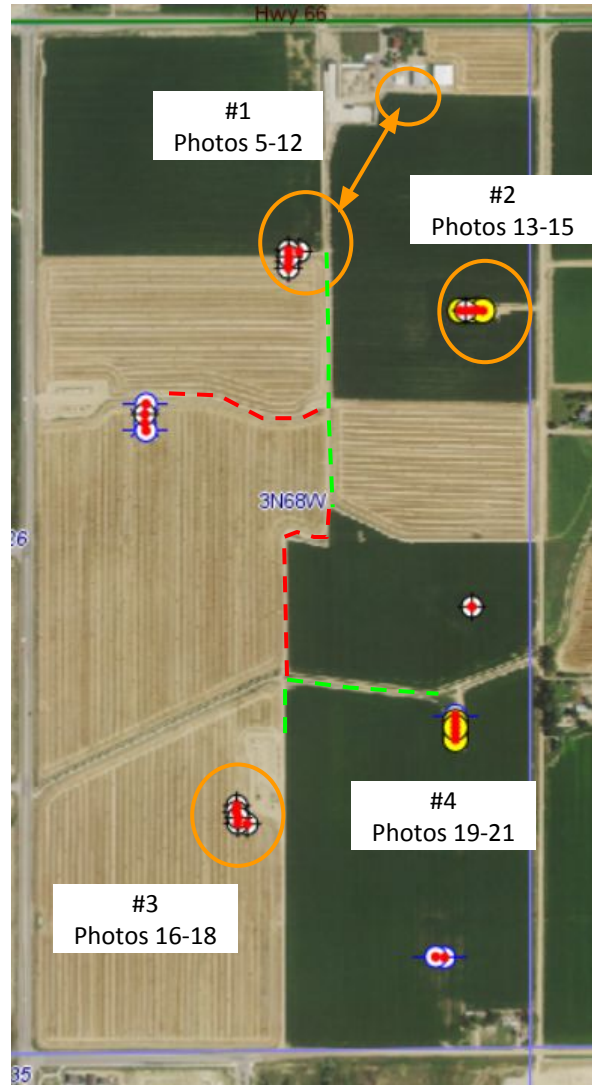
**Photo 1.** COGCC GISOnline aerial imagery taken 2019. Imagery illustrates three locations (#1-#3 orange circles) in addition to access roads with reclamation compliance issues. Access roads which were not pre-existing and need to be reclaimed per Rule 1004 are the red-dashed lines; access roads that were pre-existing only requires gravel to be removed are the green-dashed lines.

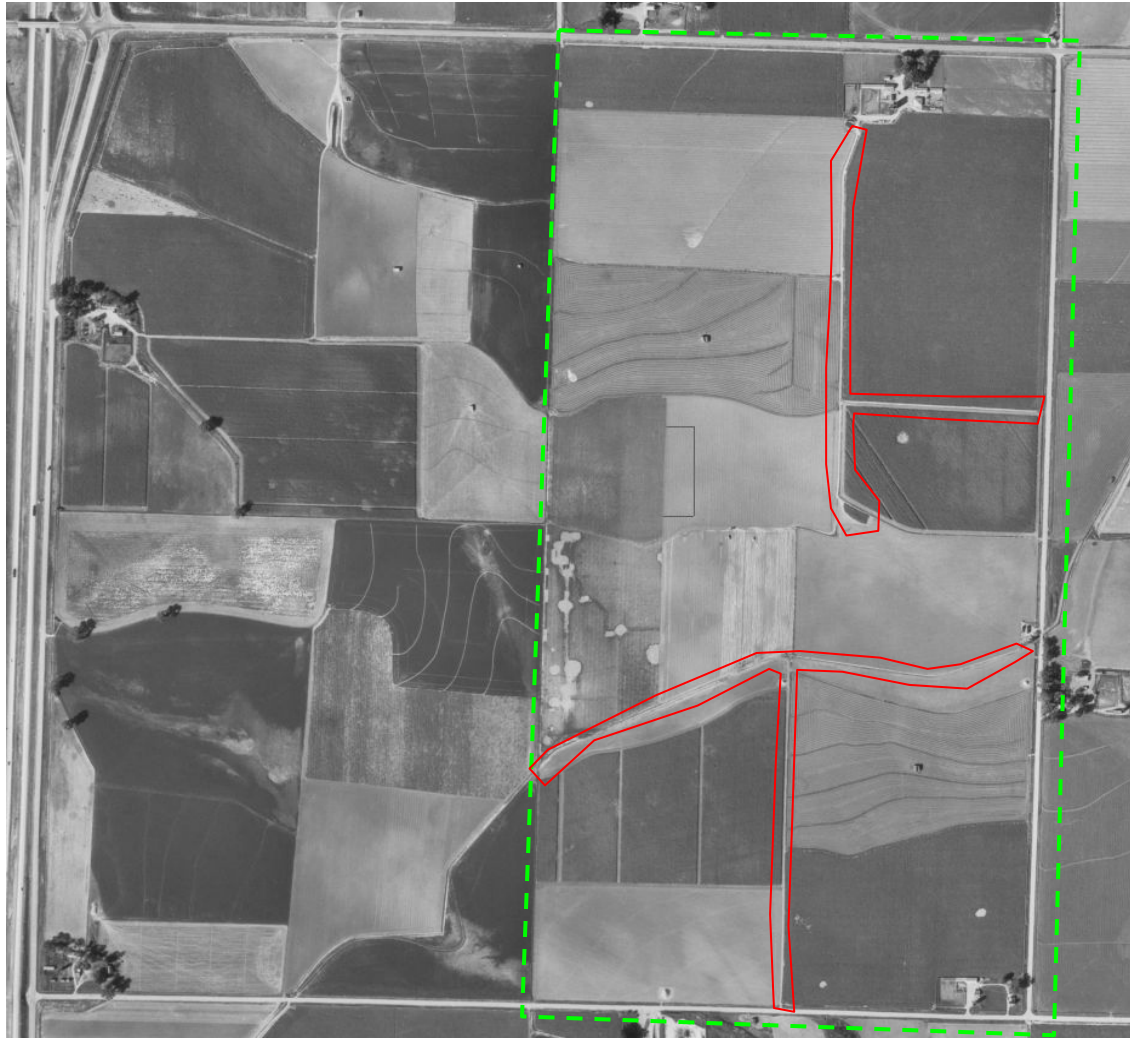
**Photo 2.** Aerial imagery taken September 20, 1967 illustrating an overview of the area (area within the green-dashed line) demonstrating its condition prior to oil and gas activity. The red polygon areas highlight areas of pre-existing roads prior to oil and gas. Refer to Photos 3 and 4 which are zoomed in areas of the above area.

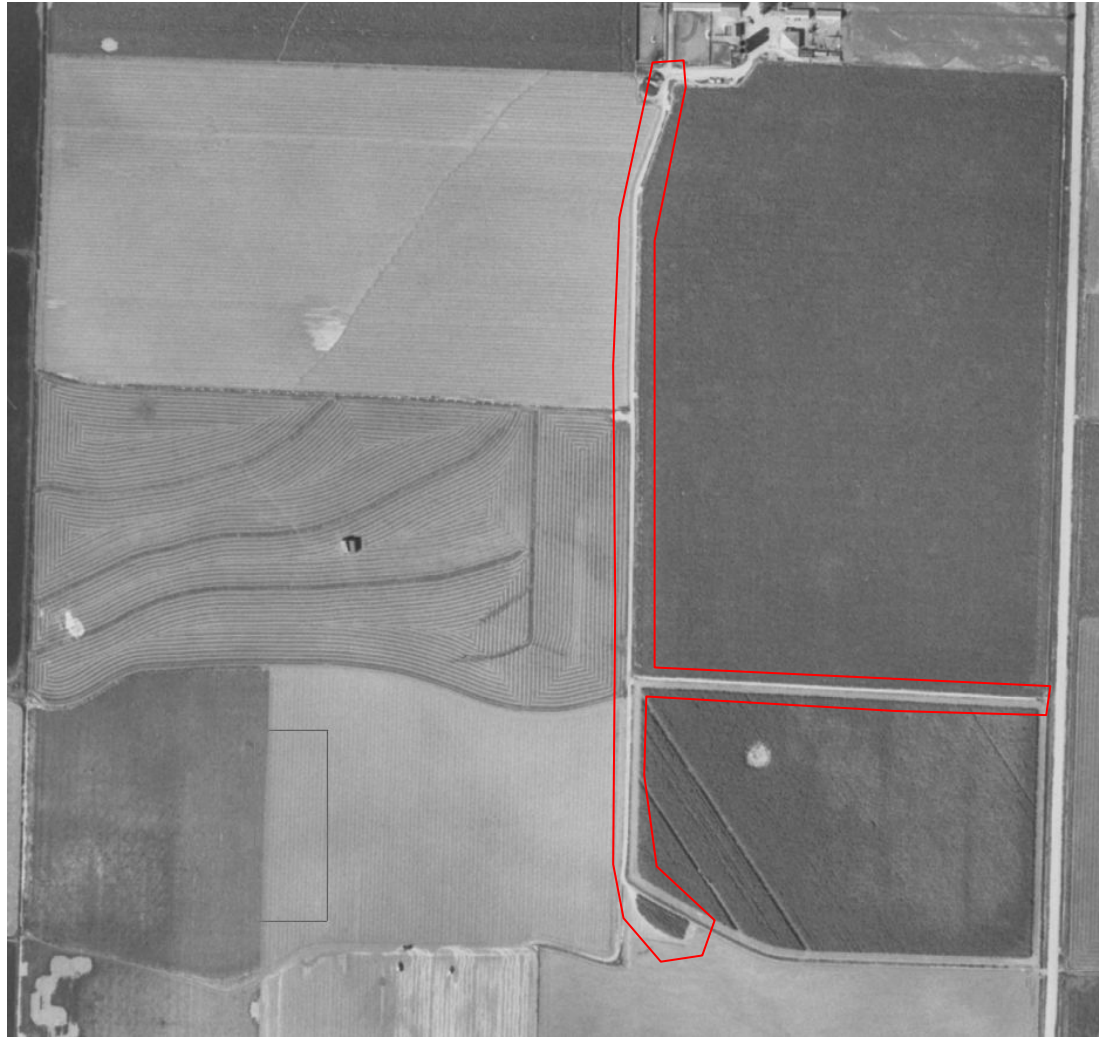
**Photo 3.** Zoomed in aerial imagery of the northern area taken September 20, 1967 illustrating an overview of the area demonstrating its condition prior to oil and gas activity. The red polygon areas highlight areas of pre-existing roads prior to oil and gas.

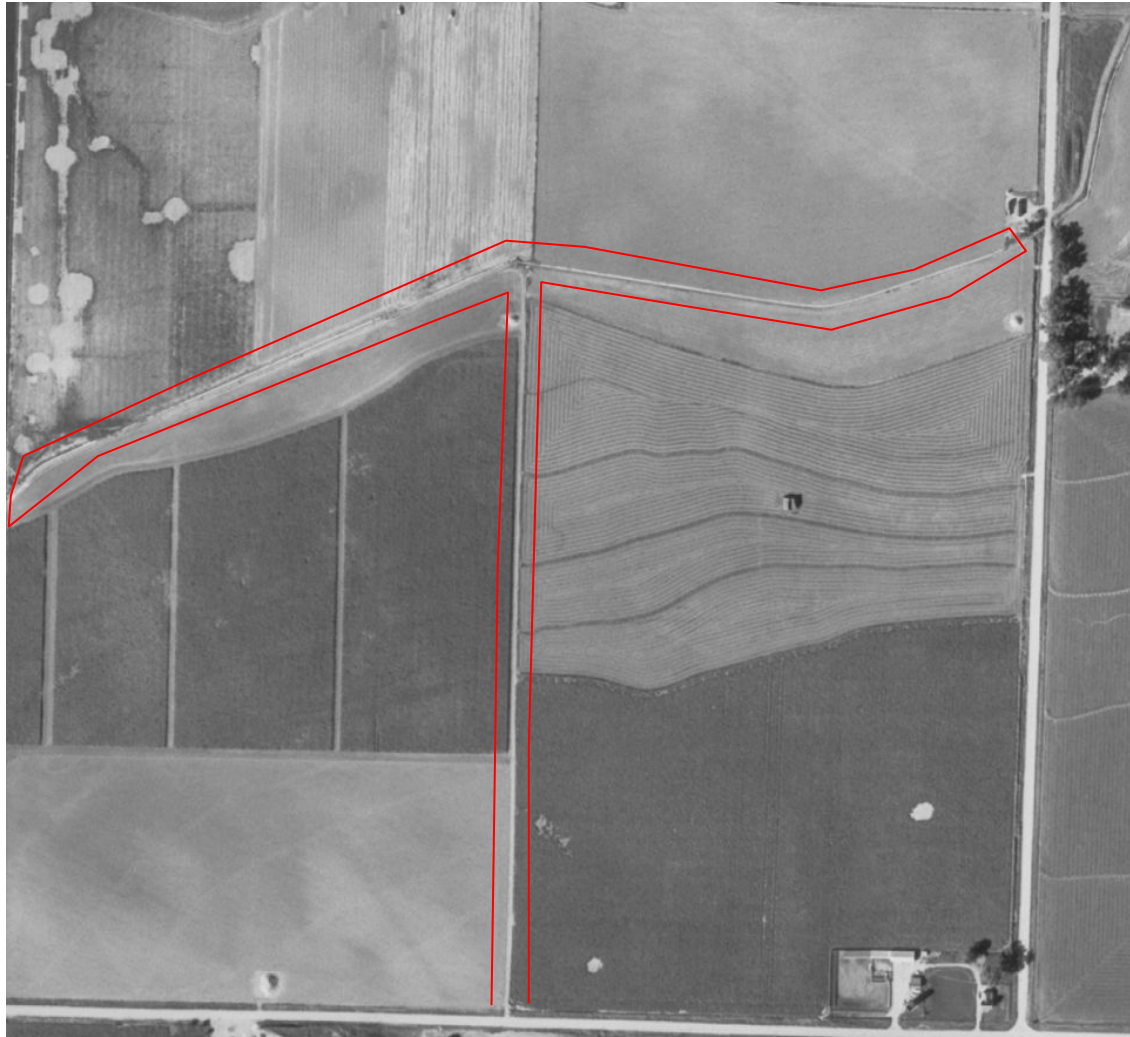
**Photo 4.** Zoomed in aerial imagery of the southern area taken September 20, 1967 illustrating an overview of the area demonstrating its condition prior to oil and gas activity. The red polygon areas highlight areas of pre-existing roads prior to oil and gas.

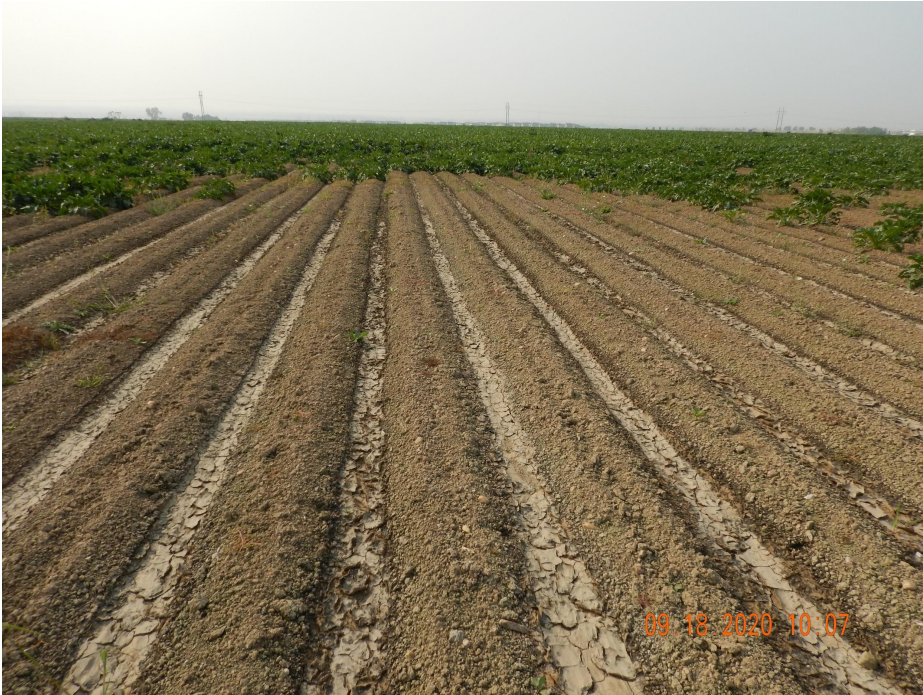
**Photo 5.** Photo taken from the southern plugged and abandoned (P&A) location, facing South. Photo illustrates the lack of crop growth (sugar beets). Sugar beets that are growing within the PA location are not reflective of reference area crop growth.

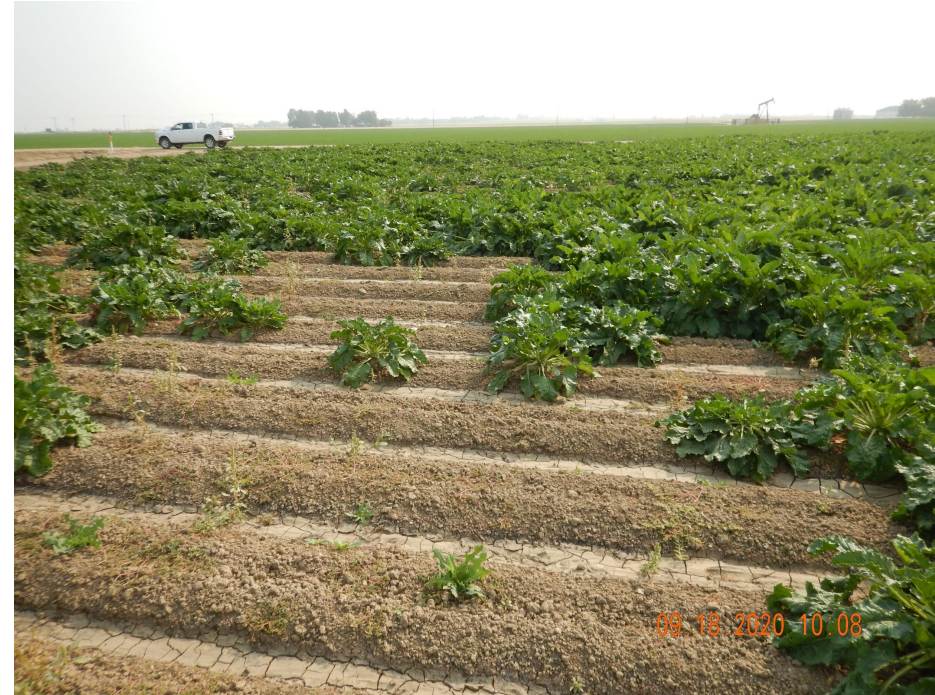
**Photo 6.** Photo taken from the southern plugged and abandoned location, facing East. See comments under Photo 5.

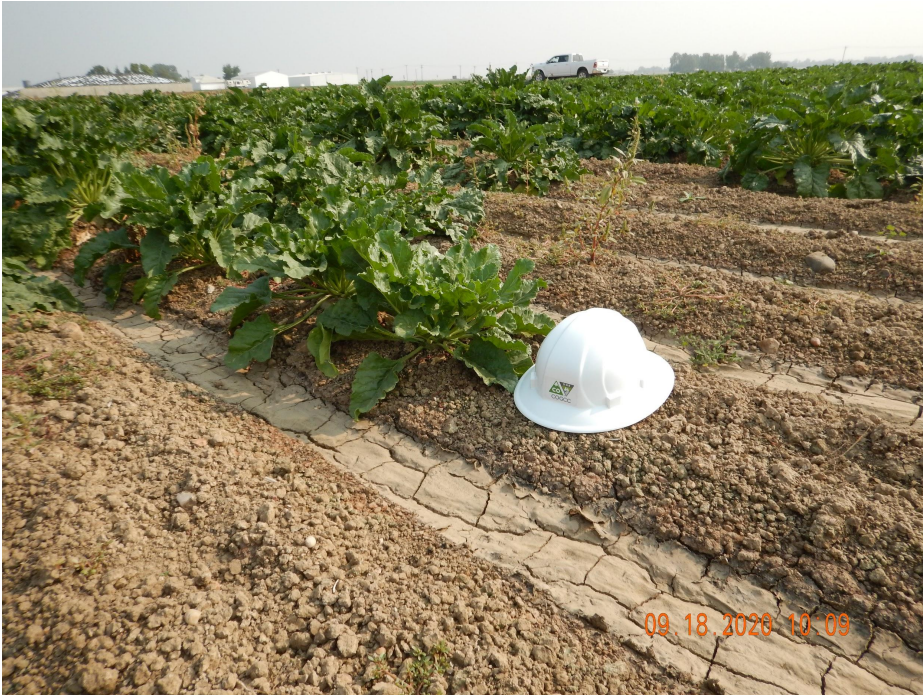
**Photo 7.** Photo taken from the southern plugged and abandoned location, facing East. Photo illustrates a stunted sugar beet not reflective of reference areas.

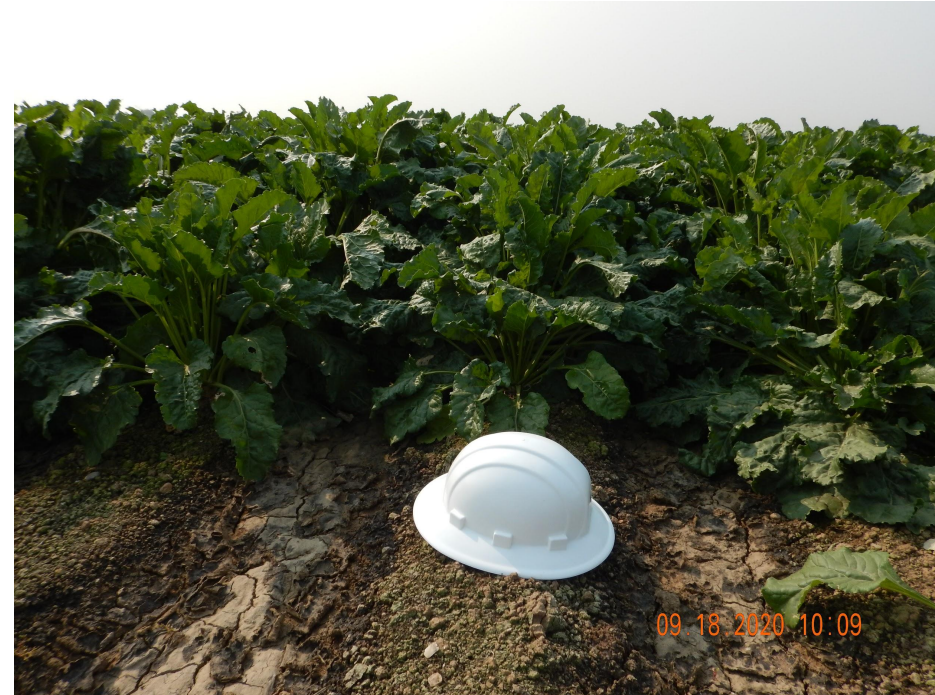
**Photo 8.** Photo taken from the adjacent reference area, facing South. Photo illustrates the crop deficiencies between the P&A crops versus the reference crops.

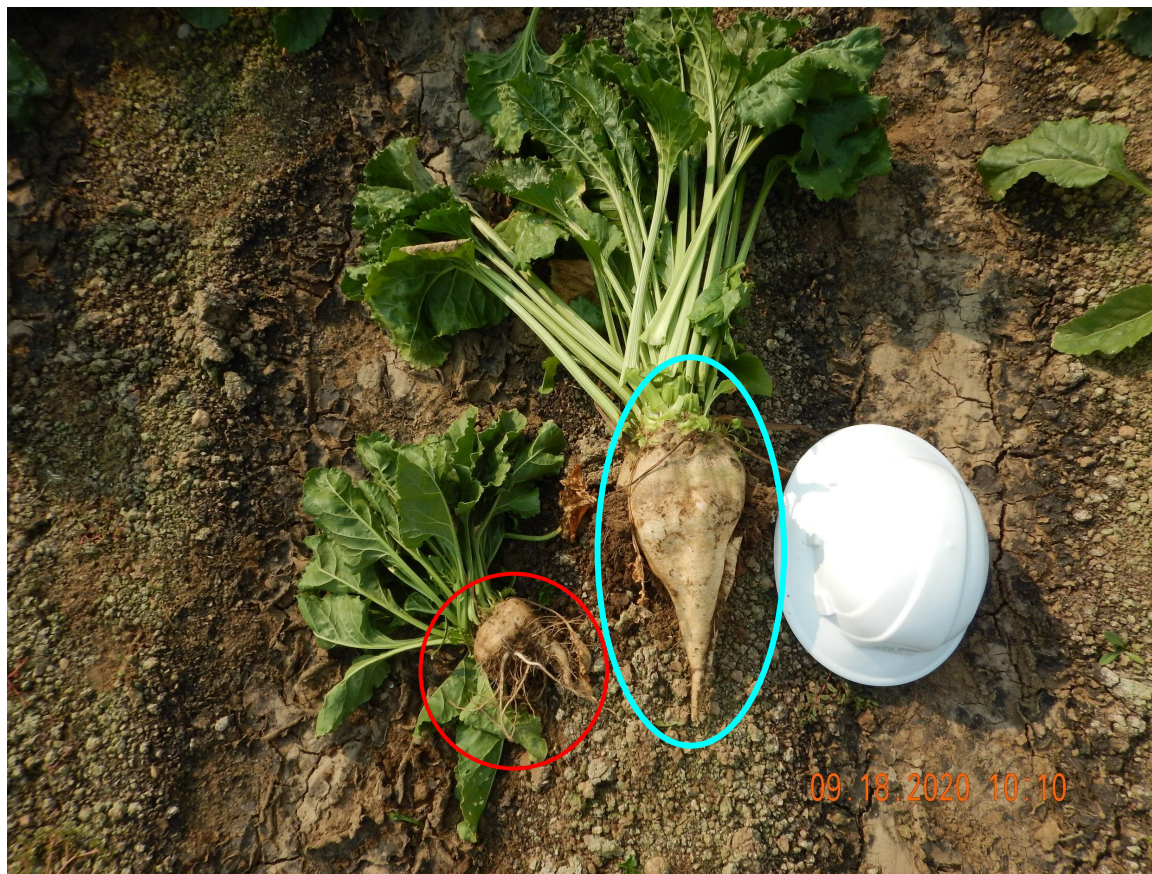
**Photo 9.** Photo taken of a sugar beet from the P&A area (red circle) and from the reference area (blue circle).

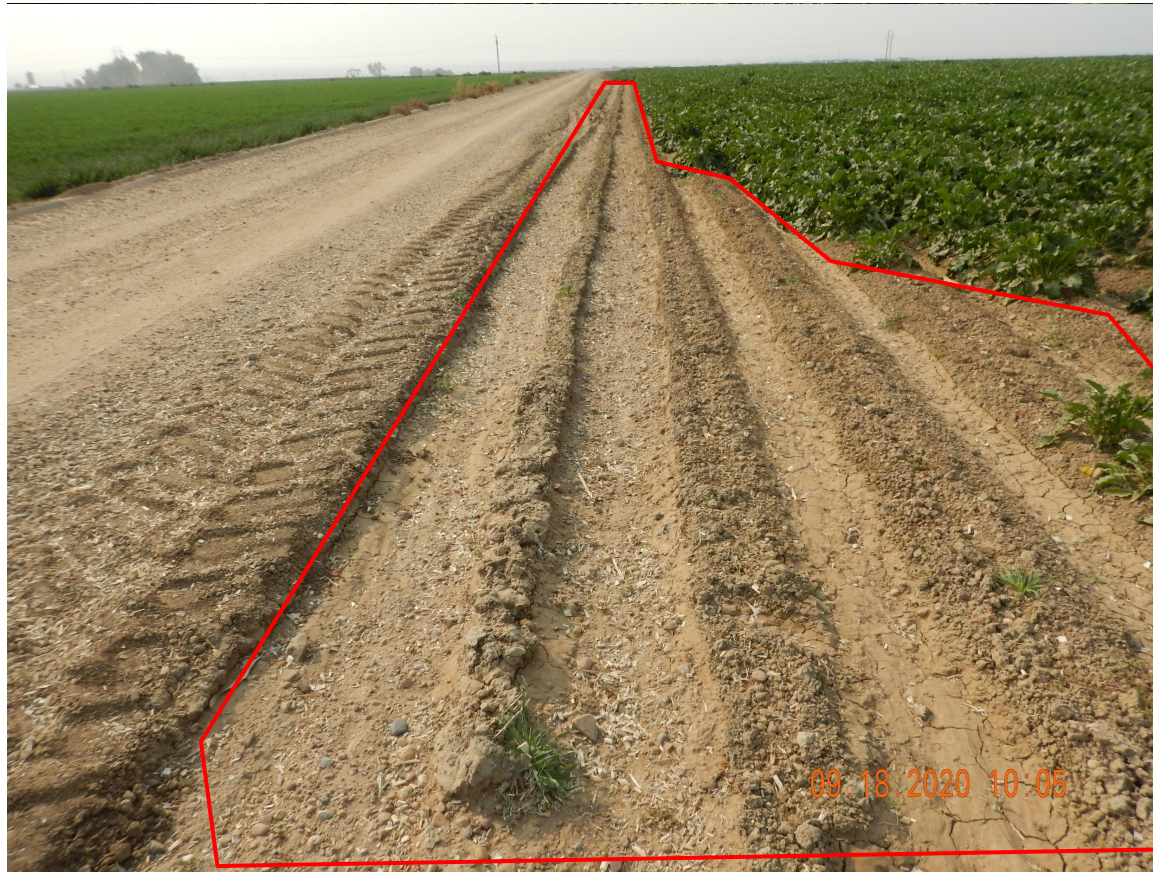
**Photo 10.** Photo taken from the eastern P&A location, facing South. Photo illustrates portions of the crop field have not been reclaimed (red polygon).

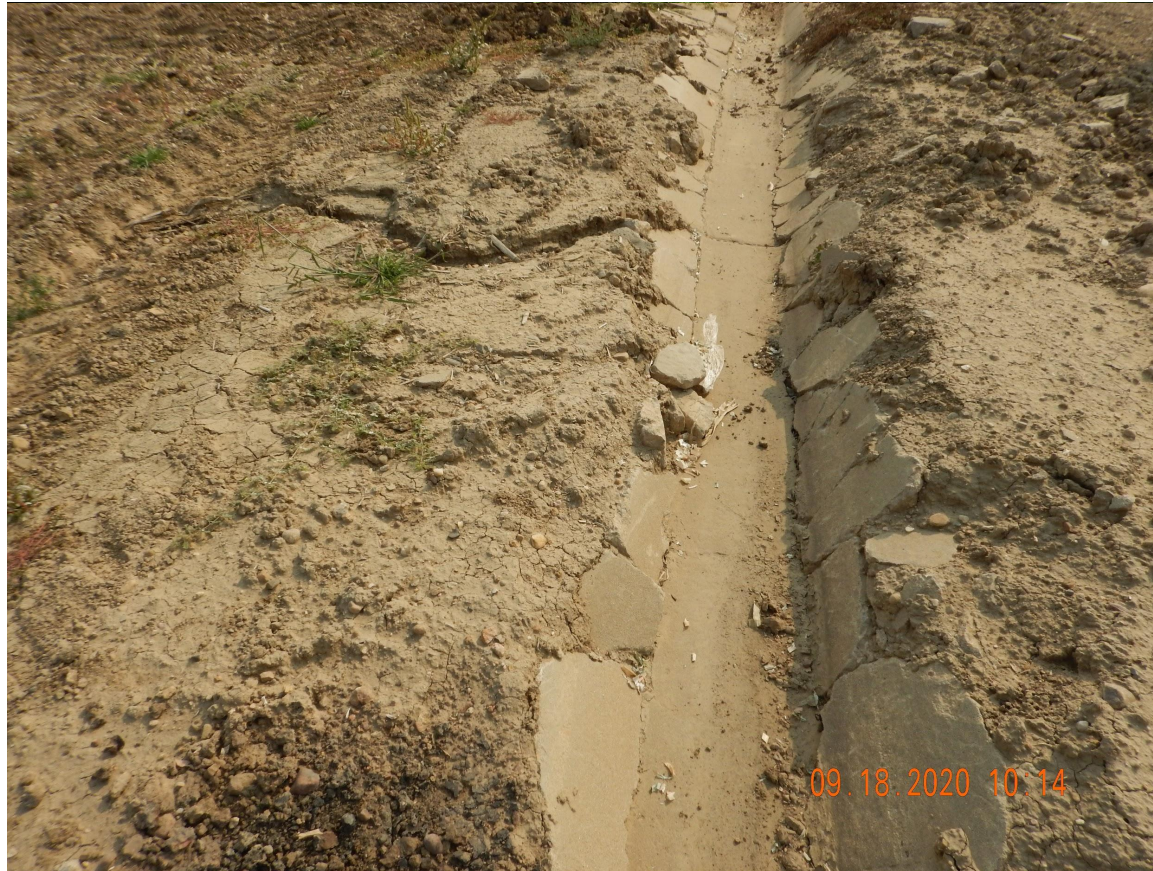
**Photo 11.** Photo taken from the P&A location. Photo illustrates a damaged irrigation ditch from plugging operations.

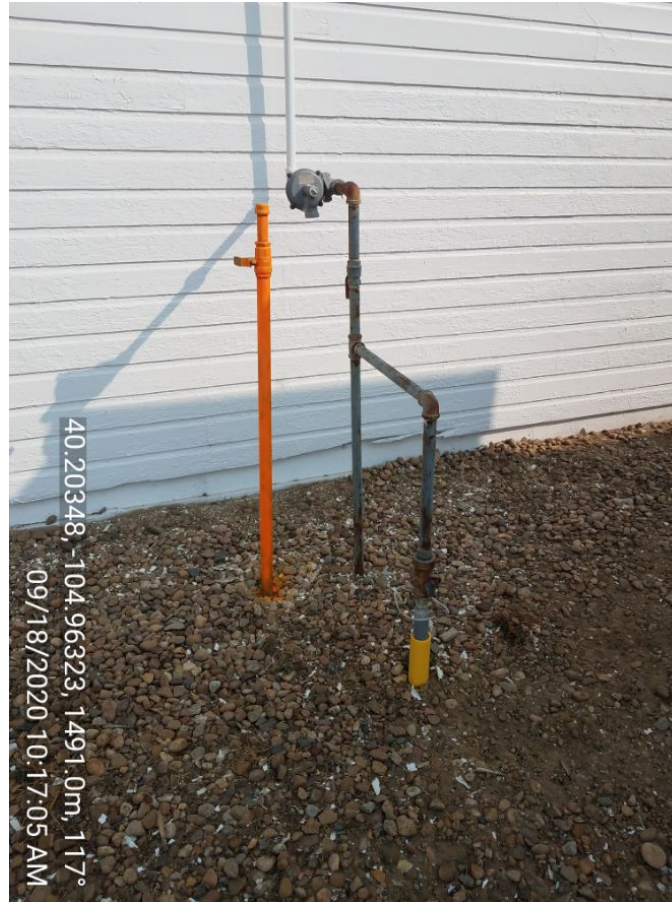
**Photo 12.** Photo taken from the nearby residence (refer to Photo 1). Photo illustrates an out of service riser related to a domestic tap which has not been abandoned per Rule 1105.

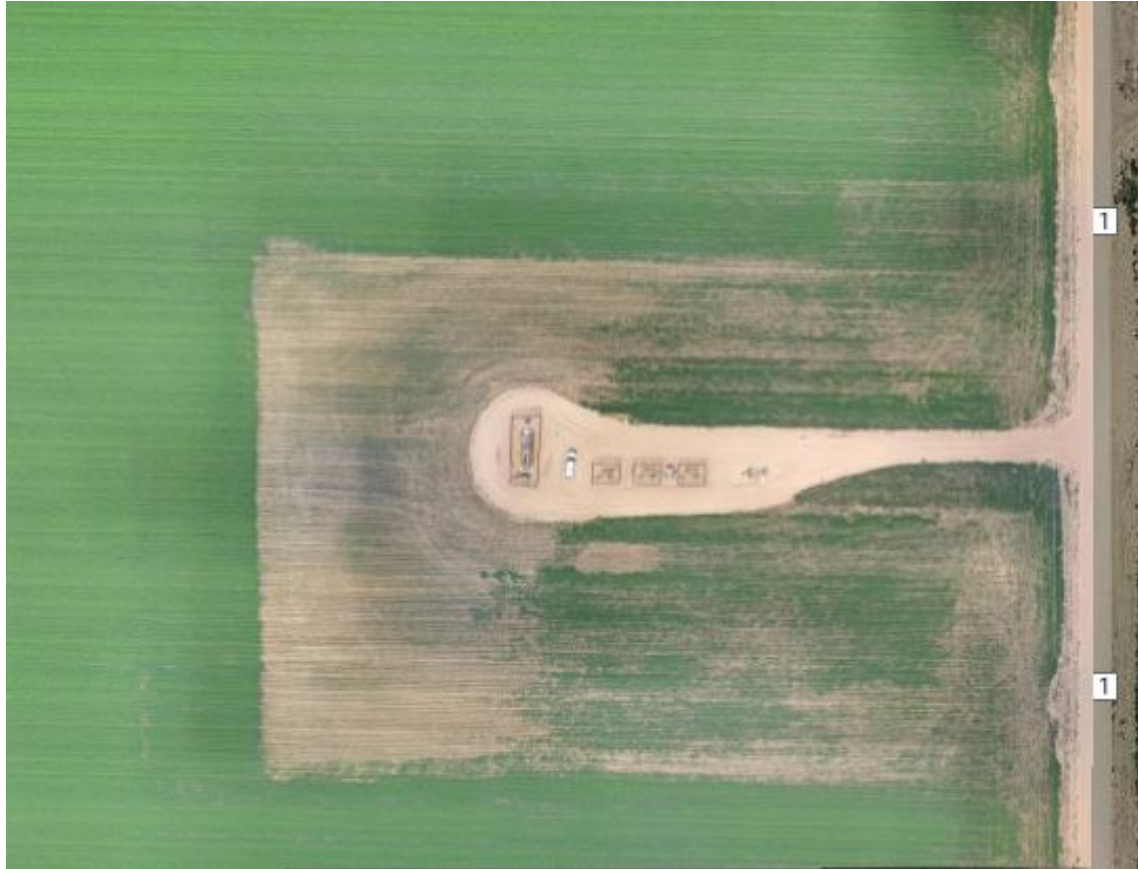
**Photo 13.** COGCC drone aerial imagery from 9/18/2020. Imagery illustrates interim reclamation areas are not reflective of reference area crop growth.

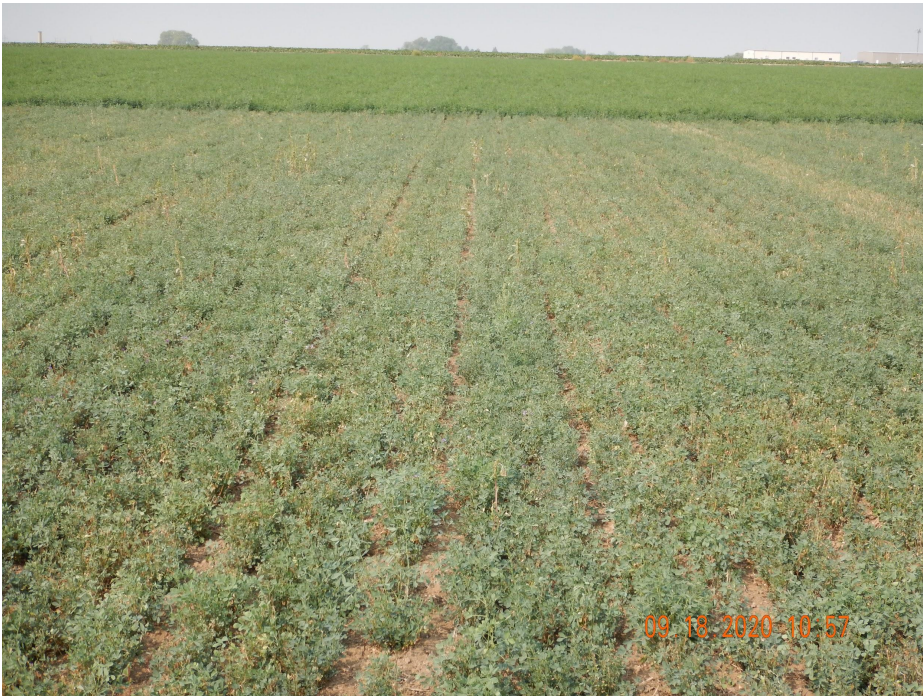
**Photo 14.** Photo taken from the western interim reclamation area, facing West. Photo illustrates crop growth within the interim area is not reflective of reference area crop growth.

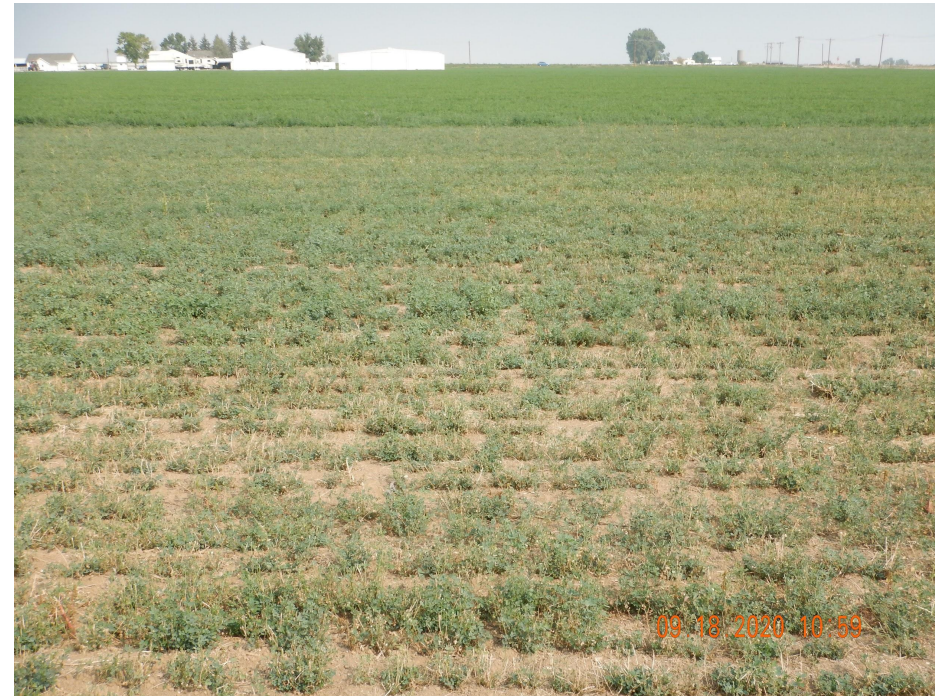
**Photo 15.** Photo taken from the northern interim reclamation area, facing North. See comments under Photo 14.

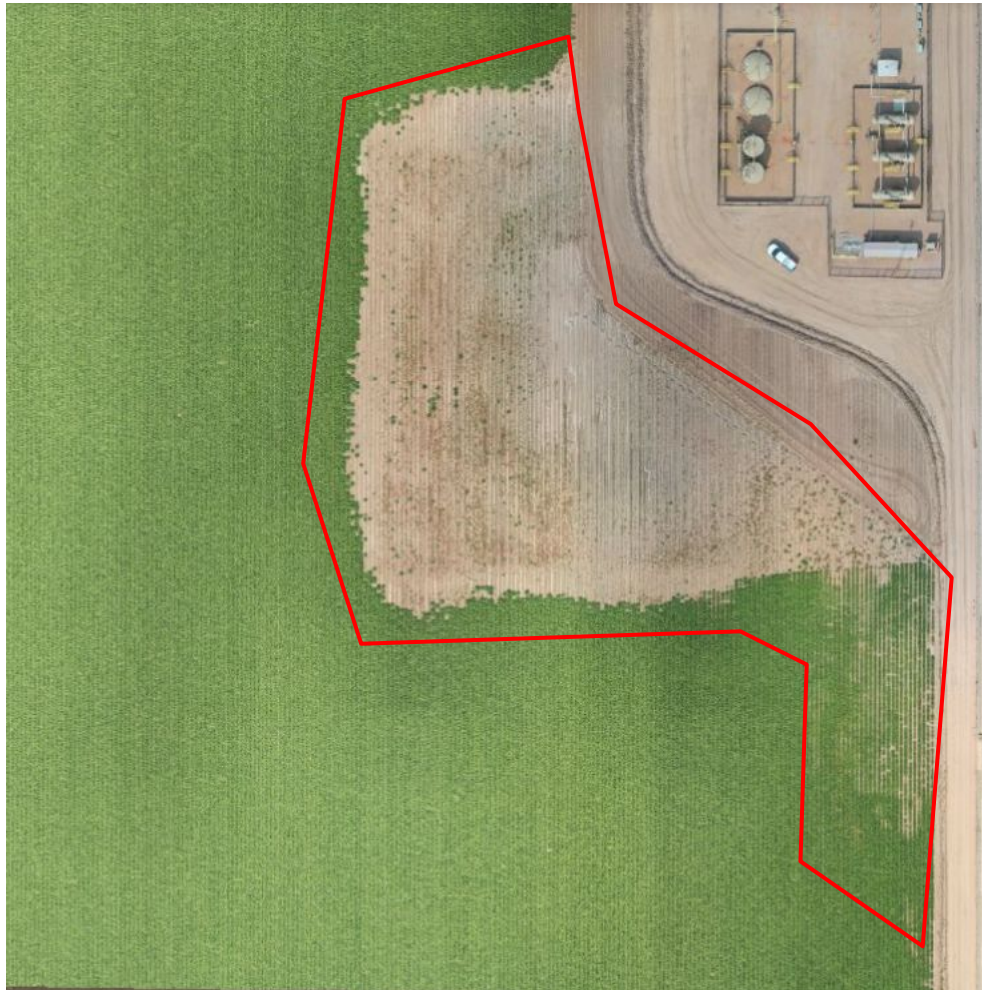
**Photo 16.** COGCC drone aerial imagery from 9/18/2020. Imagery illustrates the plugged and abandoned (P&A) location is not reflective of reference area crop growth. This P&A location includes wells and the original tank battery along the southeastern polygon.

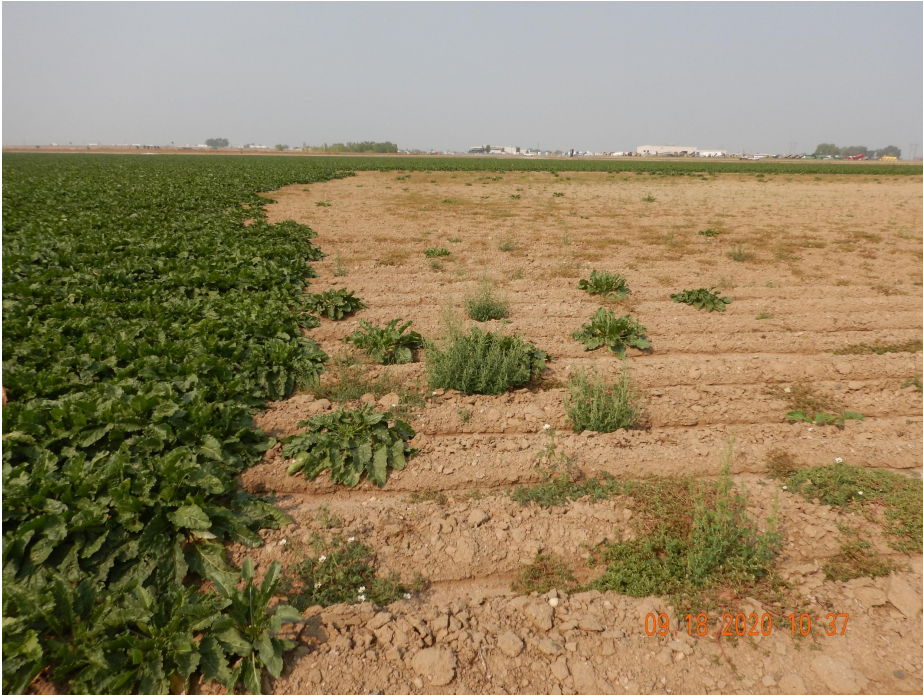
**Photo 17.** Photo taken from the southeastern P&A area, facing West. Photo illustrates the lack of crop growth within the P&A area.

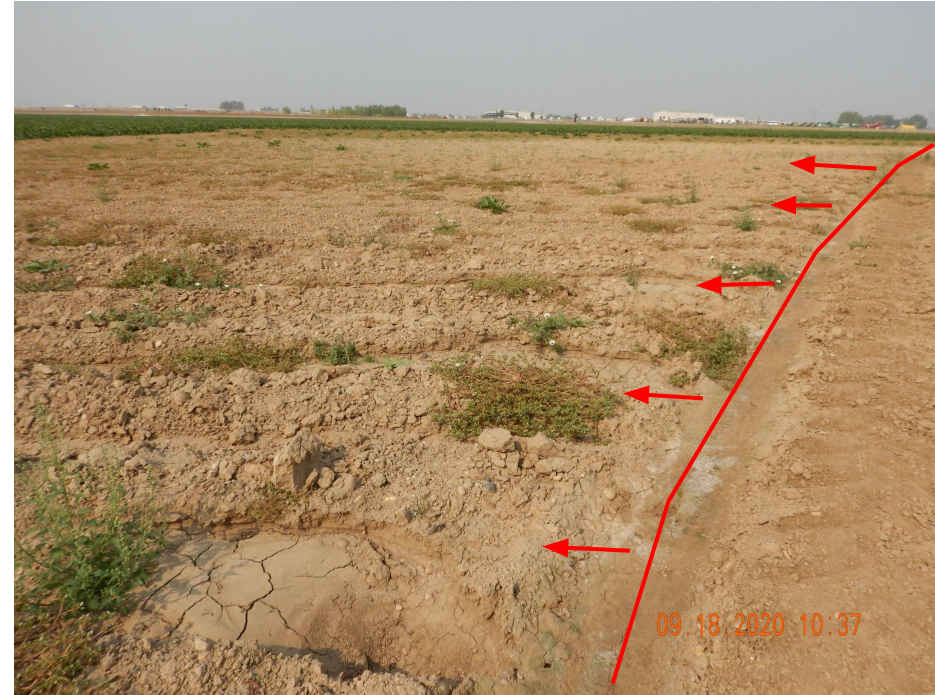
**Photo 18.** Photo taken from the eastern P&A area, facing West. See comments under Photo 17.

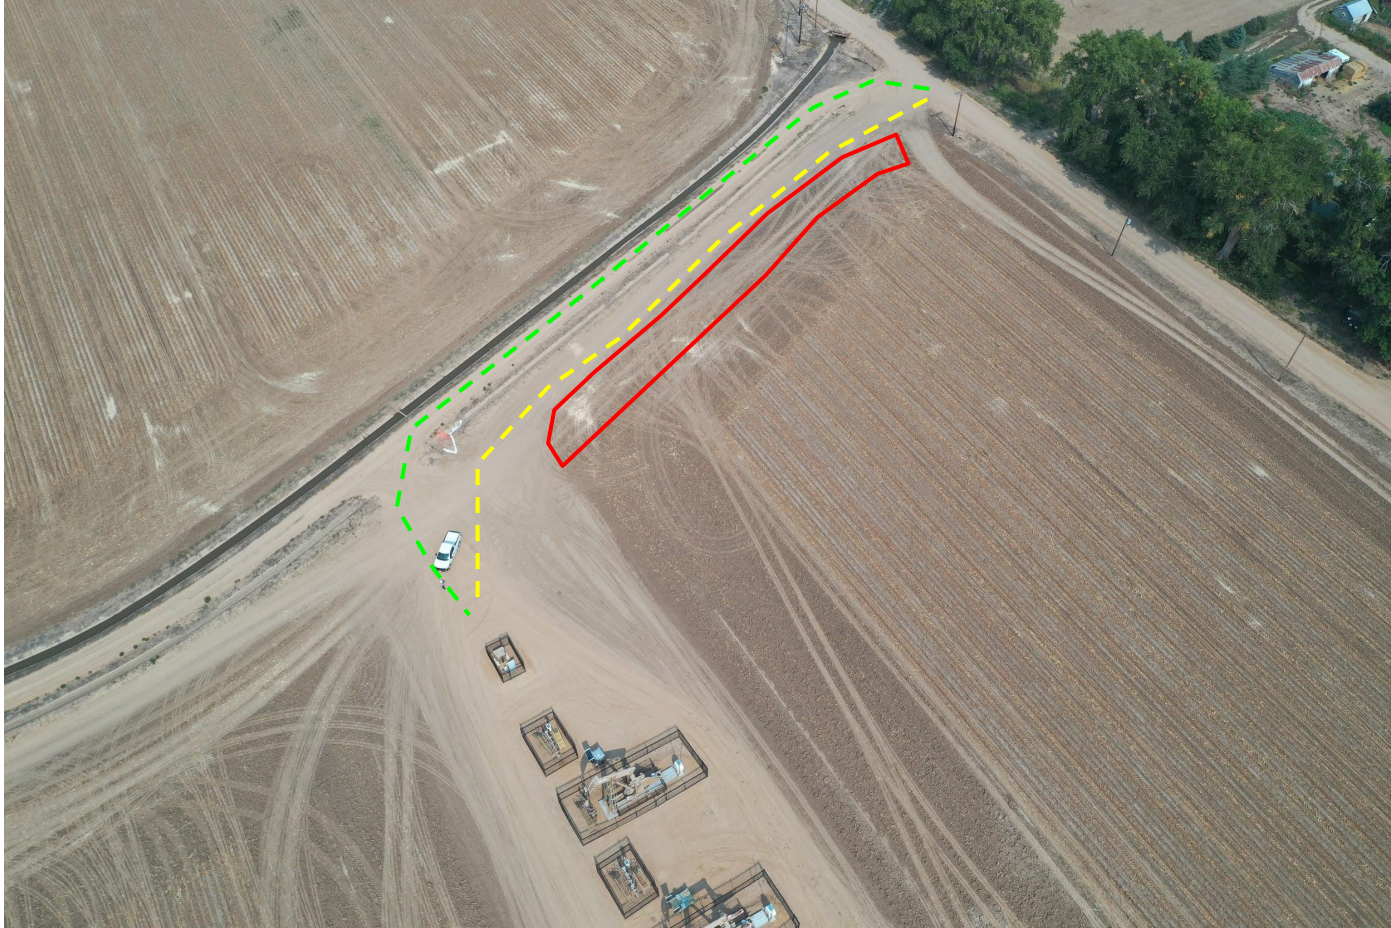
**Photo 19.** COGCC drone aerial imagery from 9/18/2020. Imagery illustrates an approximate crop area (red polygon) where the surface owner stated crop deficiencies due to subsequent oil and gas operations. Crop has already been harvested so COGCC staff could not document crop growth. Per a surface owner statement, Operator typically uses the northern access road (green dashed line) but the access was too narrow to perform subsequent operations and utilized a southern access route (yellow dashed line).

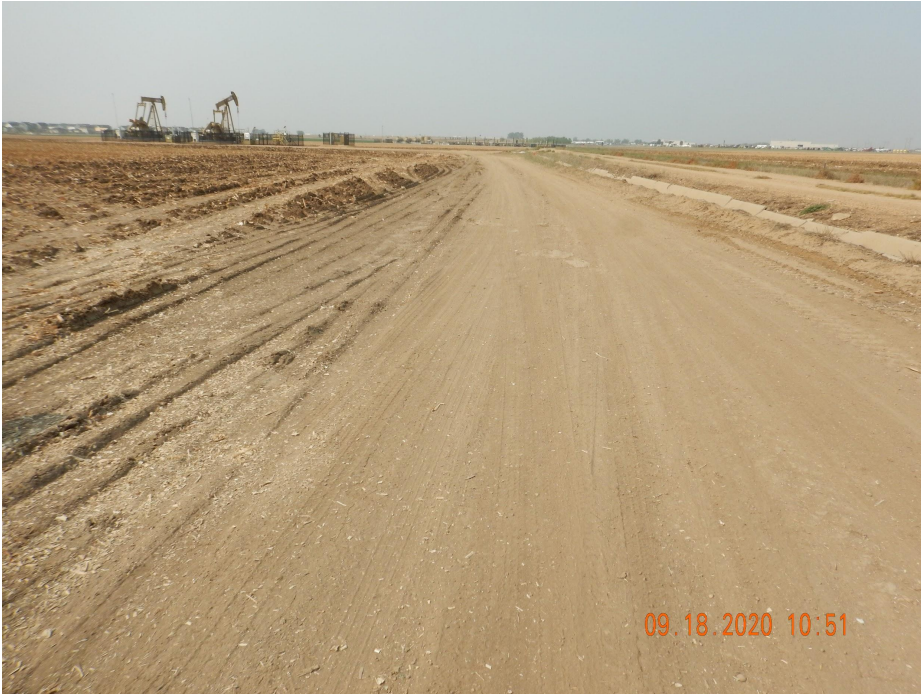
**Photo 20.** Photo taken from the southern route (orange dashed line), facing West.

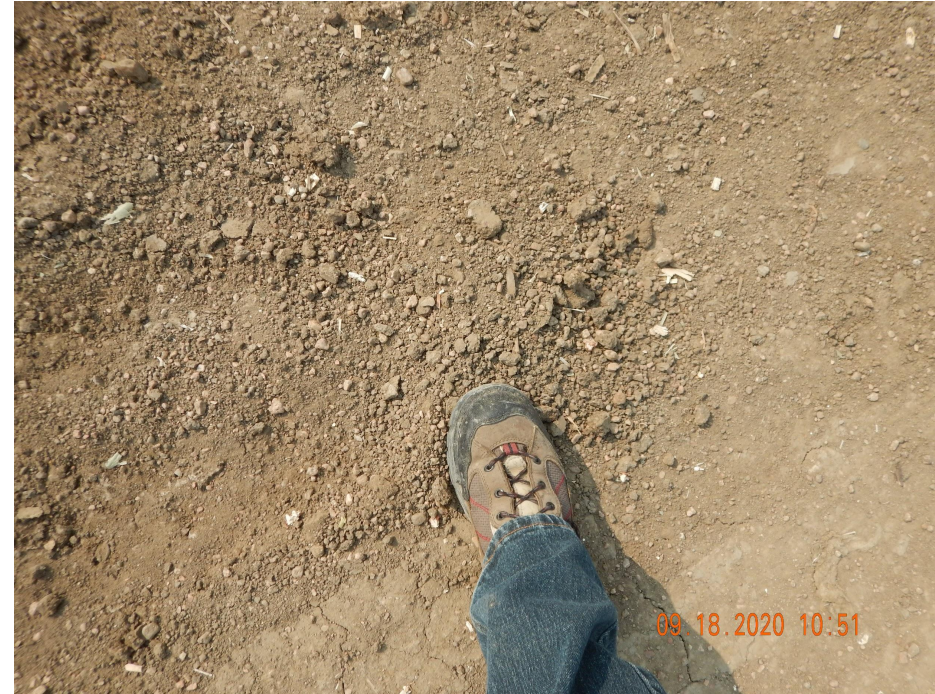
**Photo 21.** Photo taken from the southern route (orange dashed line). Photo illustrates some gravel present which might indicate it was utilized to perform subsequent oil and gas operations.
