Inspection Photos

API: 071-09444

Operator: EVERGREEN NATURAL RESOURCES

Inspection Date: 9/30/2020

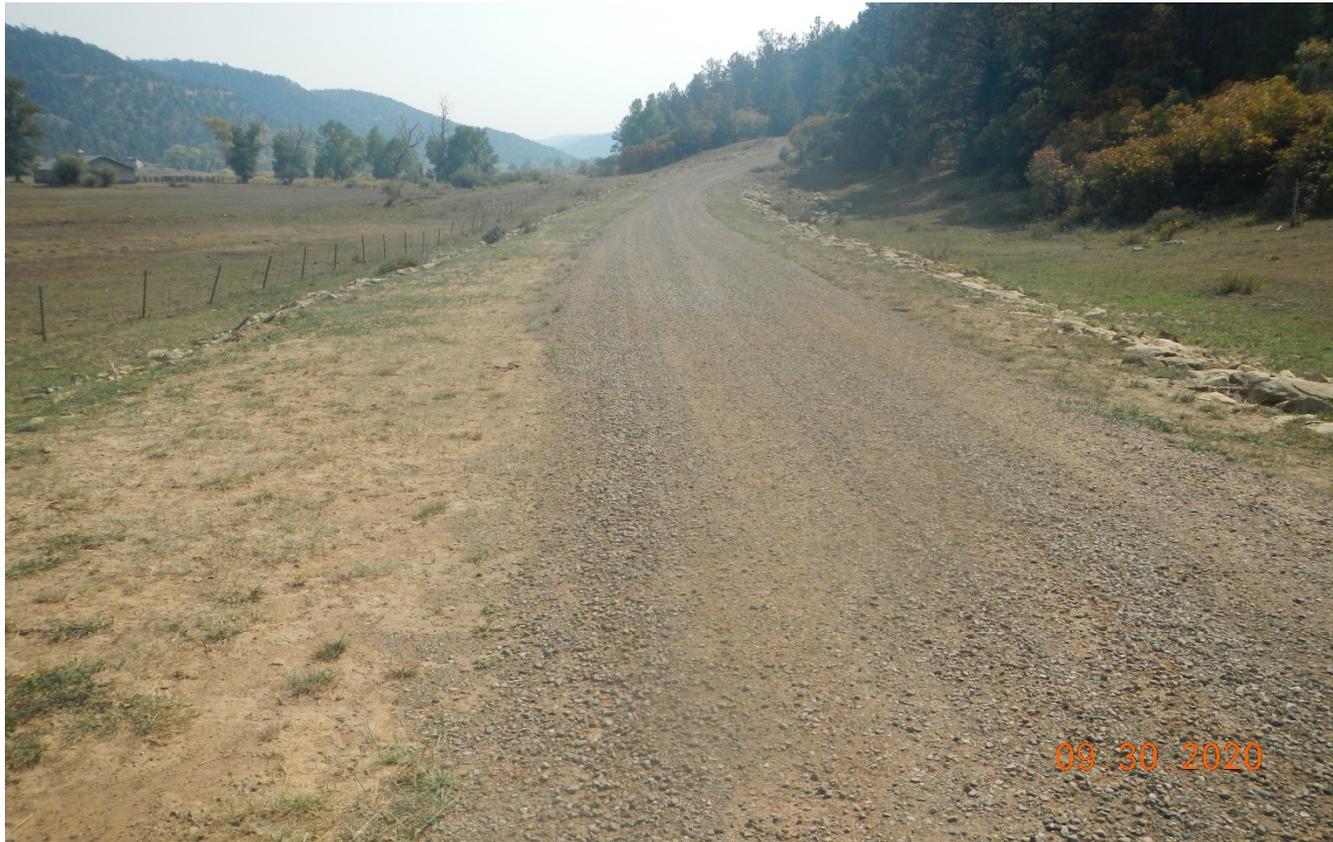
Photo 1. Facing southeast along the access road. The road all the way to the location has been graveled.

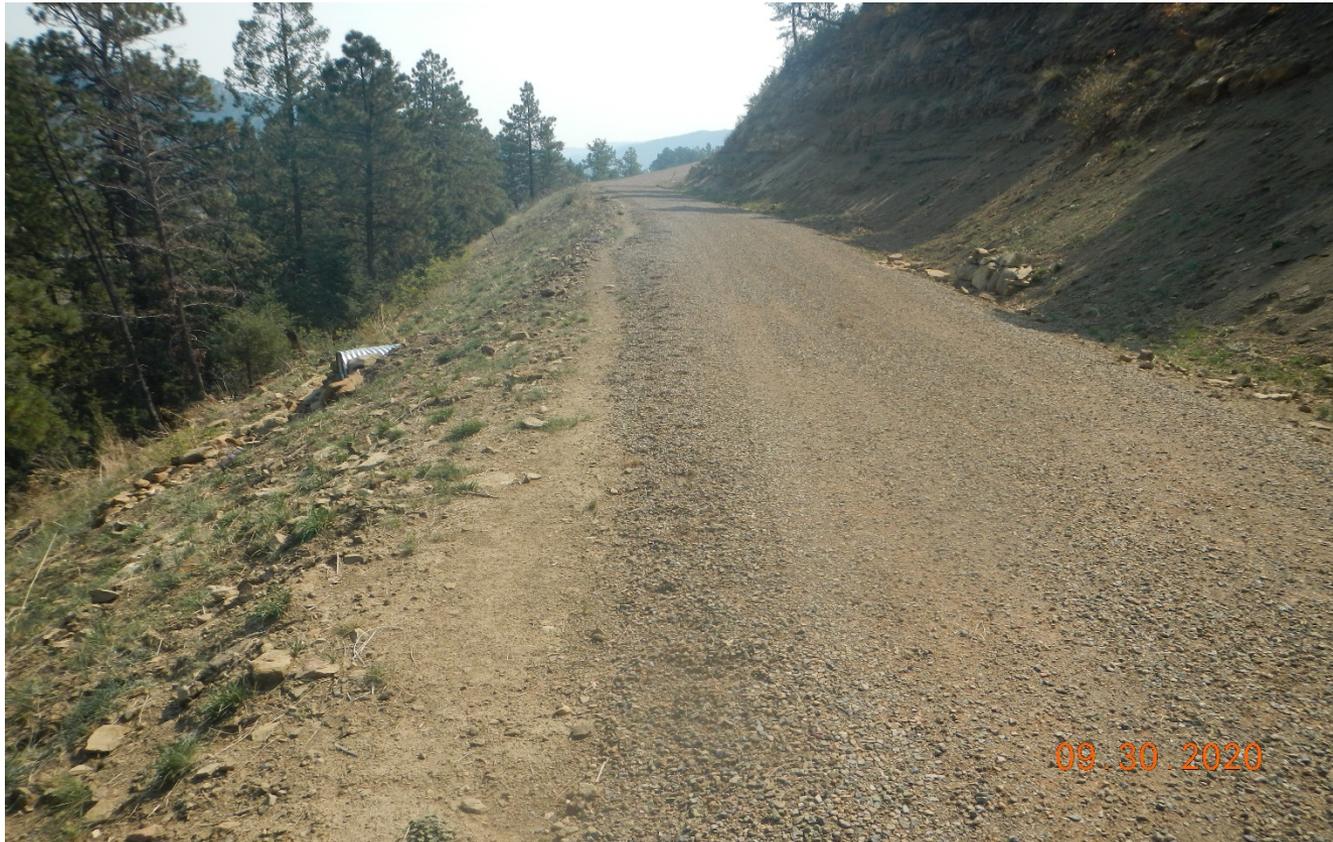
Photo 2. Facing southeast along the road. A culvert has been installed along this area of the road where the soil slough had occurred.

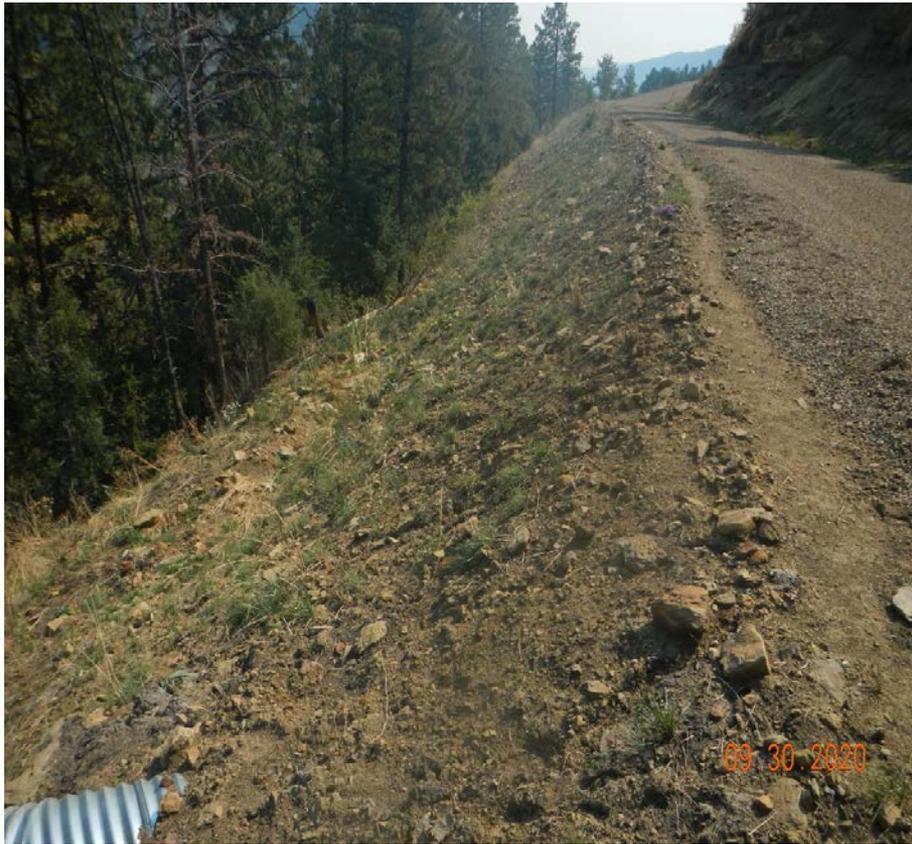
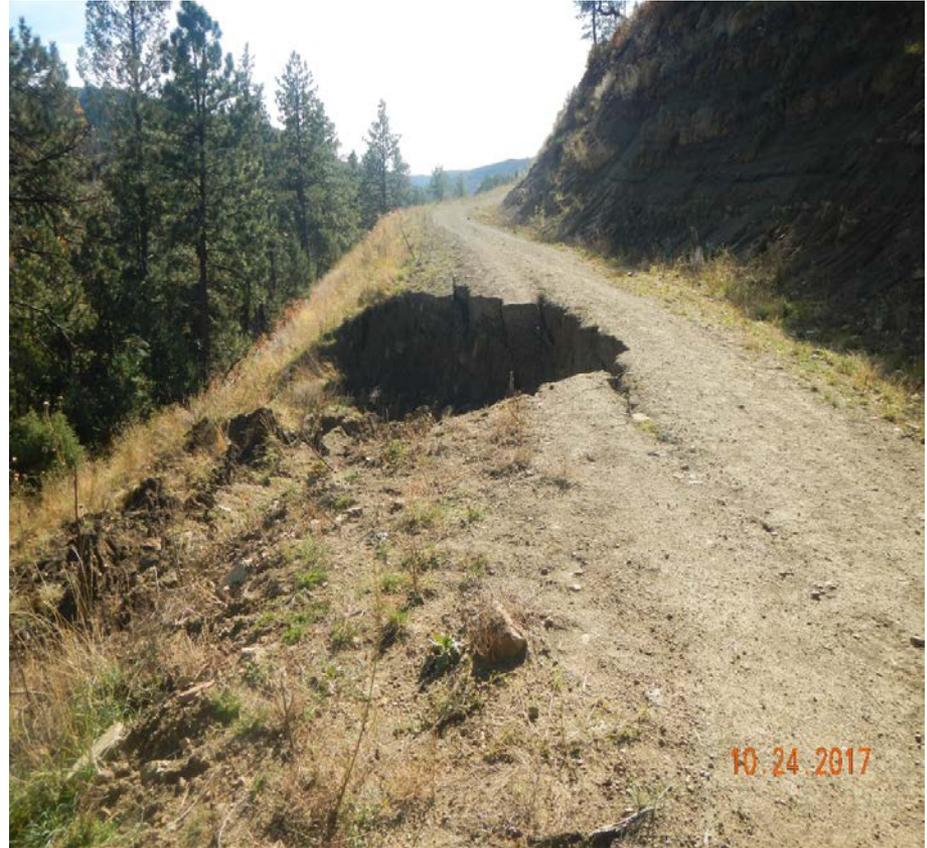
Photo 3. The photo on the left shows the area that was repaired from the slough that occurred in 2017 shown in right photo.

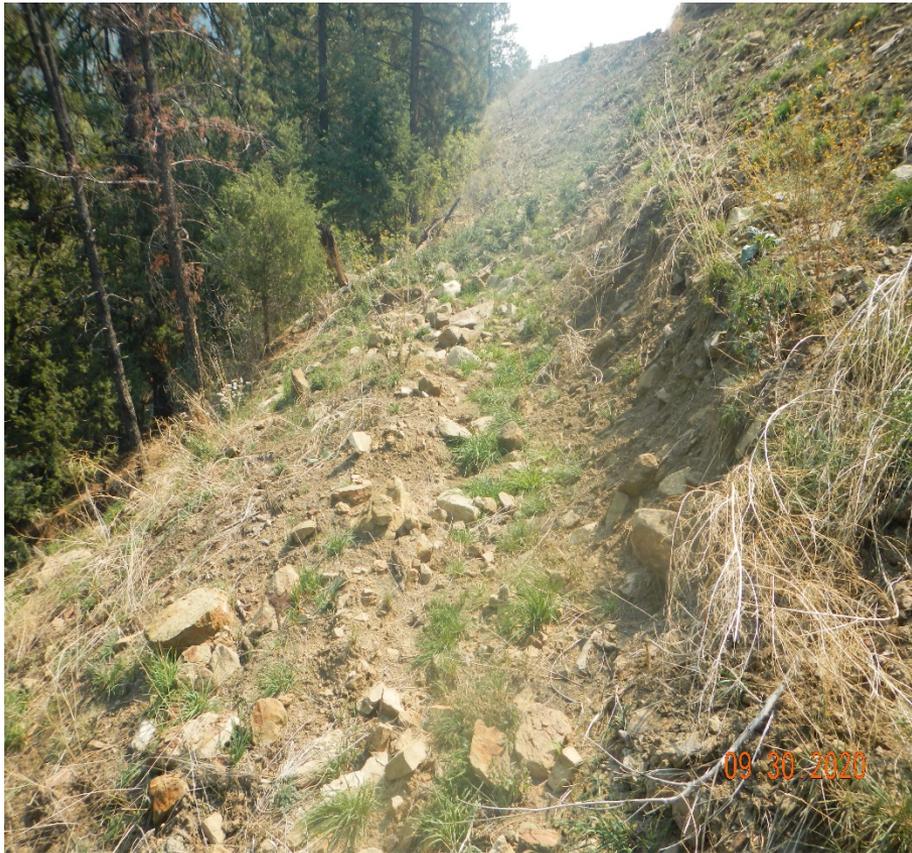
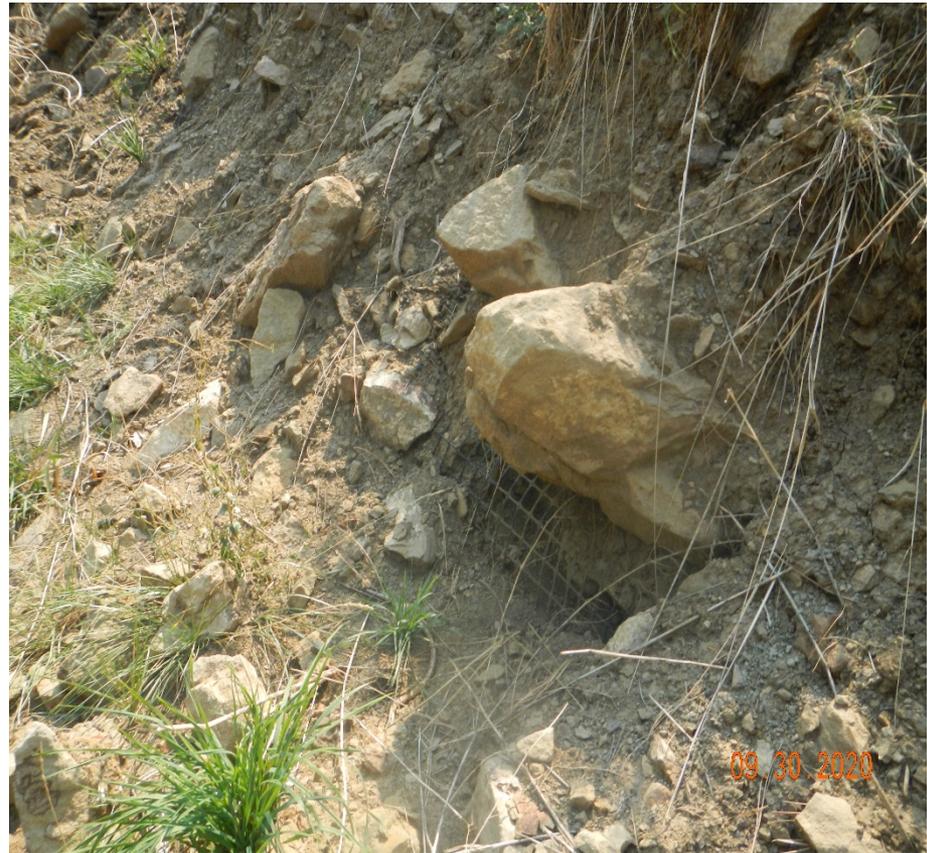
Photo 4. It appears the area of where the slough had occurred has partially sloughed again. Photo on the left shows the soil displacement and the photo on the right shows the exposed geotextile. Did not observe where French drain was installed as describe in the submitted plan.

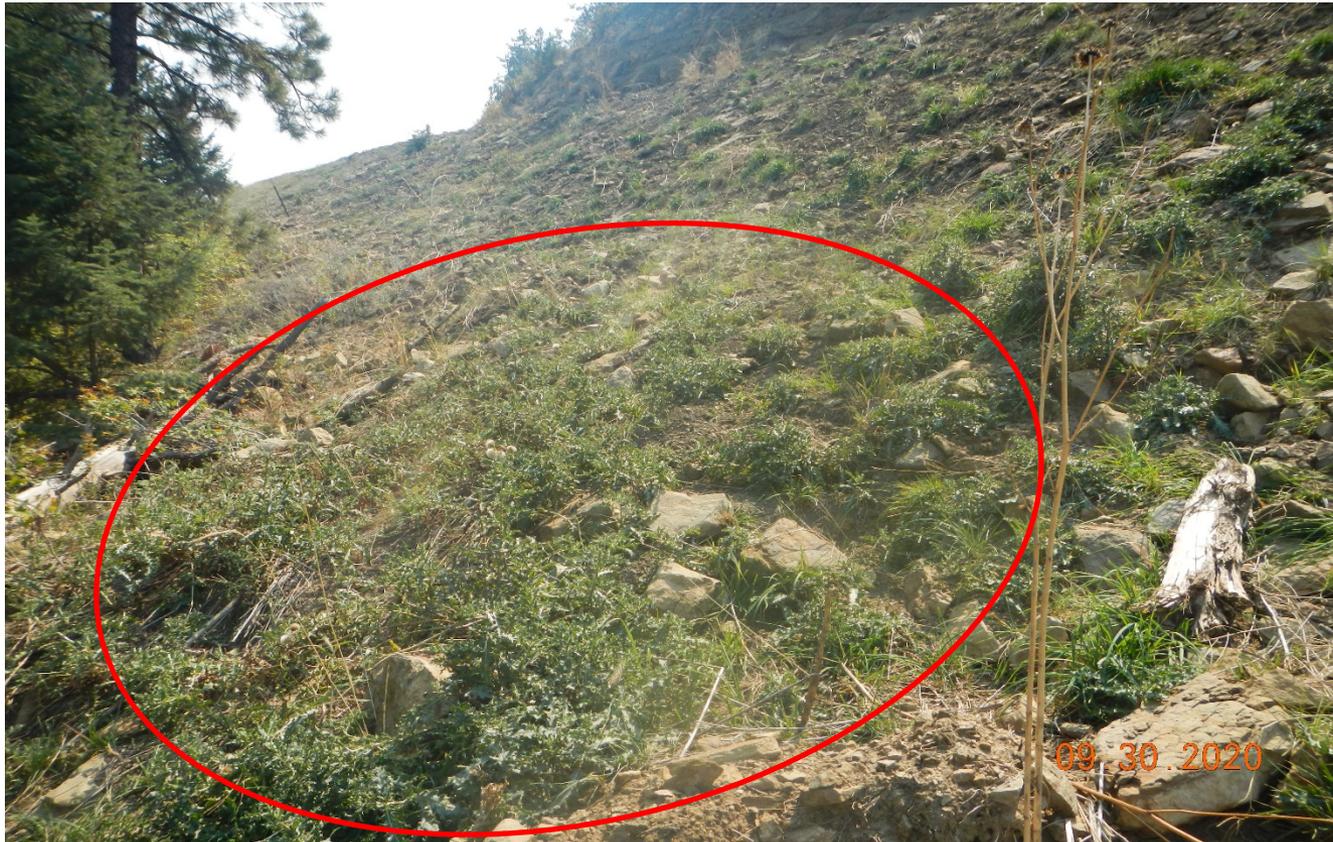
Photo 5. This area near the soil slough has noxious weeds which need to be controlled. There is still time to do a Fall treatment if done soon. Circle area is numerous Canada thistle noxious weeds.

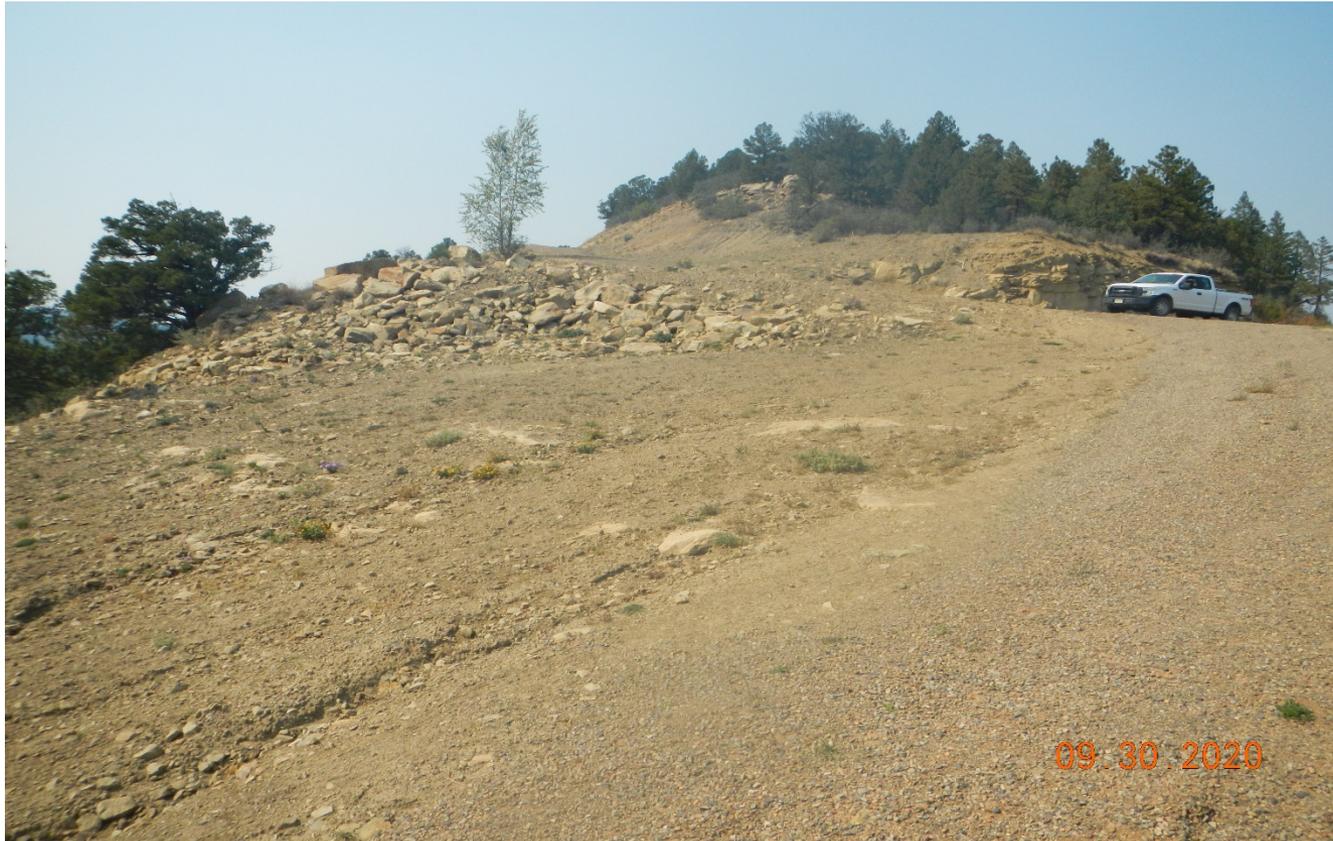
Photo 6. Facing northwest where the road turns and ascends the hillside. Disturbed areas will need to be stabilized with vegetation.

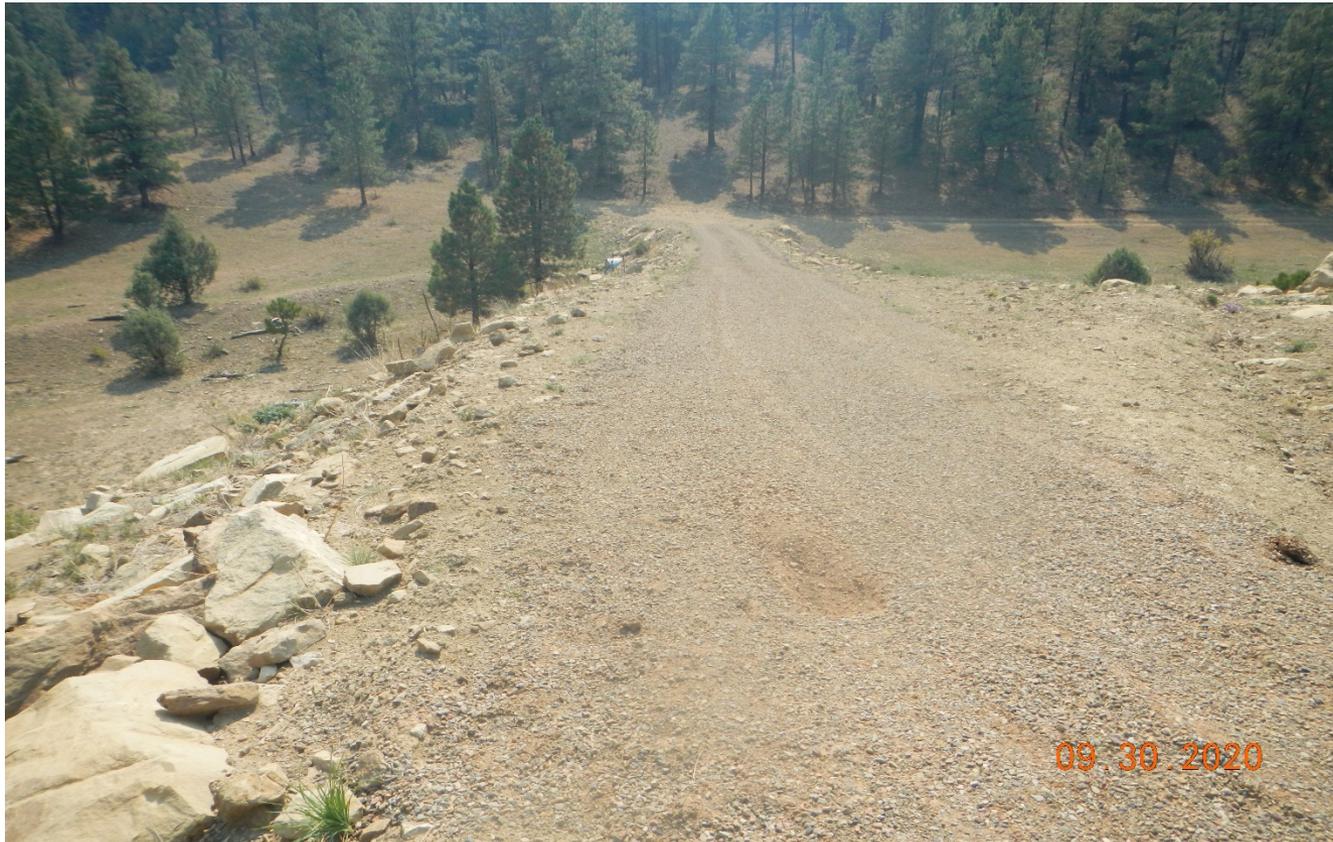
Photo 7. Facing southeast toward the road that extends into the canyon bottom. This portion of the road was graveled.

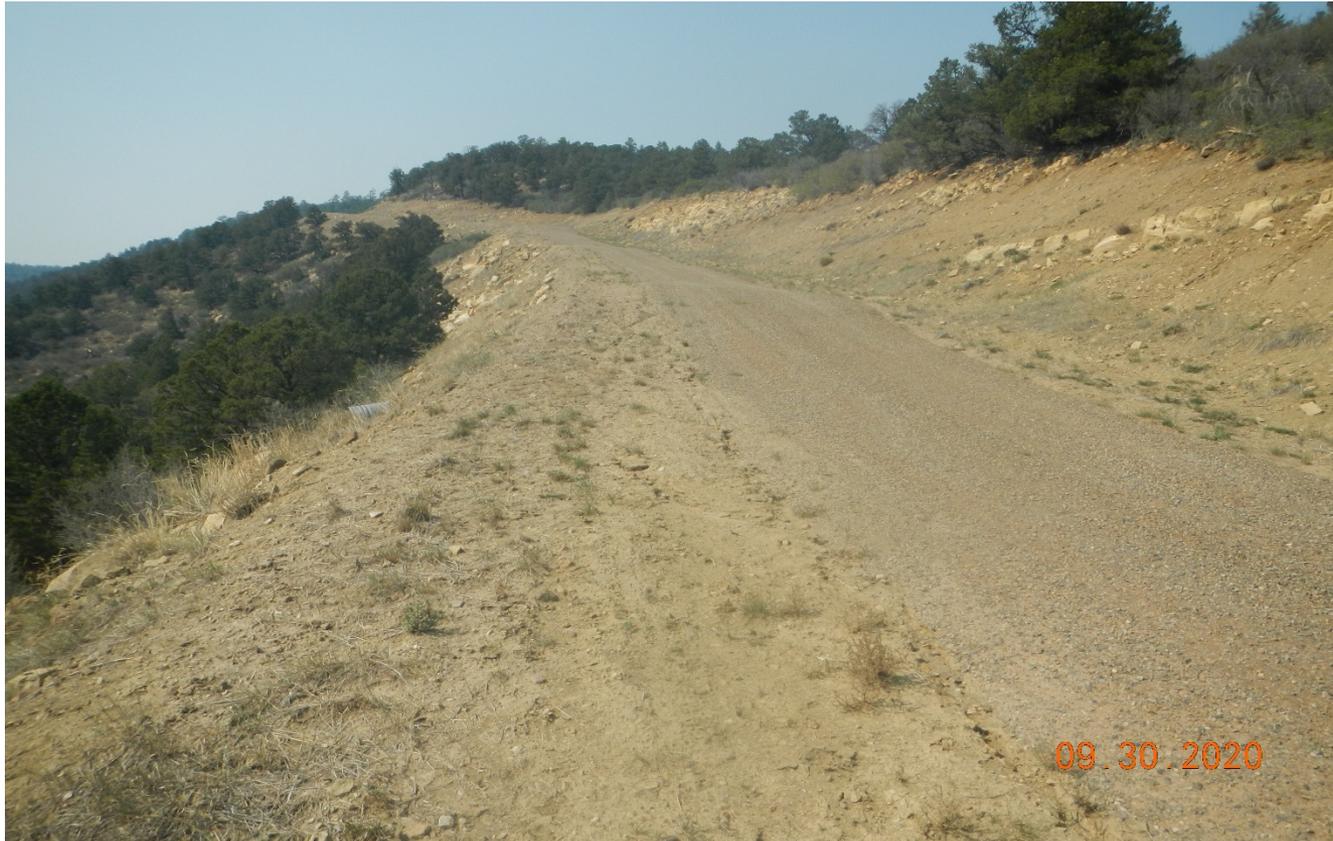
Photo 8. Facing northwest along the access road ascending the hillside. Gravel has been installed along the road. The roadsides will need to establish vegetation for stabilization.

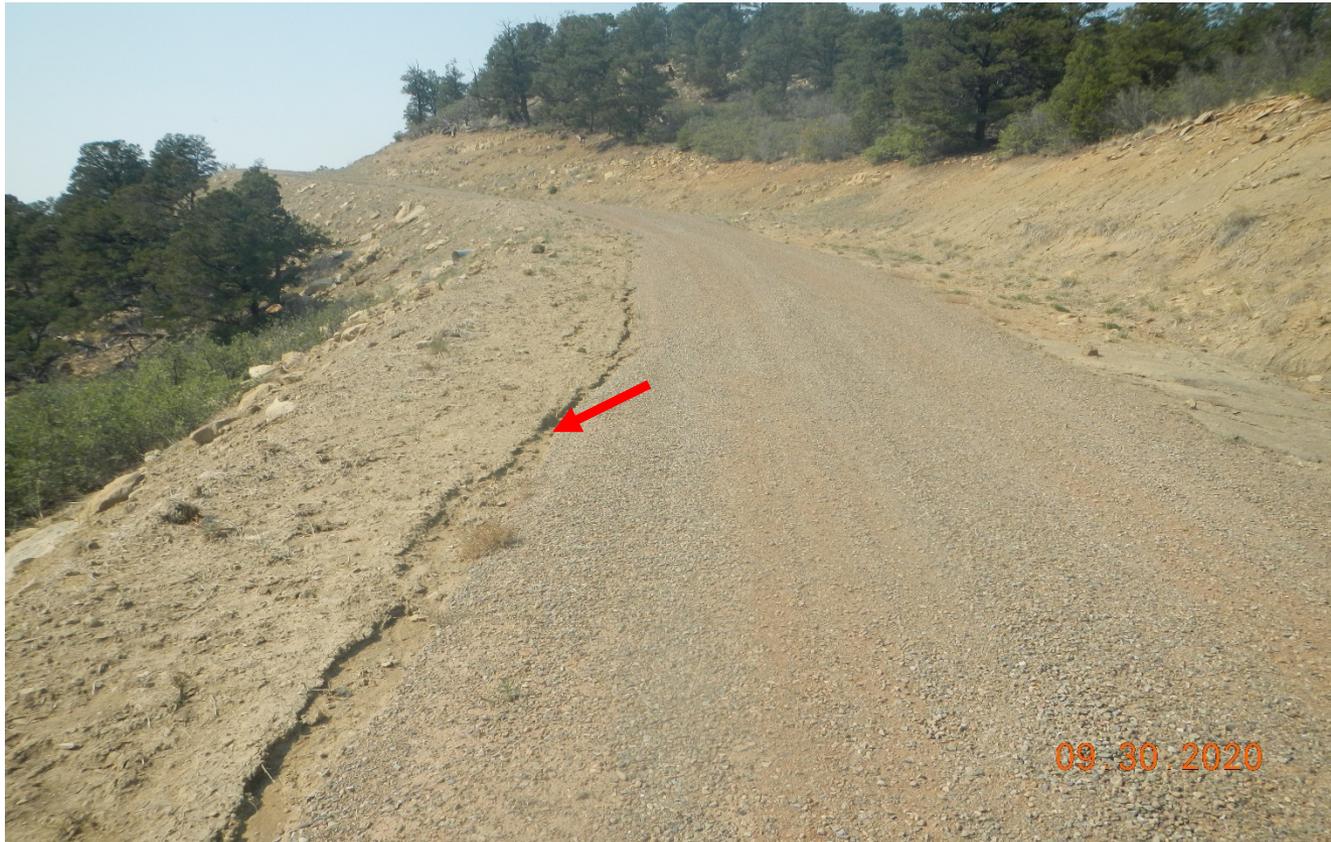
Photo 9. There is erosion beginning to channelize along the road which will worsen if not repaired.

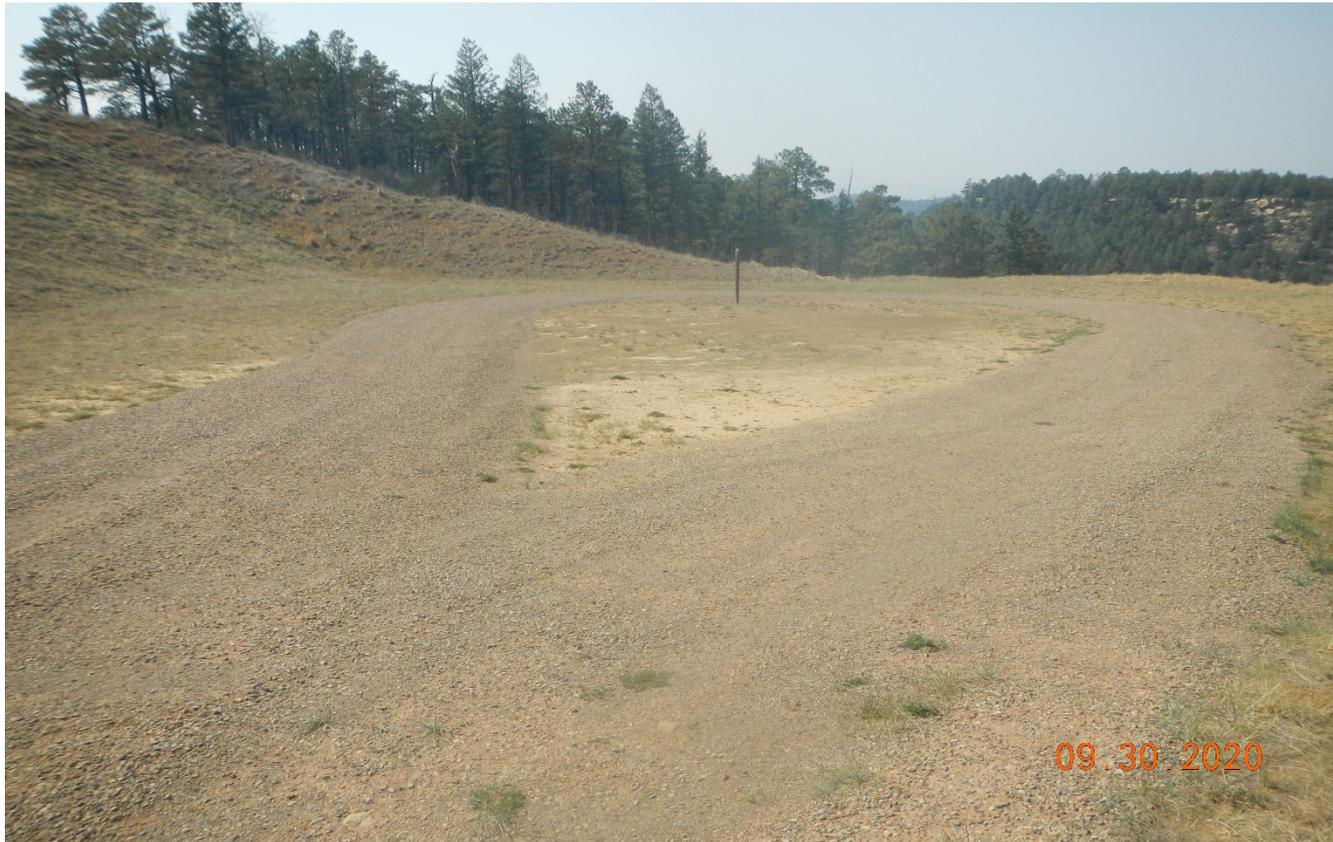
Photo 10. Facing northwest toward the location.

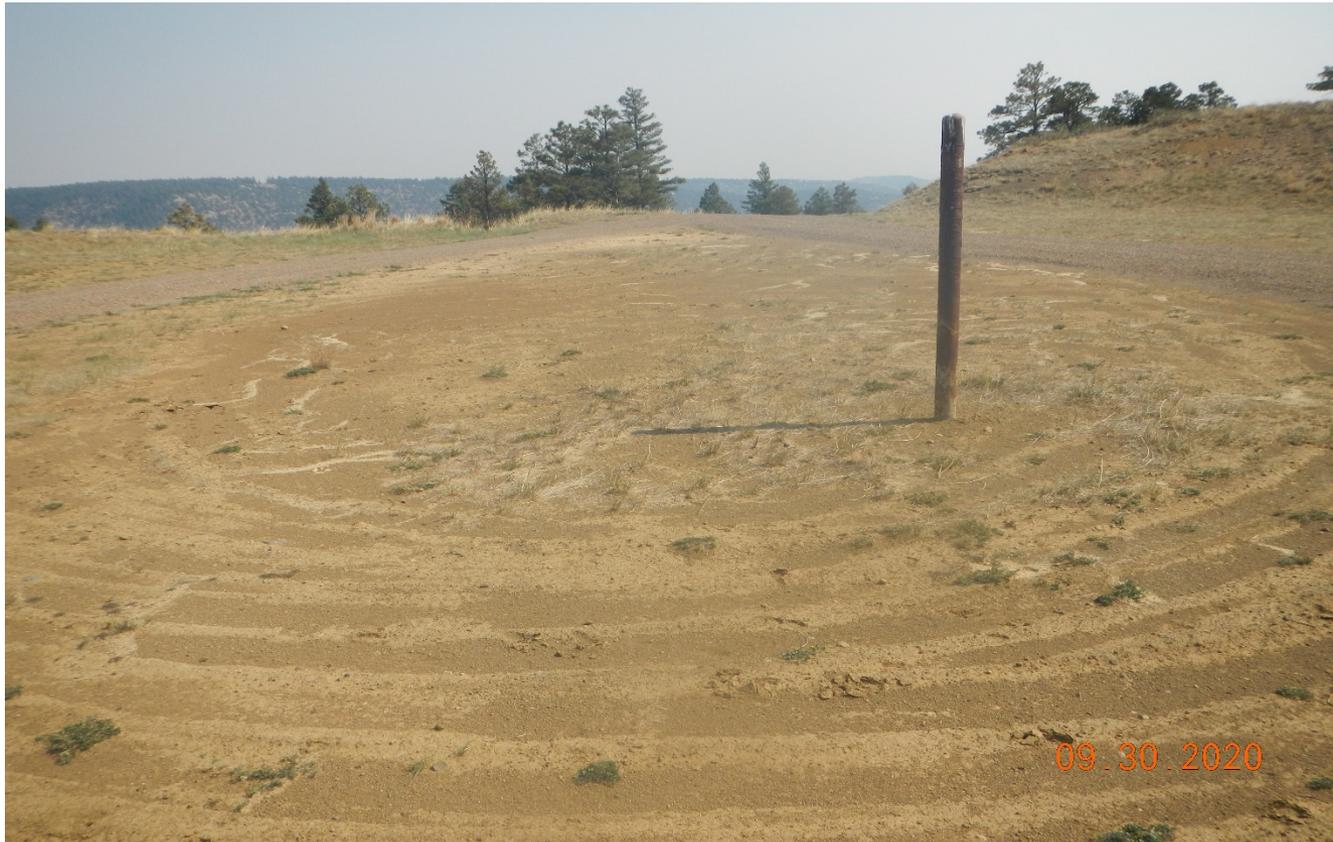
Photo 11. Facing southeast toward the location. COA requires the entire location and roadsides must establish a uniform vegetation cover of at least 80% of reference area levels.
