Inspection Photos

Operator: Catamount Energy
API: 067-09922
Date: 9/29/2020

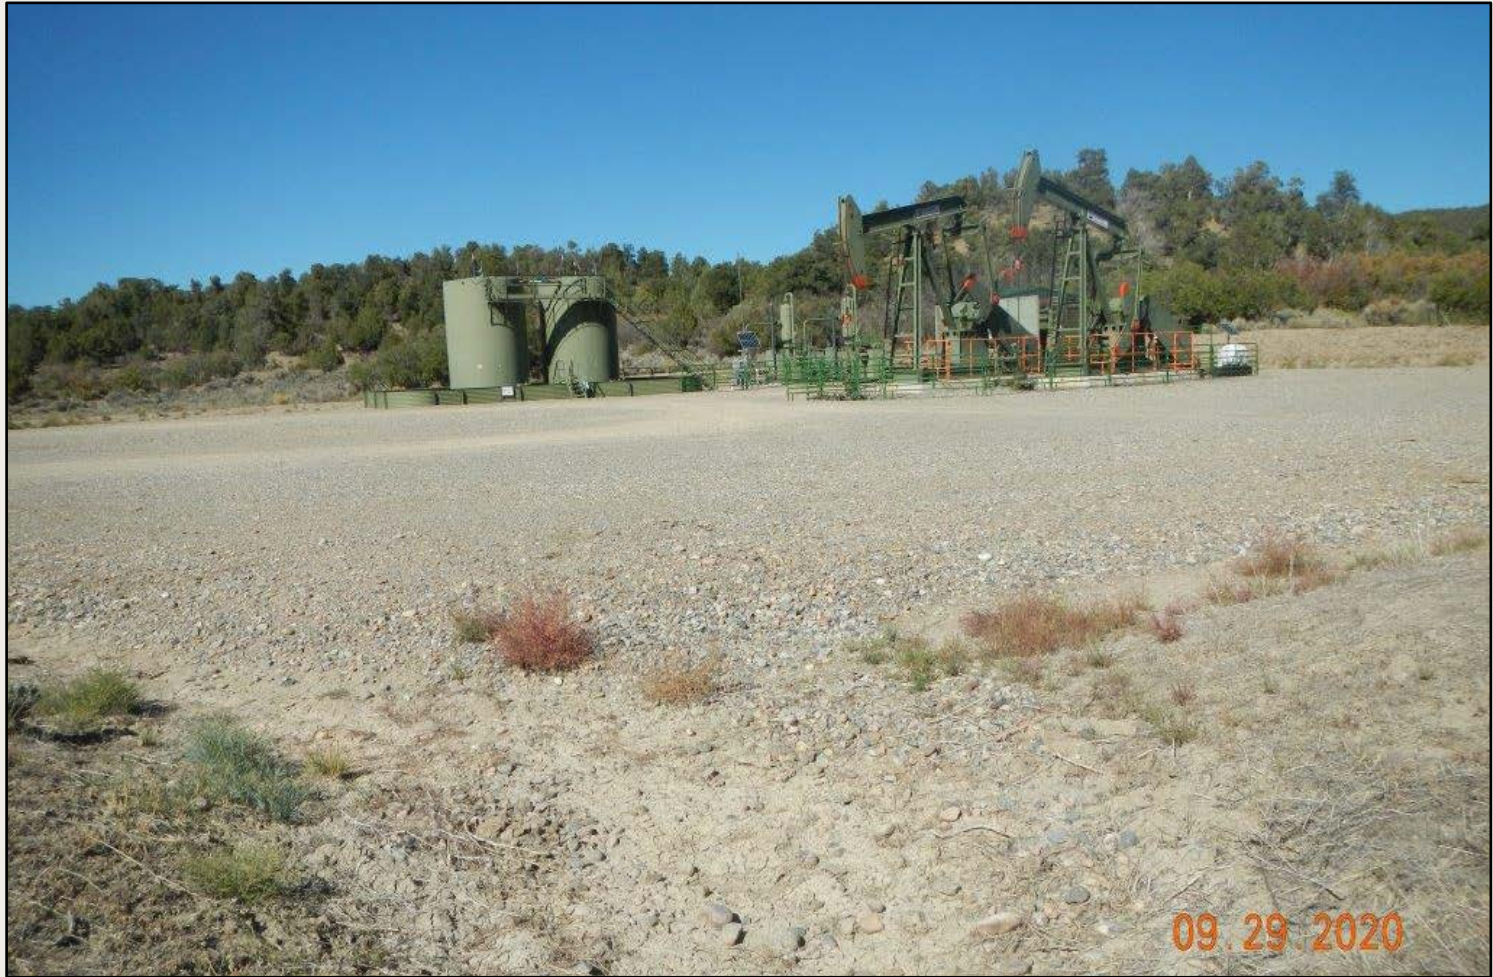
Photo 1. View of the project area from the southeastern corner facing center.

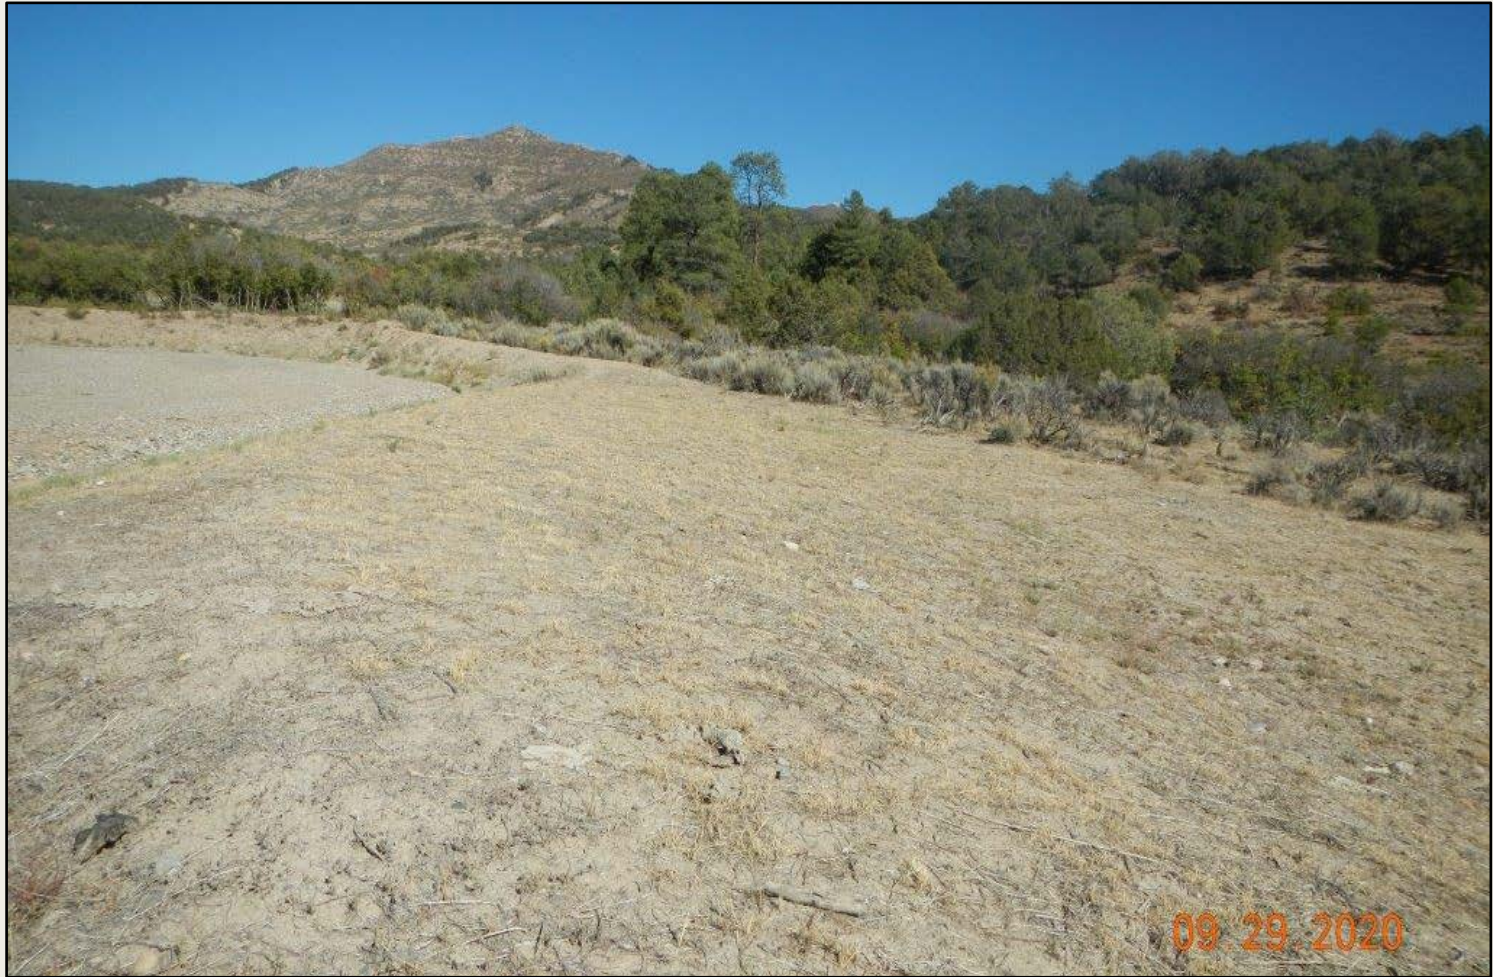
Photo 2. View of the southern project area from the southeastern corner facing eastward. Revegetation is progressing in a grazed vegetative condition. Grasses are not identifiable at this time.

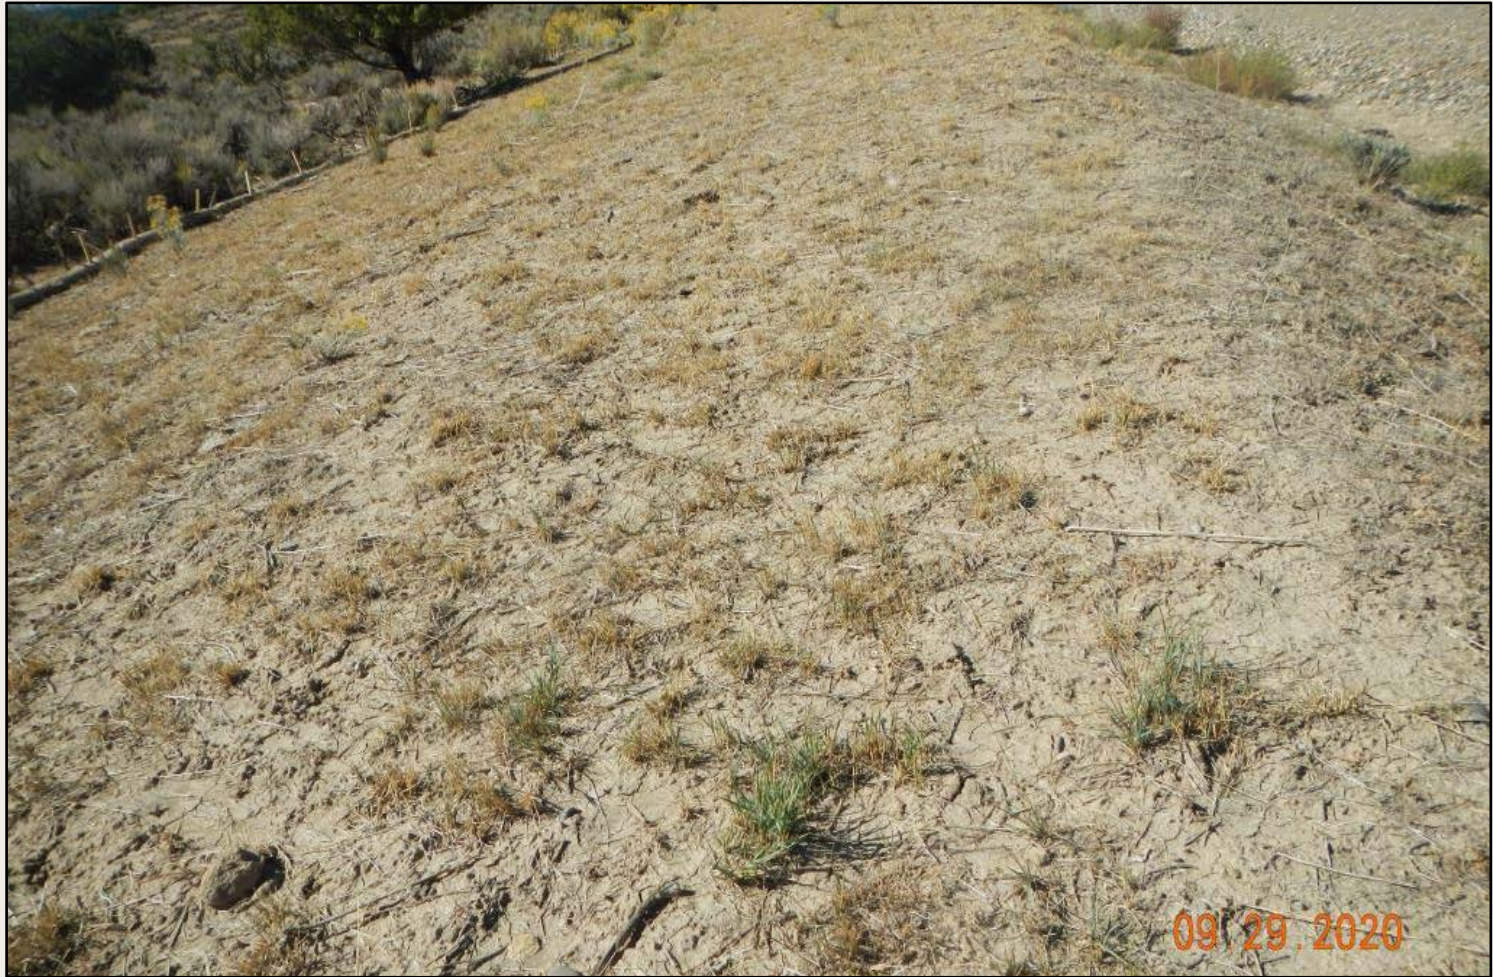
Photo 3. View from the eastern project area from the southeastern corner facing northward.

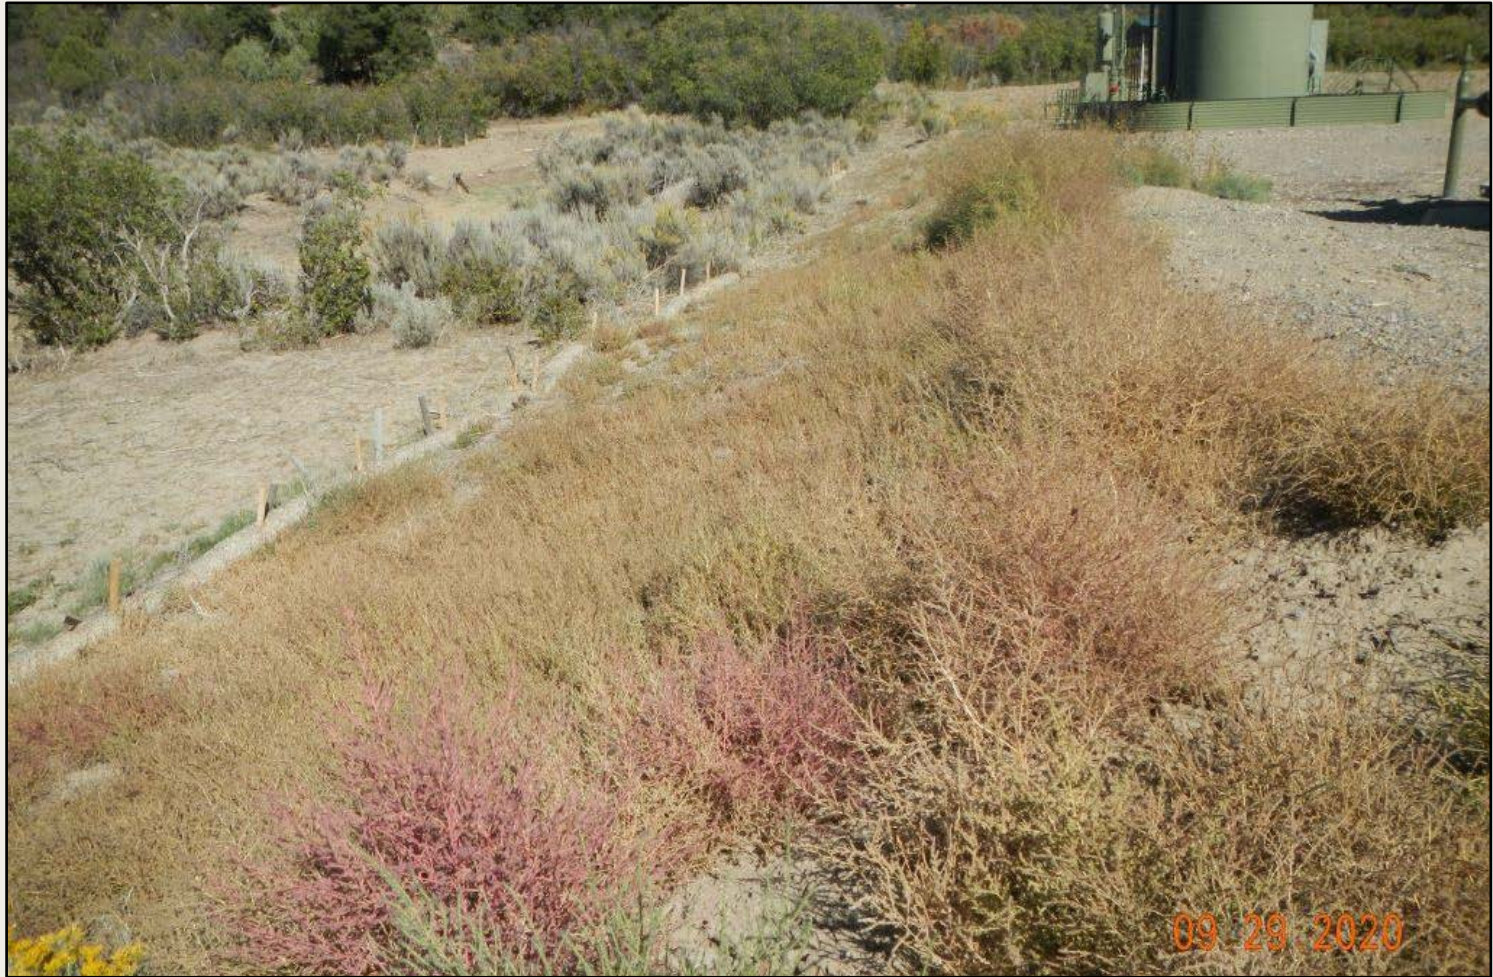
Photo 4. View of dense Russian thistle debris within the northern project area. Needs to be removed. Revegetation may need to be conducted here if desirable vegetation is not present beneath the weed debris.

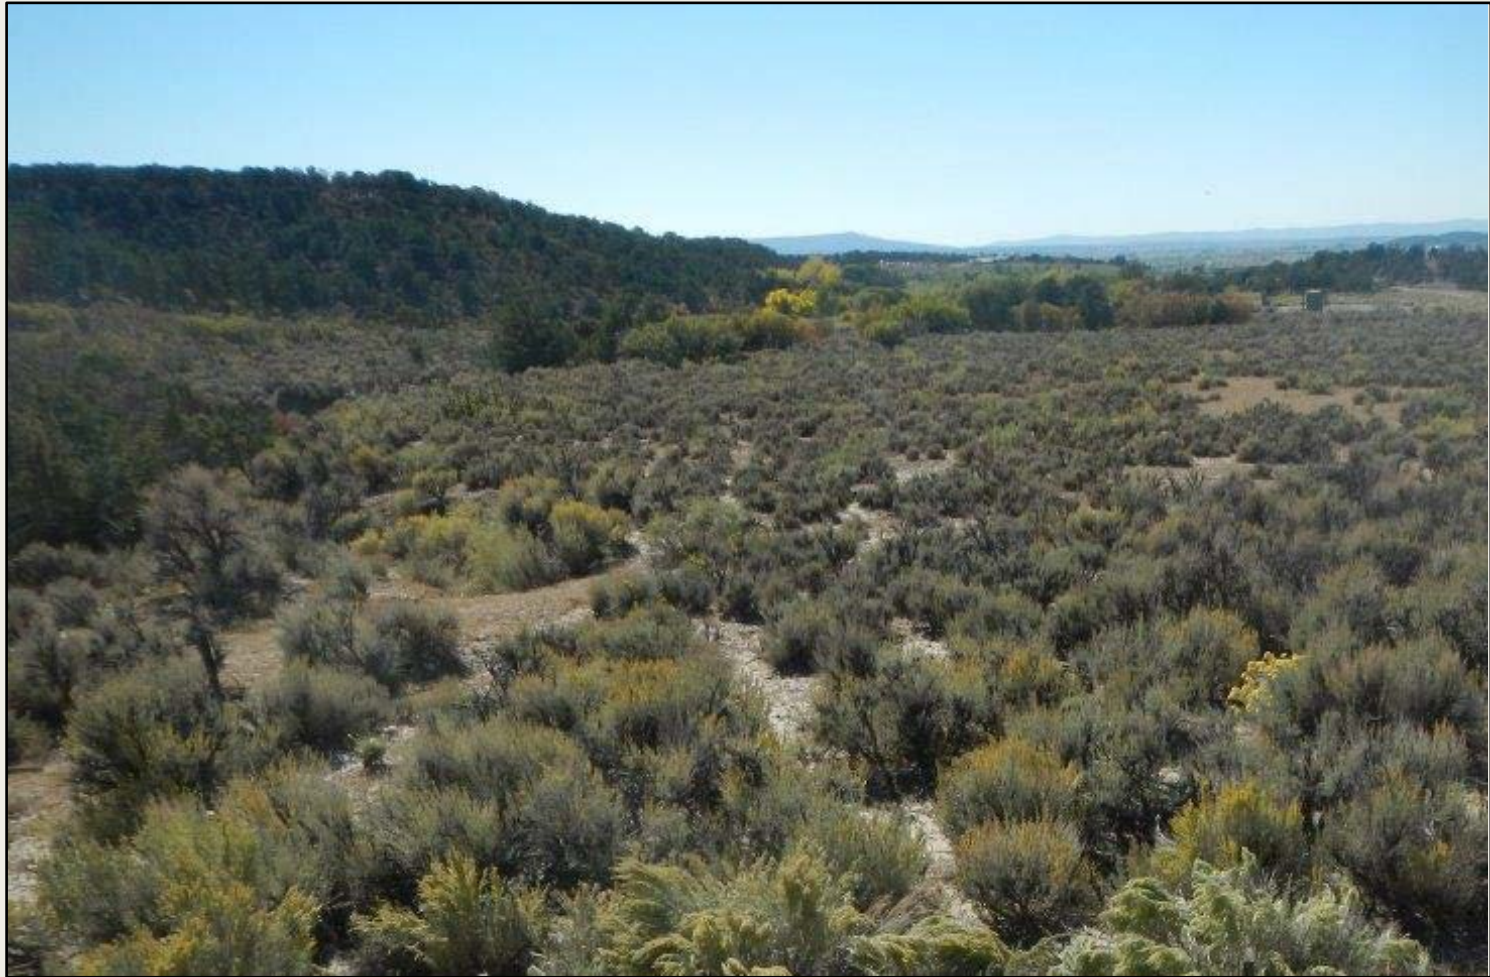
Photo 5. View of reference area vegetation comprised of sagebrush shrubland with grasses such as western wheatgrass and forbs such as

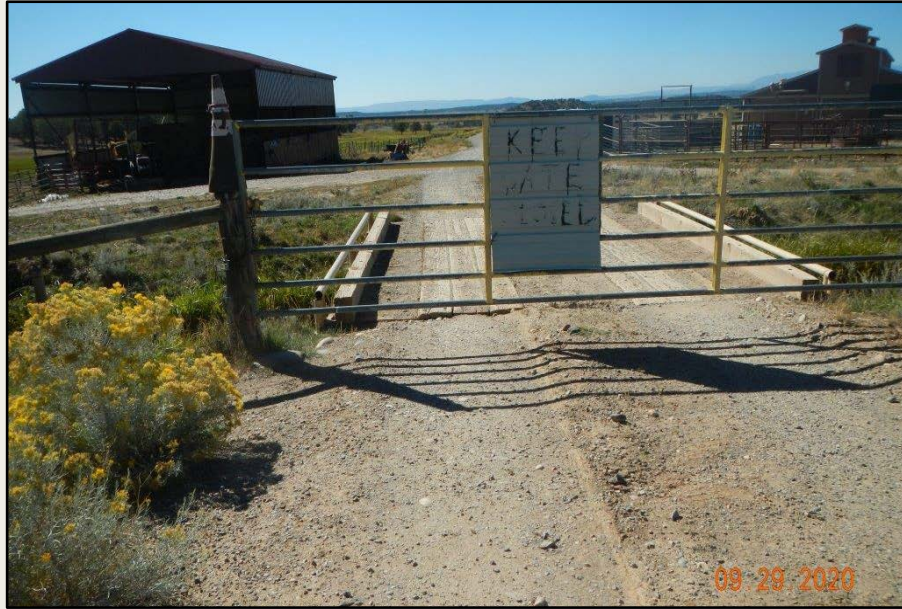
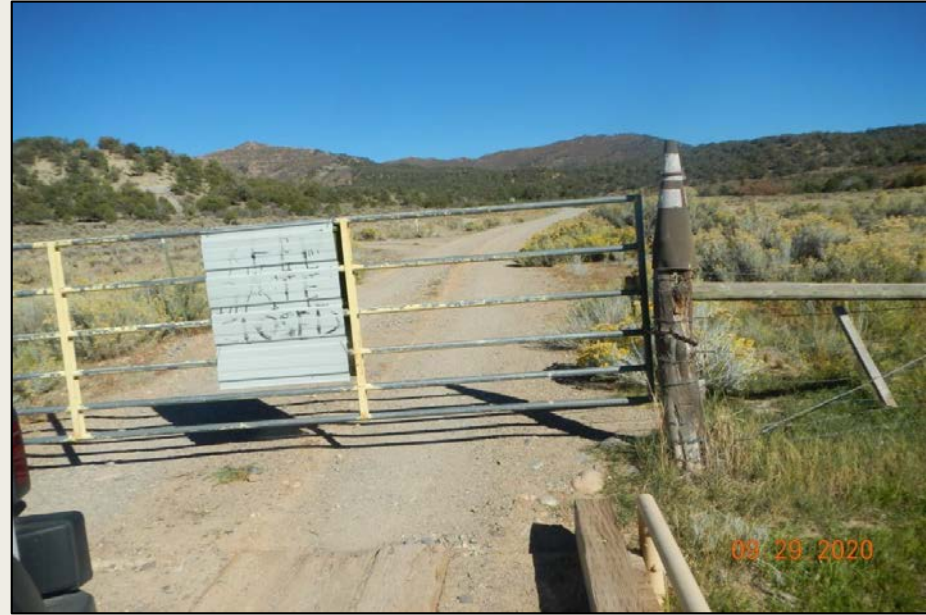
Photos 6/7. Closed gate coming in (left) and leaving (right).
