FOUR CORNERS ENERGY LLC – 10754
API# 05-033-06063 SANTA FE CANYON-FEDERAL #42-14
Inspection Date 10/1/2020

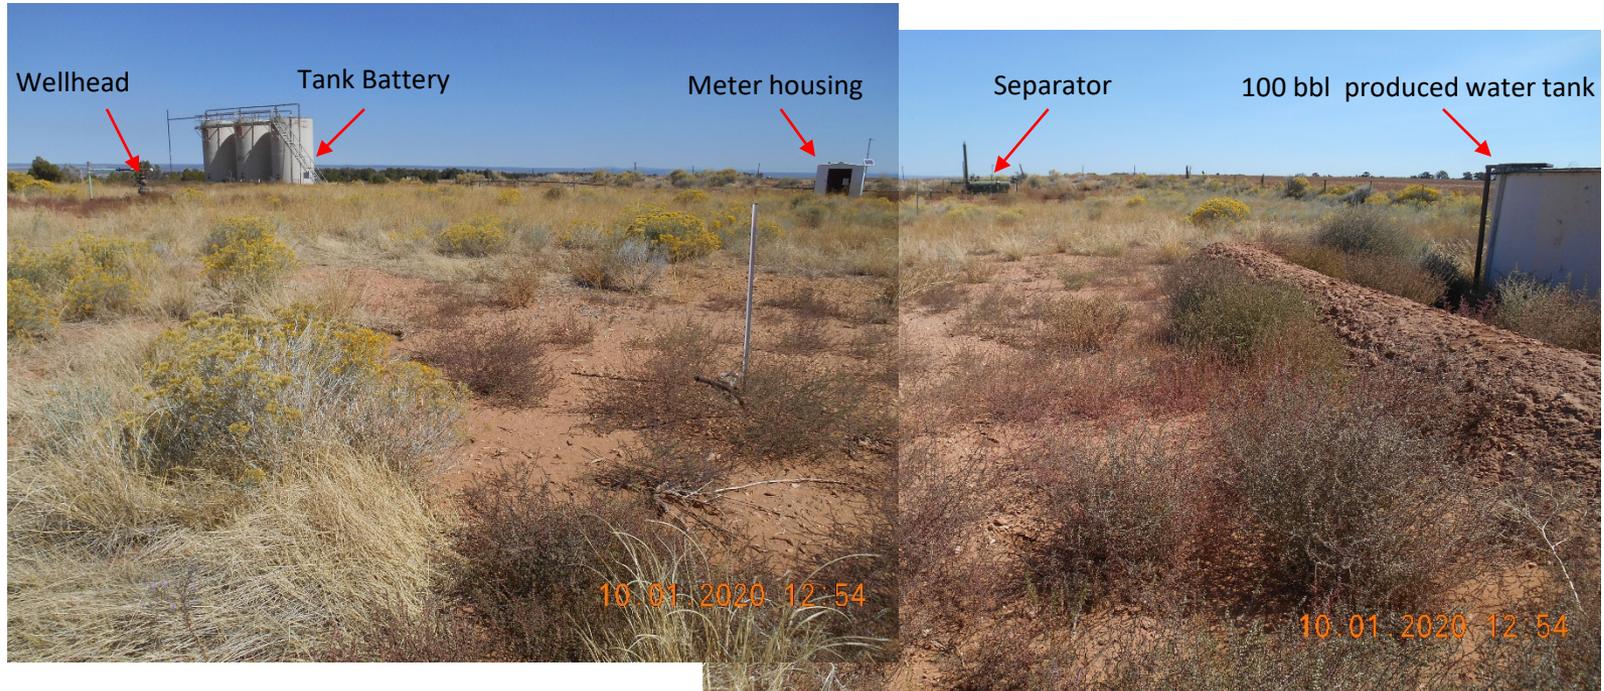
Location overview from SW anchor marker looking NE (left) to SE (right)

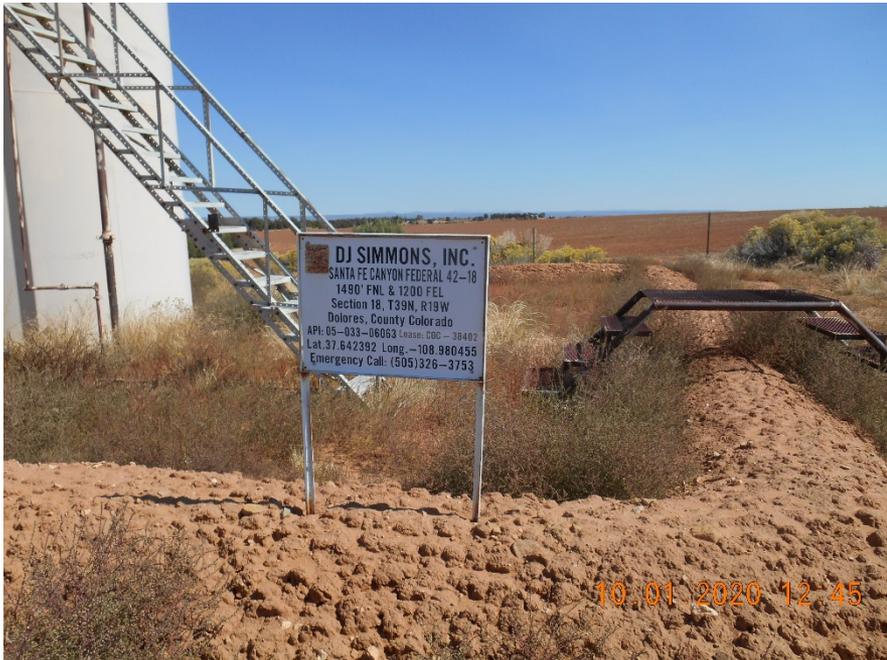
Sign at SW corner of tank battery.
Wrong operator information on sign.
Needs update emergency contact information and 911

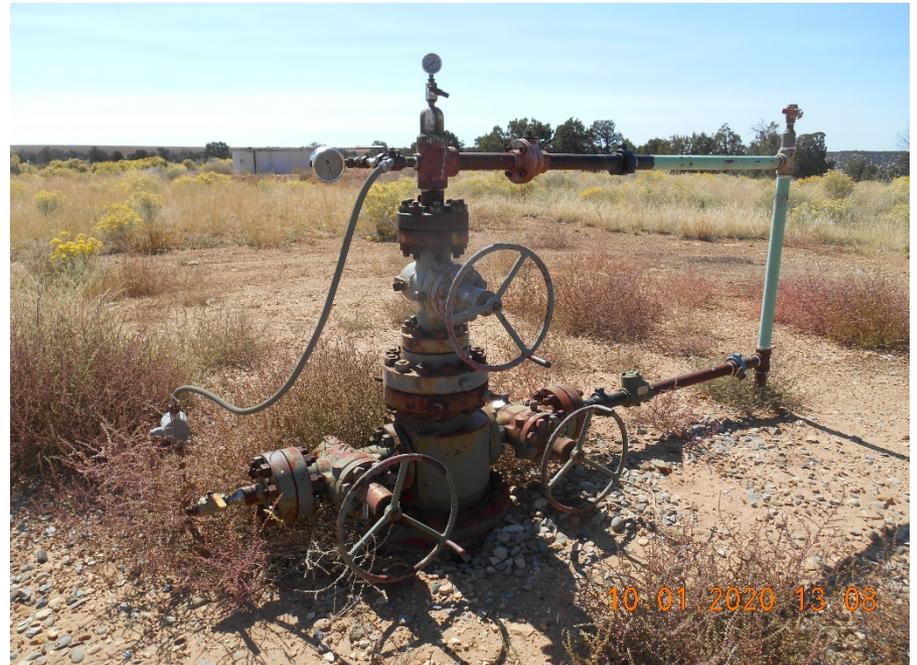
Shut in wellhead.
Audible gas leak at tubing valve packing fitting.
Bradenhead valve not plumbed to surface.

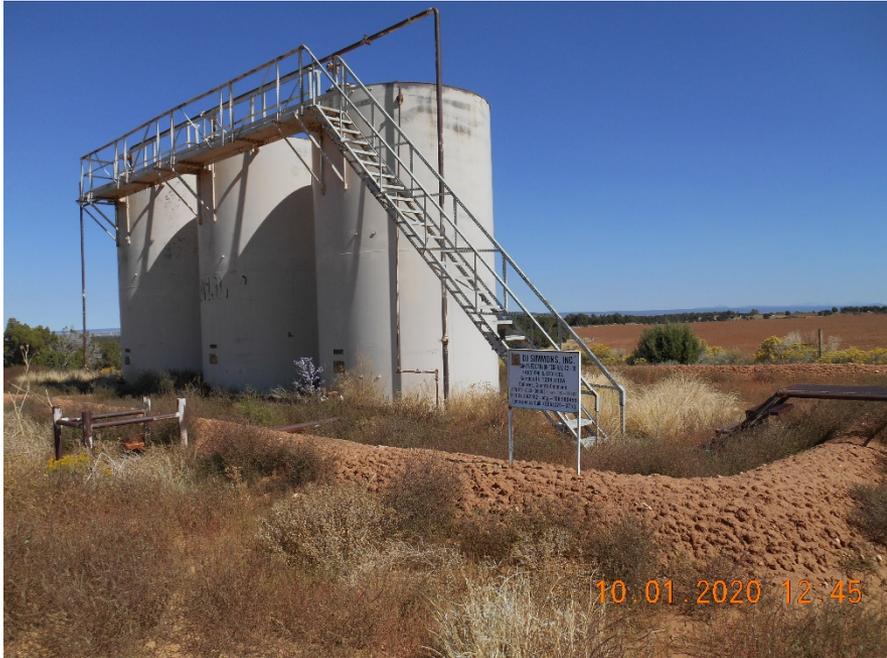
**Tank Battery with earth berms.
Weeds inside berms.**

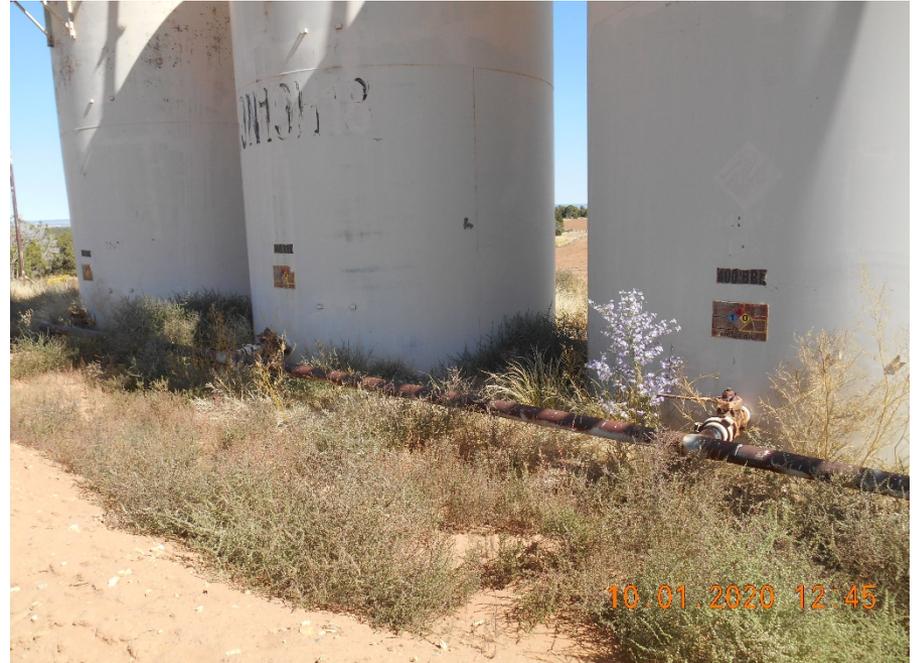
Tank Battery with improper tank labels.

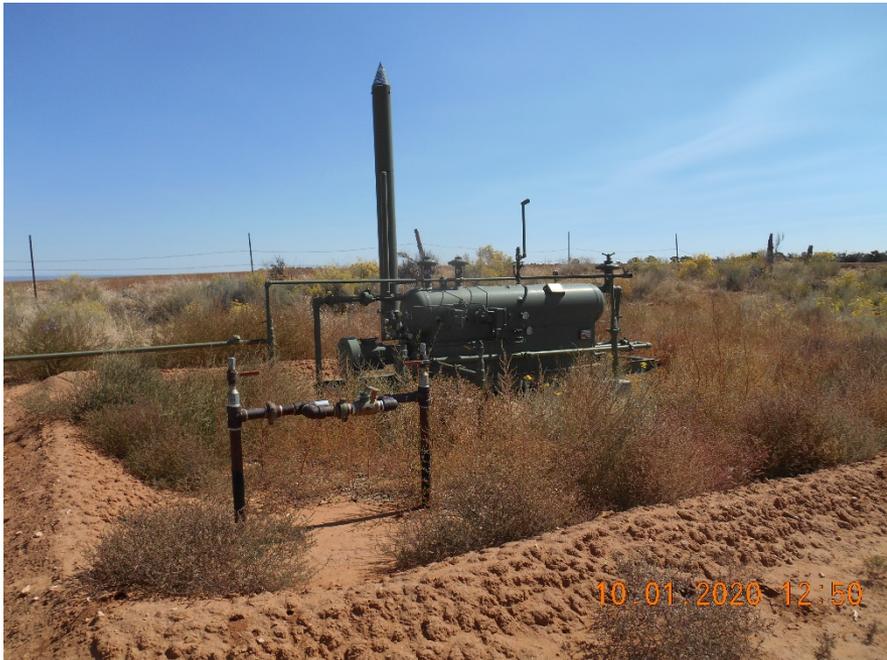
**Separator with earth berms.
Weeds inside berms.**

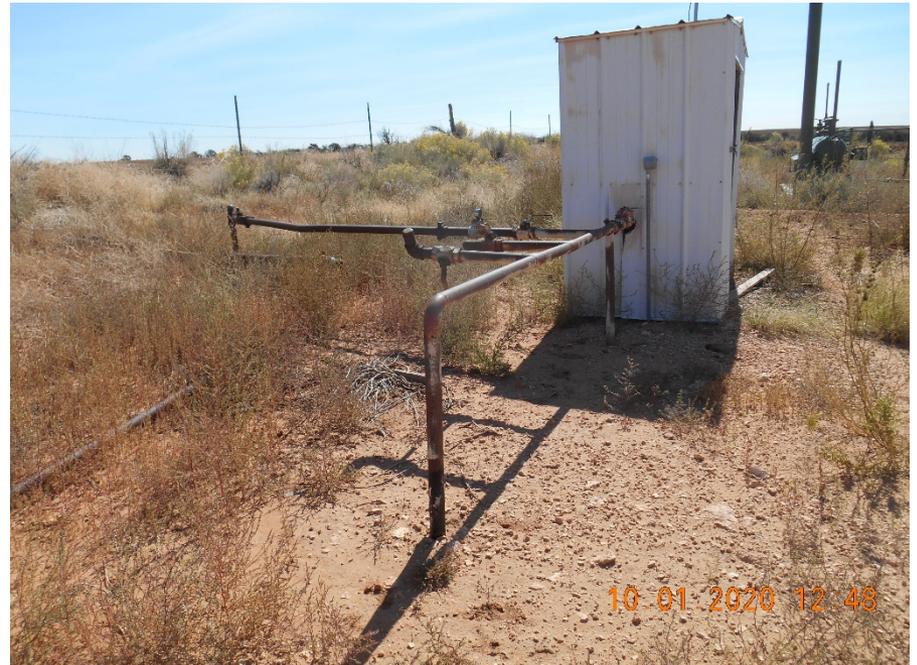
Meter housing and off location flowlines

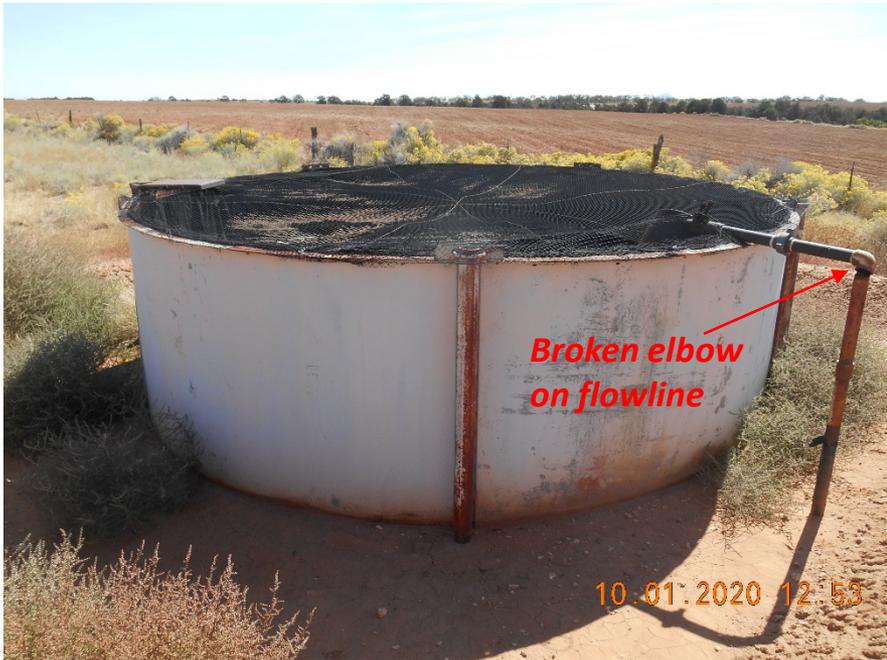
**100 bbl produced water tank ½+ full of oil/water.
No berms. Broken elbow on flowline.**

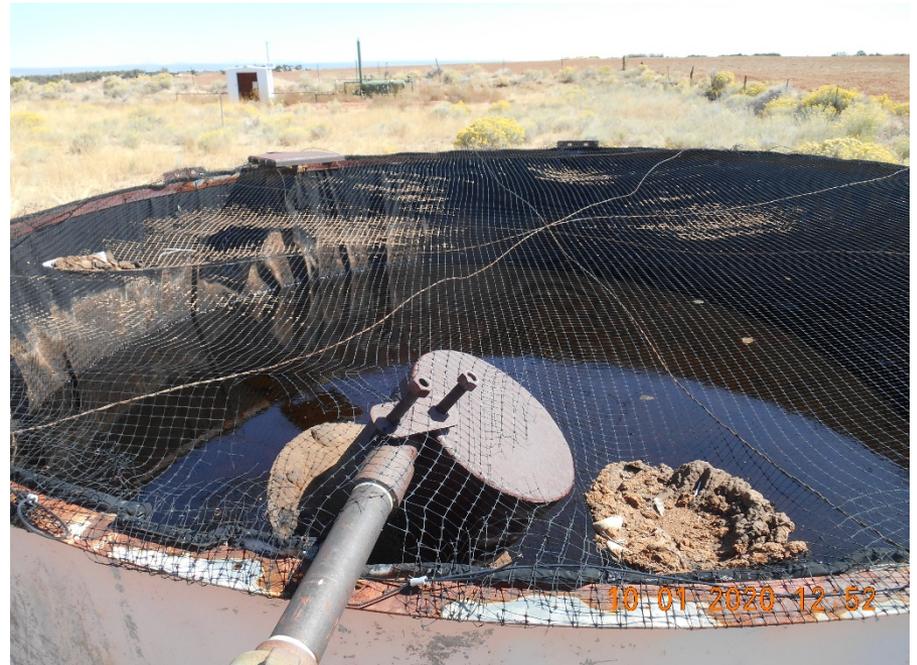
**Oil/water level in produced water tank
wth less than 2 feet freeboard.**

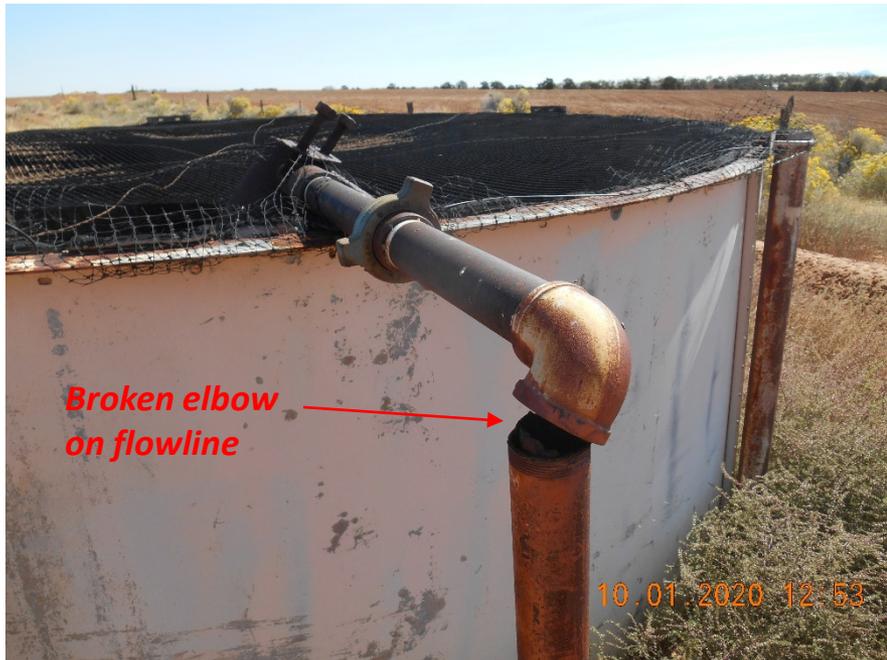
*Broken elbow
on flowline*

Close up of Broken elbow on flowline.

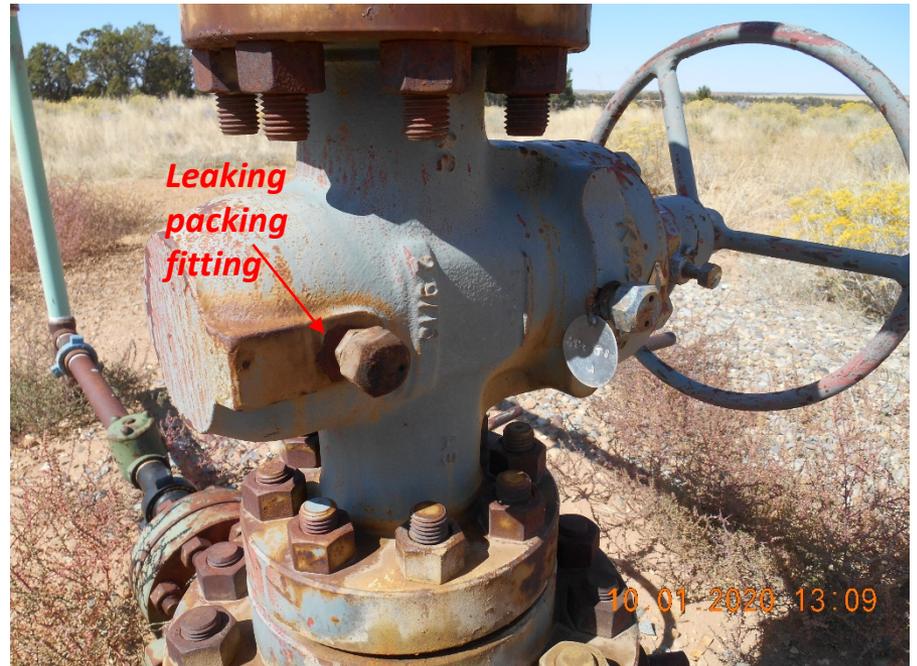
*Leaking
packing
fitting*

Audible leak on tubing valve packing fitting.
