Inspection Photos

API#107-06123

Operator: Bayless

Inspection Photos: Bayless PA Grassy Creek Coal API#107-06123

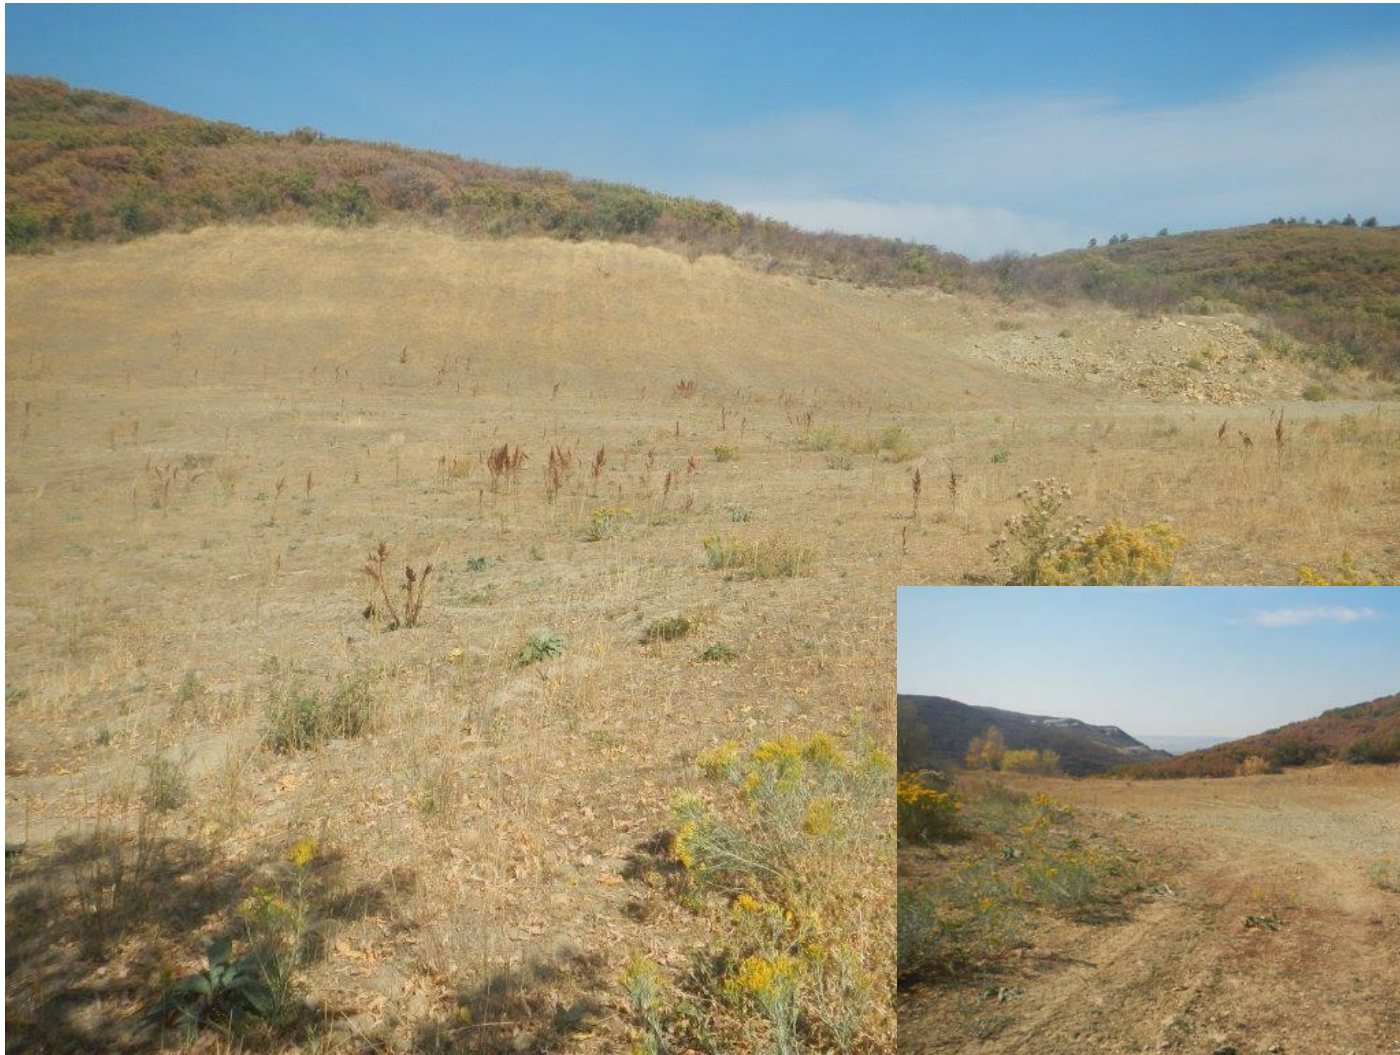
Photo#1:

Over views of Location which has not been reclaimed.

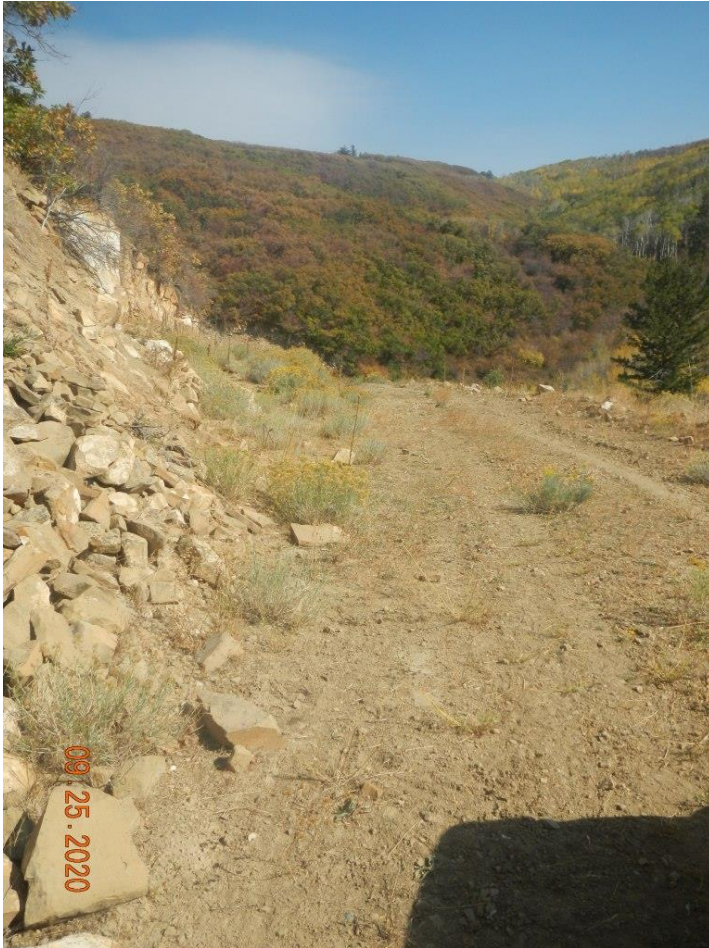
Photo#2:
Access Road has not been reclaimed.

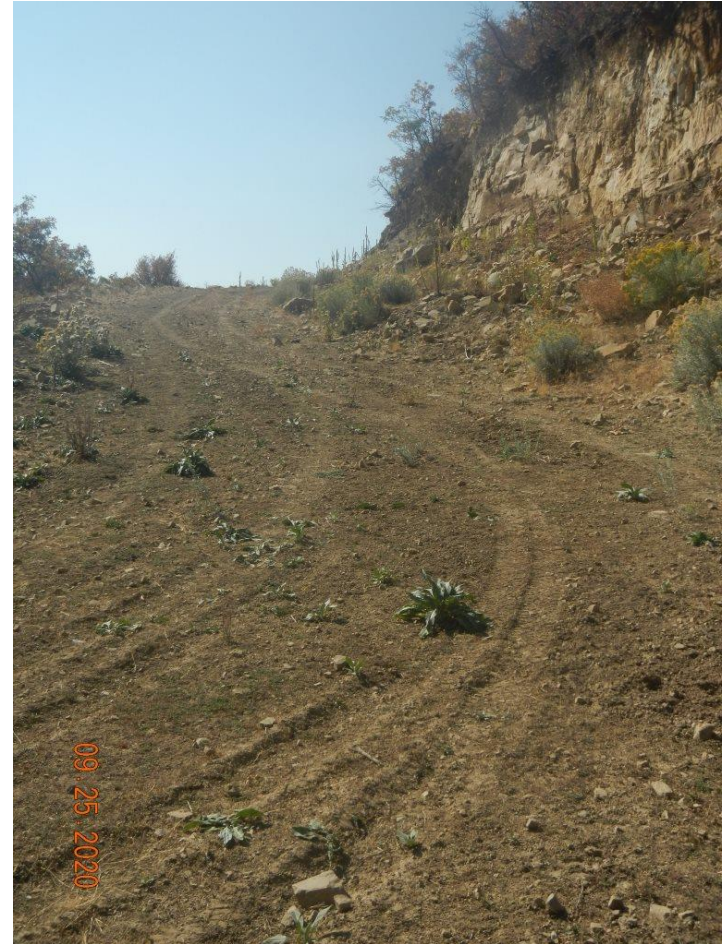
Photo#3:
Access Road has not been reclaimed.

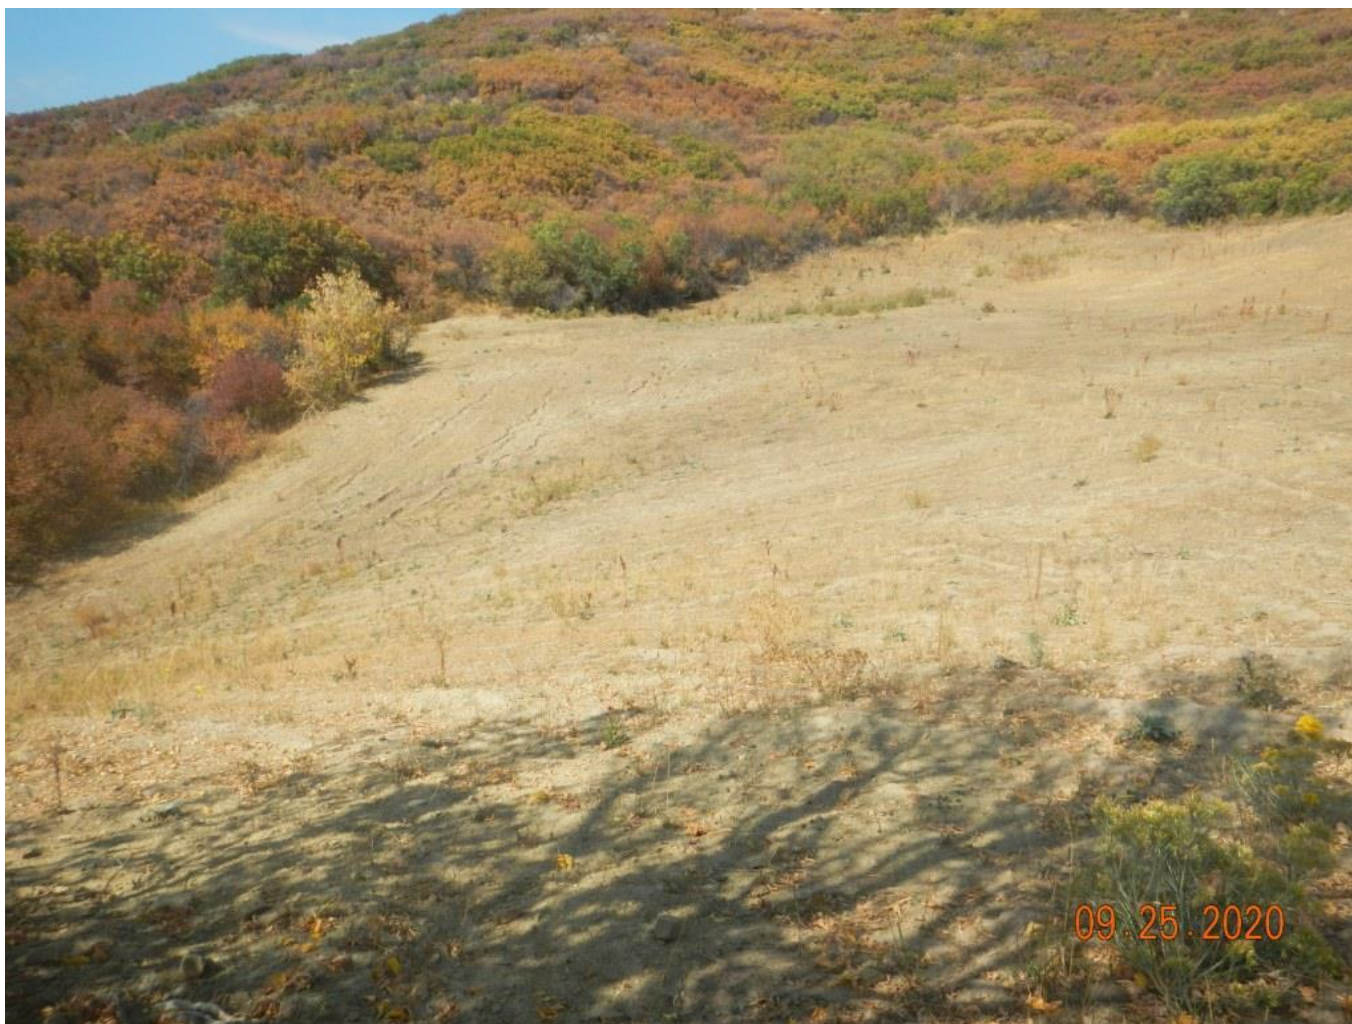
Photo#4:
Northwest end of Location where erosion issues are evident.

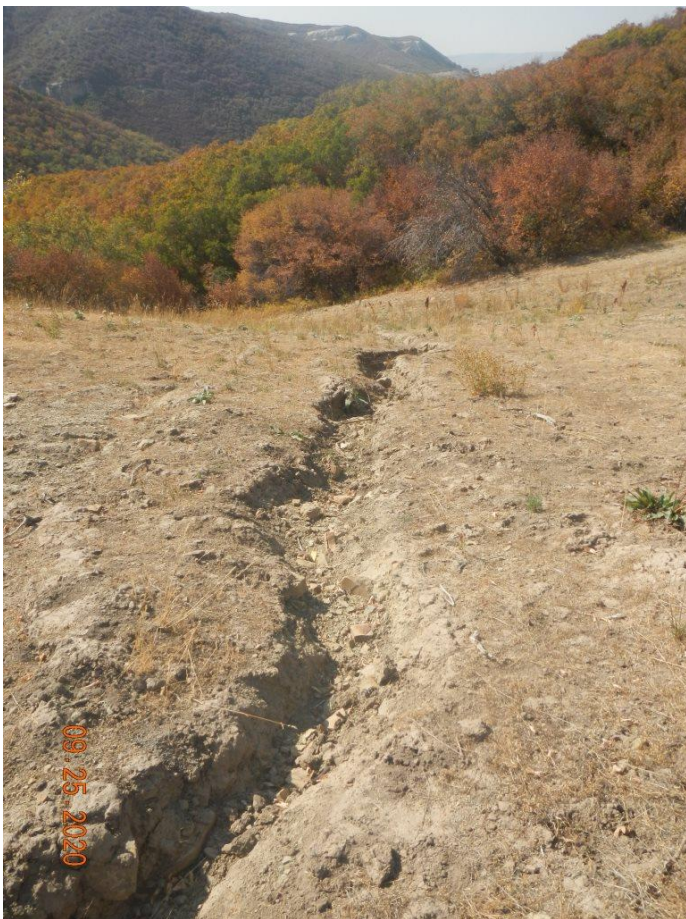
Photo#5:
Close up of erosion at NW end of site.

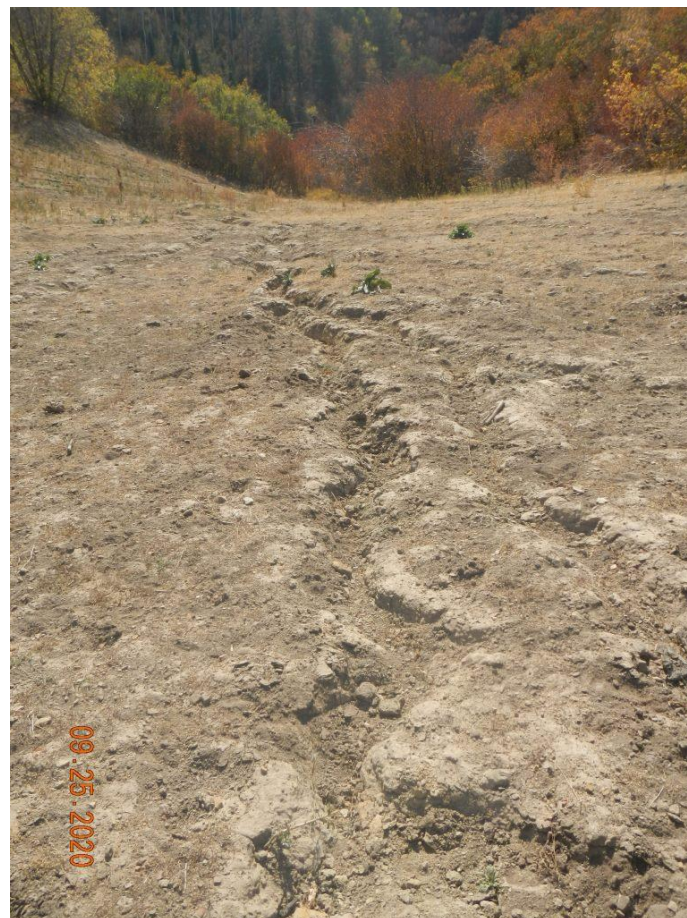
Photo#6:
Close up of erosion at NW end of site..

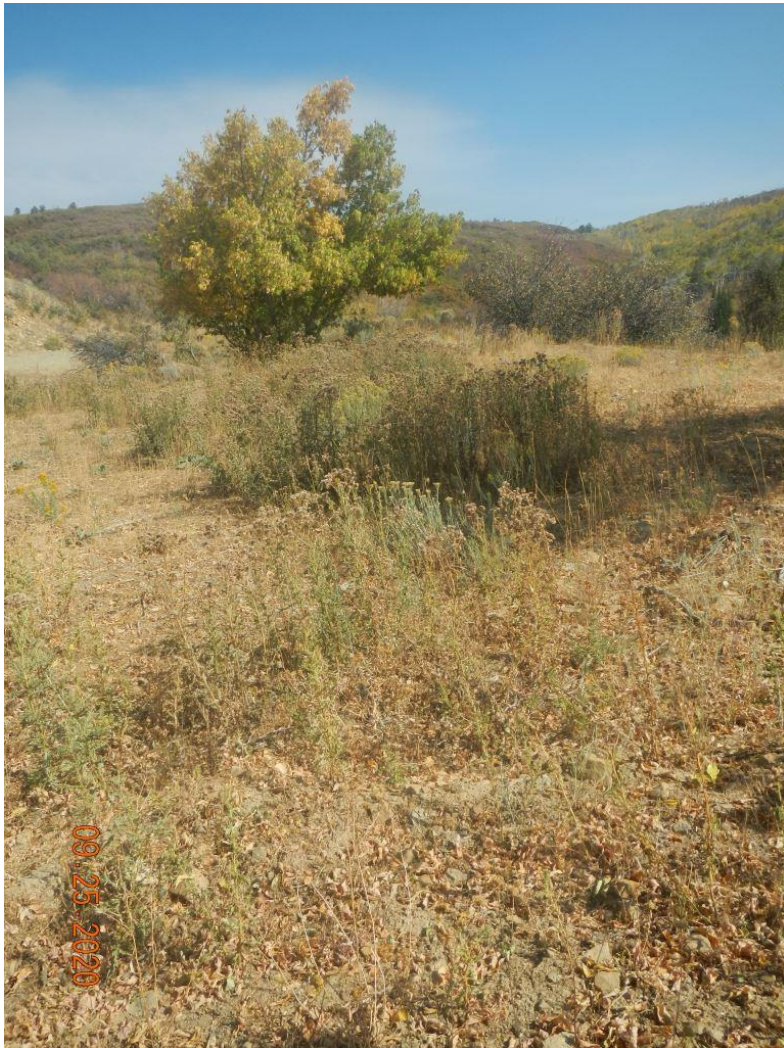
Photo#7:
Weed concerns at site.

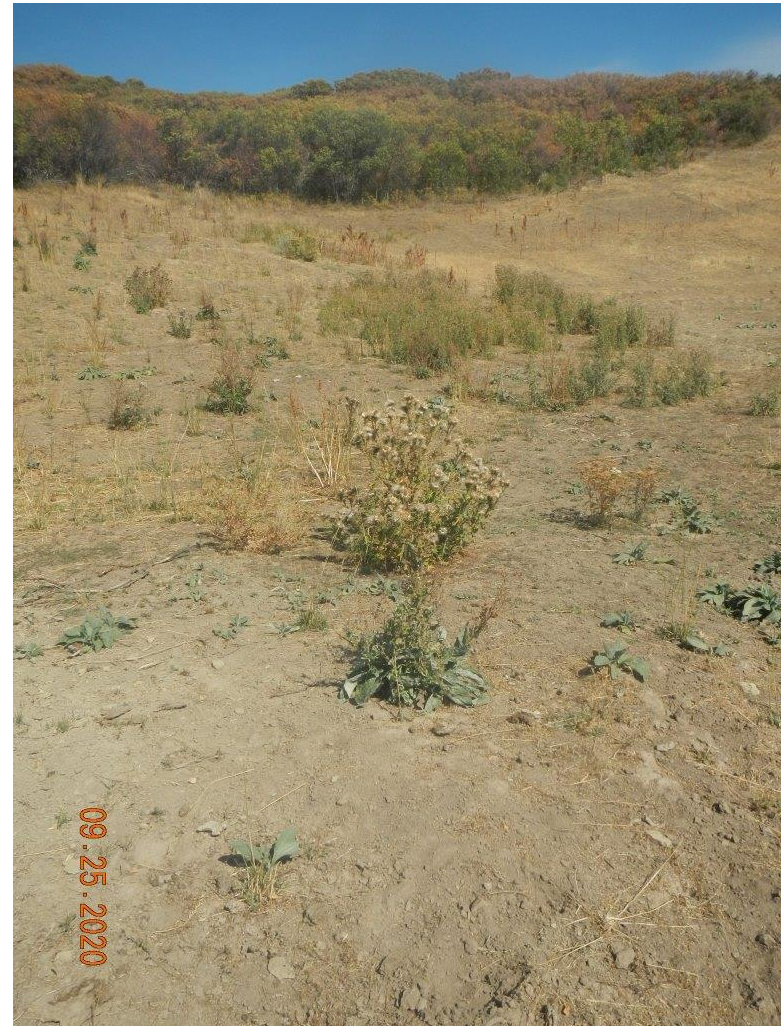
Photo#8:
Weed concerns at site.
