Inspection Photos

Location Name: South Canyon Fed

Location ID: 322299 & Remediation Project Number: 10464

Inspection Date: September 29, 2020

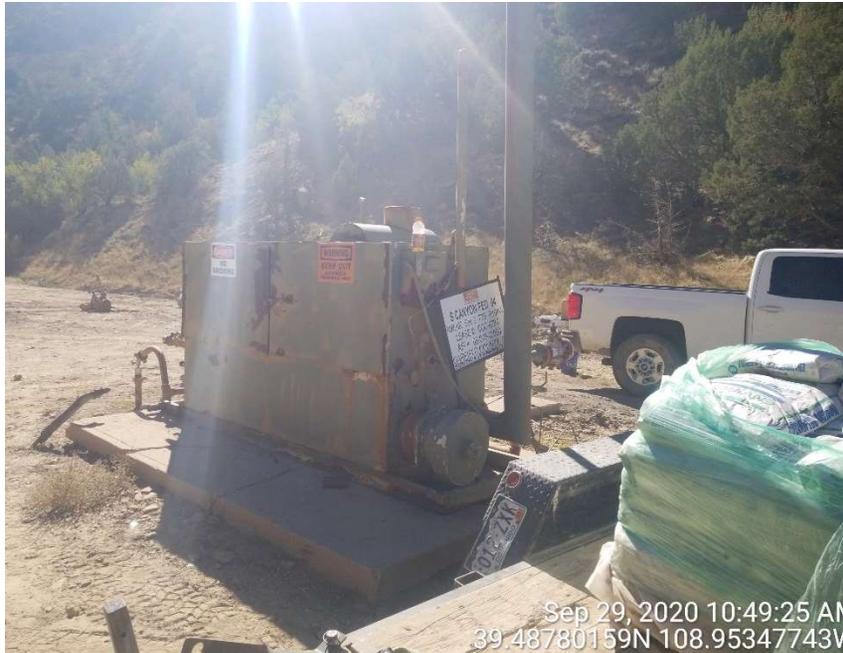
Location sign.

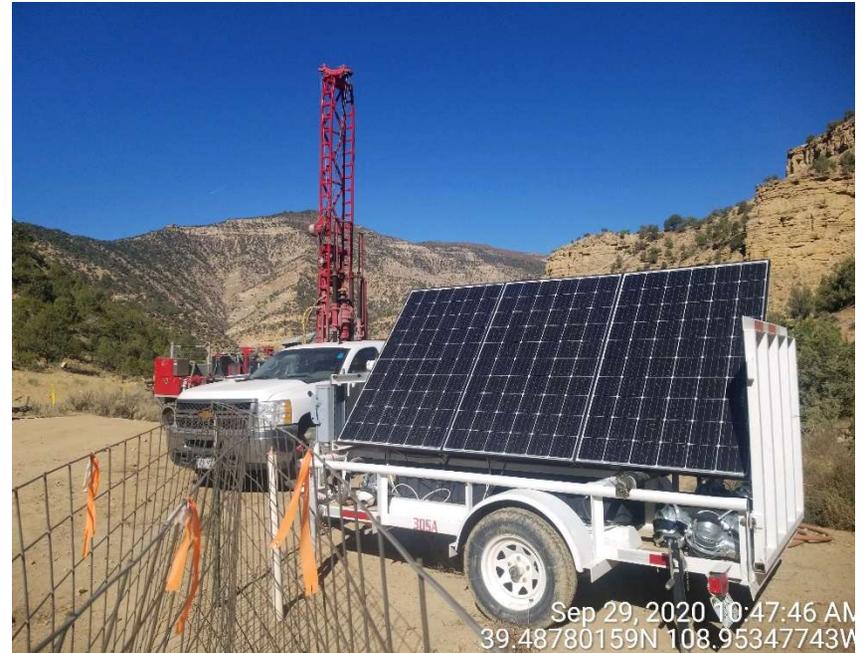
Monitoring well drill rig and solar powered SVE system.

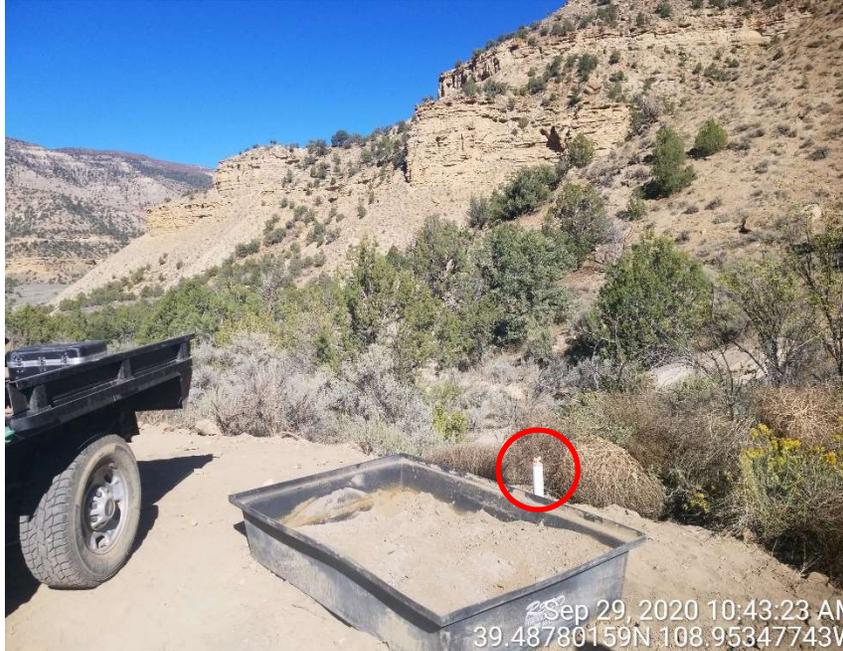
Newly installed monitoring well (red circle) and the arroyo located north of the location.

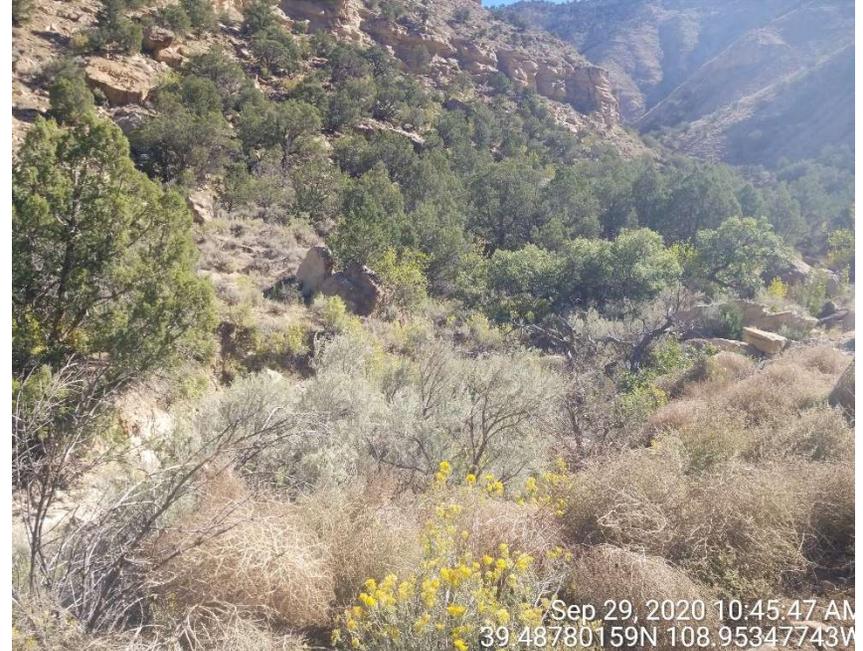
Arroyo located north of the location.

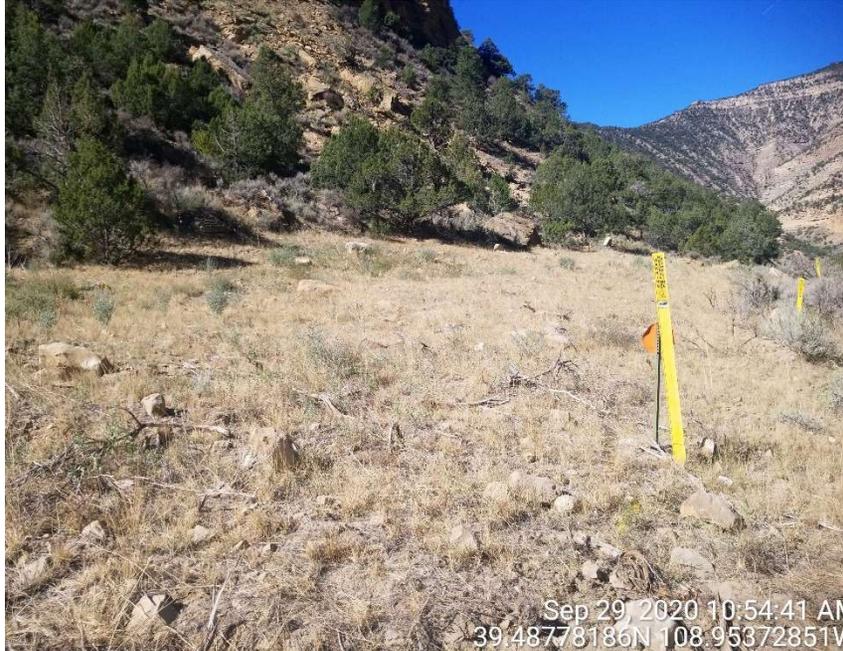
View of the area where the impacted material from the pit was landfarmed. The larmfarm was located south of the location, adjacent to the access road.

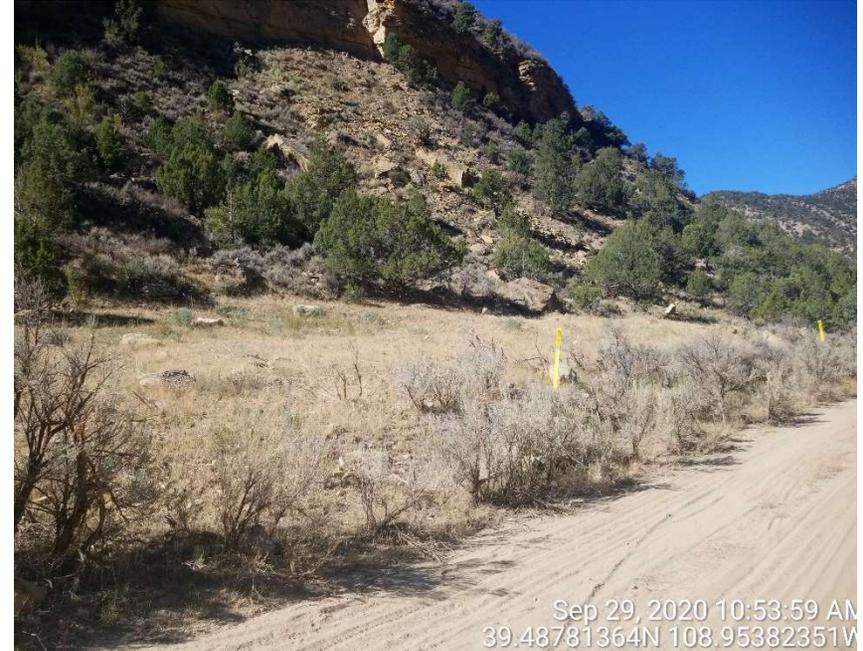
View of the area where the impacted material from the pit was landfarmed. The larmfarm was located south of the location, adjacent to the access road.

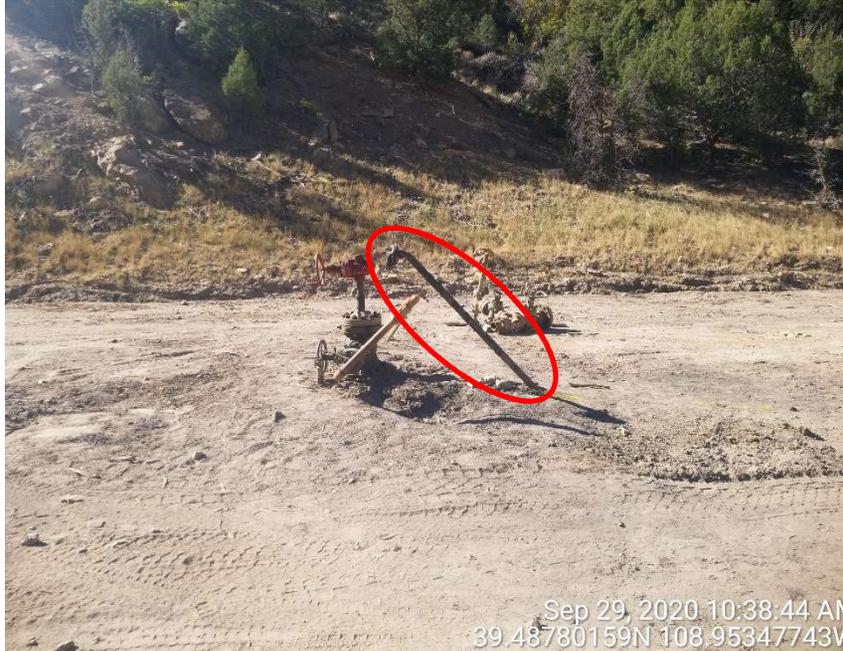
Wellhead, note the unmarked riser (red area).

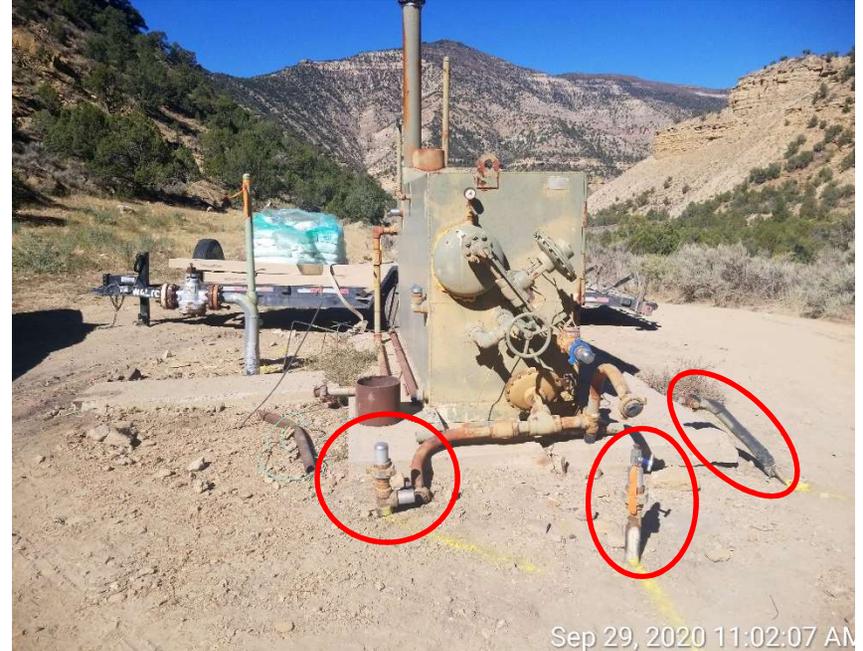
Separator, note the unmarked risers (red areas).
