Well Name: Federal 26-1 **API #** 007-06095

Document Number: 692902243

Inspector: Catherine Roy

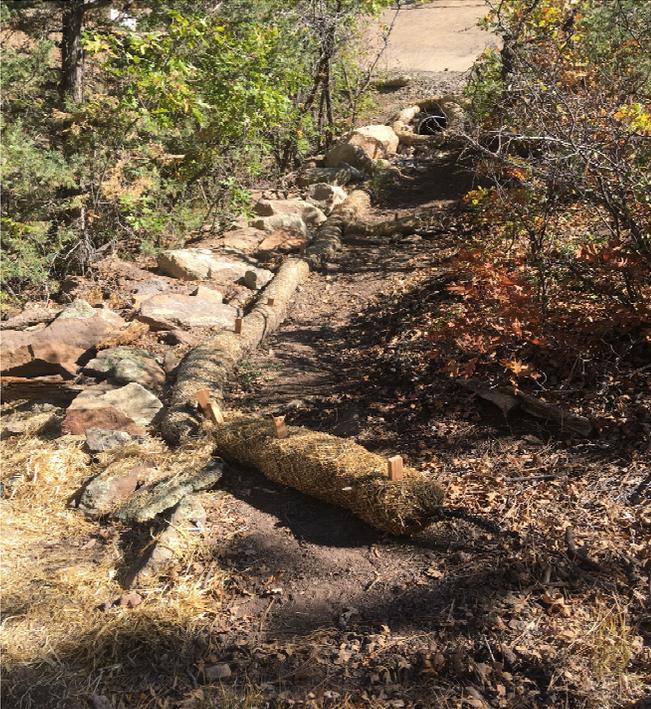
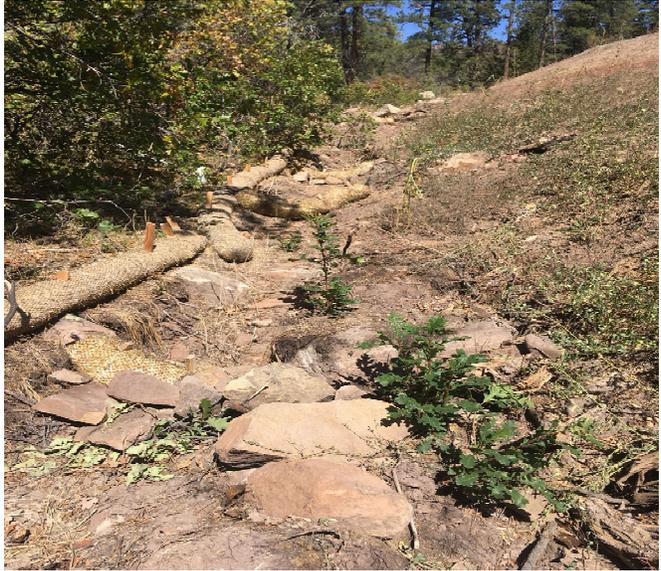
Corrective Action: Erosional scouring/channeling is occurring downstream from culvert at the well pad entrance and along the wattles flowing toward a drainage in the western project area. Wattle at the culvert outlet is full of sediment and is not an adequate BMP in this area. Perimeter wattles are full of sediment/soil in many places
Stormwater controls need to be installed, maintained, and adjusted to control erosion within the project area. Stormwater controls need to be selected, sized, installed, and maintained according to good engineering practices.

Action Taken: Removed sediment from the perimeter wattles. Installed rock dams along the channel downstream from the culvert near the entrance to the drainage on the Western edge of the project area.

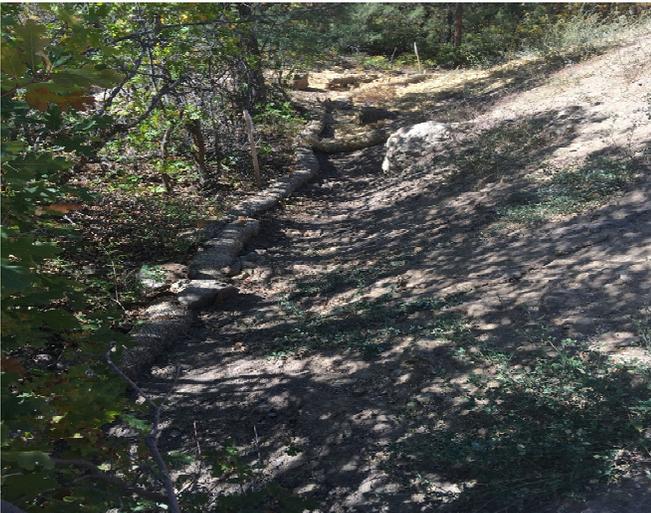
Corrective Action: Orange fencing twine around the project perimeter is down in several areas and is a wildlife hazard/debris.

Fencing debris needs to be removed and properly disposed of.

Action Taken: Removed and disposed the fencing debris around the premier of the project area.
