Inspection Photos

Operator: Southland Royalty
API: 067-09493
Date: 10/1/2020

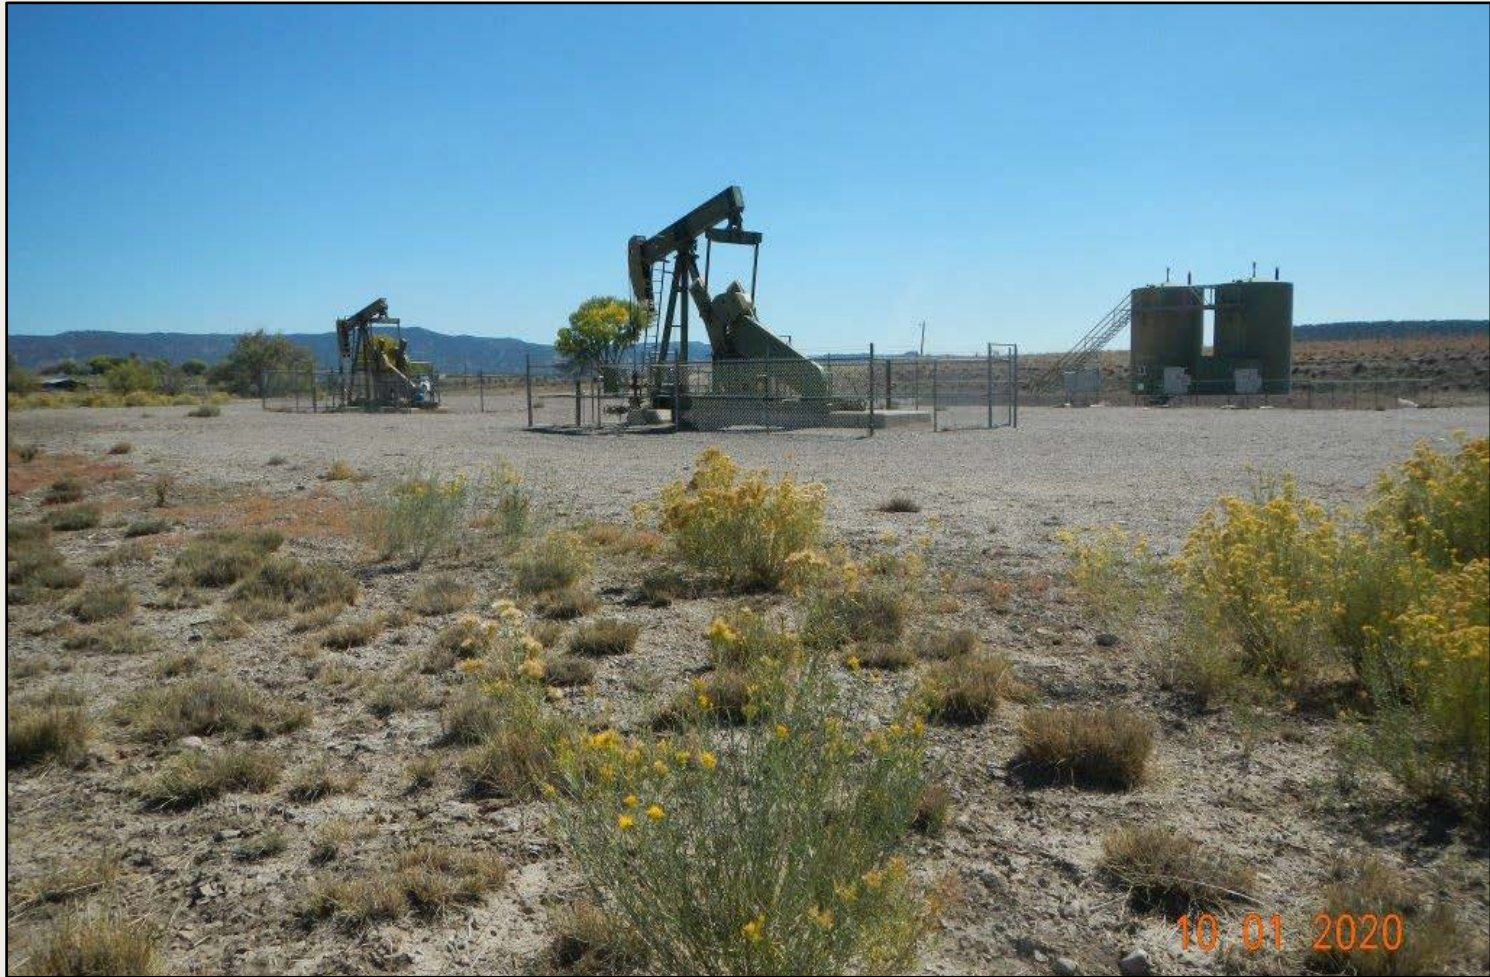
Photo 1. View of the project area from the northwestern corner facing center.

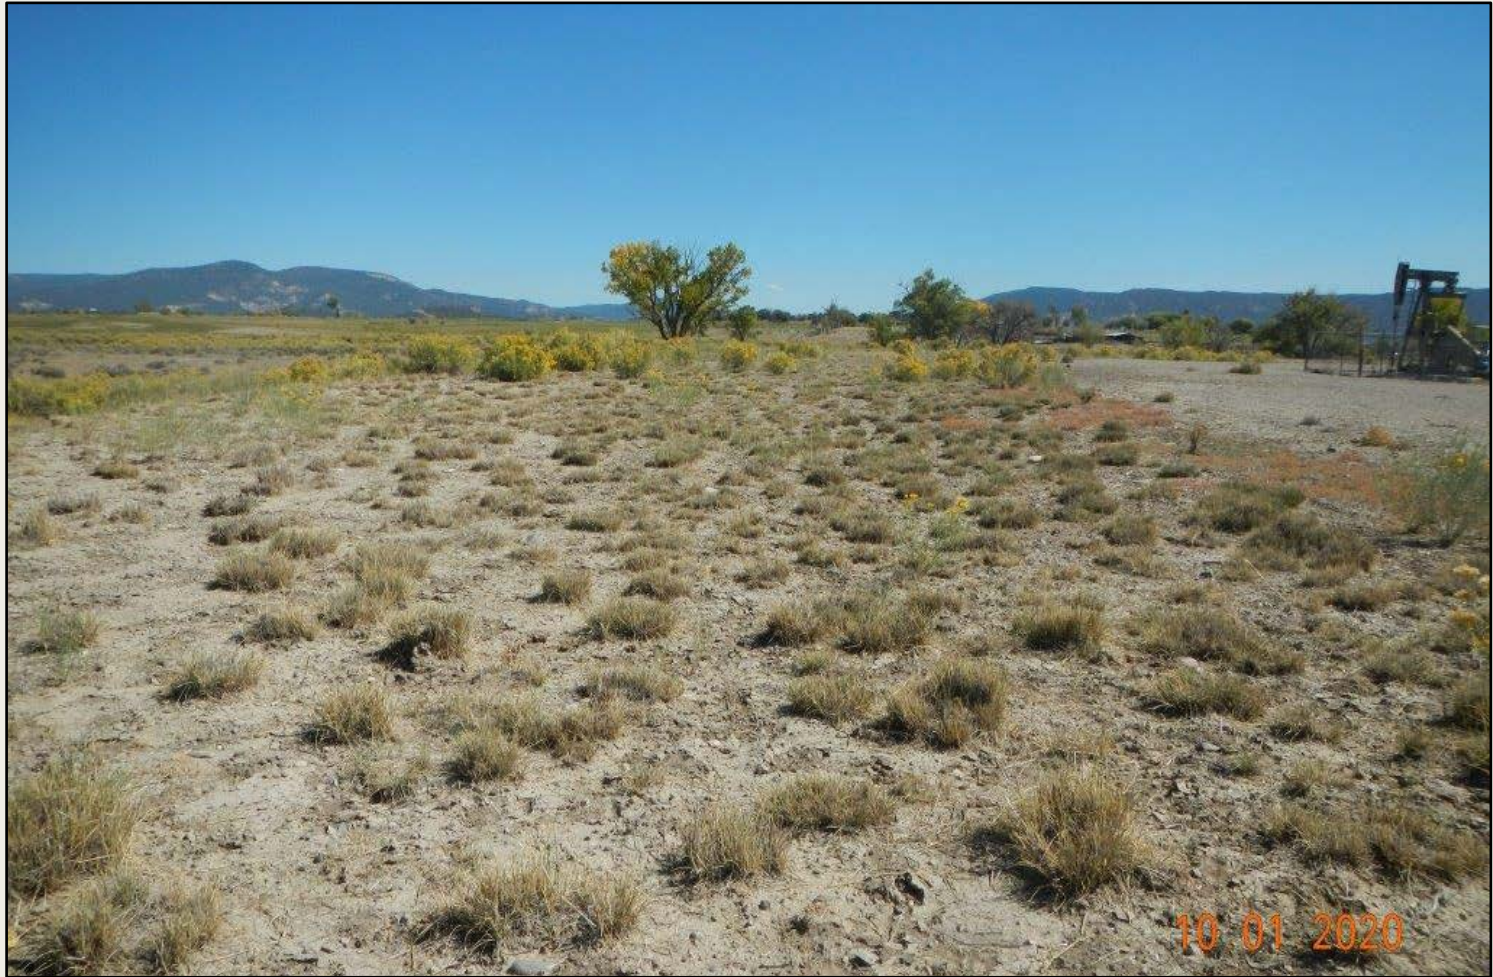
Photo 2. View of the northern project area from the northwestern corner facing eastward. Vegetation appears to be progressing here largely with grasses such as crested wheatgrass, in a grazed condition.

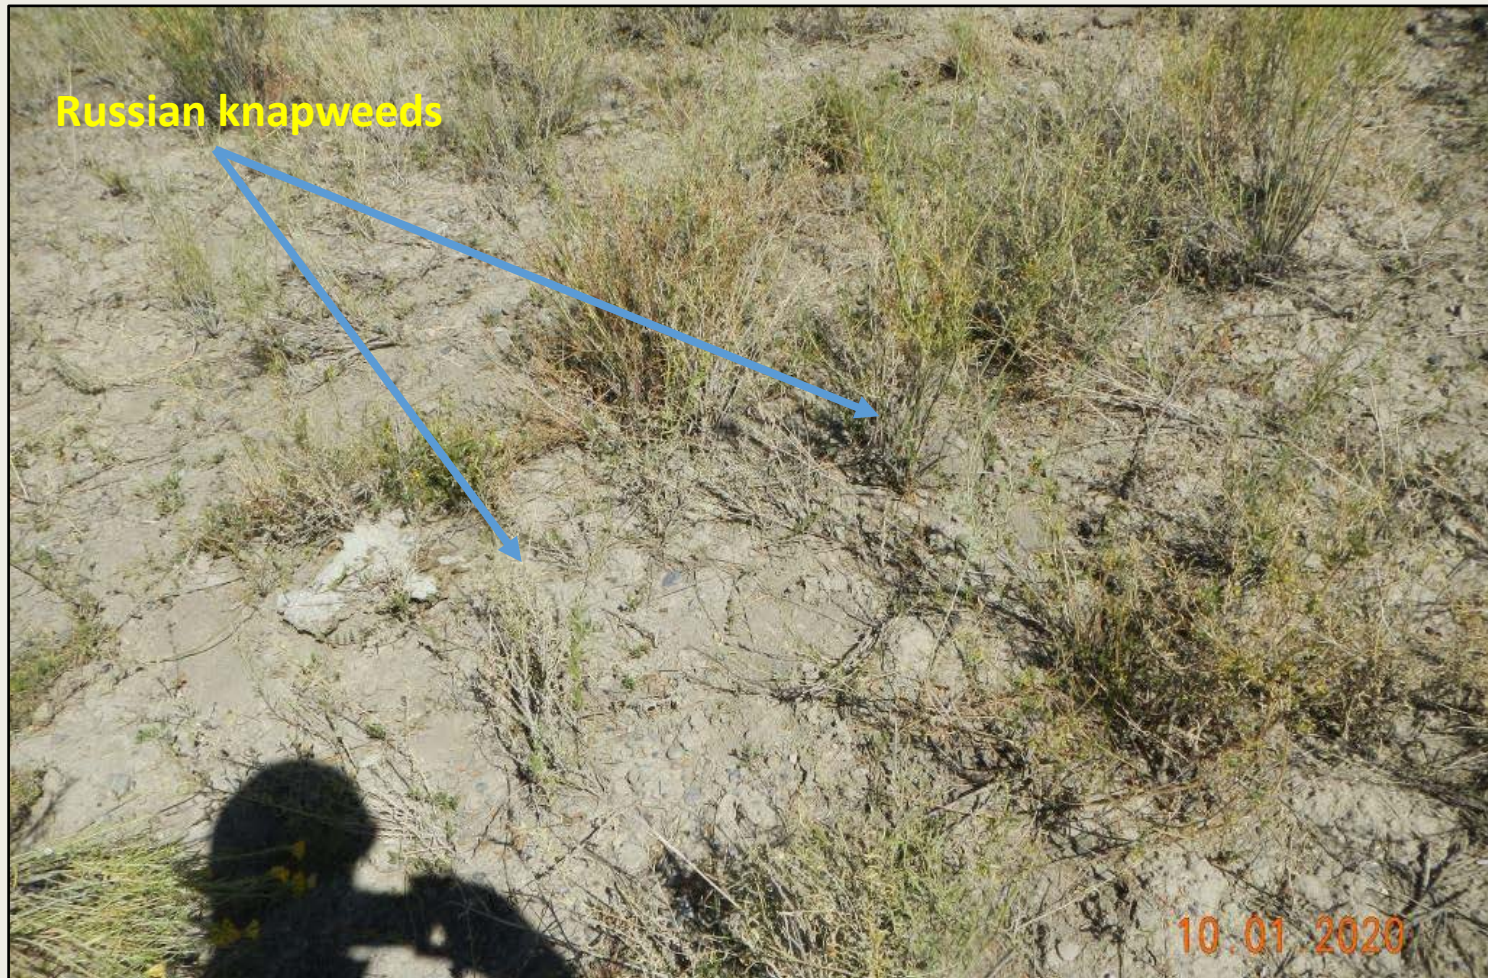
Photo 3. View of Russian knapweed within the northwestern project area. Approximately 200 individuals observed.

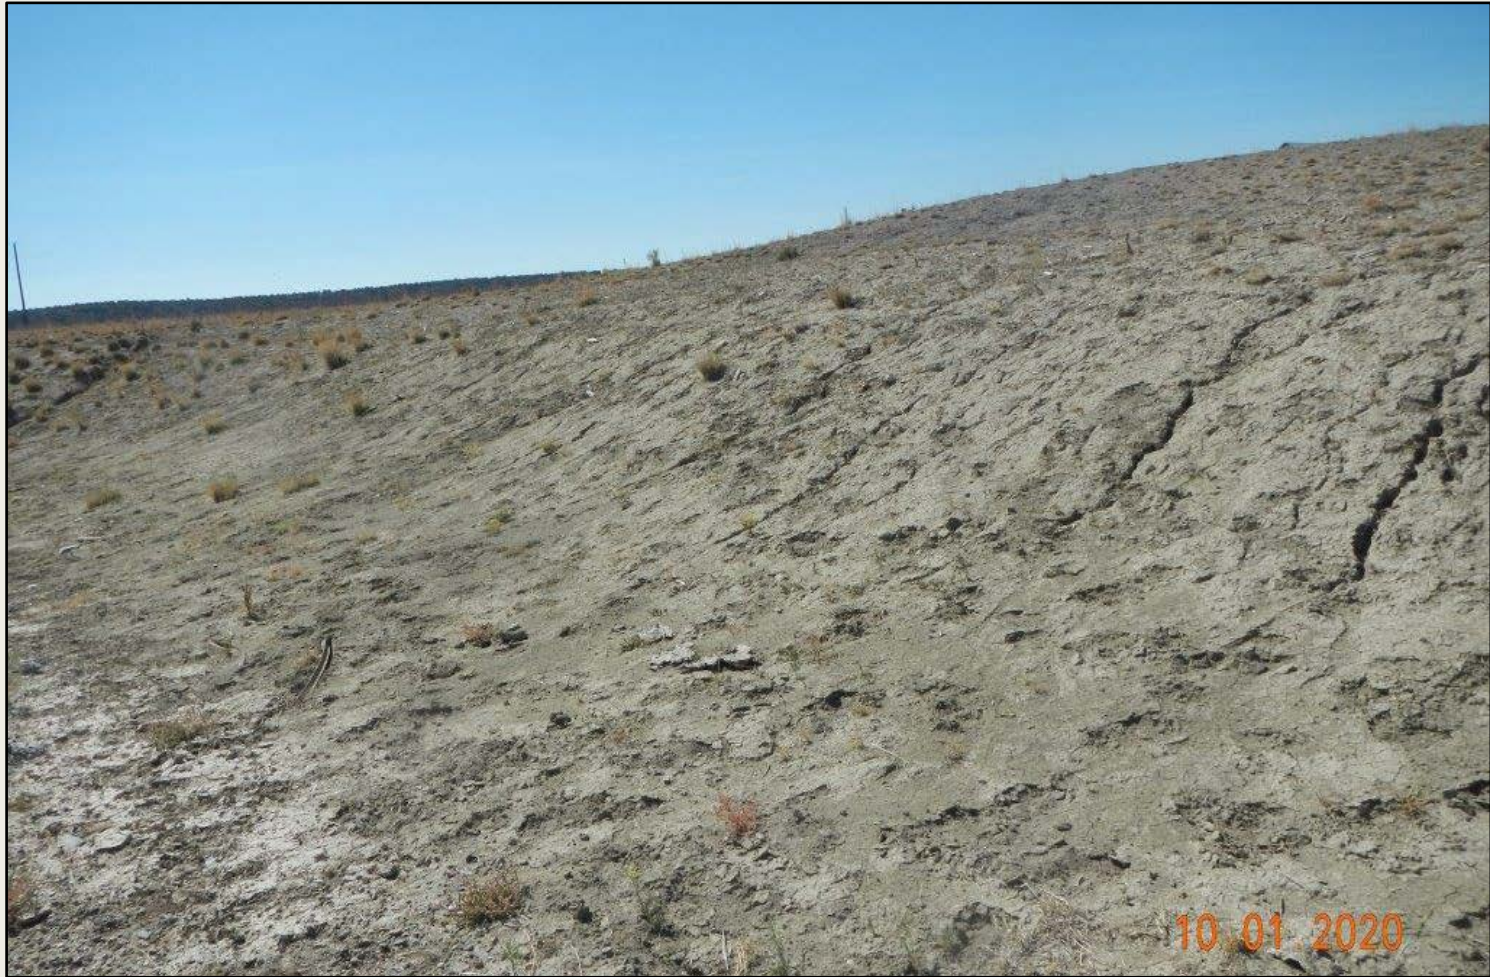
Photo 4. View of erosional rilling and bare soils on the well pad cut-slope. Additional stabilization is needed.

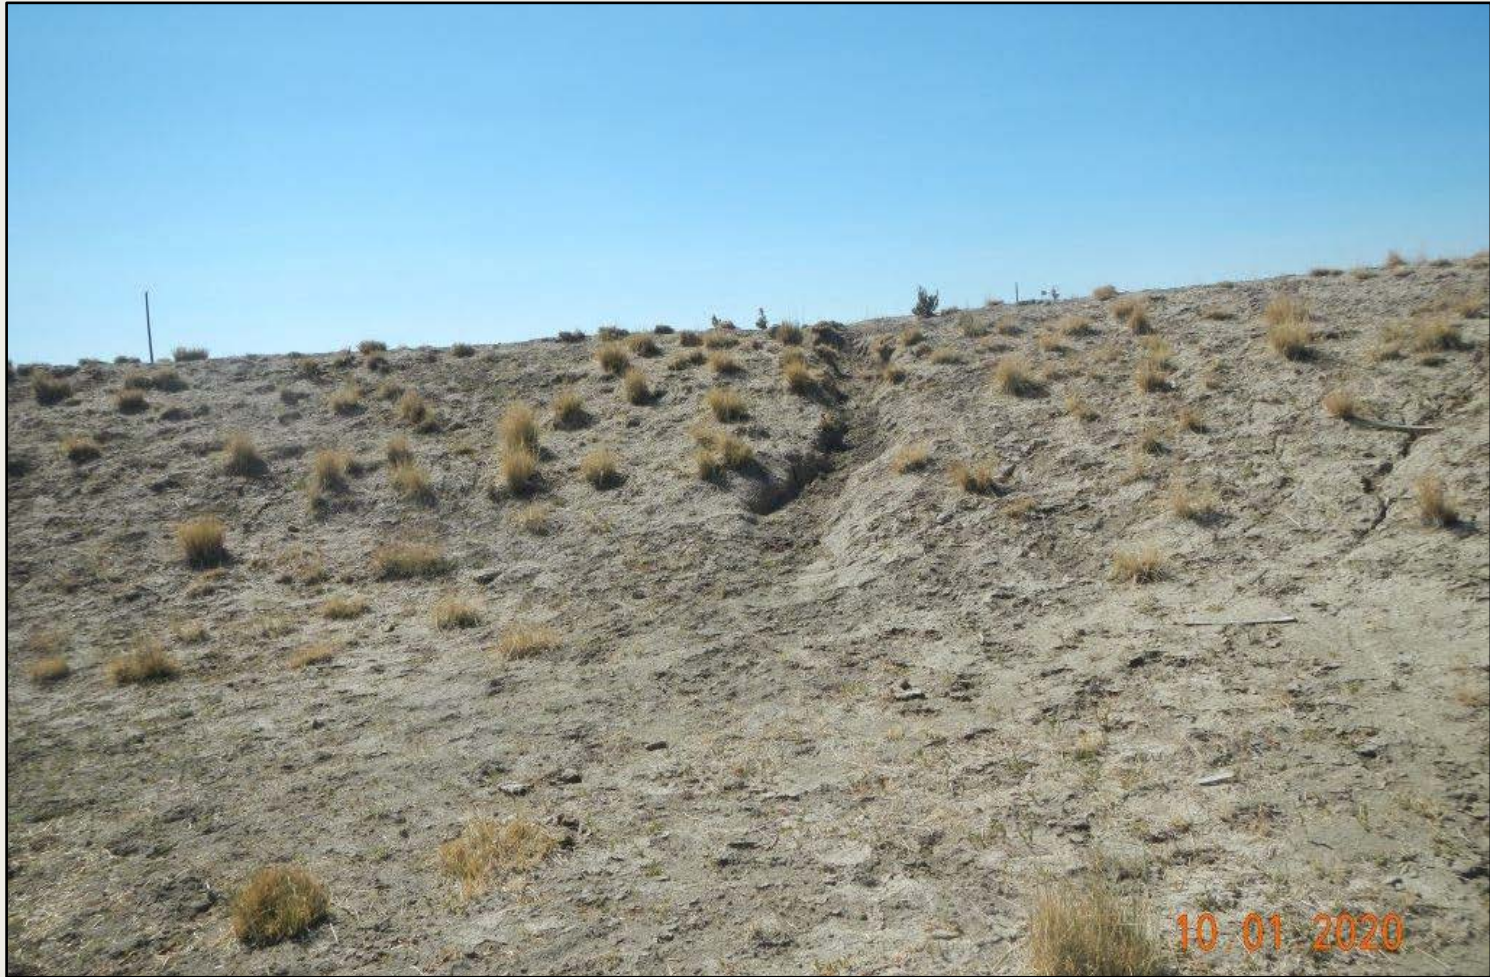
Photo 5. View of erosional channel, approximately 2.5 feet wide and 2 feet deep, within the southwestern cut-slope.

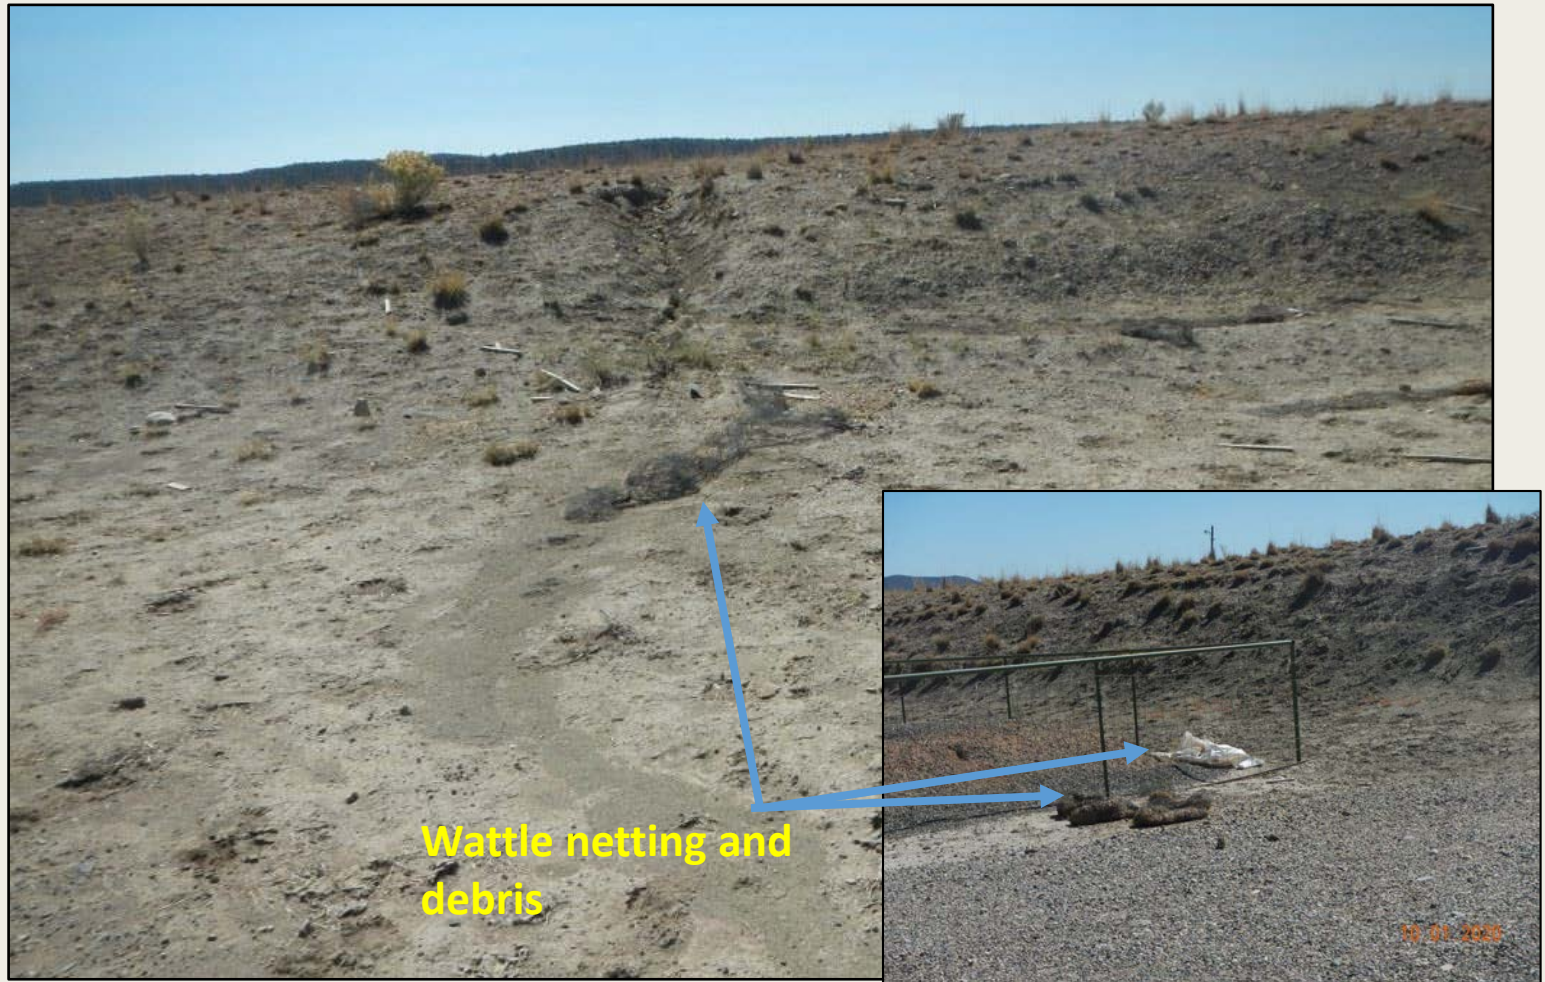
Photo 6. View of erosional channeling in the southeastern cut-slope. Wattle netting and debris present.

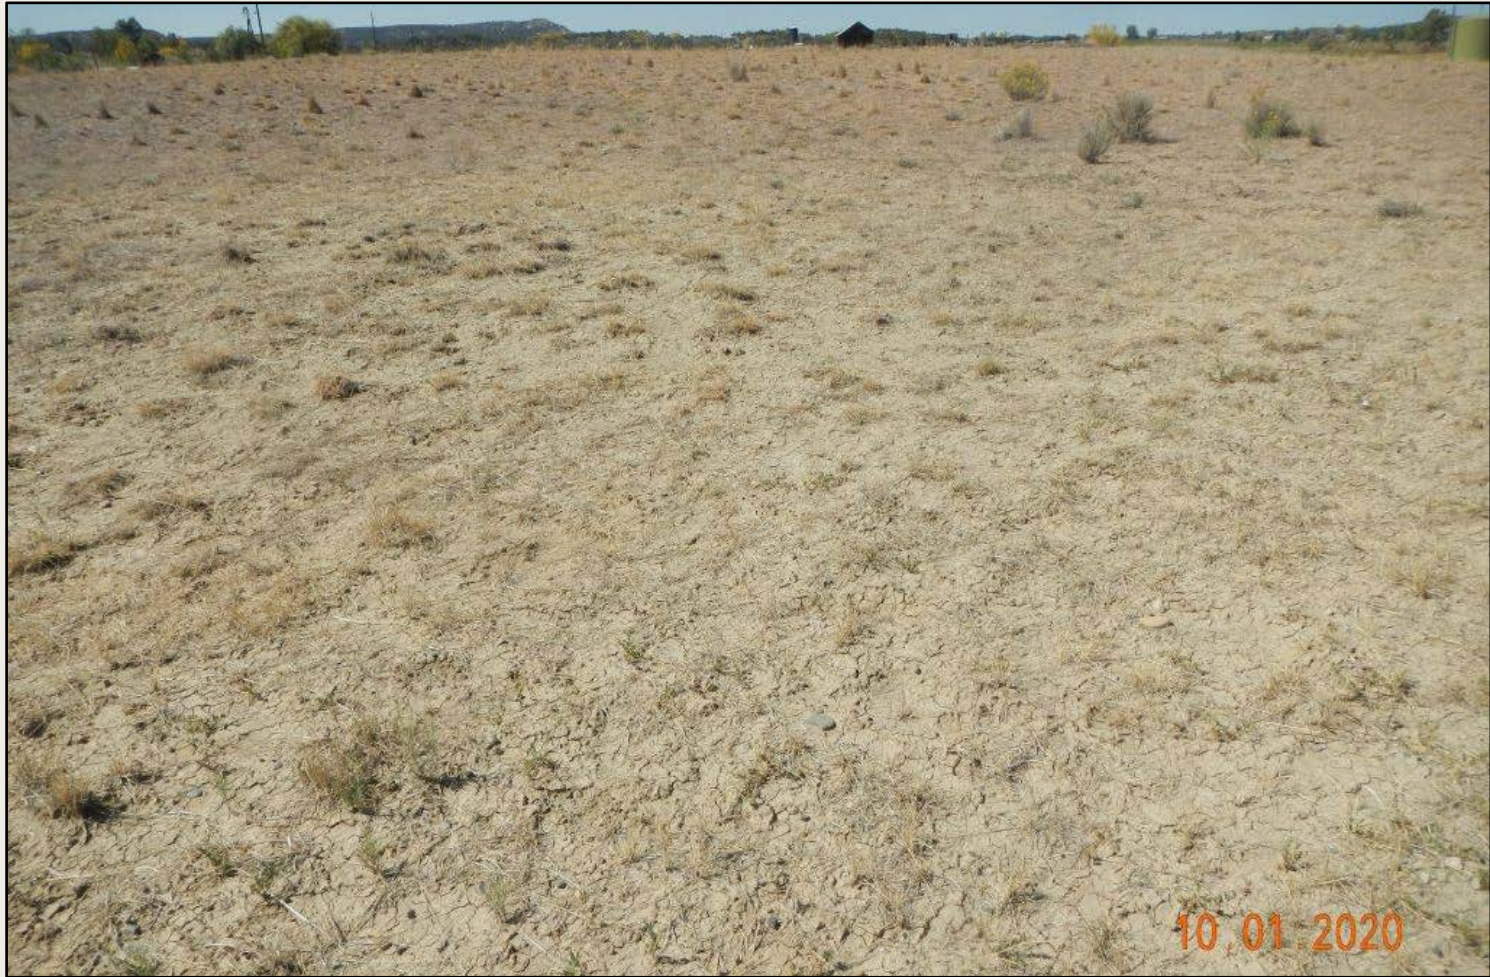
Photo 7. View of reference area comprised of grass field, largely with grazed grasses in a dormant vegetative condition.

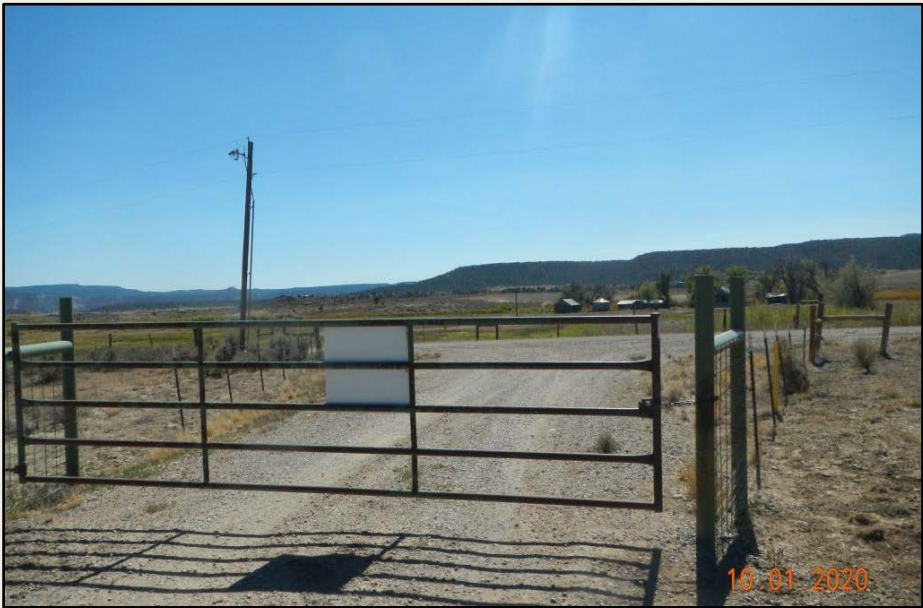
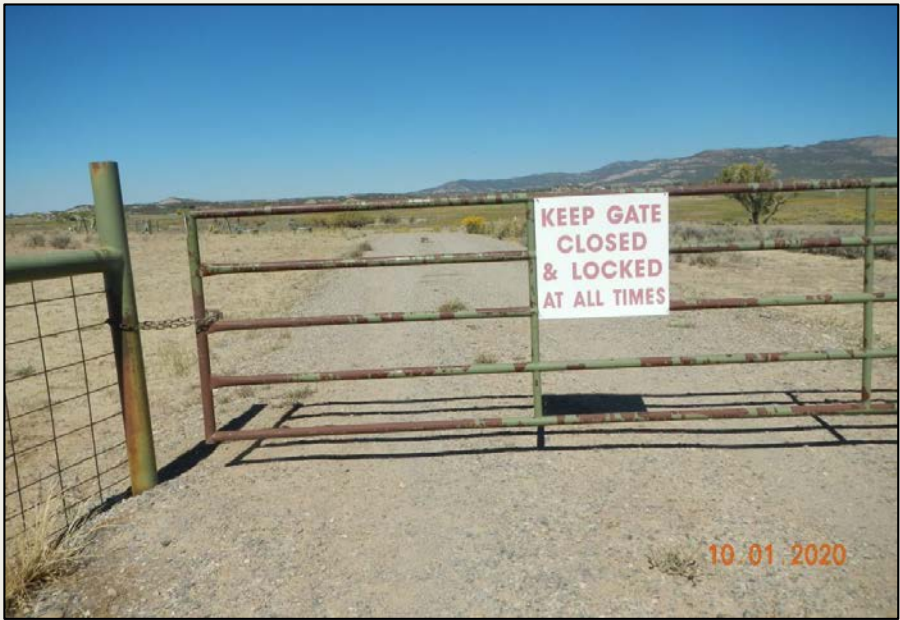
Photos 8/9. Closed gate coming in (left) and leaving (right).
